PRE-PURCHASE PROPERTY INSPECTION BUILDING REPORT

Visual Pre-Purchase Building Inspection Report.

6 RENNELL STREET KINGS PARK.

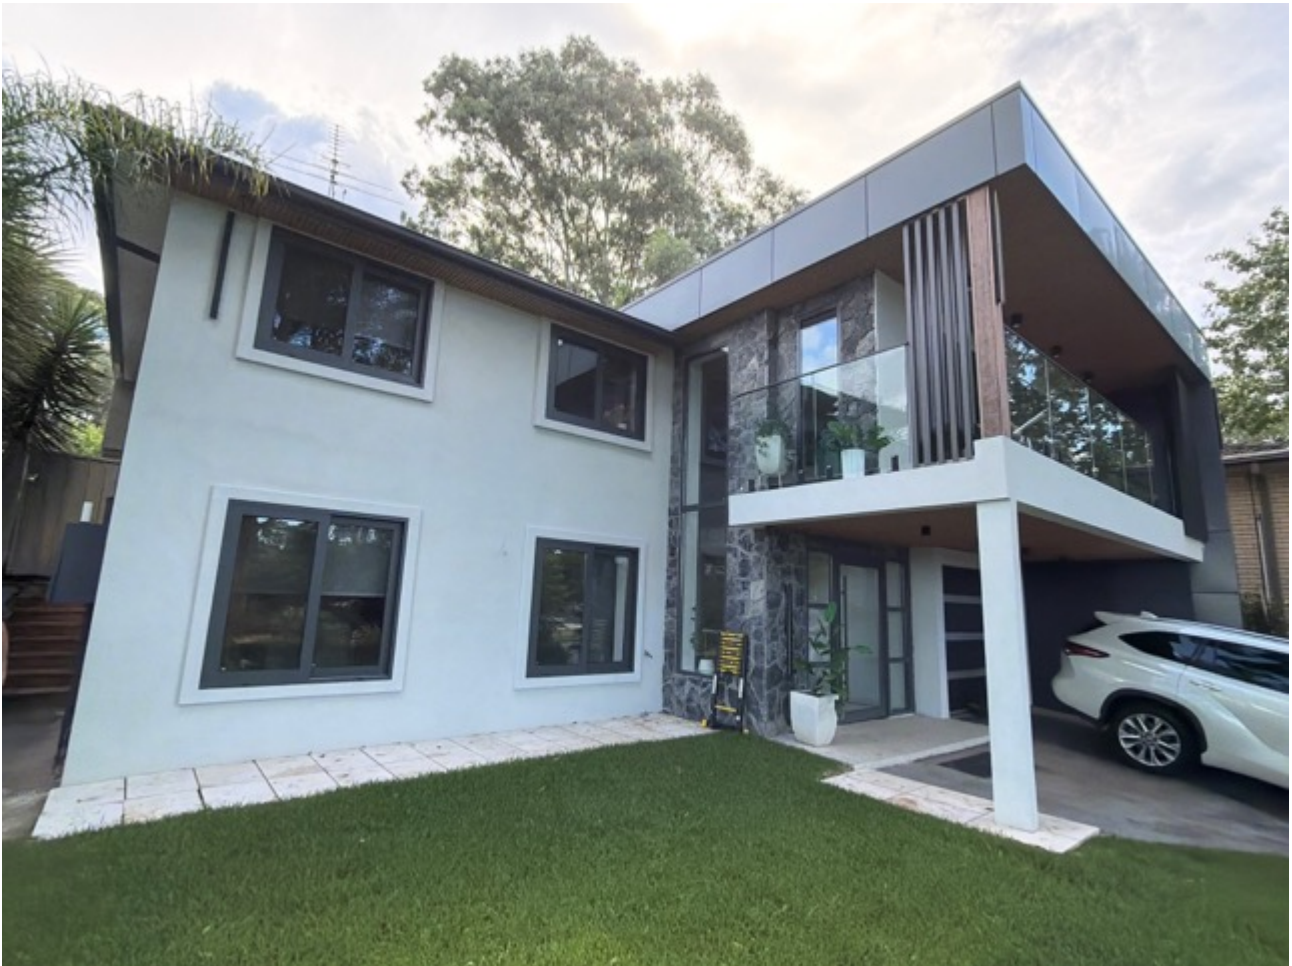
Front elevation of the Inspected property inspected.

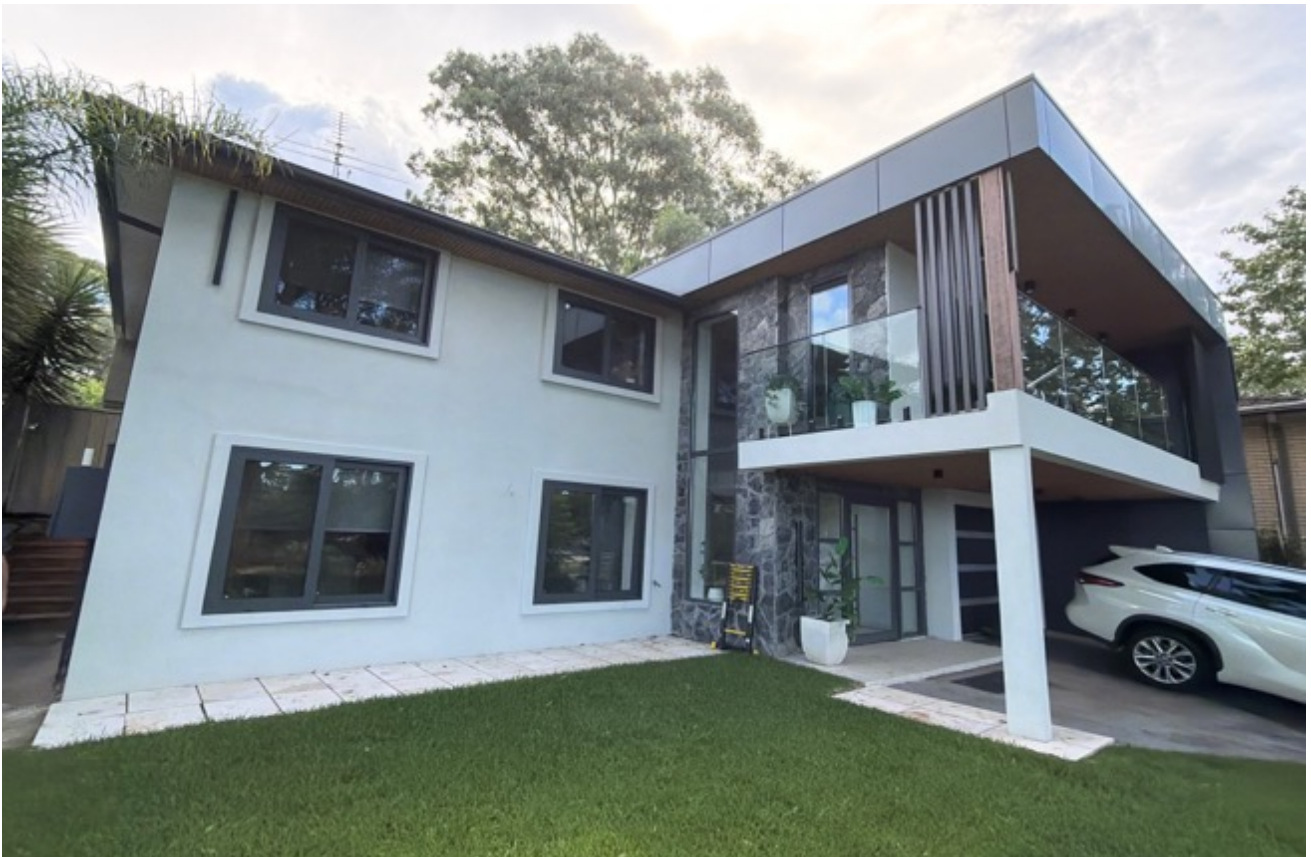
The exterior of the house presents in satisfactory condition displaying no major structural issues at the time of inspection.

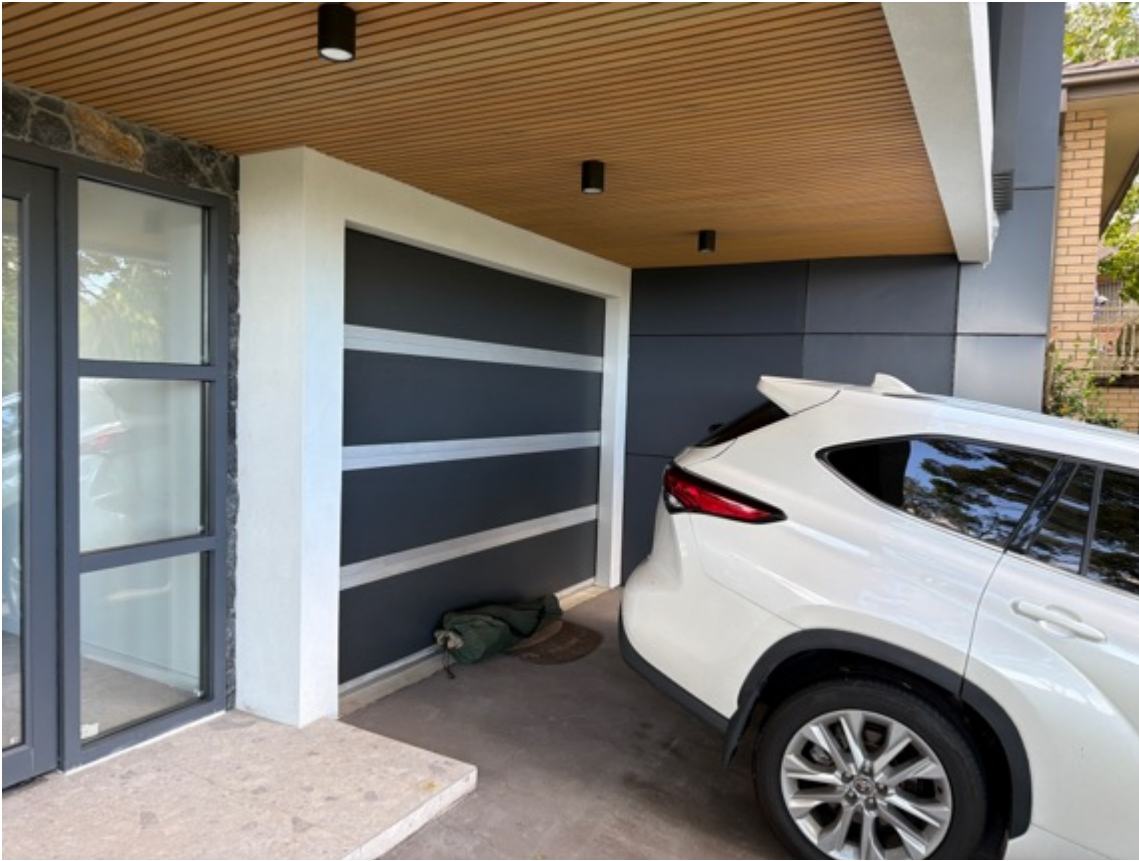
The garage roller door tested, functioned at the time of inspection.

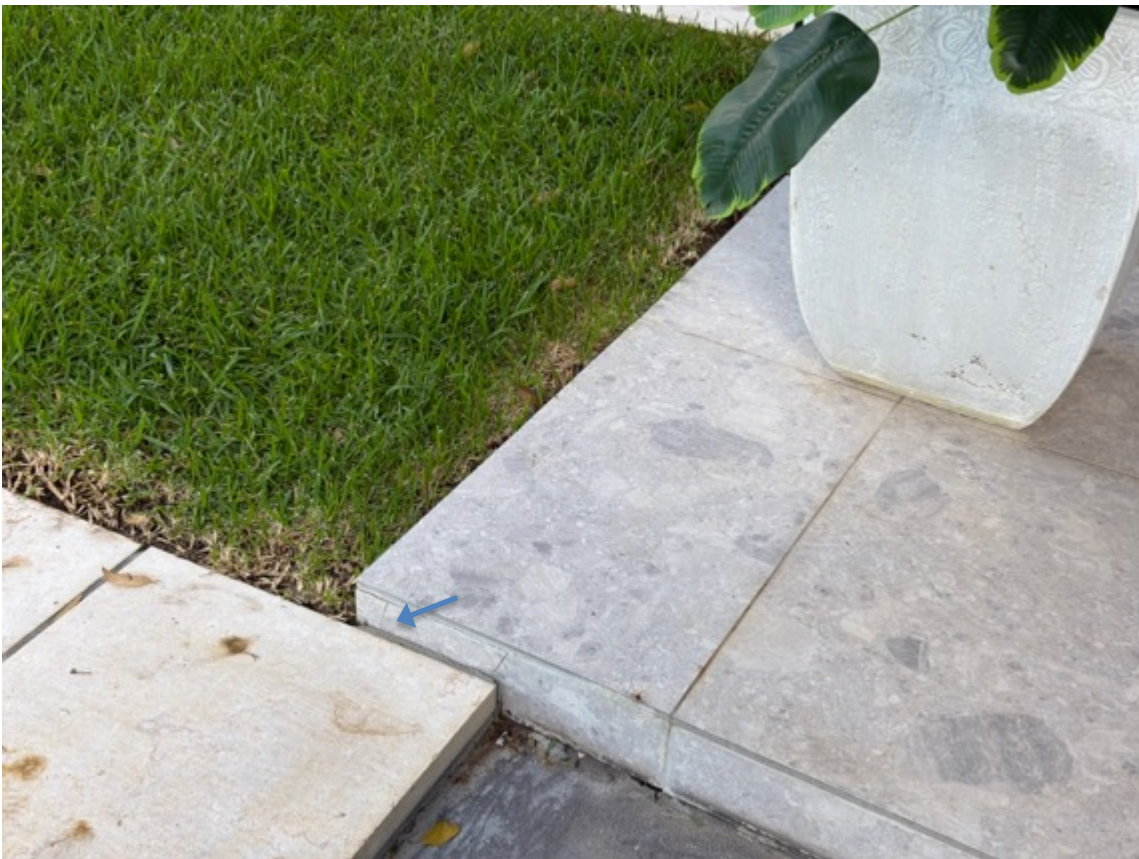
Isolated sections of external tiles are cracked, consistent with age (front patio example above.)

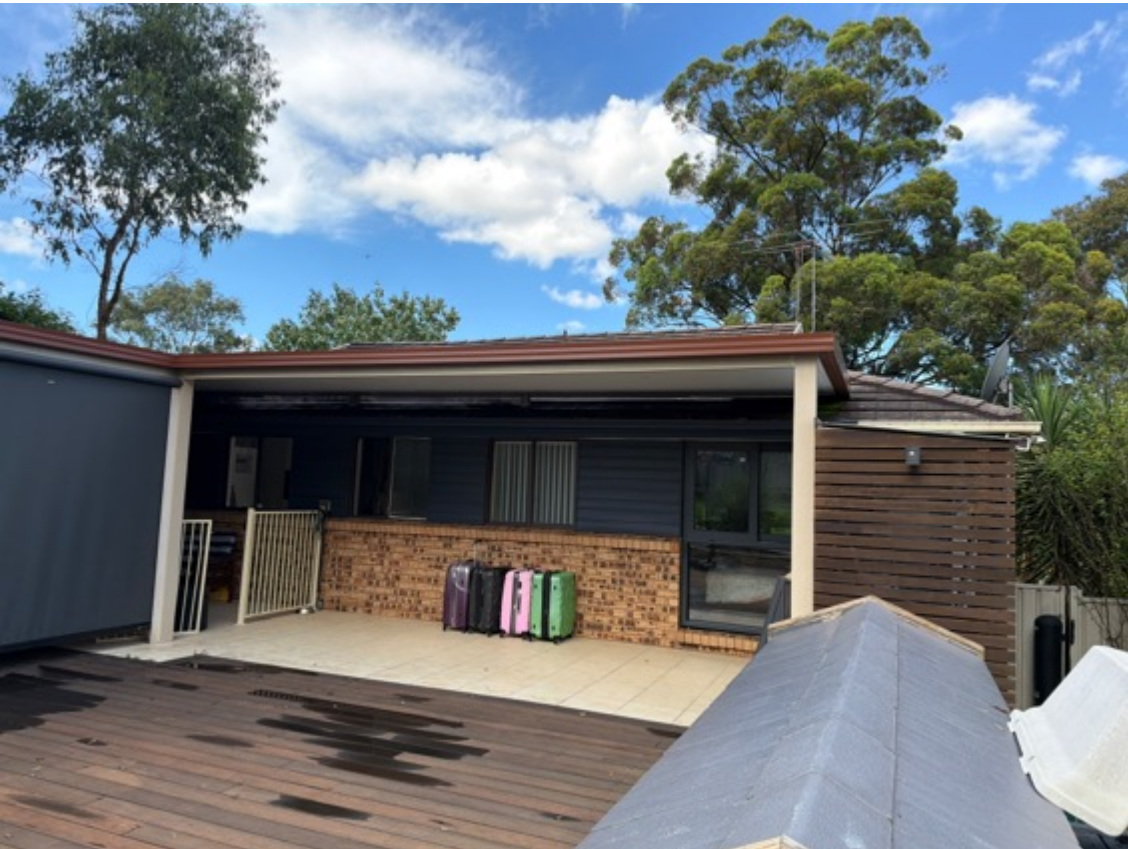
Exterior windows and doors present in satisfactory condition for the age.

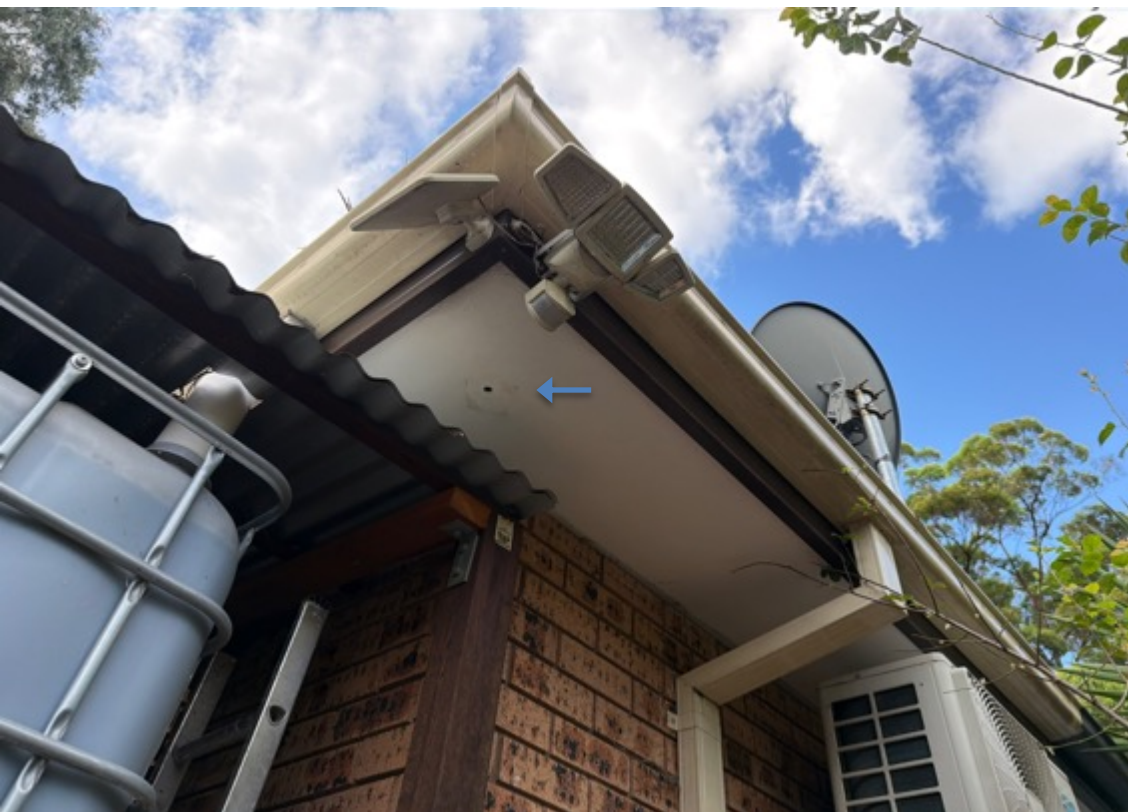
Exterior surfaces display low level paint blemishes, and the rear left elevation eaves lining has been patched here.

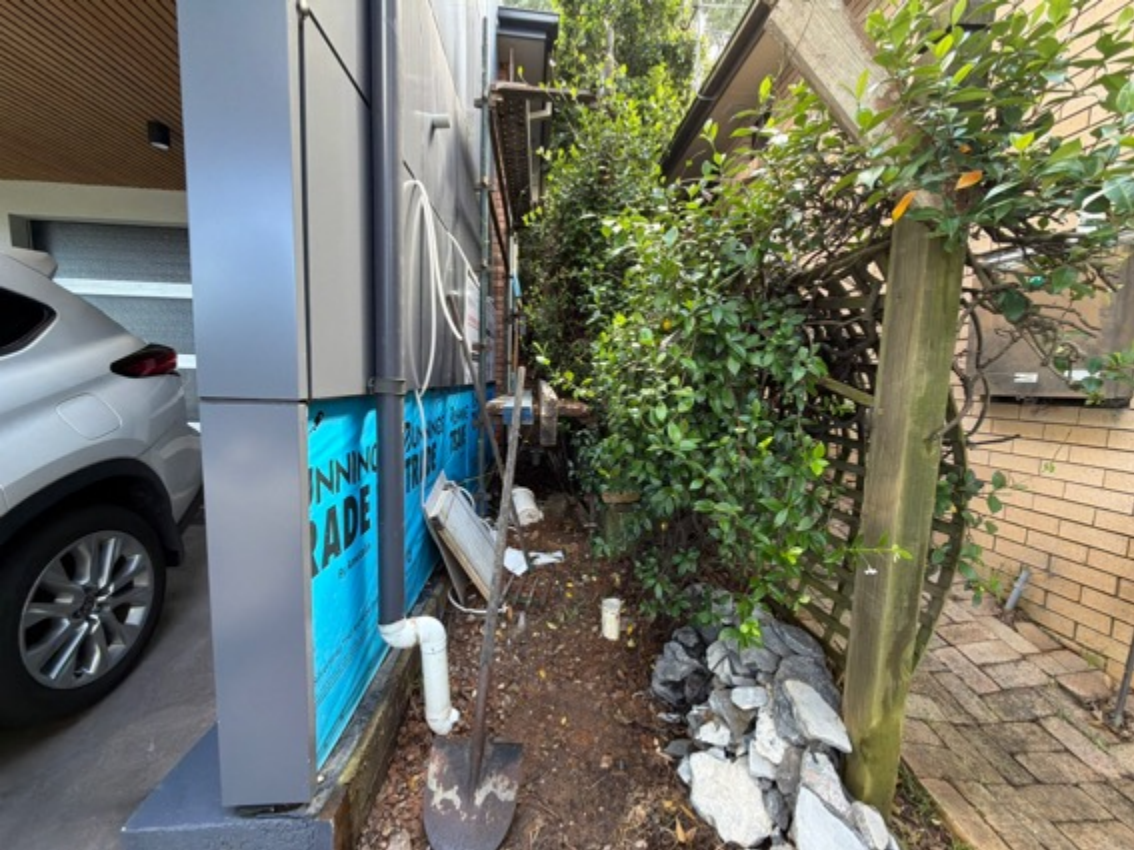
The right side elevation has sections of incomplete work.

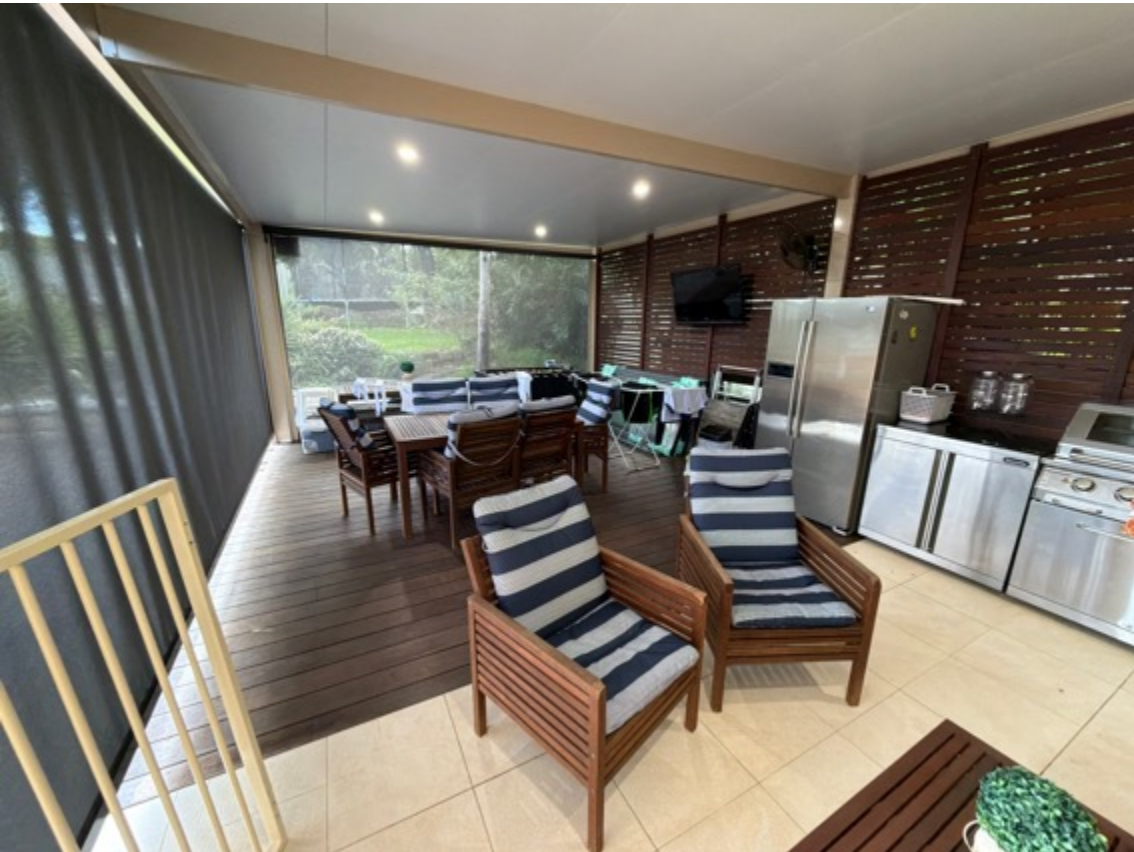
The rear pergola checked is structurally sound.

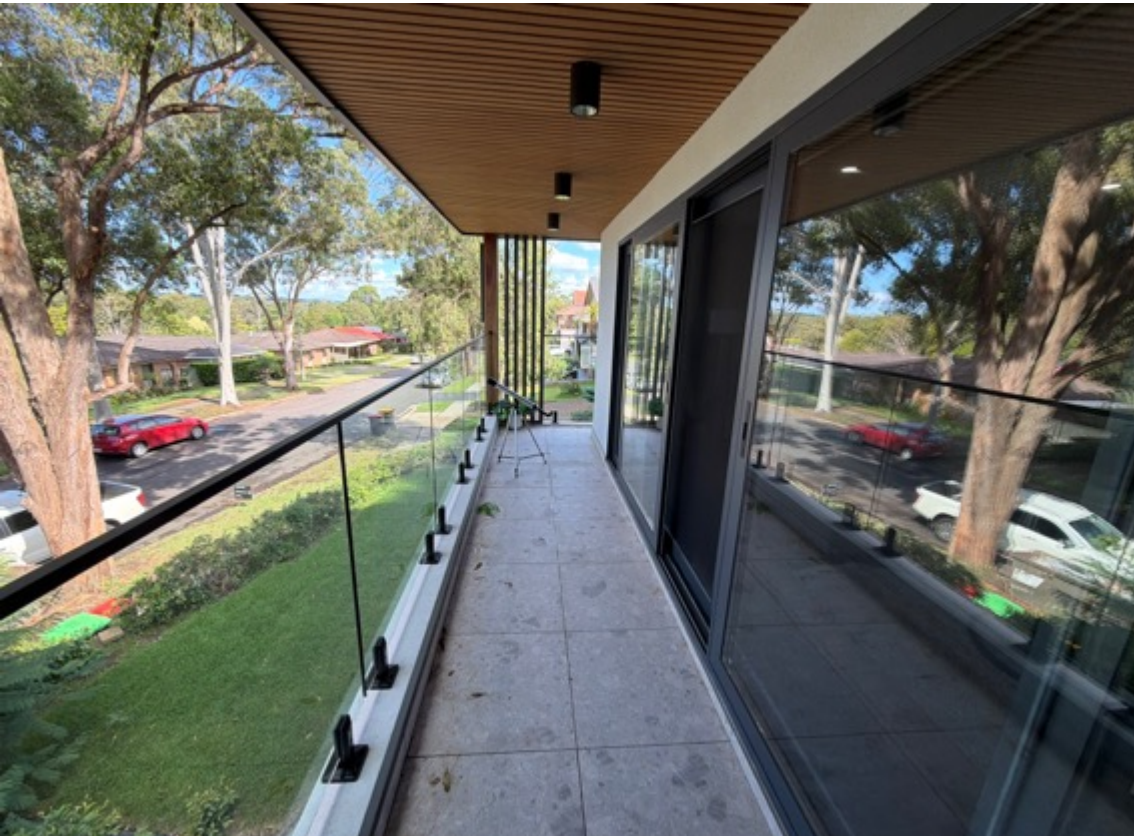
Exterior railings checked are structurally sound –an overflow provision is required.

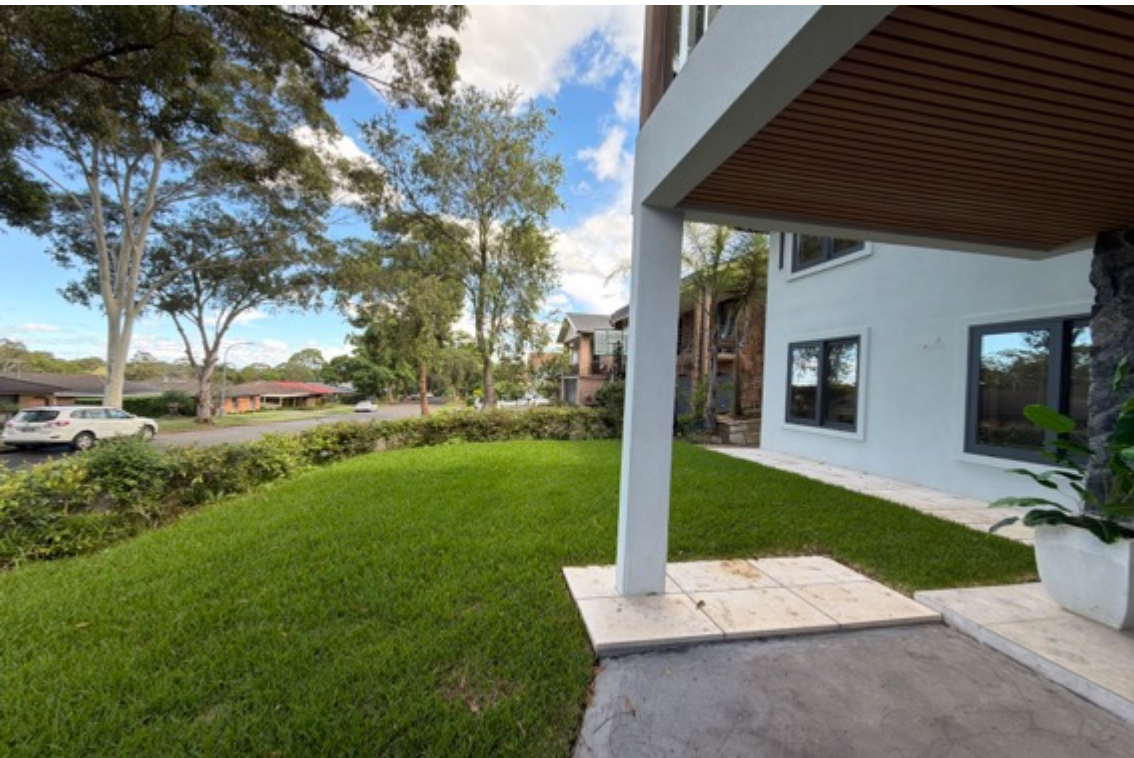
Site drainage / land overflow appears to function adequately with no signs of water laying at the time of inspection.

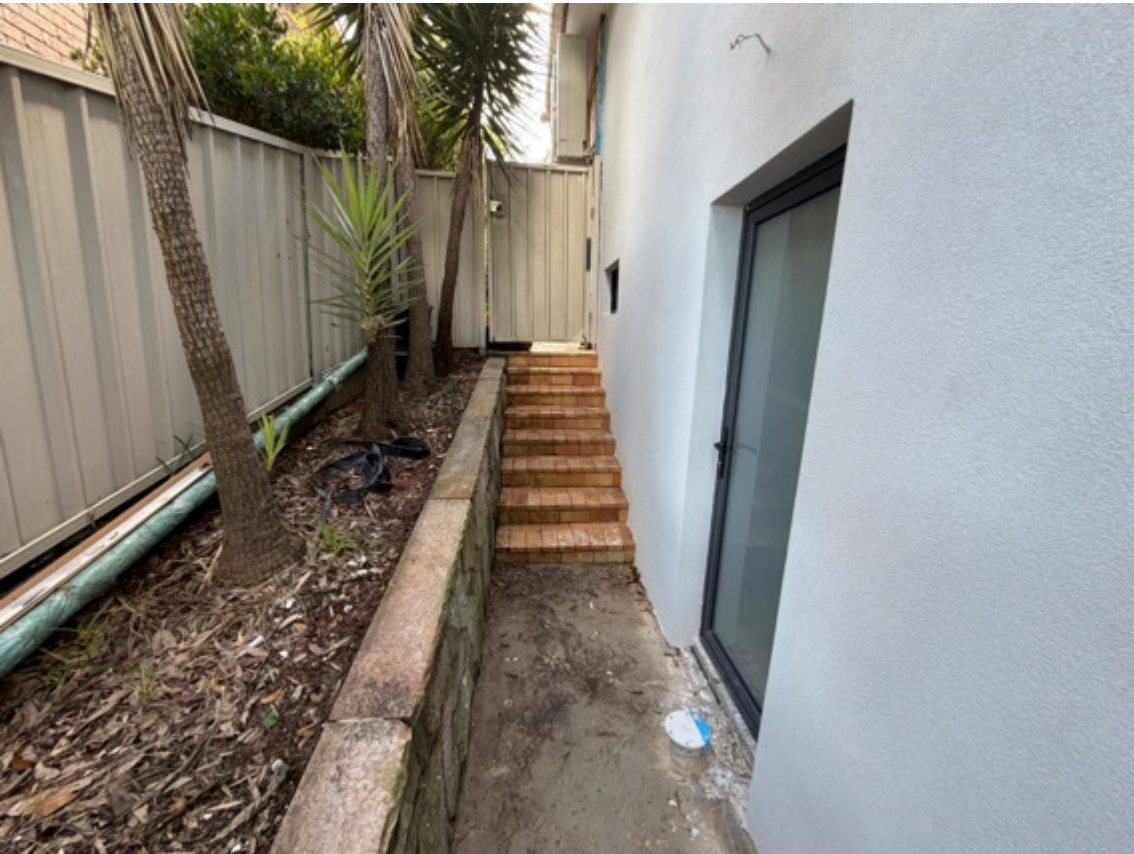
Site fences are in serviceable condition, isolated sections have a slight lean (consistent with age.)

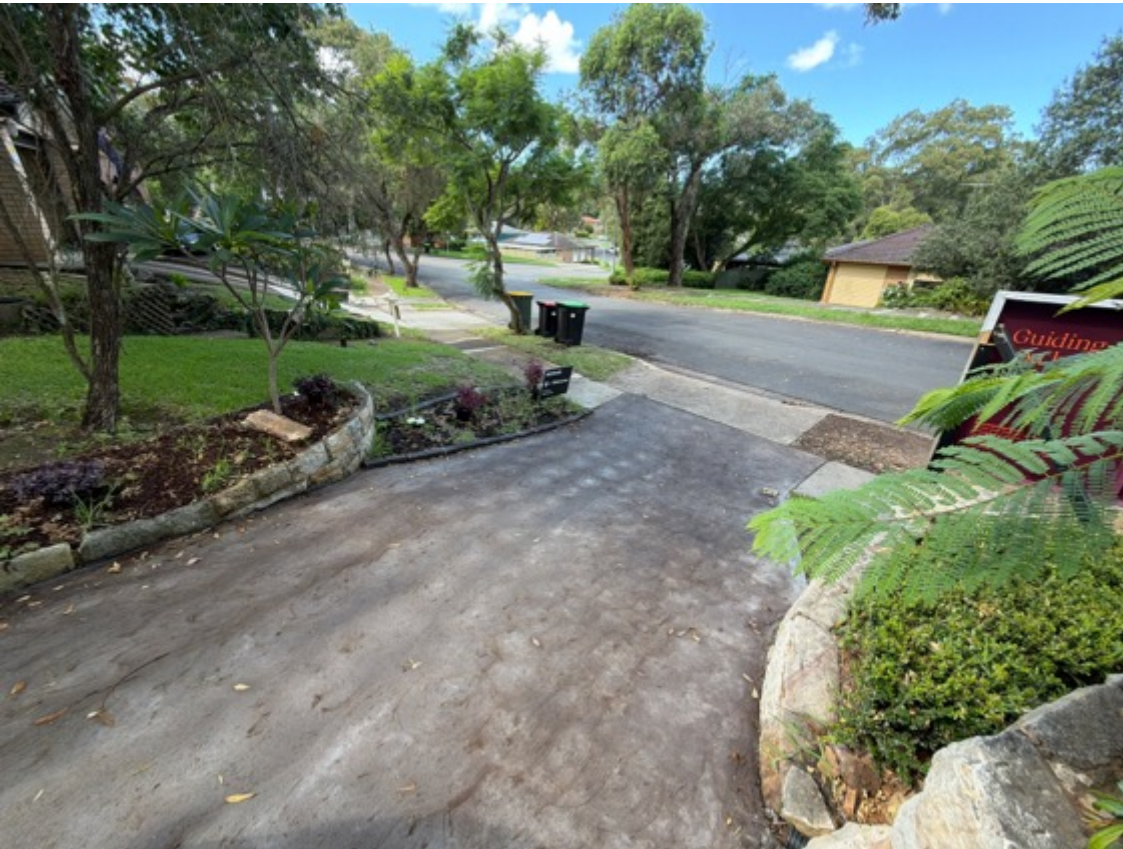
Isolated sections of exterior concrete displays typical shrinkage cracks and undulations - consistent with age.

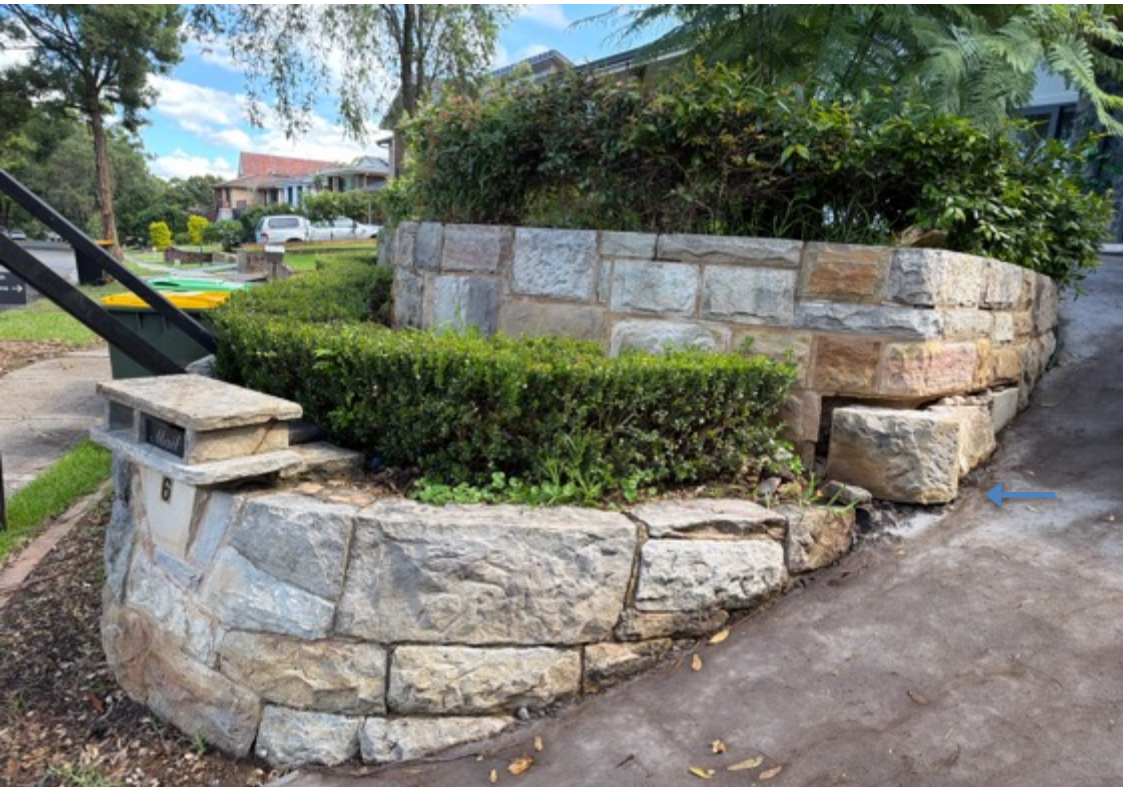
Sections of sandstone garden edging is damaged, requires remedial works.

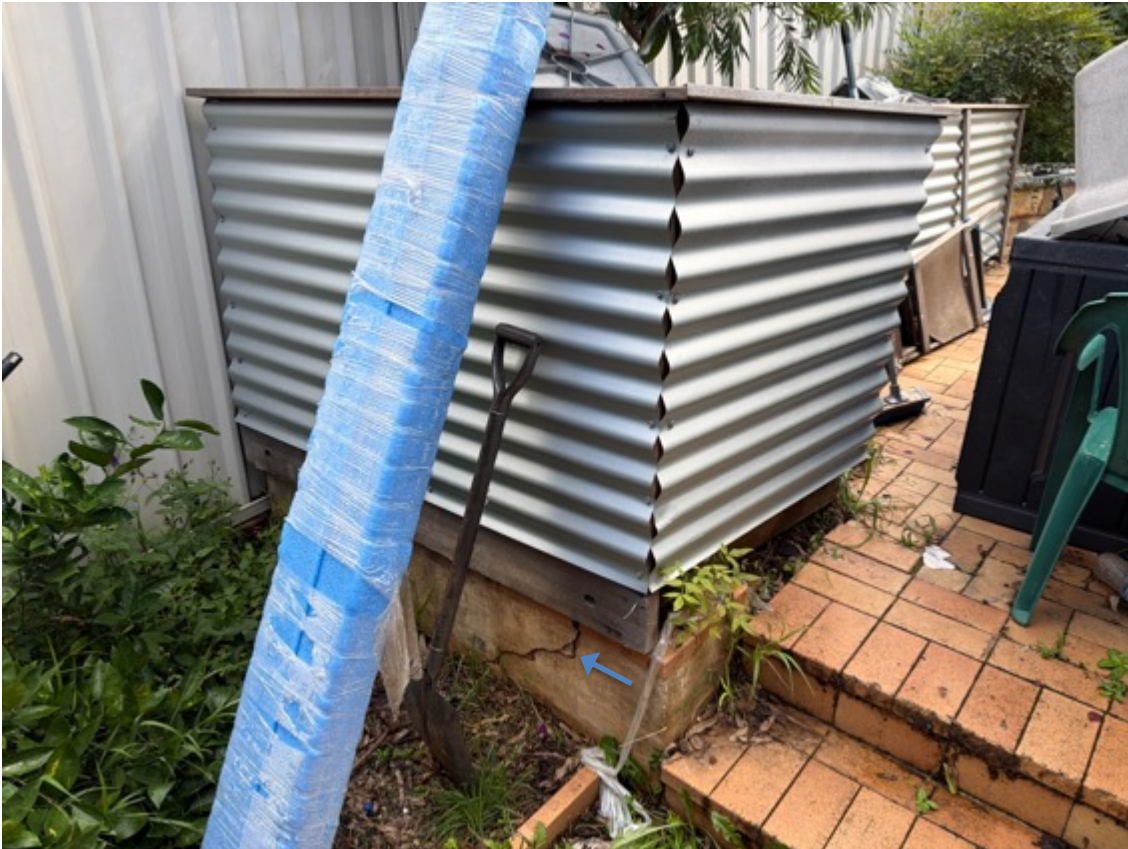
Rear left elevation render is cracking here.

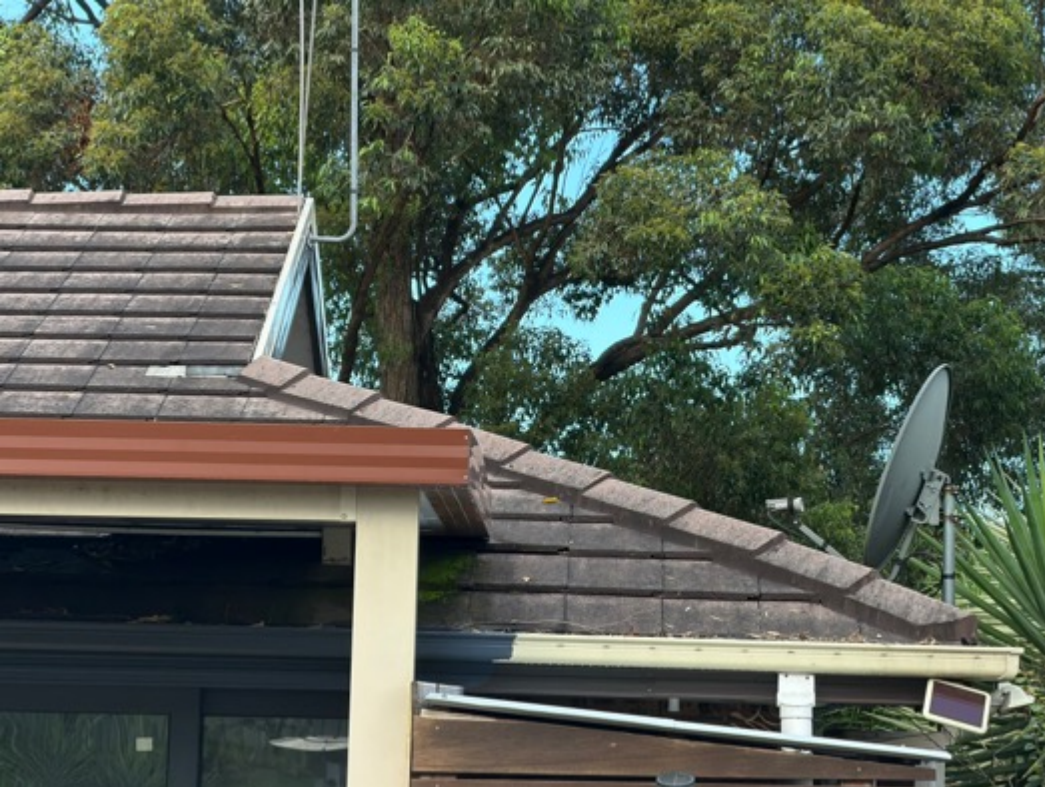
The roof exterior presents in satisfactory condition for the age.

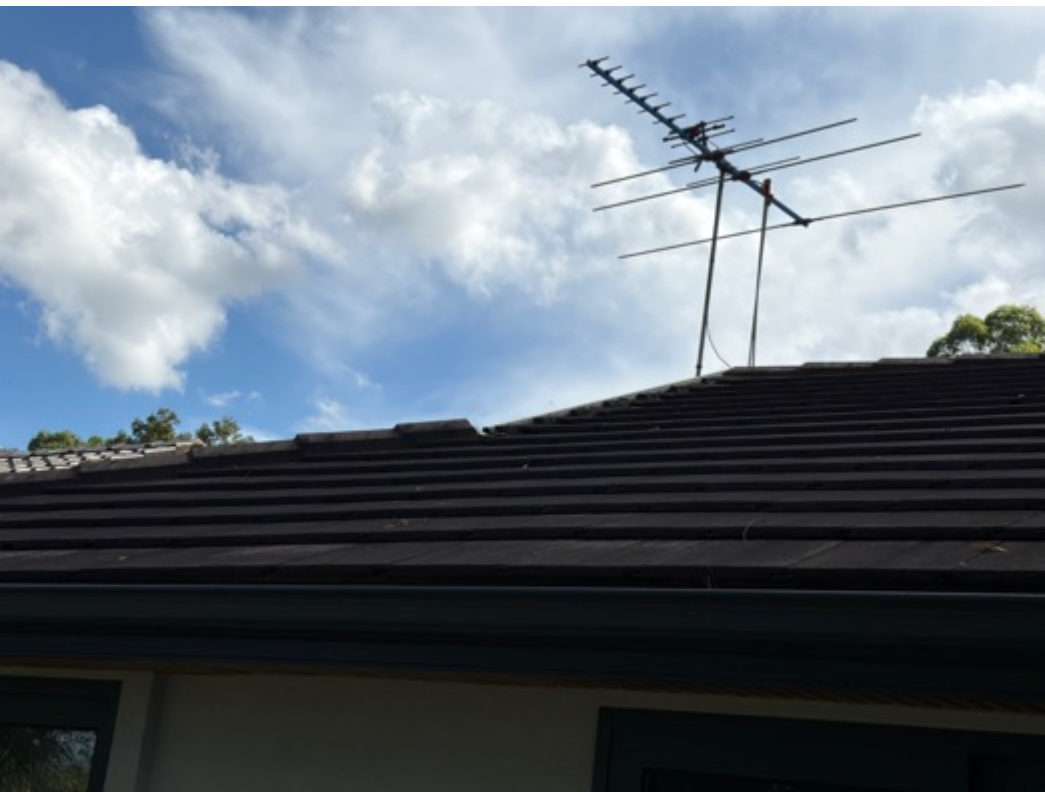
Isolated sections of capping is cracking, consistent with age.

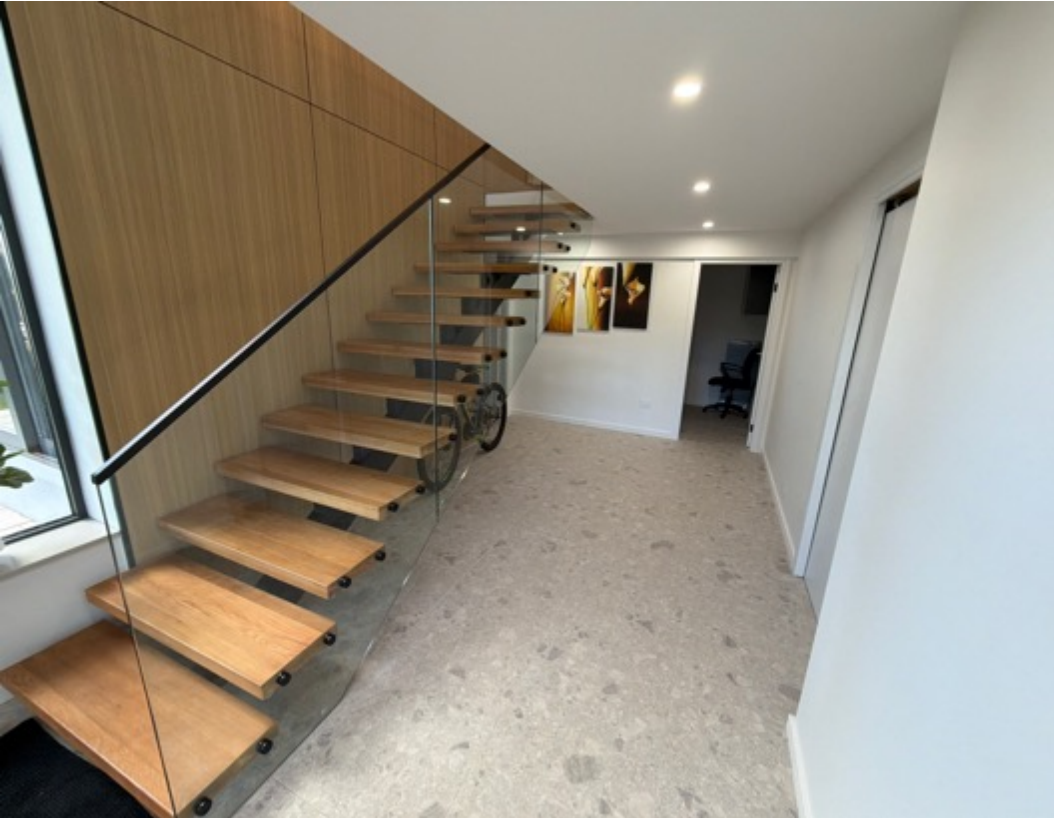
The interior of the house presents in satisfactory condition, maintained to a high level for the age.

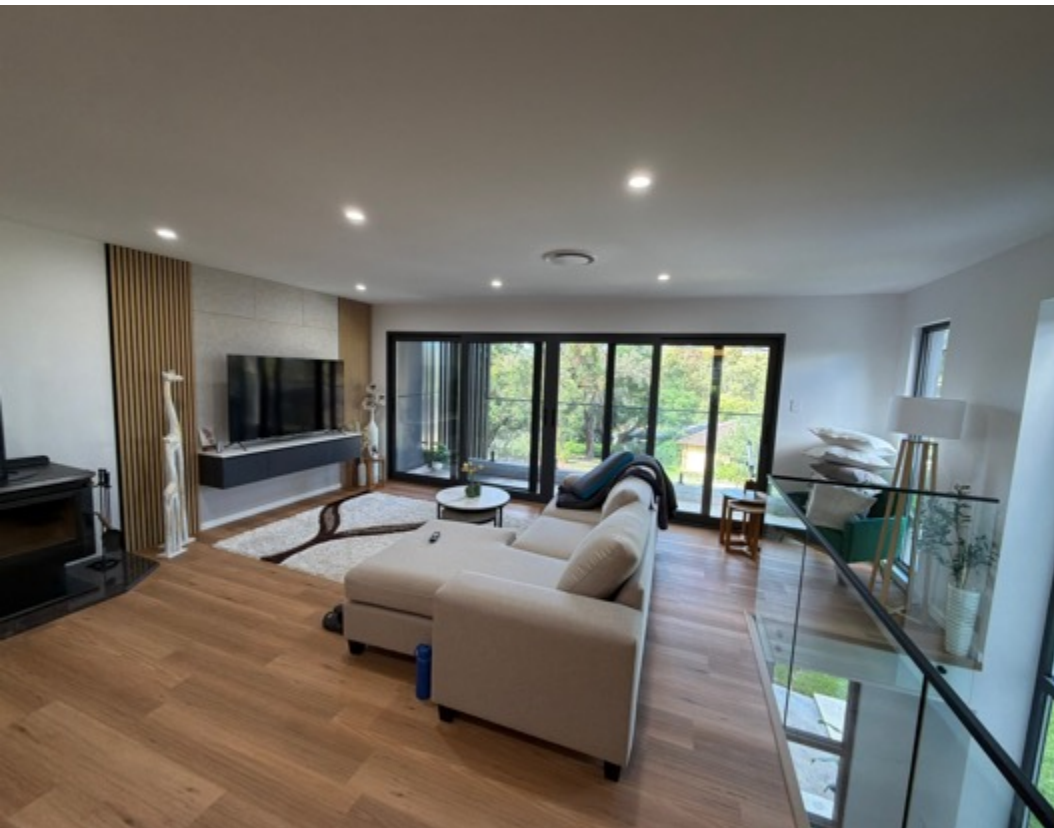
Interior living rooms present in satisfactory condition for the age.

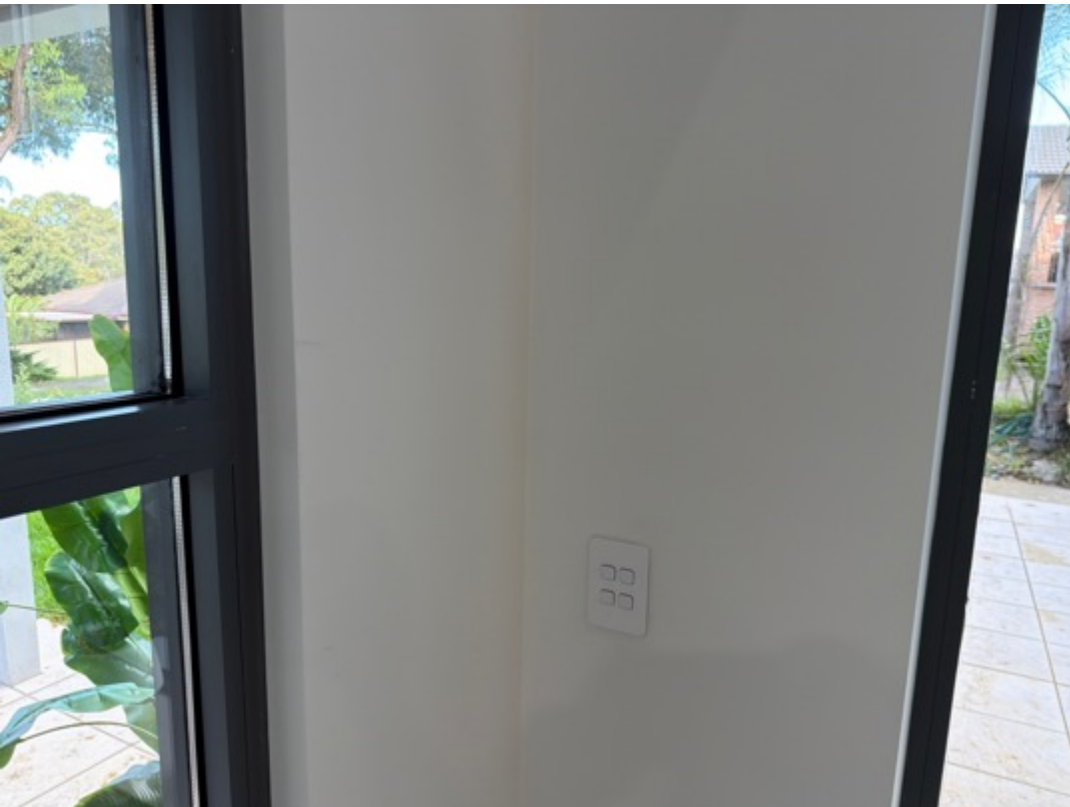
Internal surfaces display low level paint blemishes, consistent with age.

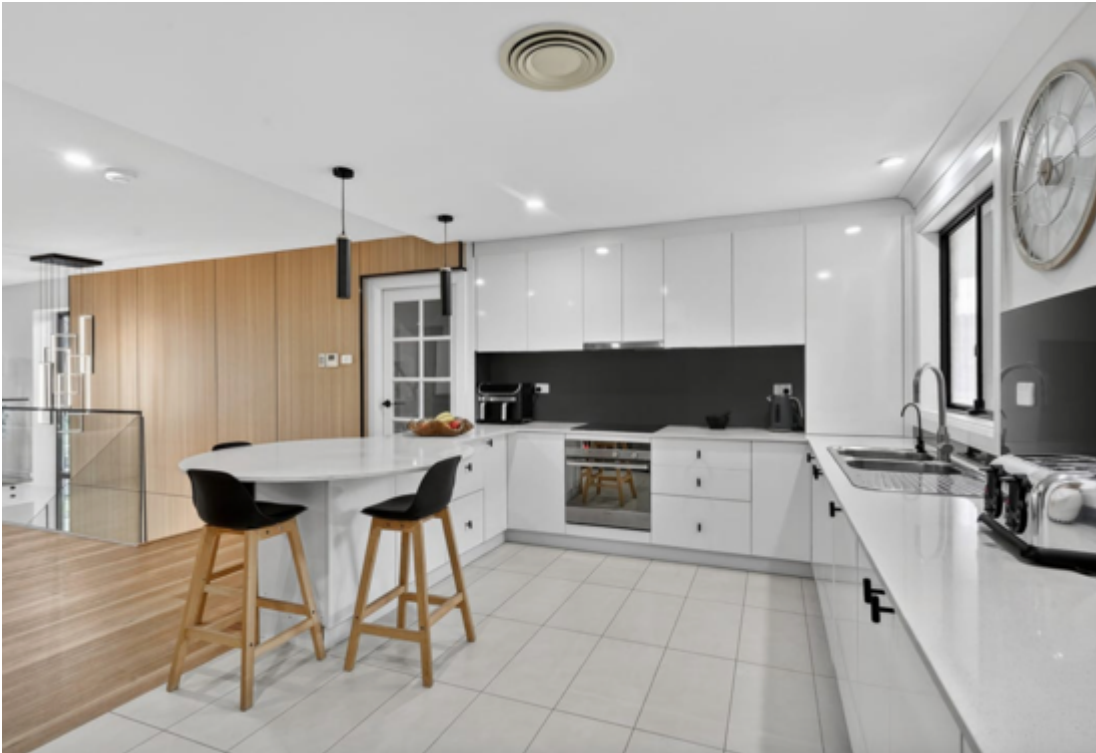
The kitchen area presents in satisfactory condition.

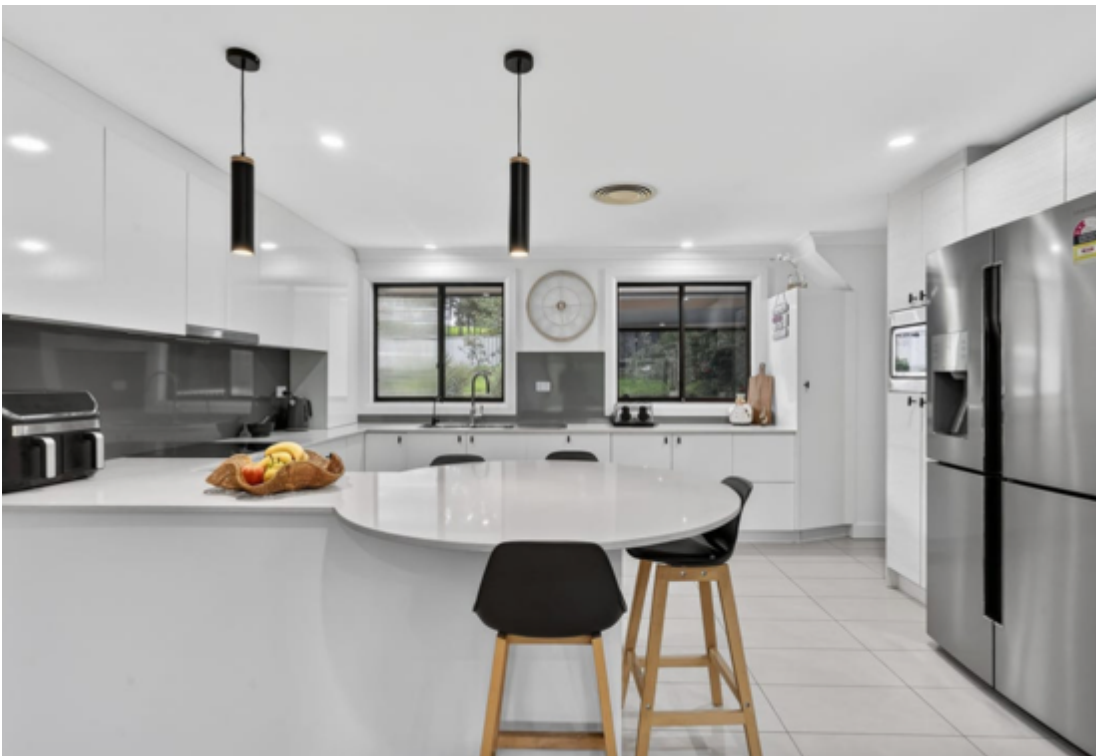
Appliances tested, functioned at the time of inspection.

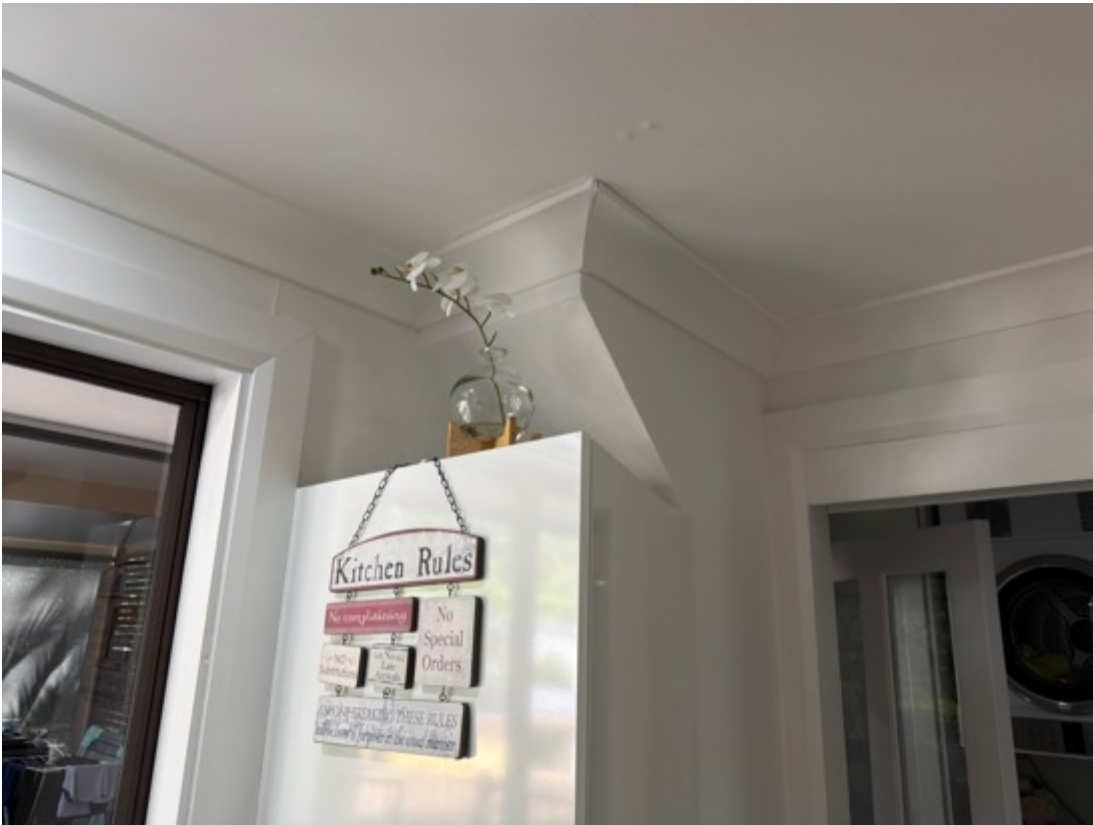
Sections of plasterboard and cornices are cracking, display imperfections.

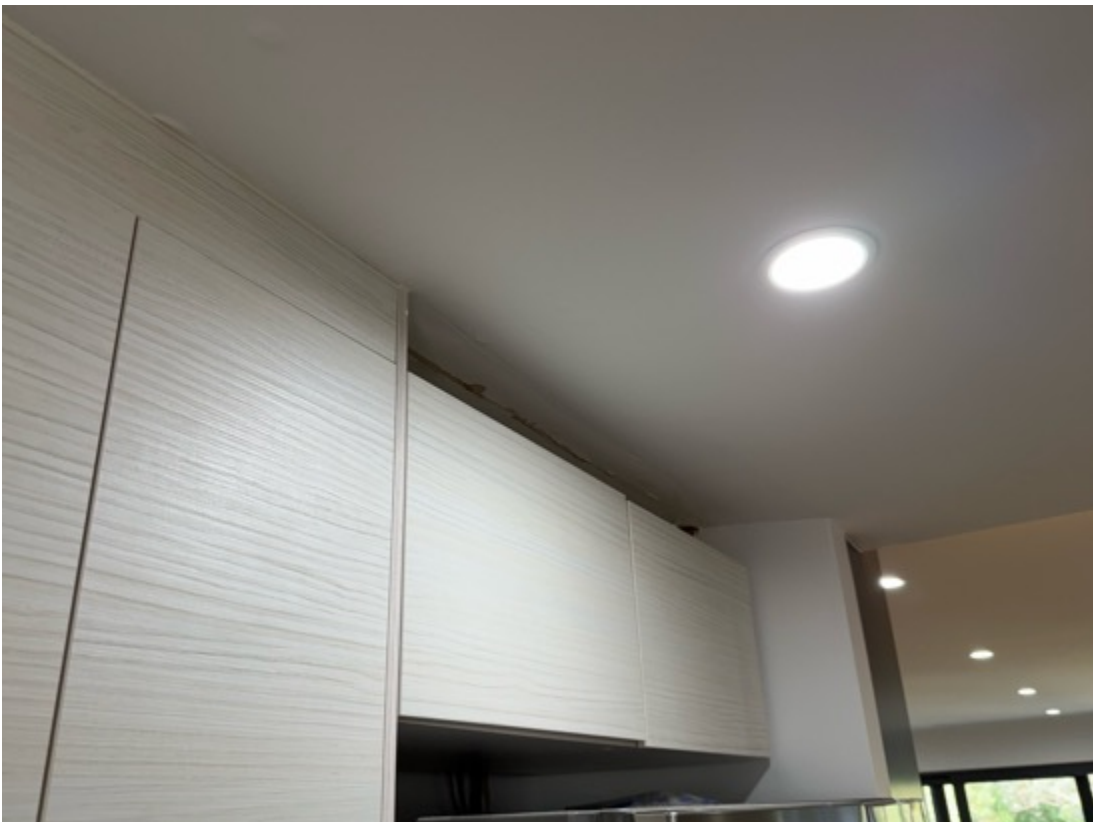
Sections of internal works are incomplete (kitchen example above.)

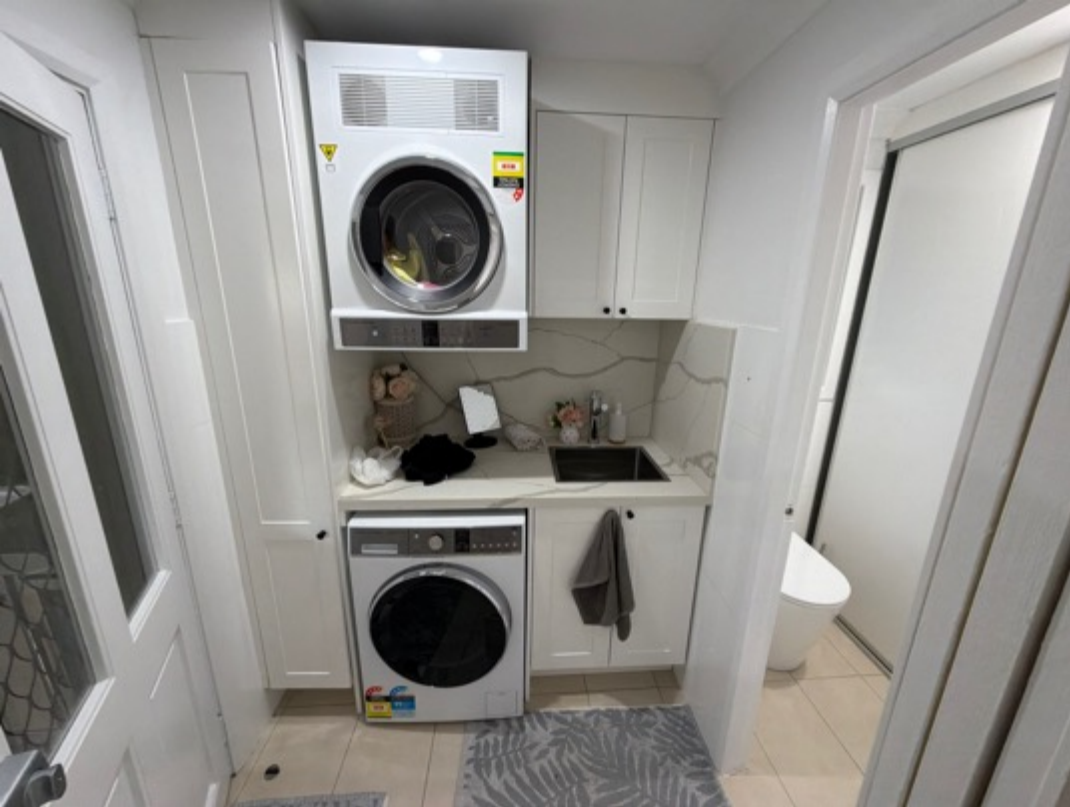
The laundry is in serviceable condition.
