PRE-PURCHASE PROPERTY INSPECTION BUILDING REPORT

Visual Pre-Purchase Building Inspection Report.

6 RENNELL STREET KINGS PARK.

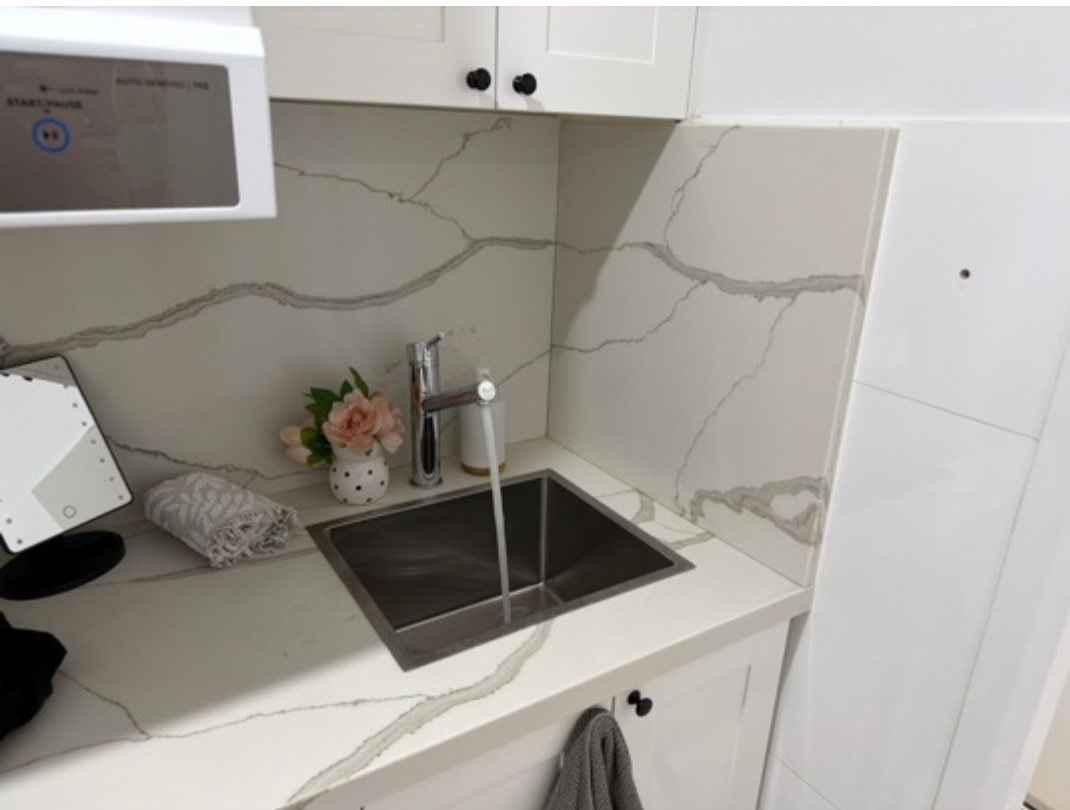
Water pressure tested, is sufficient.

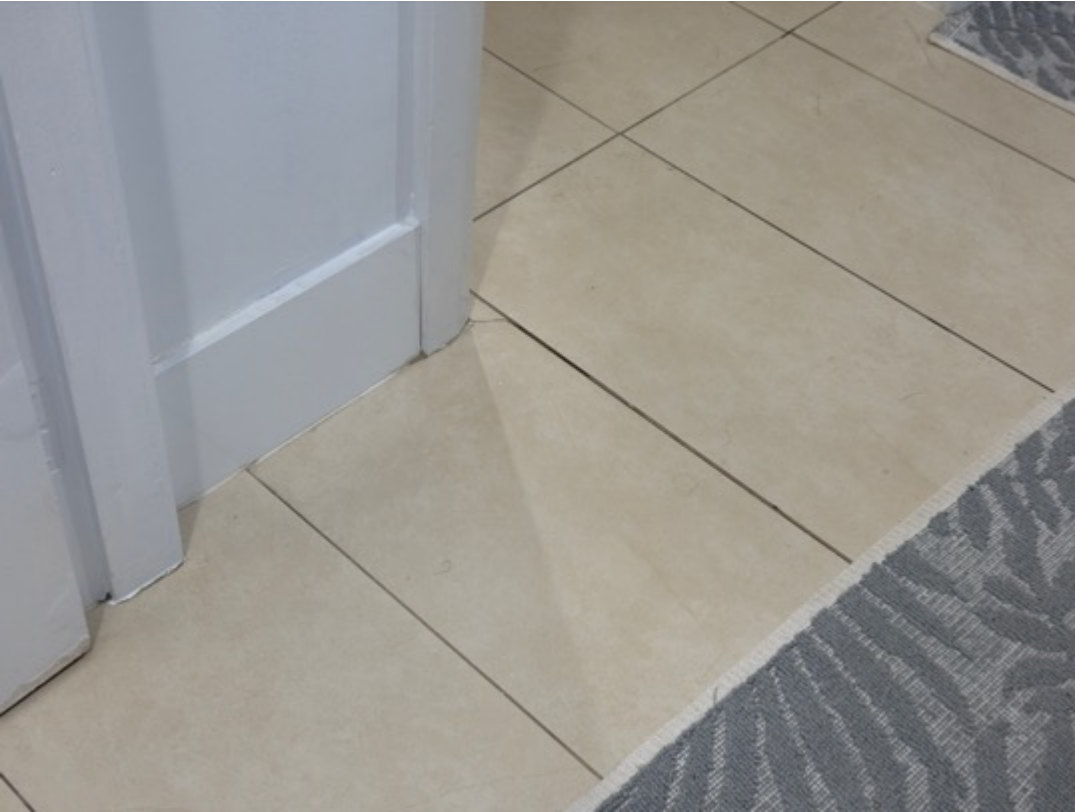
Isolated sections of tiles are cracked, consistent with age.

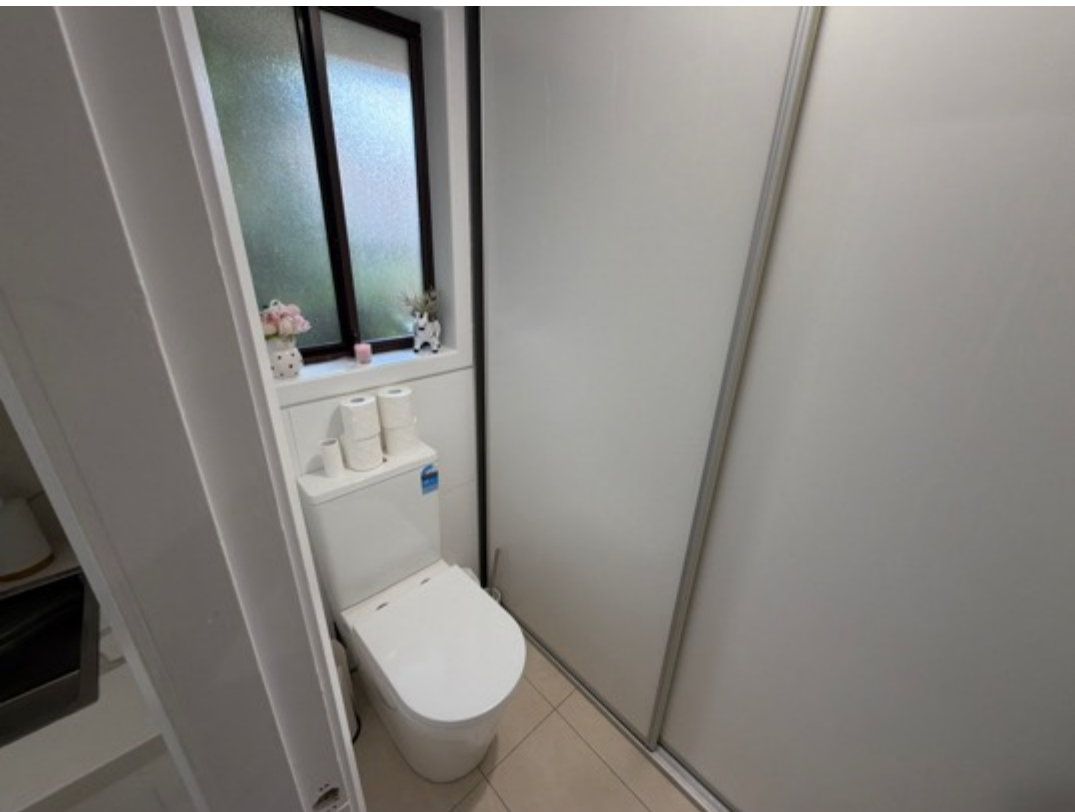
The common toilet tested, functioned at the time of inspection.

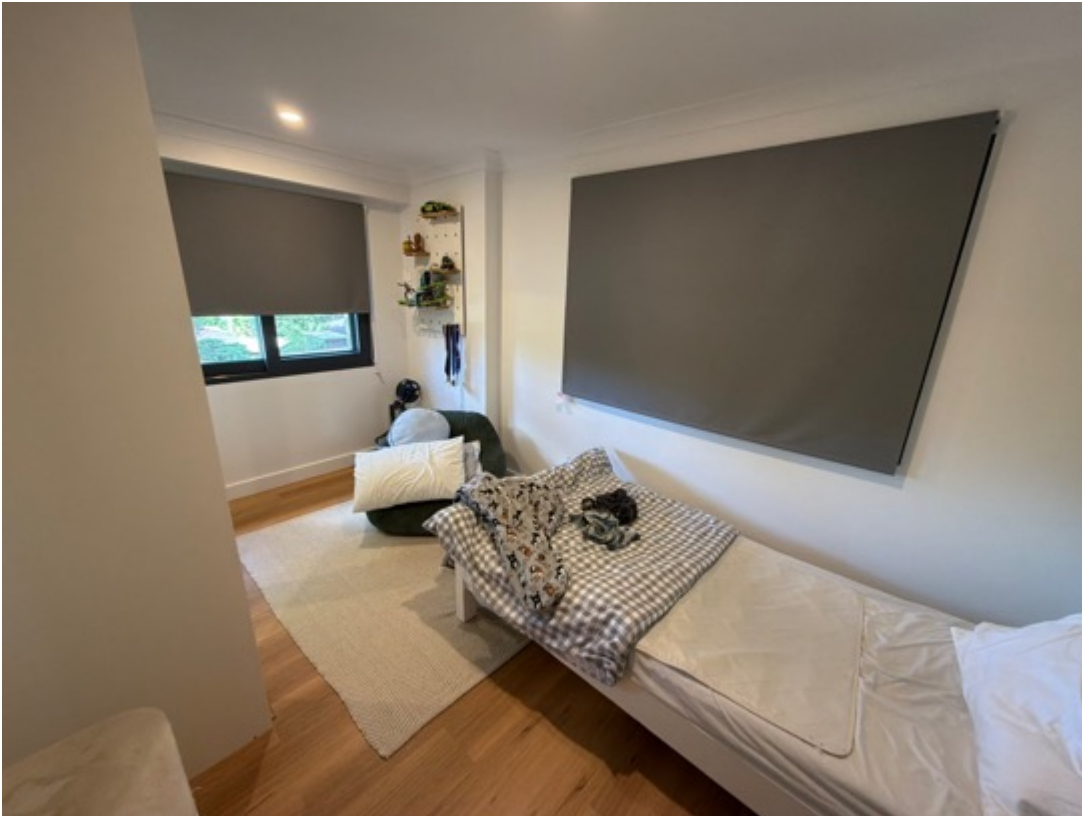
Interior bedroom areas present in satisfactory condition for the age.

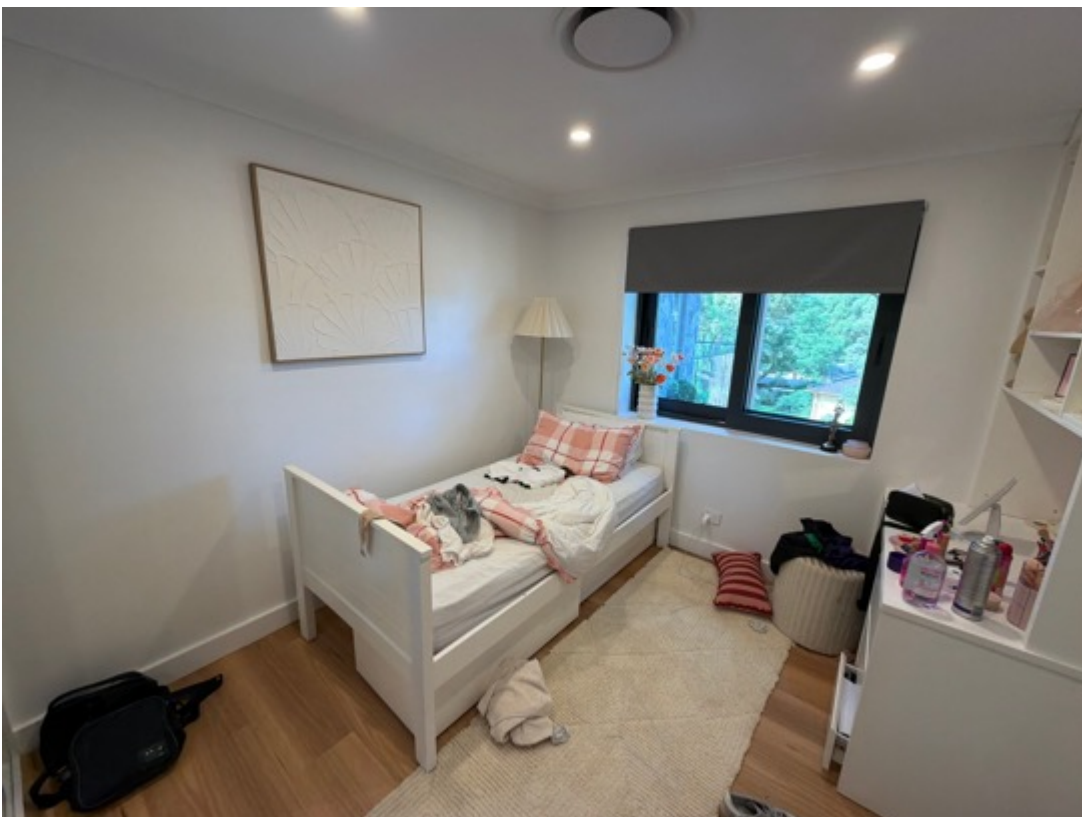
All interior lights tested, functioned as intended at the time of inspection.

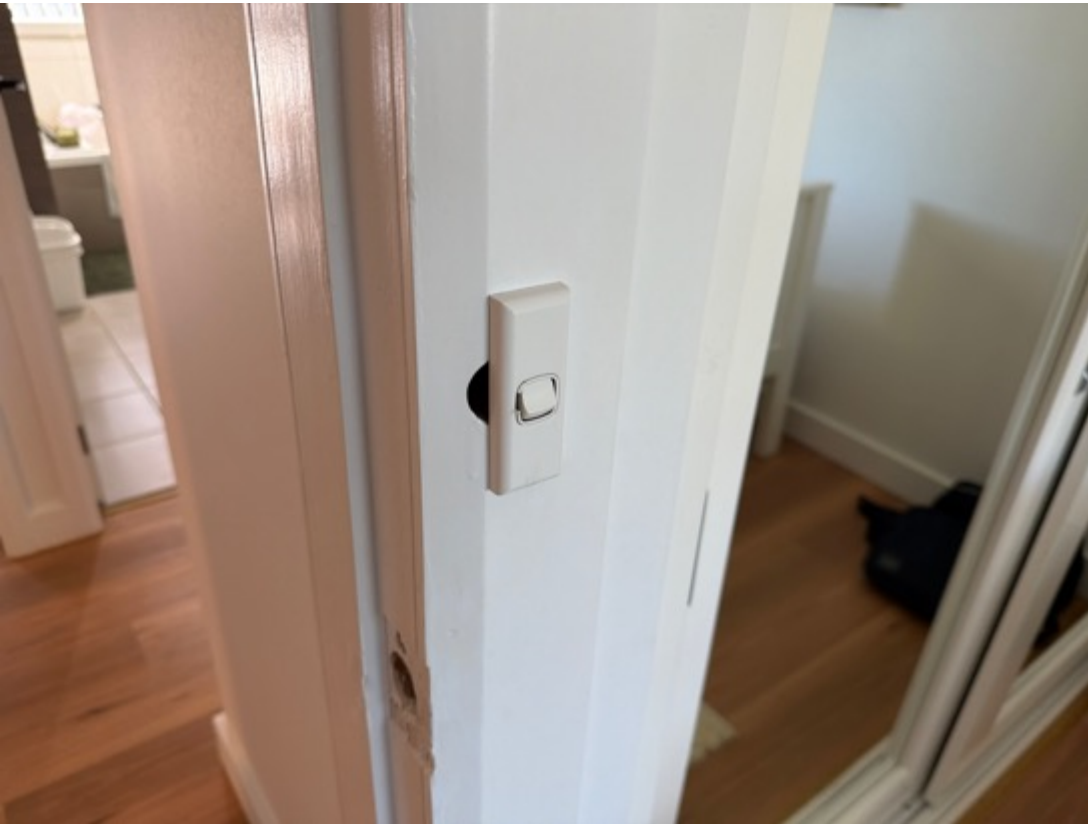
The light switch has a hole here.

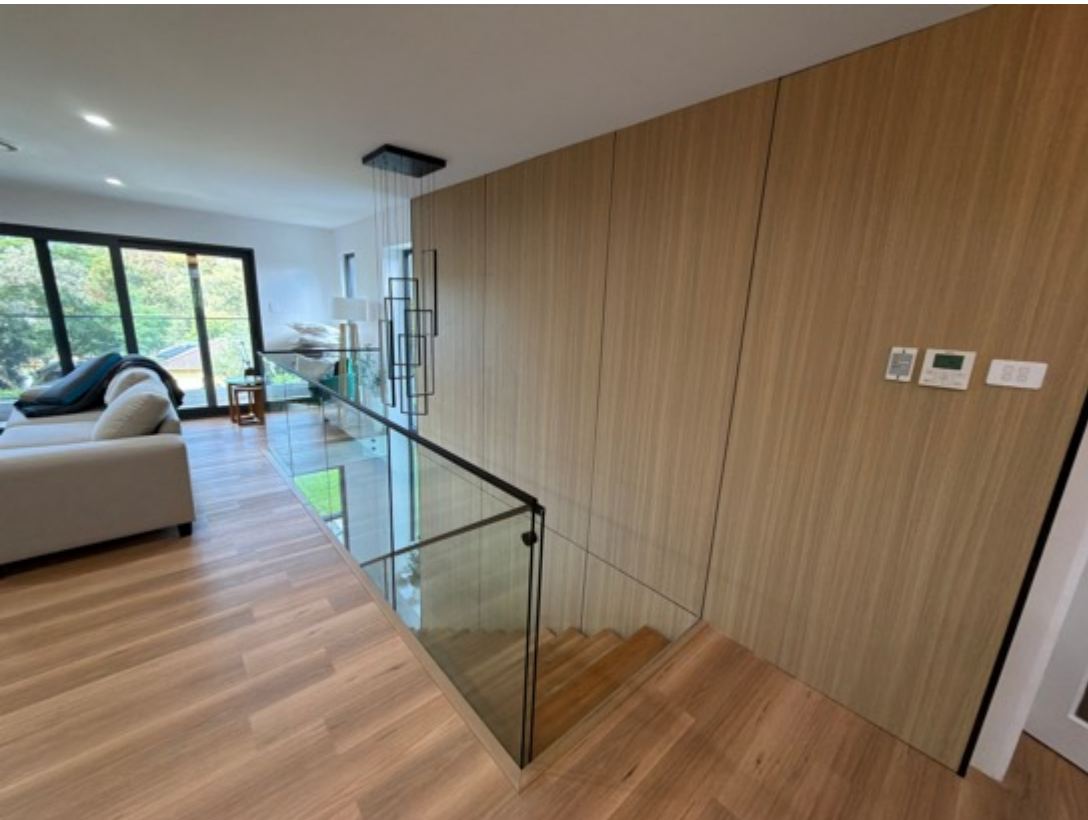
Interior railings checked are structurally sound.

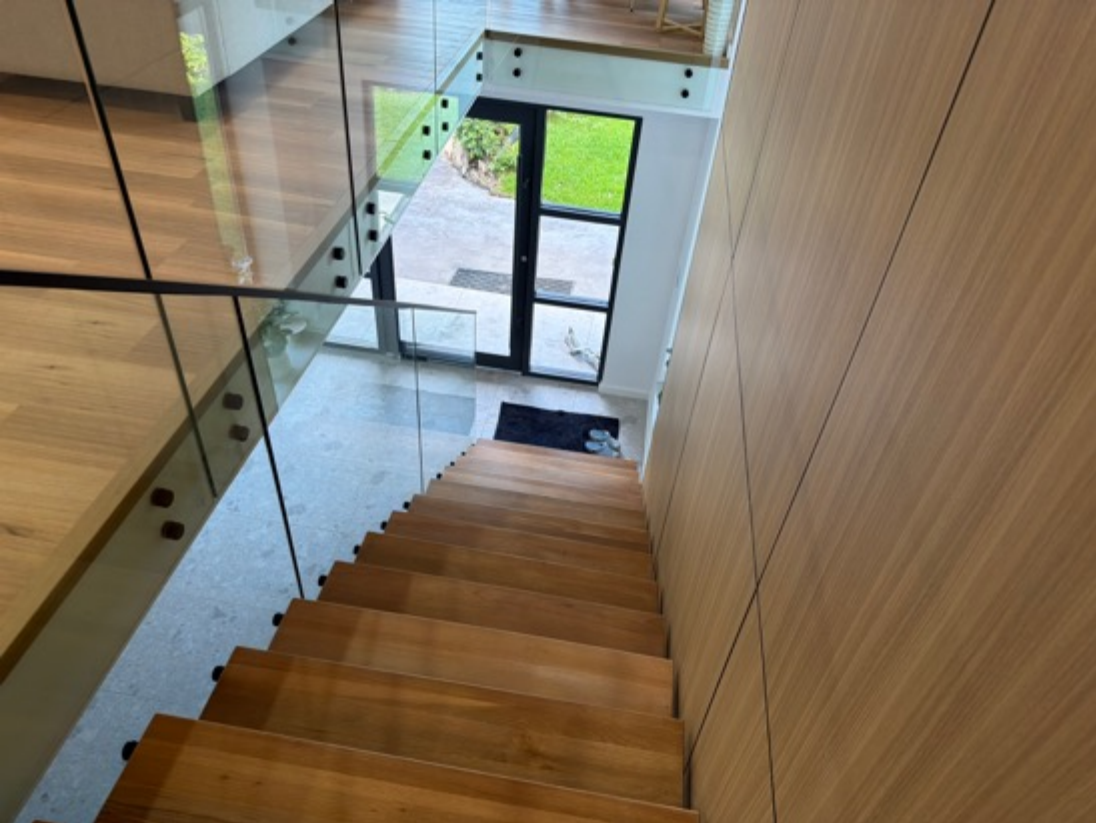
Staircase steps feel uneven under foot.

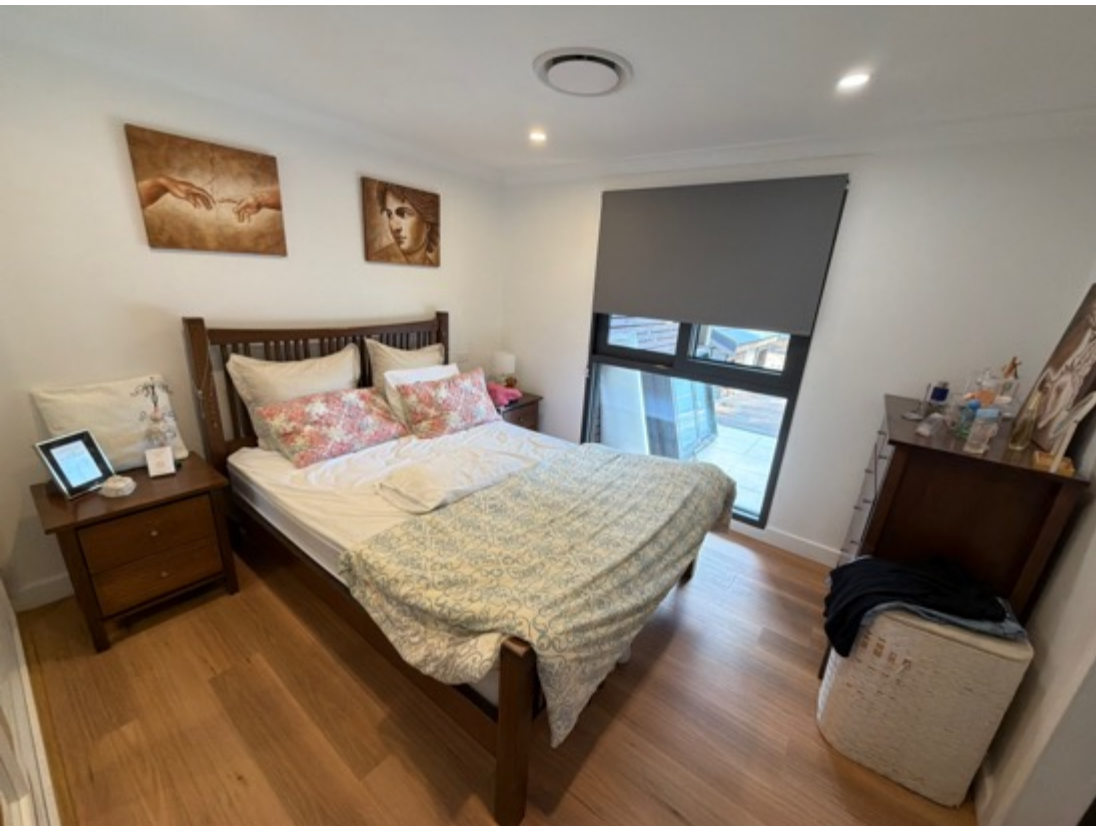
The main bedroom area presents in satisfactory condition for the age.

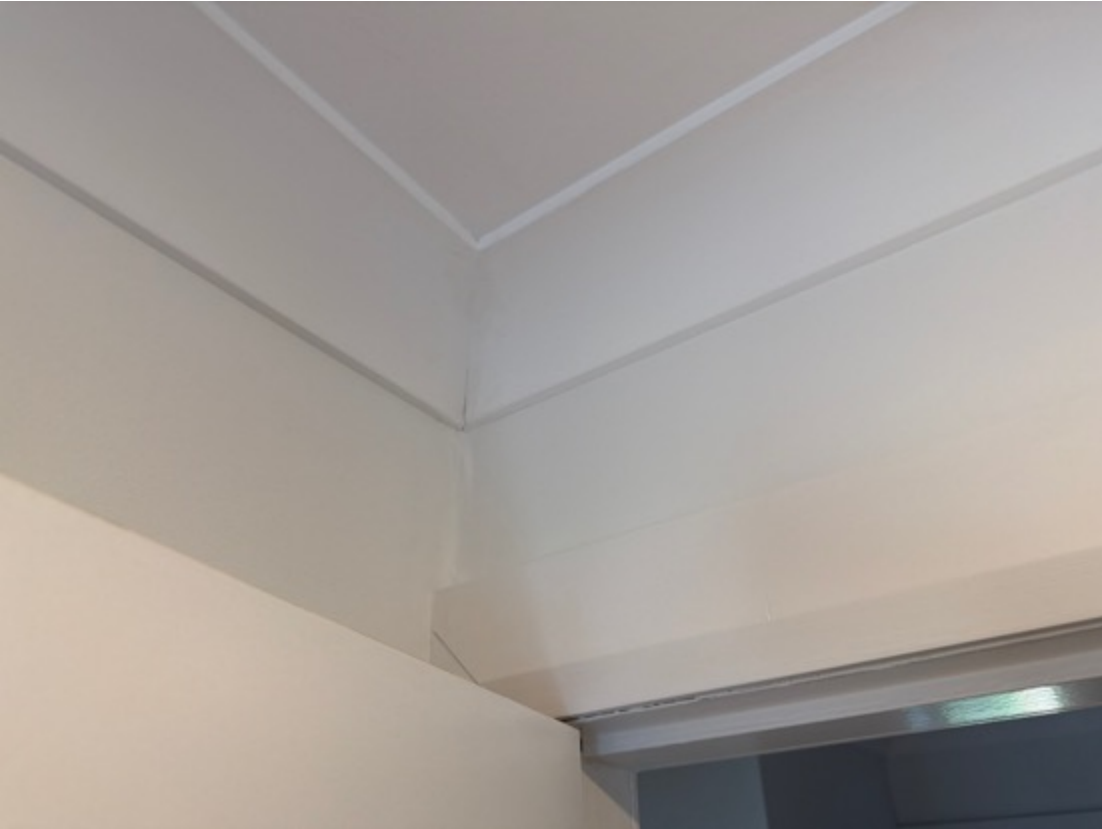
Plasterboard and cornices have minor blemishes and cracking visible (example above the main bedroom entry door.)

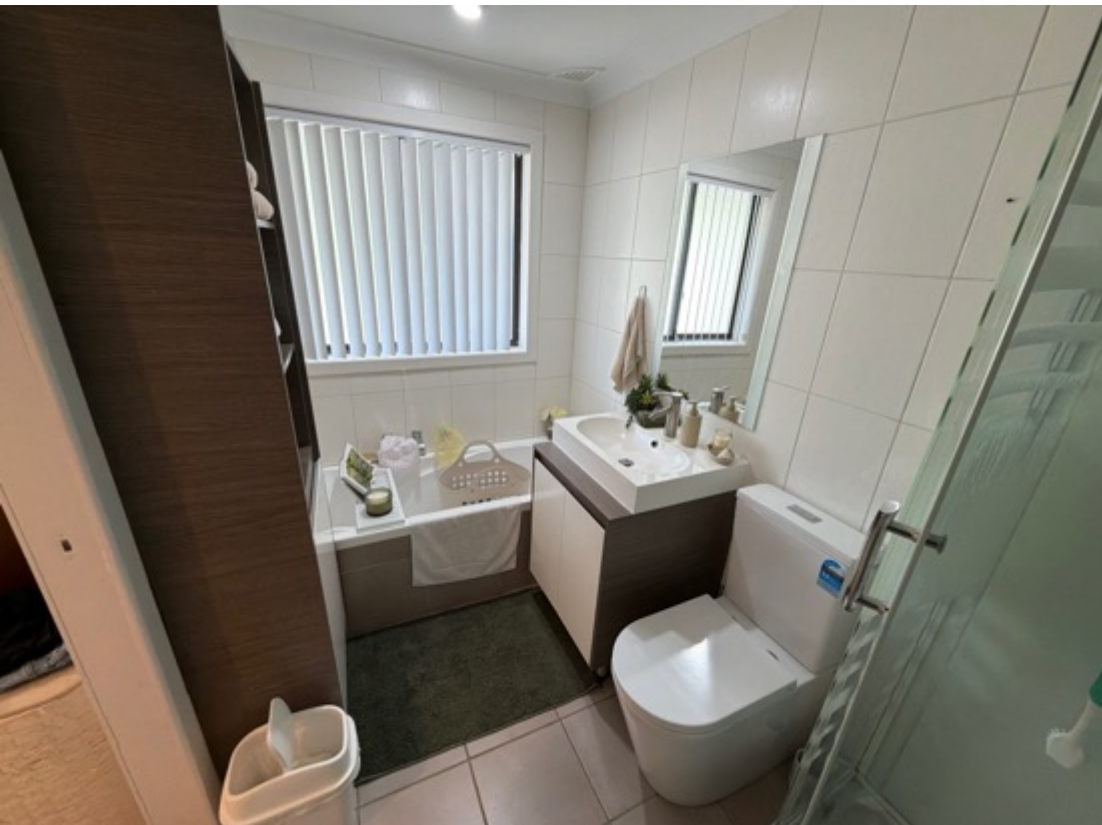
The ensuite bathroom area tested for leaks, fixings and stability was all clear at the time of inspection.

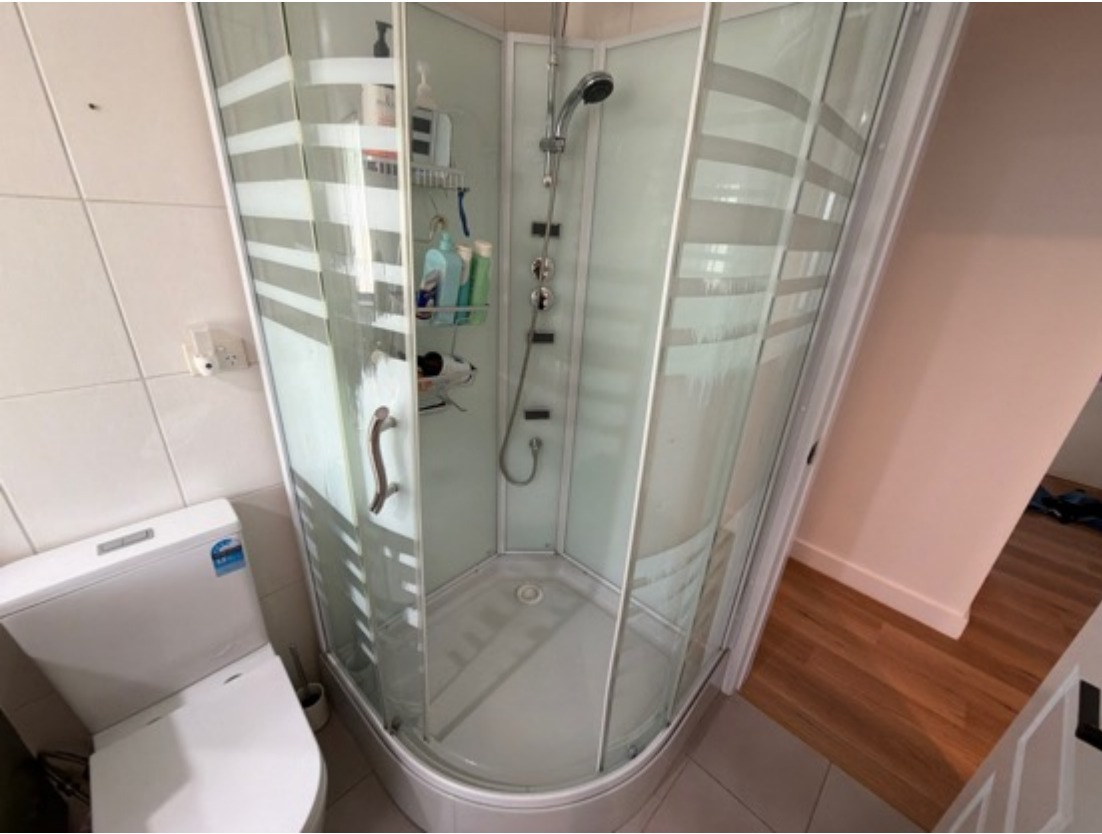
Hot and cold water services tested, functioned as intended at the time of inspection.

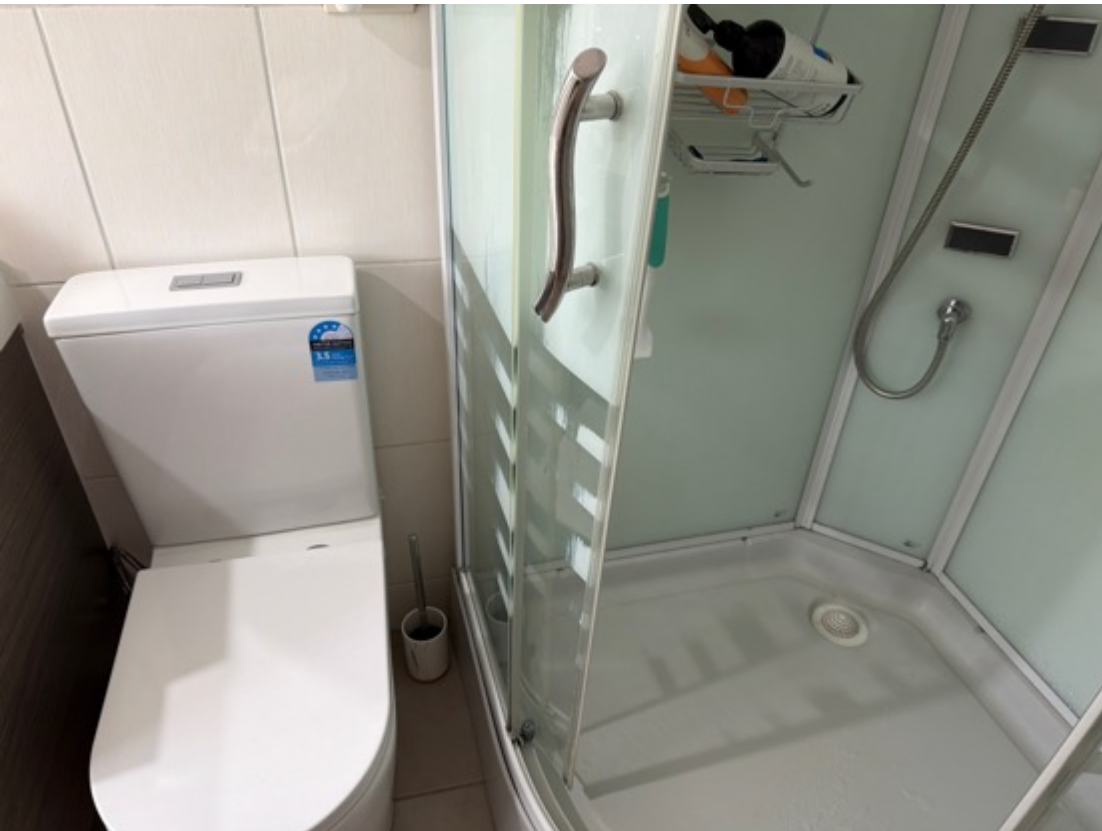
The shower door slider is loose.

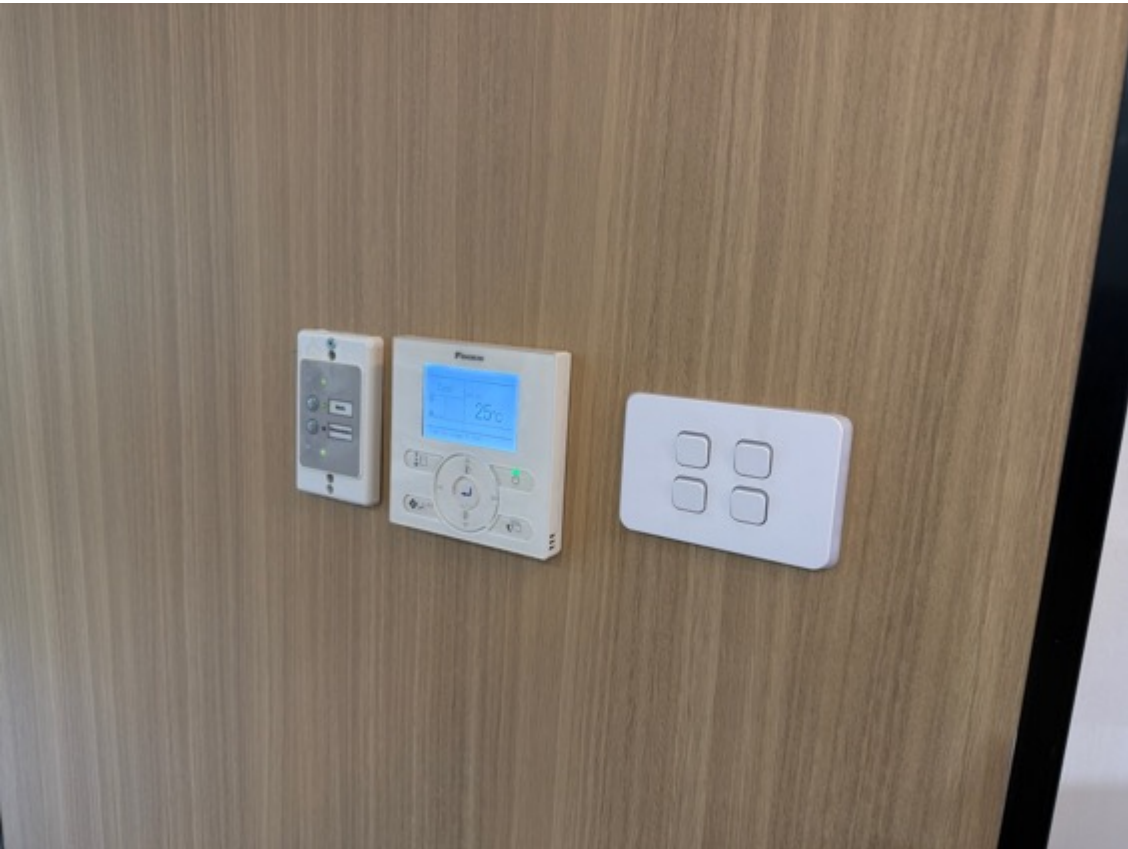
The AC tested, functioned at the time of inspection.

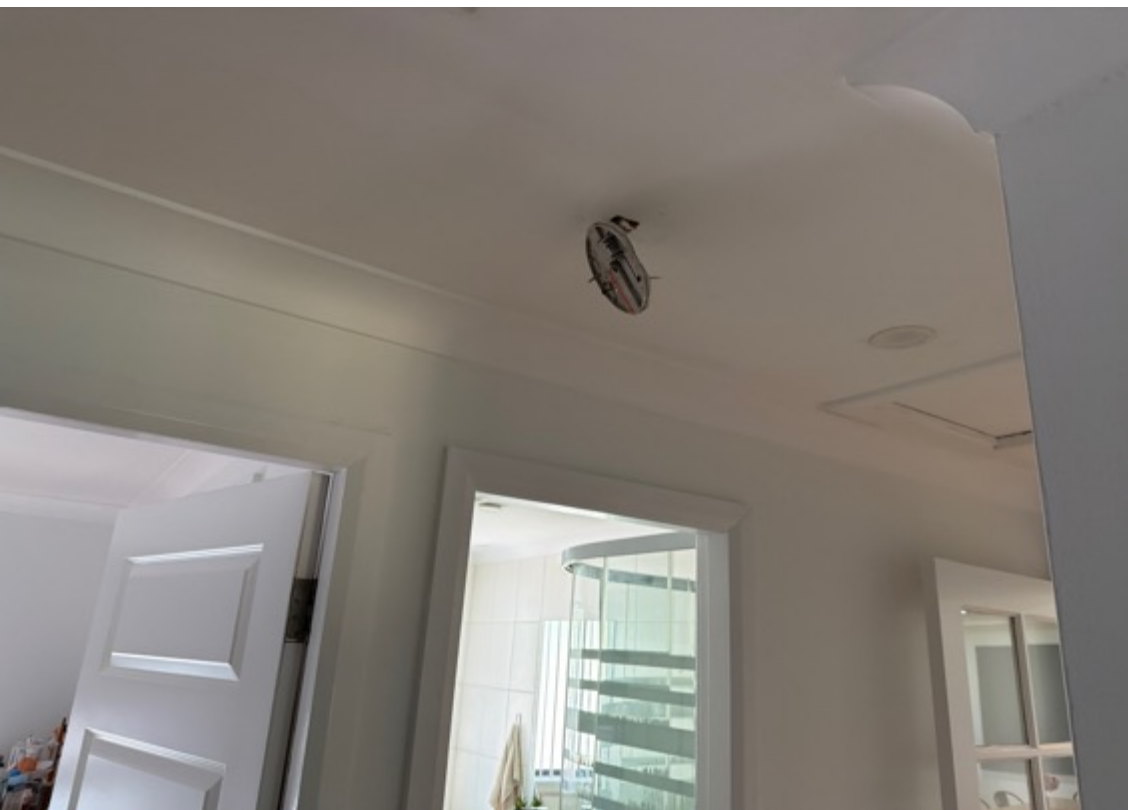
The smoke detector requires checking by a licensed electrician.

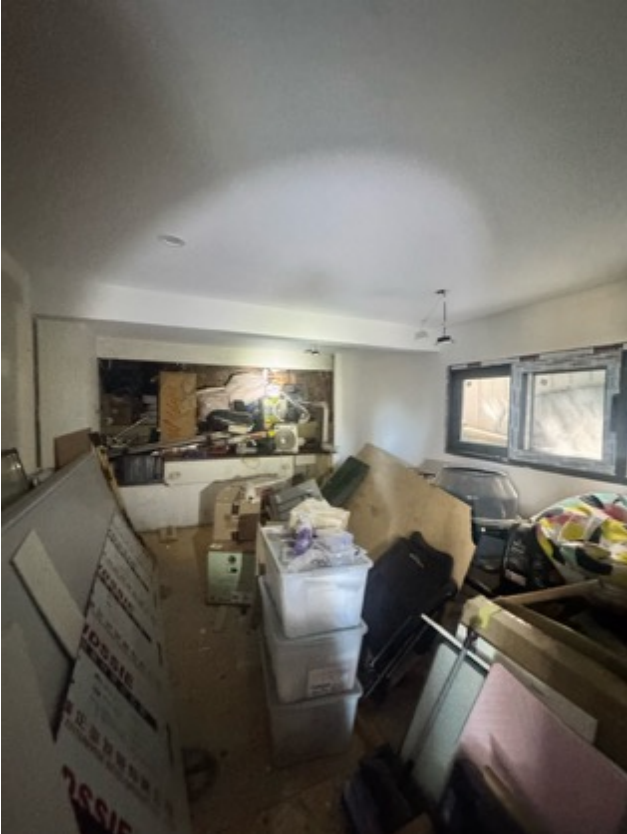
Garage works are incomplete - finishes, drainage, painting etc.

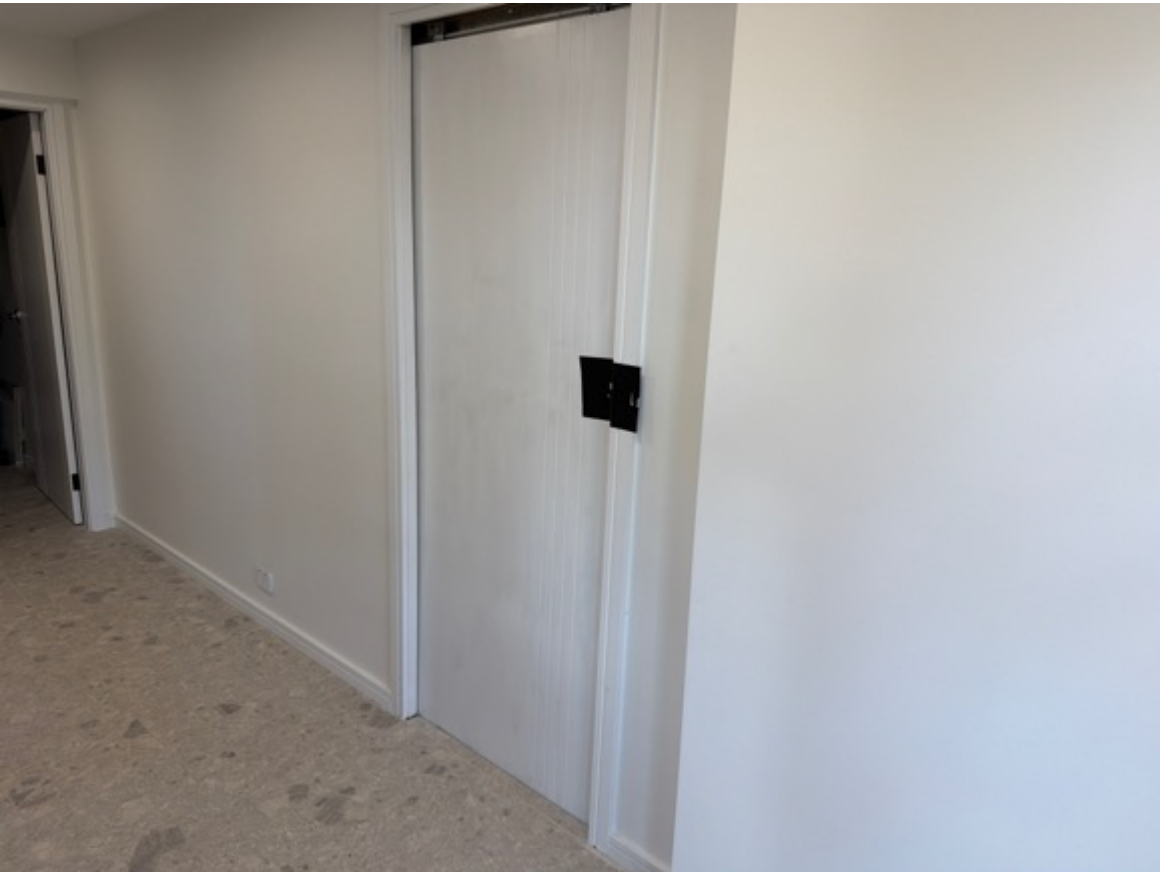
The garage sliding door painting is patchy.

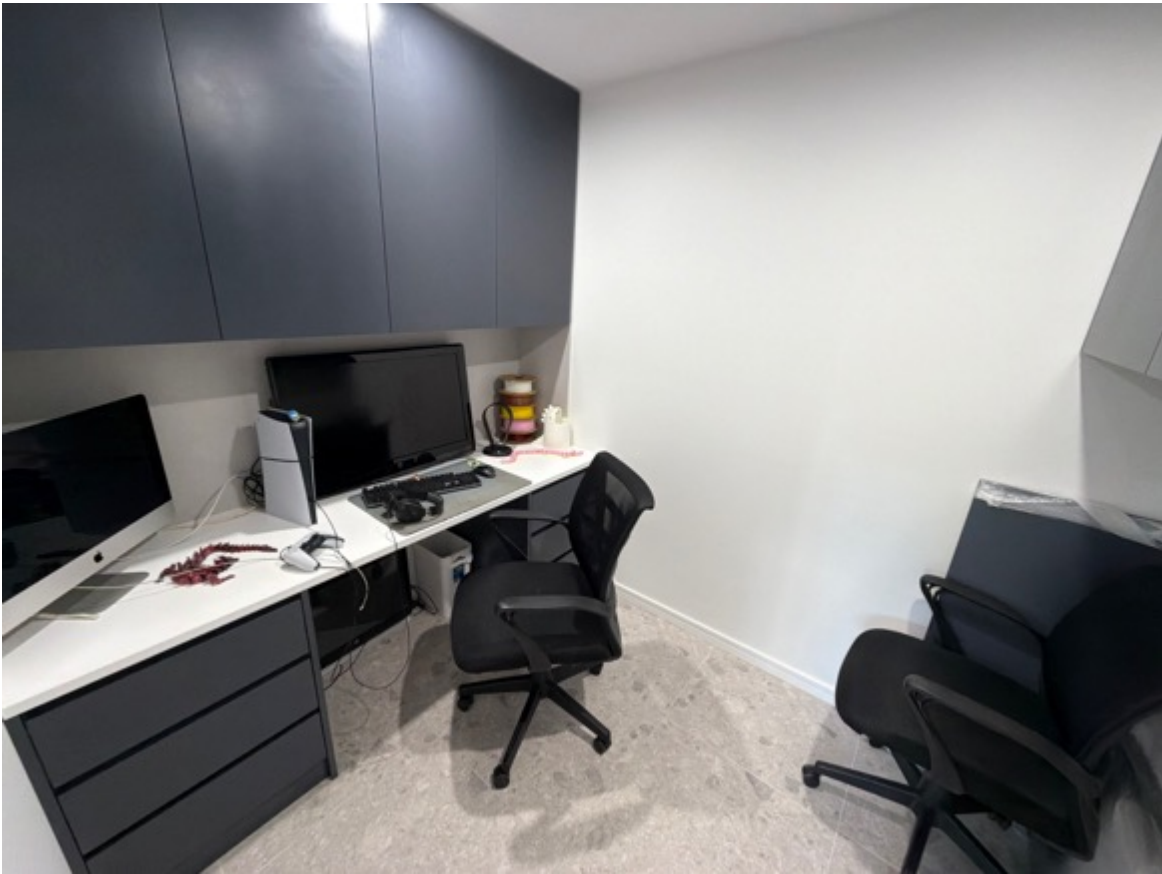
The ground floor common area is in serviceable condition.

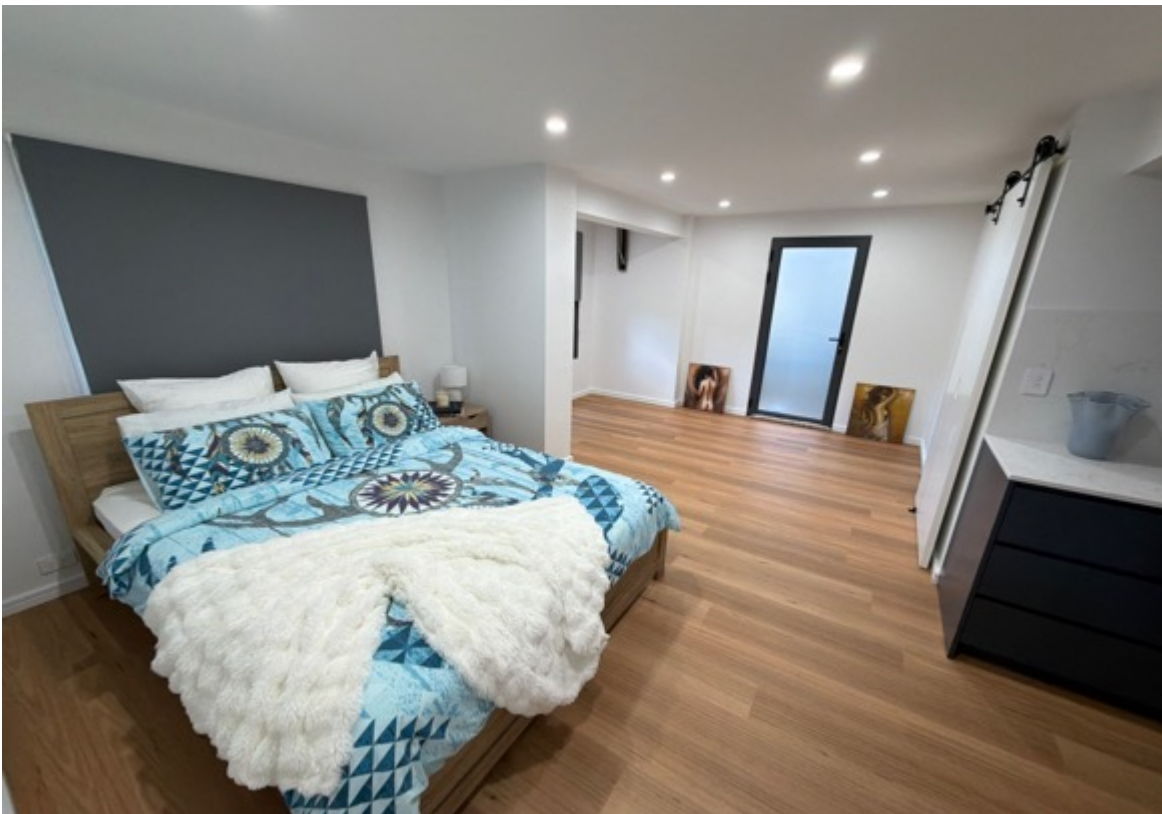
The ground floor granny flat is in serviceable condition.

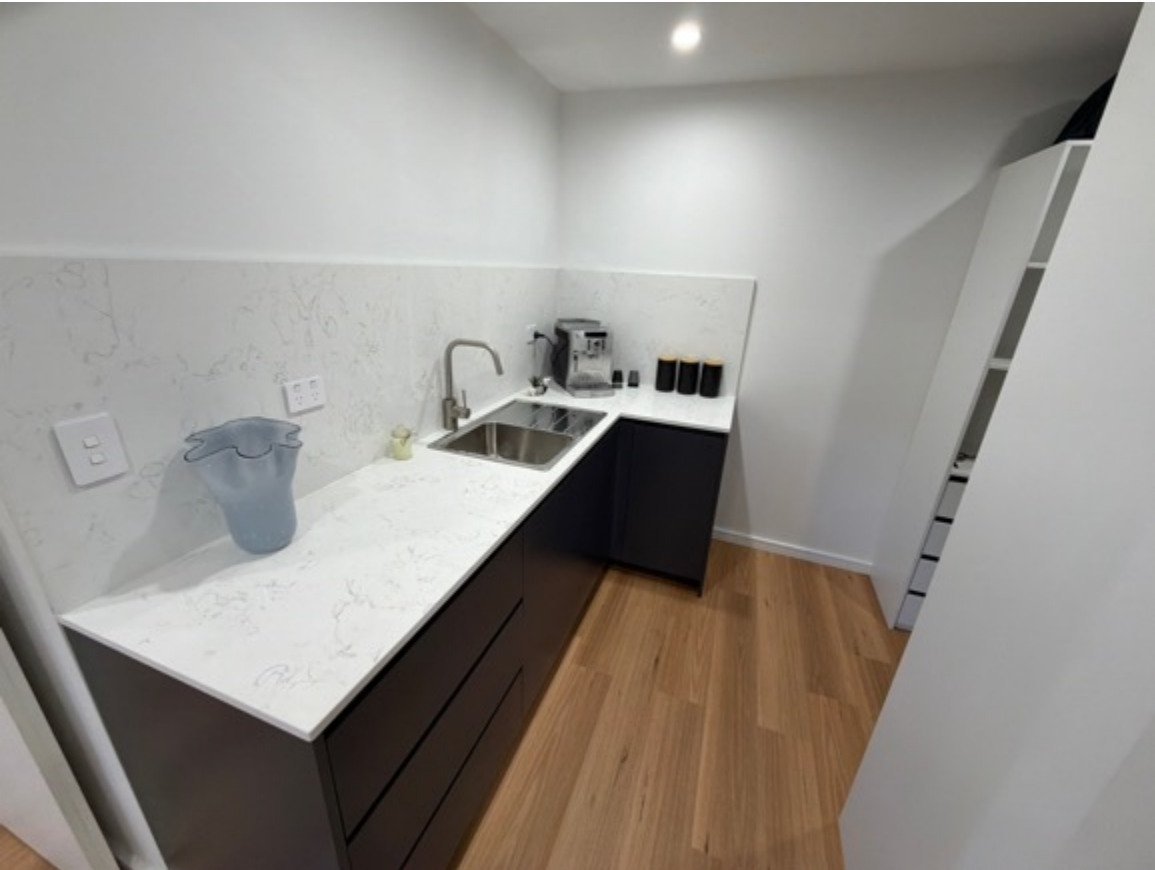
The kitchenette is in serviceable condition.

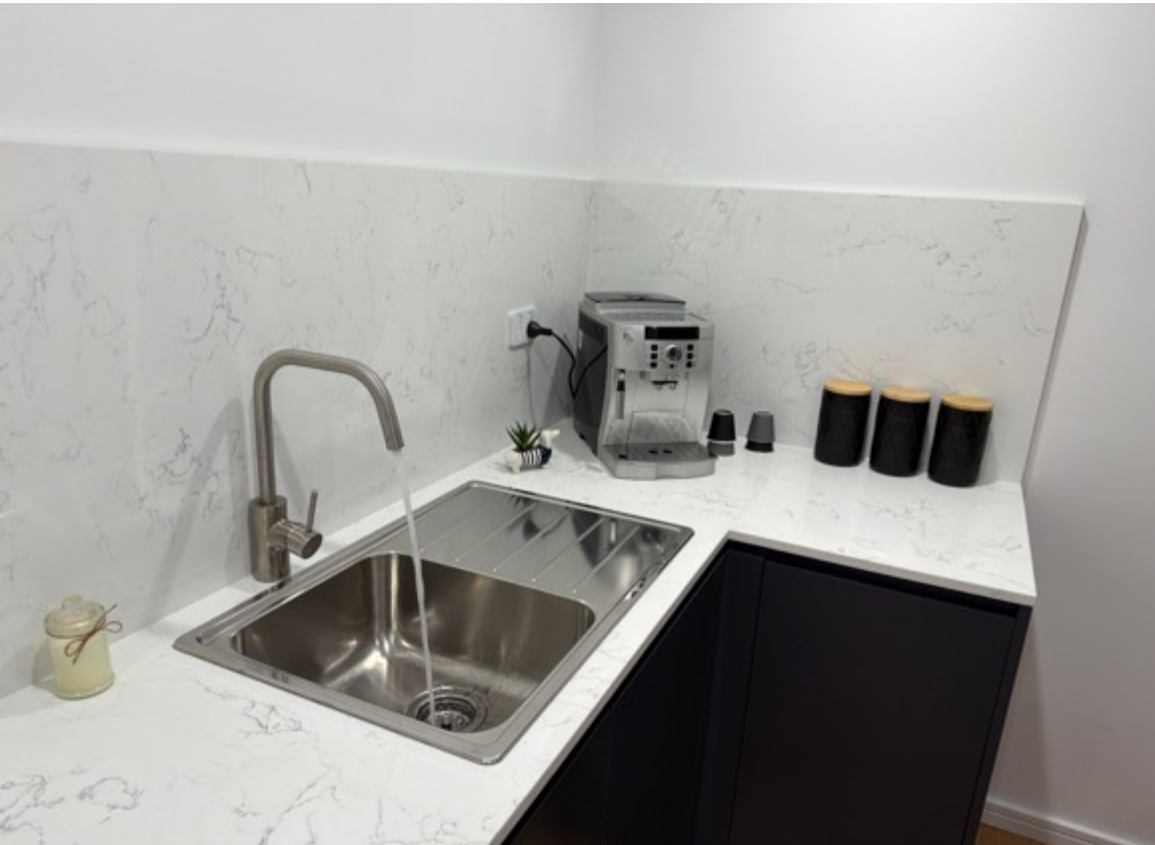
Water pressure tested, is sufficient.

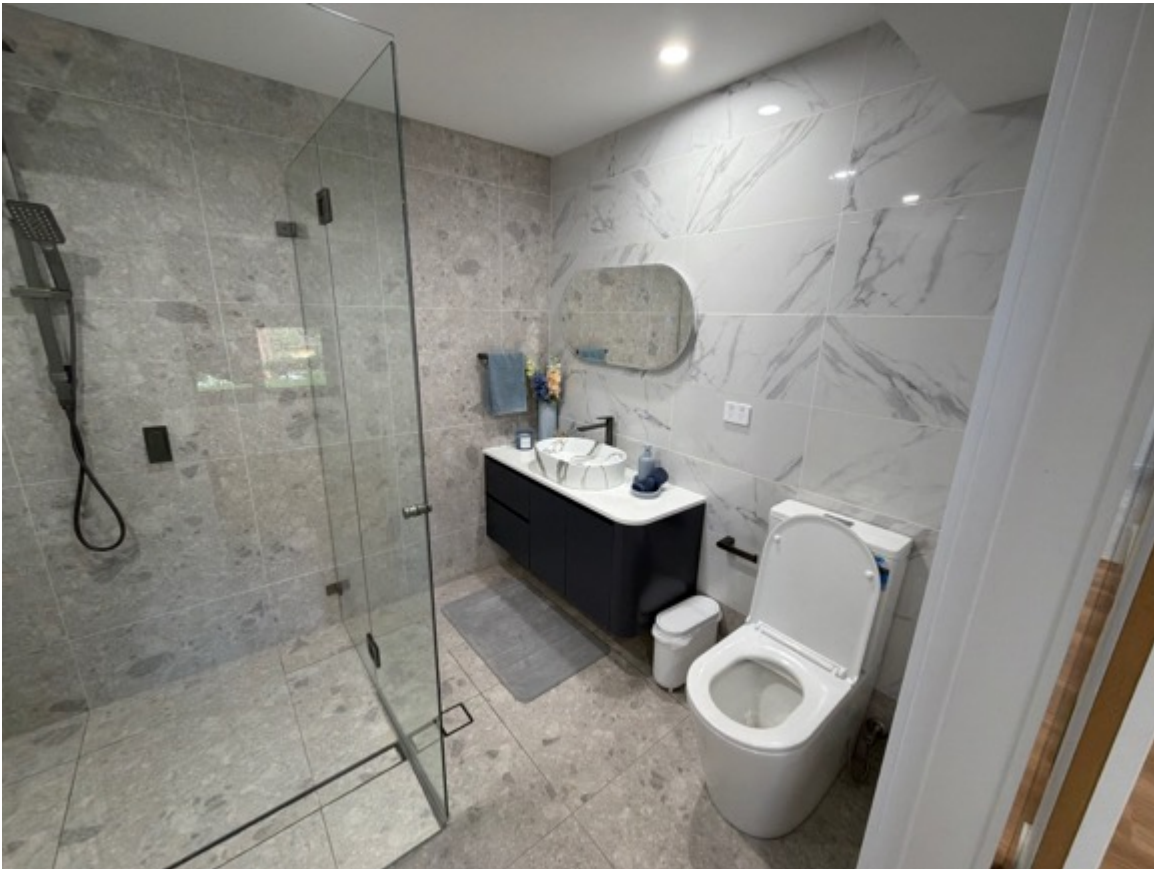
Common bathroom water services tested, functioned at the time of inspection.

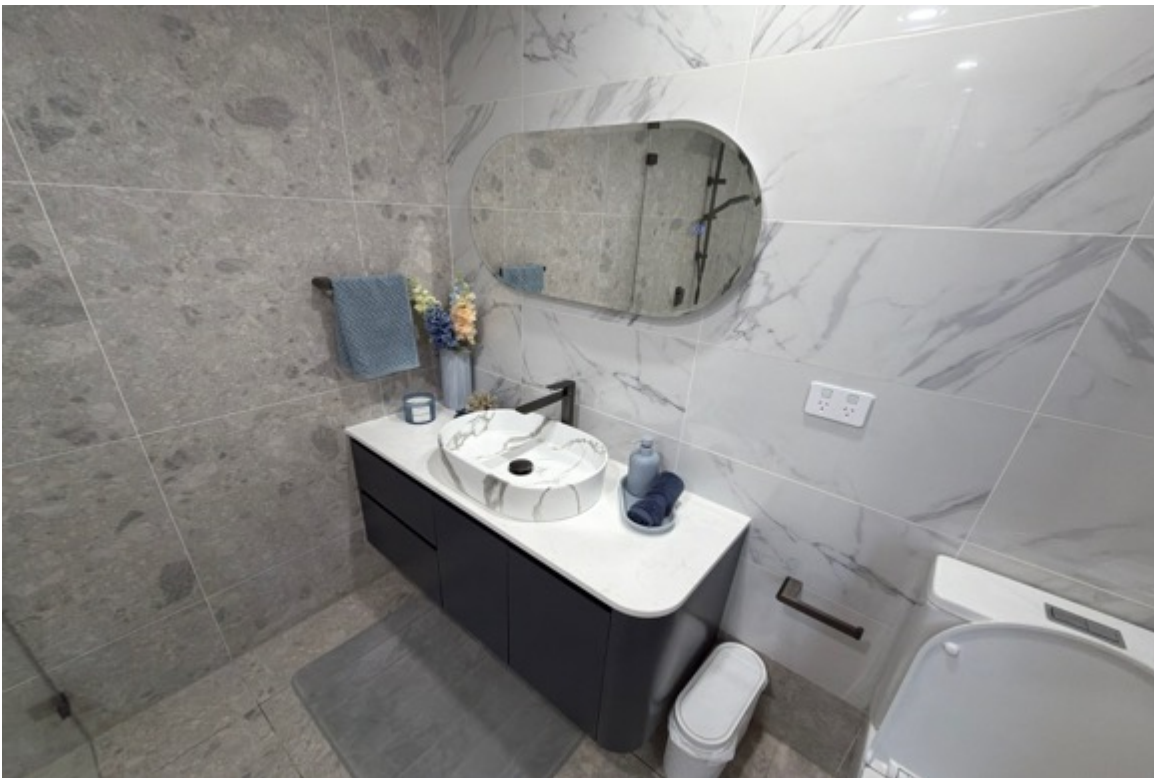
Water pressure tested, is sufficient.

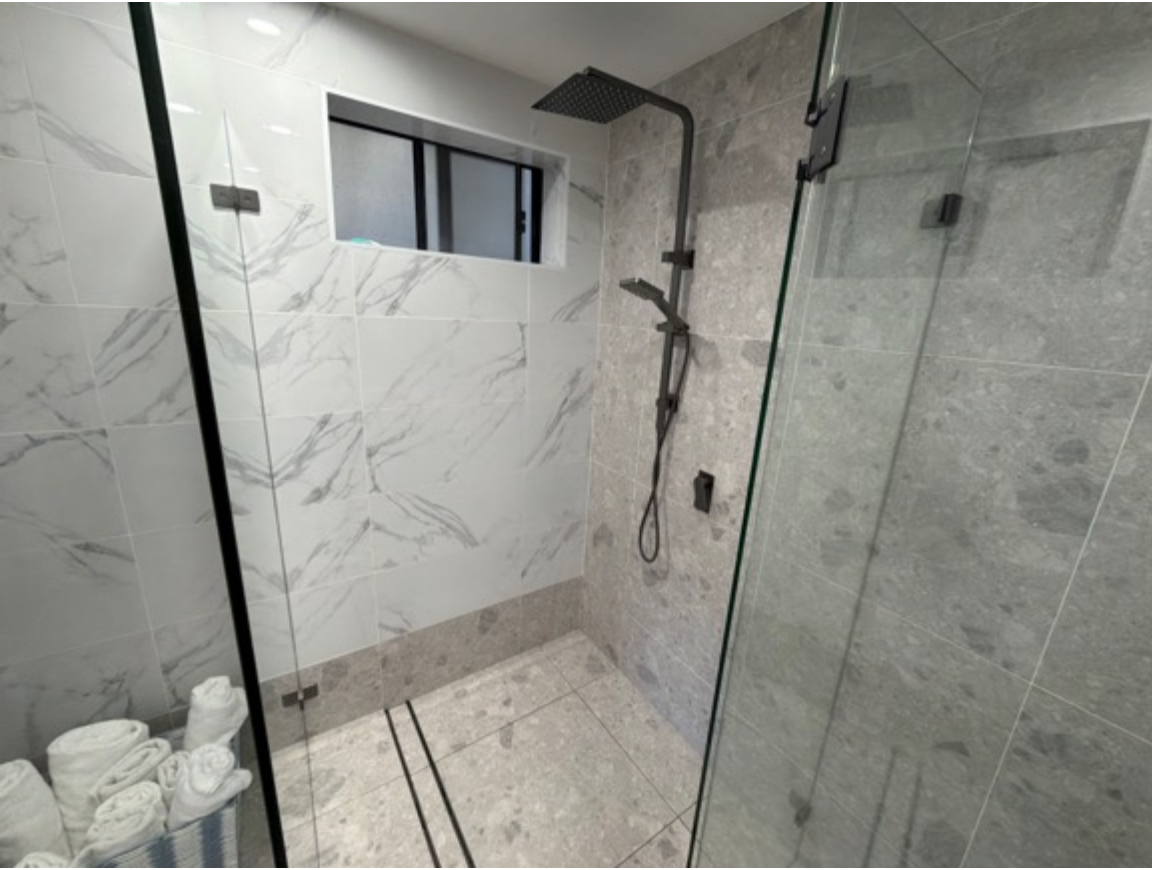
Hot and cold water services tested, functioned at the time of inspection.

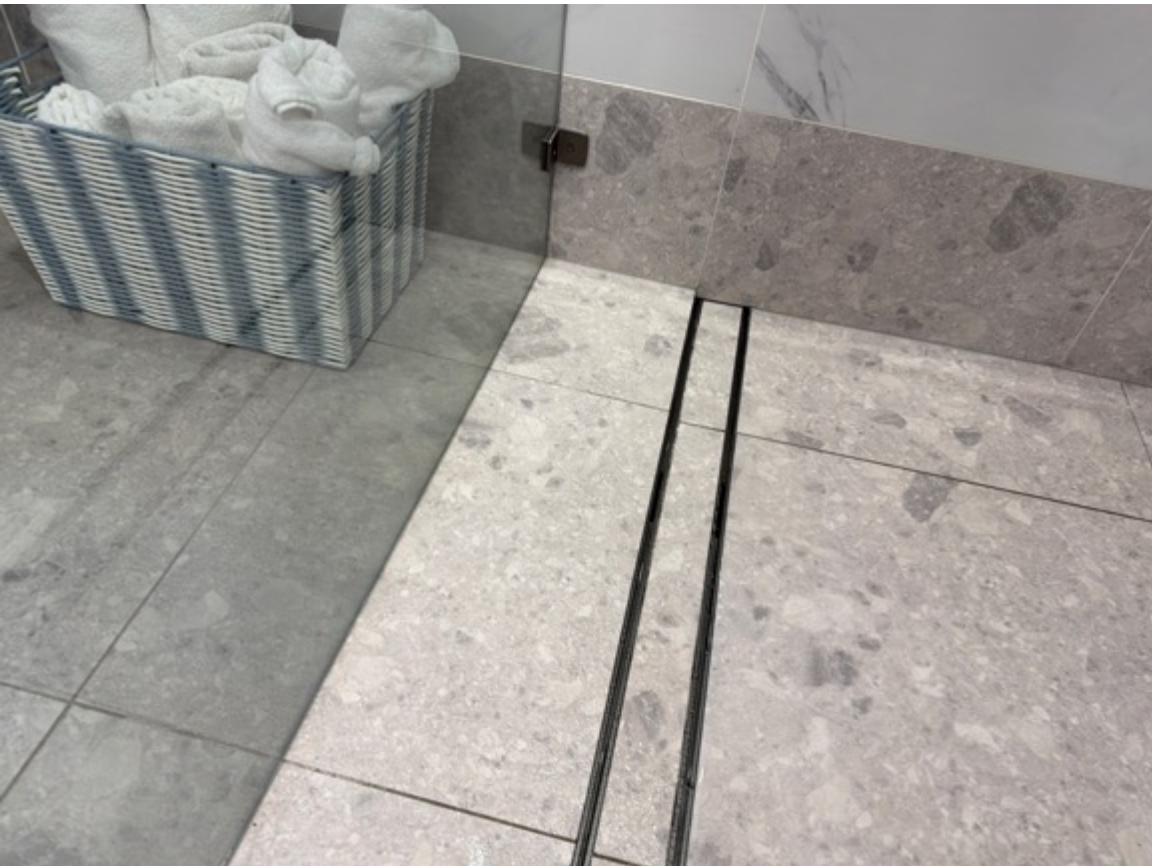
The grate drain finishes lower than the floor tiles.
