PRE-PURCHASE PROPERTY INSPECTION BUILDING REPORT

Visual Pre-Purchase Building Inspection Report.

6 RENNELL STREET KINGS PARK.

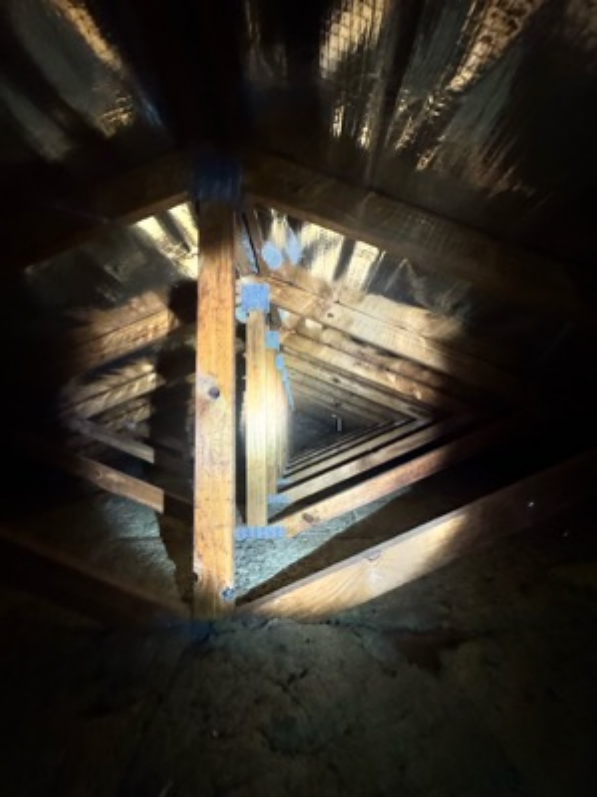
All areas within the roof space were dry at the time of inspection.
