# BUILDING AND TIMBER PEST INSPECTION - VR

Complies with Australian Standard AS 4349.1-2007 & AS 4349.3-2010  
Inspection of Buildings Part 1 & Part 3: Pre-Purchase  
Inspections of Residential Buildings - Appendix C

Sep 10, 2026

81 Solander Rd  
Kings Langley, NSW 2147, Australia

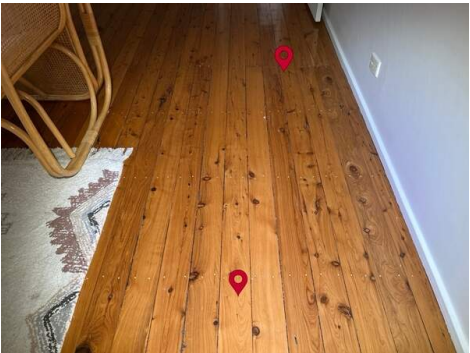
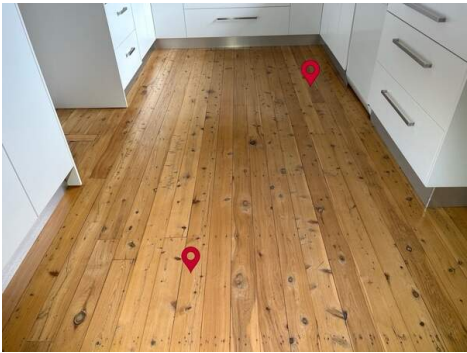
Unfinished or substandard building works are likely to degrade more quickly and may create potential for secondary defects.

Recommended trade to be contacted: Carpenter

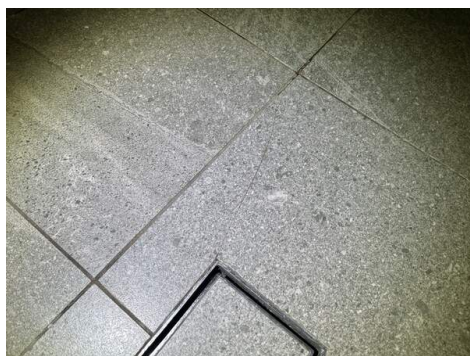
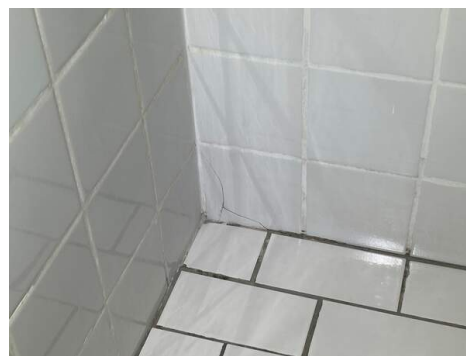
### 7.3.2 Tiles - Cracked or Damaged

Cracking was evident to the tiling in this area at the time of inspection.

While the damage appears to be minor, If left unmanaged, water penetration to surrounding areas may lead to secondary water damage, which is likely necessitate repair work to other affected building elements. A tiling contractor should be appointed to replace affected tiles as well as a leak detection specialist to ensure the area has not encountered water egress as a result.

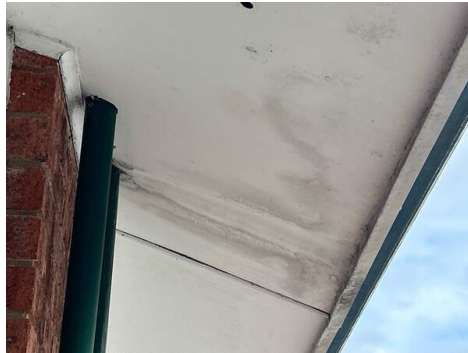
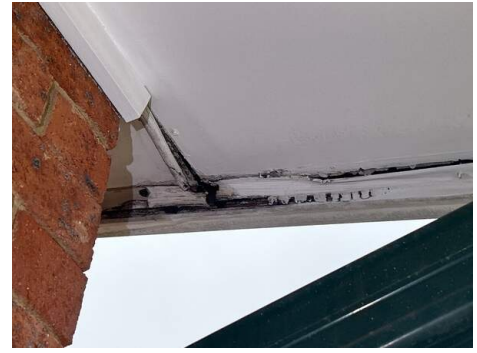
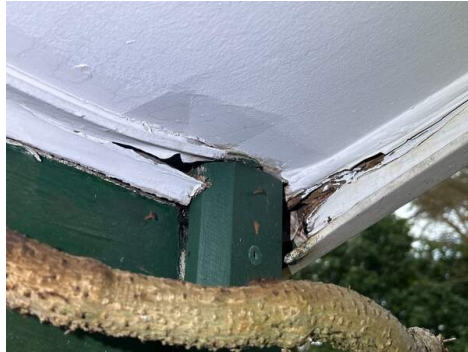
### 7.3.3 Moisture Damage Observed

Moisture damage to building elements can weaken structural components and lead to deterioration. It typically results from leaks, poor drainage, or high humidity, with signs including staining, mould, and peeling paint. Early detection is essential to prevent more serious issues.

Prolonged moisture exposure can cause timber rot, mould growth, and corrosion of metal parts, increasing maintenance costs and health risks. Addressing problems promptly helps preserve the building's integrity and safety.

Preventative measures include proper sealing, effective drainage, and moisture barriers. Regular inspections and ventilation minimise internal moisture, reducing damage and extending the lifespan of building elements.

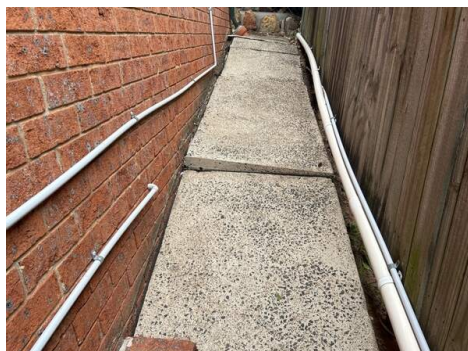
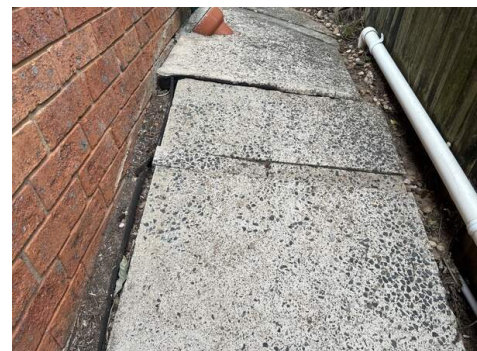
#### 7.3.4 Concrete Slab Sections - Raised or Settled

Unfinished or substandard building works are likely to degrade more quickly and may create potential for secondary defects.

Recommended trade to be contacted: Concretor or Building Contractor

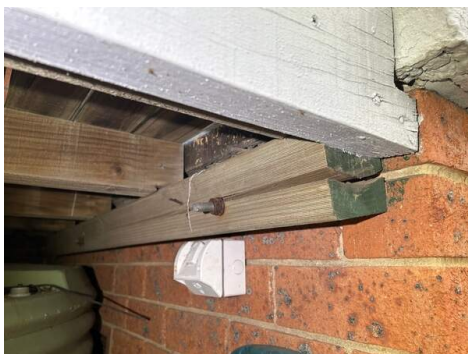
The observed condition of this building element or photographic finding is provided for informational purposes only. It highlights an area that may benefit from further assessment and maintenance.

The client is advised to engage the appropriate trade specialist to review and address the issue at their discretion. Prompt attention can help prevent further deterioration and reduce the risk of secondary defects.

Recommended trade to be contacted: Carpenter

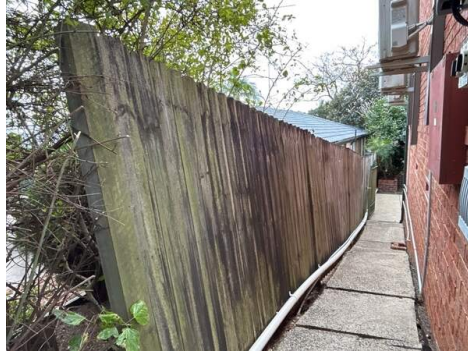
### 7.3.6 Fencing - Deteriorated in sections or leaning

At the time of inspection, sections of the fencing around the property were observed to be deteriorated, likely resulting from age, wear, and exposure to weather conditions over time. Causes may include rot, rust, or inadequate installation and maintenance. If left unaddressed, further damage is probable.

Repair of multiple fencing elements may be necessary, though replacement could also be considered depending on the extent of deterioration. It is recommended to engage a licensed fencing contractor to assess the condition, provide further advice, and carry out any required repairs or replacements to restore the fencing's integrity.

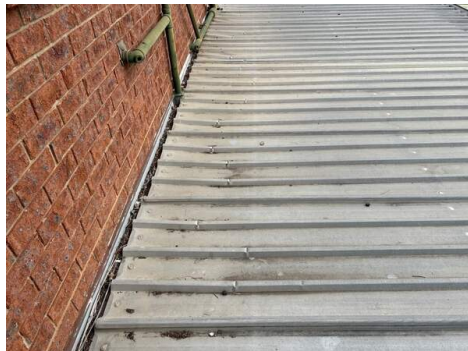
### 7.3.7 Roof Sheets - Deteriorated or Damaged

The exterior roof sheets show signs of deterioration, with some sheets having come loose from their fixing points. Age and lack of maintenance have led to issues such as loose sheeting, lifting, sagging, and deterioration of related building elements.

Loose or damaged roof sheets can allow water ingress, risking internal leaks and water damage. To prevent further issues, all loose or damaged sheets should be re-fixed or replaced promptly. Larger sections or associated materials may need replacing depending on the damage extent.

It is highly recommended to engage a roofing restoration contractor to carry out the necessary remedial works and ensure the roof's integrity is restored.

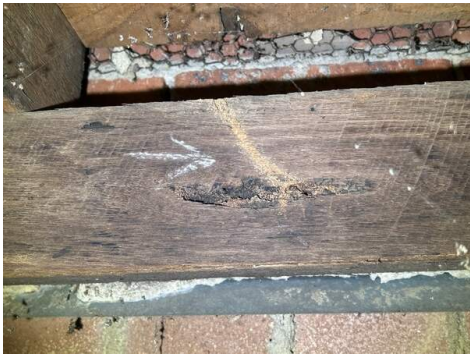
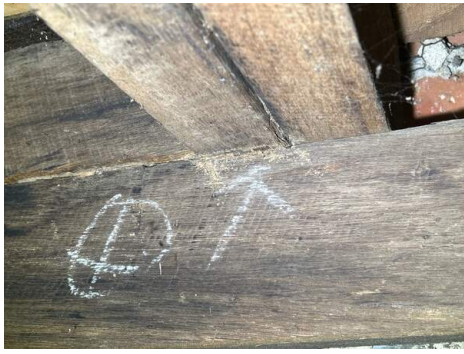
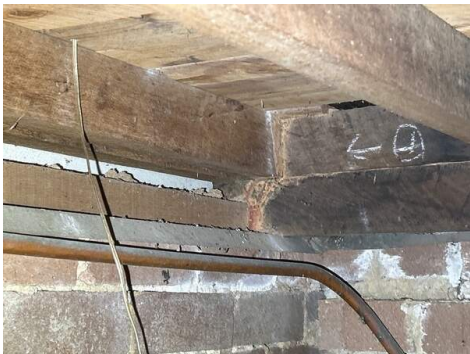
# 7.5 Timber Pest Damage

Evidence was observed during the inspection suggesting that termite activity has occurred on the property, including signs of past activity and mudding.

Building: Main Building  
Area: Subfloor  
Location: Subfloor  
Defect Significance: Timber Pest Damage  
Defect Type: A (Damage)

Visible evidence of subterranean termite activity, workings such as mud packing, and or leads or termite damage was found at the time of the inspection in the subfloor area.

There is a high risk that other concealed damage or activity exists in other areas of the dwelling.

It is recommended that a thermal imaging inspection of the structural framework be conducted initially to assess the likelihood of any concealed damage, enabling a more thorough understanding of potential ongoing issues.

A second opinion timber pest inspection is also strongly recommended by an alternate timber pest contractor.

We strongly recommended a follow up invasive inspection to completely ascertain the extent of any termite activity or concealed termite damage. This invasive work can be carried out by the use of a thermal imaging device, bore-scope or the removal of wall and ceiling linings by a qualified builder.

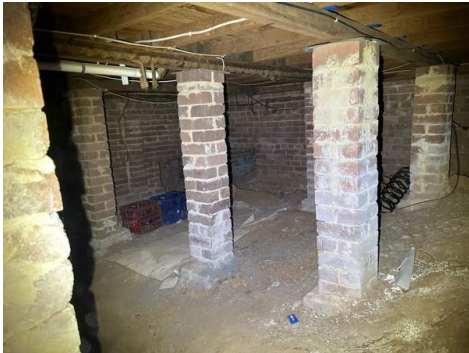
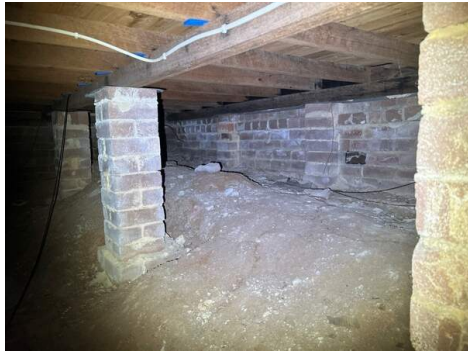
## 7.6.1 Subfloor Ventilation - Inadequate Cross Flow

Maintaining adequate subfloor ventilation contributes to a dry environment, which helps prevent excessive moisture, wood rot, and conditions conducive to termite activity.

It is recommended considering consultation with a registered builder to evaluate the current ventilation and discuss preventative measures to optimise airflow and moisture control.

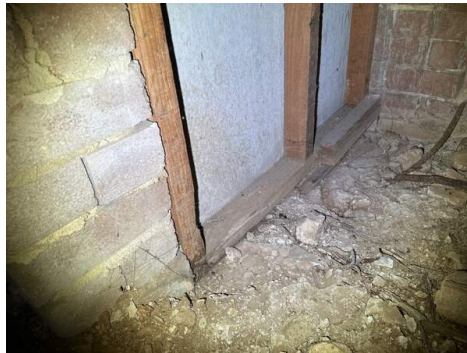
There is evidence that timber elements in direct contact with the ground or exposed to moisture can create an environment conducive to termite activity. This applies to structural components, fencing, or stored timber, all of which can attract termites.

Excessive moisture can cause the timber to decay and develop wood rot, further increasing the risk. Untreated or non-durable timber in contact with external ground areas provides an entry point for subterranean termites, which can lead to damage.

To minimise the risk of termite infestation, any timber in direct contact with the ground or exposed to moisture should be removed or treated as soon as possible. Preventative measures help protect the property from potential termite-related damage.

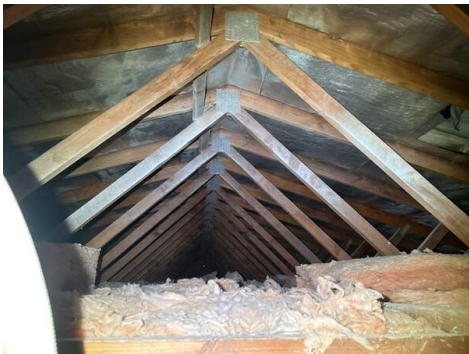
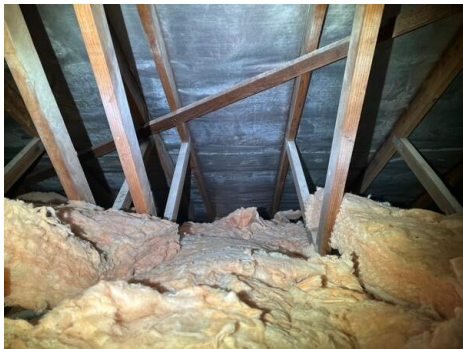
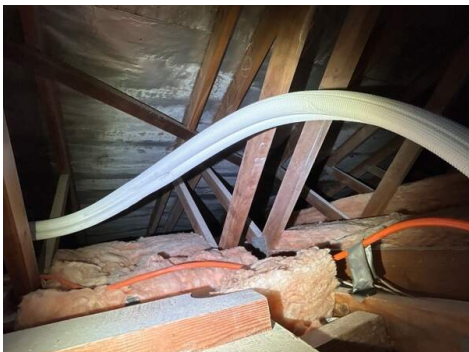
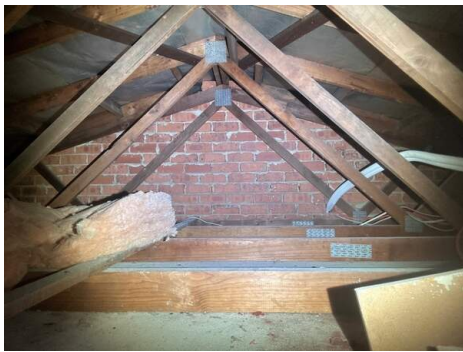
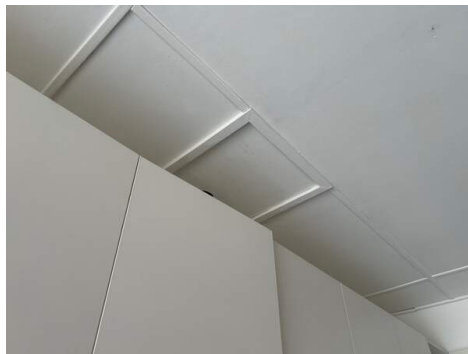
Building: Main Building  
Area: Roof Void  
Location: Roof Space  
Finding Significance: For Information Purposes  
Comments: Bulk Insulation and Low Clearance

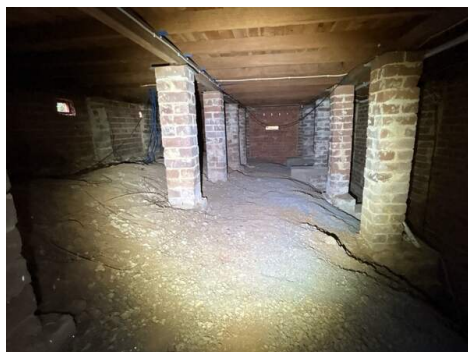
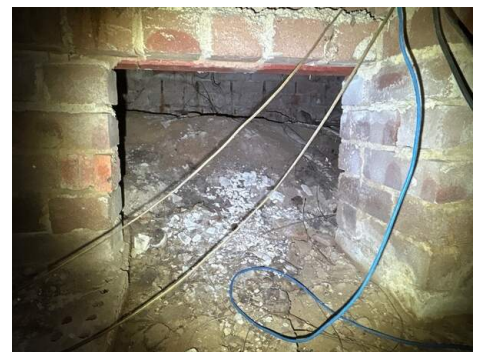
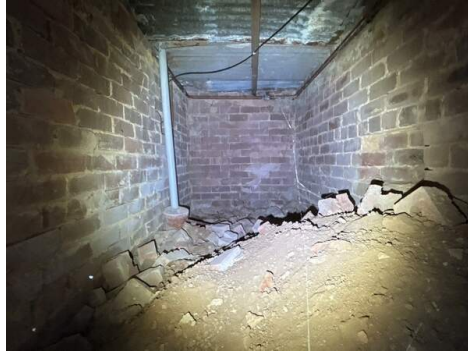
Building: Main Building  
 Area: Subfloor  
 Location: Subfloor  
 Finding Significance: For Information Purposes  
 Comments: Services, Debris and Low Clearance
