BUILDING AND TIMBER PEST INSPECTION

Complies with Australian Standard AS 4349.1-2007 & AS 4349.3-2010
Inspection of Buildings Part 1 & Part 3: Pre-Purchase
Inspections of Residential Buildings - Appendix C

Jun 03, 2026

22 Hawke Pl
Kings Langley, NSW
2147, Australia

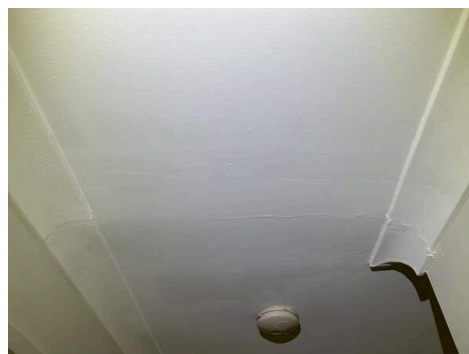
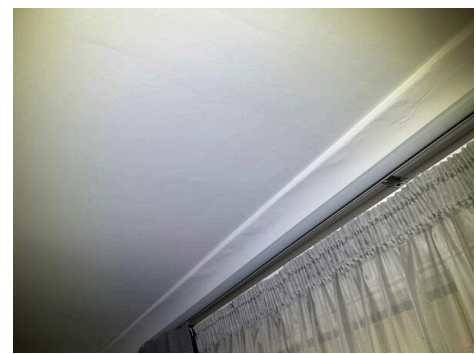
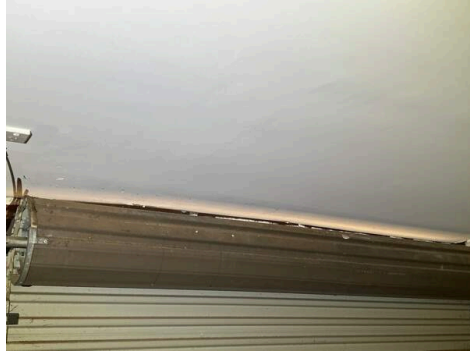
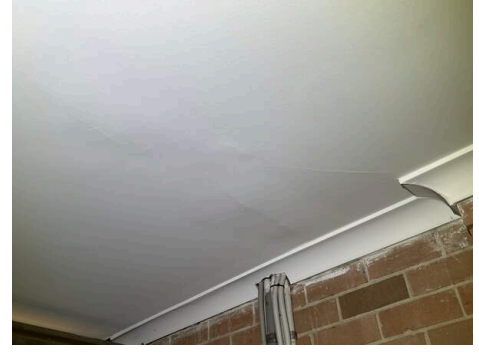
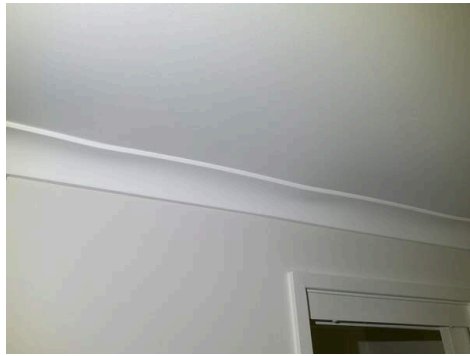
During the inspection, minor issues were observed with the plasterboard joints, indicating a substandard joint set. This may include minor cracking, inconsistent finishing, or slightly exposed joint tape. These issues are typically cosmetic and do not compromise the structural integrity of the wall.

This minor defect is unlikely to impact the safety or function of the space but should be monitored and rectified to maintain quality standards.

While the condition is minor, addressing these issues can improve the overall appearance and prevent further deterioration. It is recommended to have a qualified plasterer or tradesperson review and carry out any necessary remedial work to ensure a smooth, even finish.

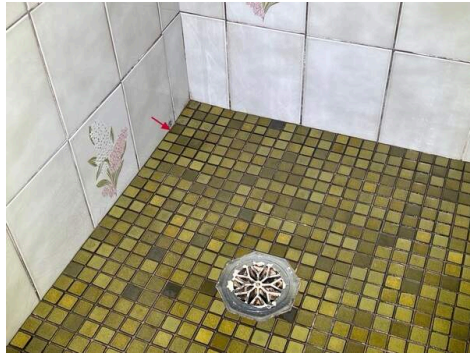
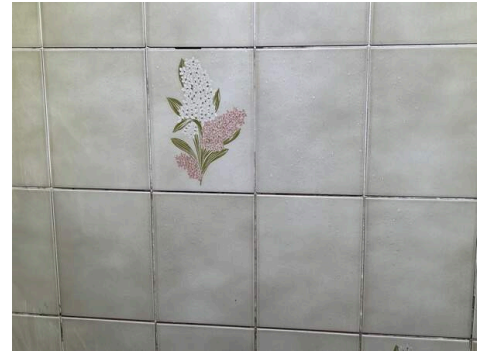
7.3.2 Grout/Sealant - Missing or Deteriorated

During the inspection, it was observed that the sealant or grout in the tiled shower alcove and other bathroom areas has deteriorated. Natural movement of materials and expansion and contraction over time can cause cracking in grout and sealant joints.

Applying flexible, mould-resistant sealant and grout to affected areas will help maintain water tightness and protect surrounding materials. Regular maintenance and prompt replacement of damaged or missing sealant and grout are crucial, especially in wet areas.

To ensure long-term durability, it is advisable to engage a sealant specialist or tiling contractor to carry out these repairs as soon as possible. Proper upkeep will help prevent water ingress and related damage.

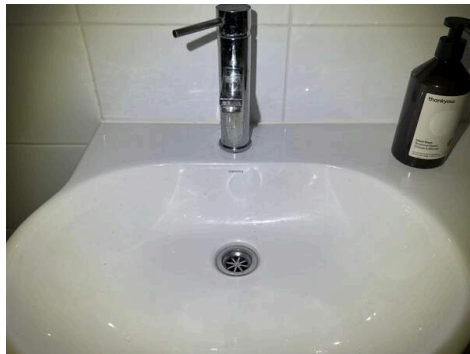
7.3.3 Water Hammer/Knock

The client is advised to contact the responsible trade to undertake any necessary rectification work at their discretion. Unfinished or substandard work is likely to deteriorate more quickly and may lead to secondary defects.

Recommended trade to be contacted: Plumbing Contractor

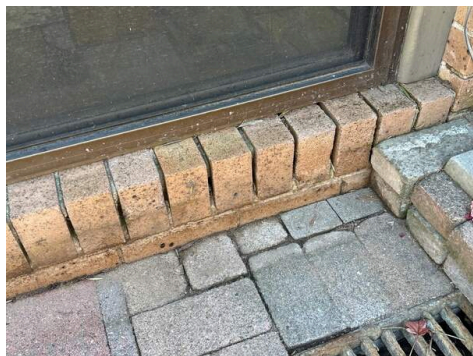
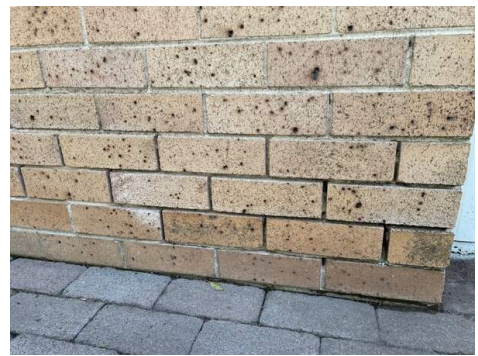
7.3.4 Mortar Deterioration

Sections of mortar between external brickwork were observed to show minor deterioration and surface erosion. This is typically due to natural weathering and age-related wear, particularly in areas exposed to direct sun, wind, or moisture over time. The condition is considered common in established dwellings and not unusual for masonry of this type and age.

While no structural movement or significant cracking was identified, the affected joints should be monitored and repointed as required to prevent moisture entry or further erosion. Repointing is a straightforward maintenance task involving the removal of loose material and replacement with new mortar to restore integrity and appearance.

Maintenance and repointing should be carried out by a qualified bricklayer or masonry restoration specialist to ensure the repairs are correctly matched to the existing mortar and finish.

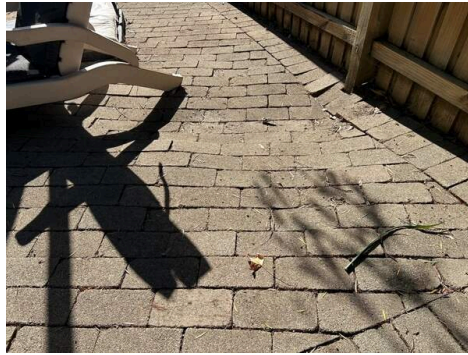
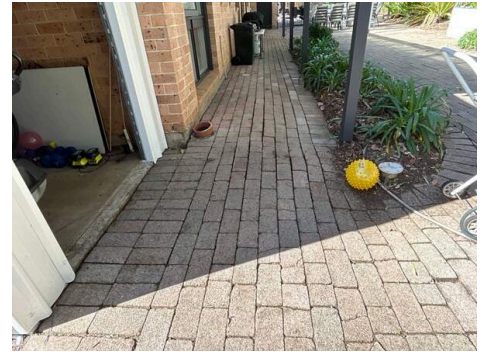
7.3.5 Paving - Uneven and Undulating

Paving in some instances may create a trip hazard, personal due caution is to taken by all persons within this area.

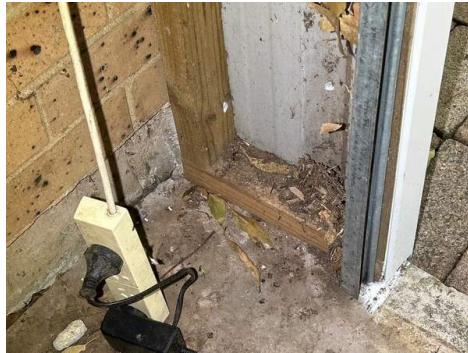
7.6 Conditions Conducive to Timber Pest Activity

There is evidence that timber elements in direct contact with the ground or exposed to moisture can create an environment conducive to termite activity. This applies to structural components, fencing, or stored timber, all of which can attract termites.

Excessive moisture can cause the timber to decay and develop wood rot, further increasing the risk. Untreated or non-durable timber in contact with external ground areas provides an entry point for subterranean termites, which can lead to damage.

To minimise the risk of termite infestation, any timber in direct contact with the ground or exposed to moisture should be removed or treated as soon as possible. Preventative measures help protect the property from potential termite-related damage.

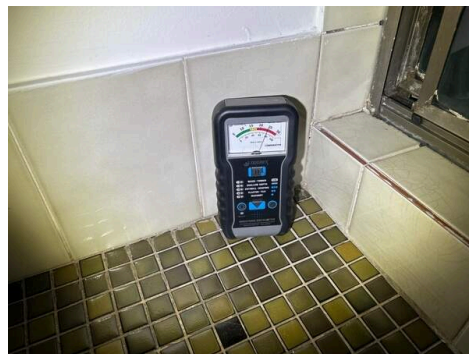
7.7.2 High moisture meter readings - Evident

High moisture readings may indicate a possible shower membrane breach causing damp transfer to surrounding areas or saturated tiled bedding transferring to door and wall frames or lateral and rising damp emanating from under wall and walls backing onto areas of fill.

Excessive moisture that affects internal framing may also attract termite or other timber pests and concealed termite infestation risk become high.

A leak detecting or damp specialist is recommended to be engaged to further investigate the reason as to why high moisture readings are presenting. Once confirmed the recommended trade should be contacted to carry out rectification works.

Recommended trade to be contacted: Plumbing Leak Detection Specialist and Remedial Builder

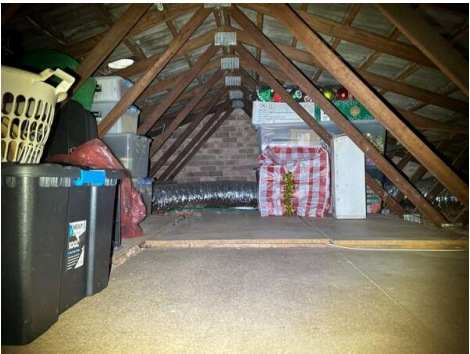
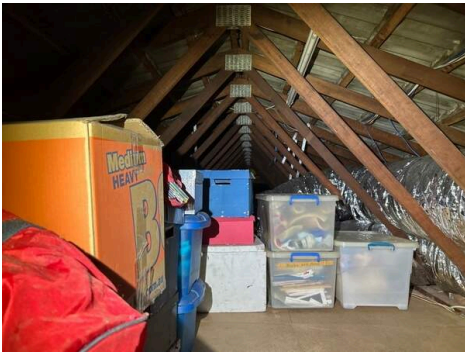
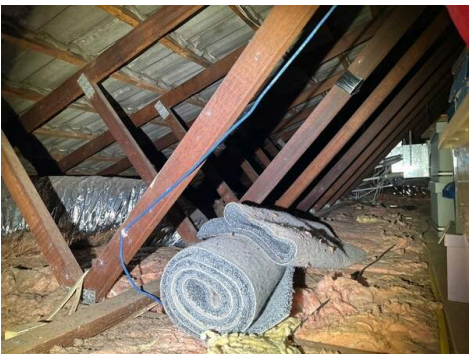
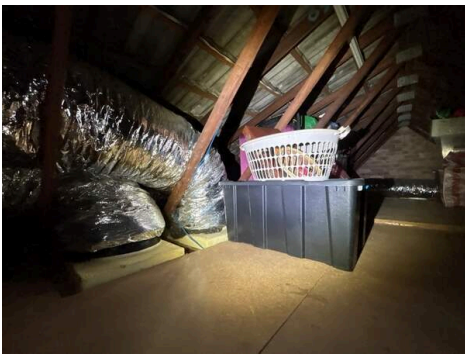
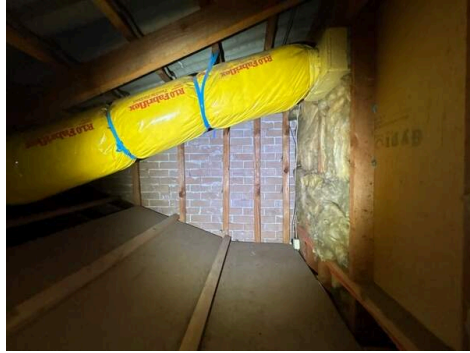
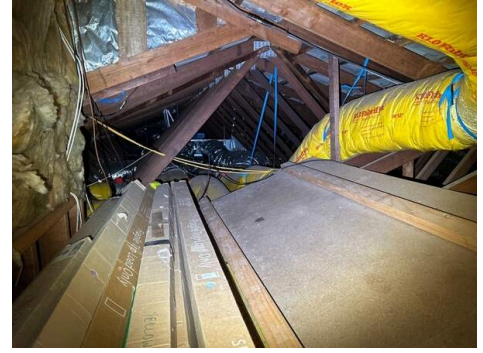
Building: Main Building
Area: Roof Void
Location: Roof Space
Finding Significance: For Information Purposes
Comments: Stored Items, AC Ductwork, Bulk Insulation and Low Clearance

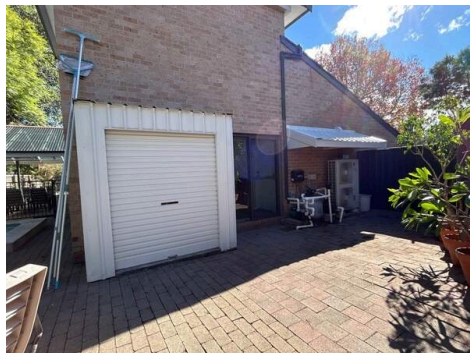
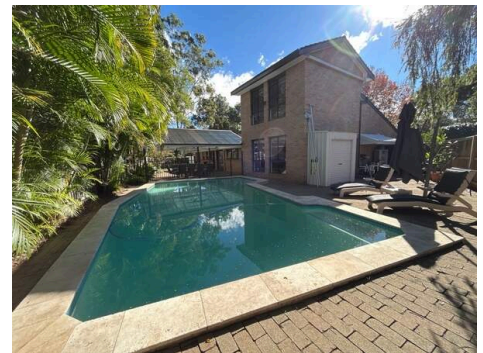
Building: Main Building
 Area: Exterior
 Location: Yard Side & Rear
 Finding Significance: For Information Purposes
 Comments: Stored Items, Services and Furniture
