# PRE-PURCHASE PROPERTY INSPECTION BUILDING REPORT

**Visual Pre-Purchase Building Inspection Report.**

**12 BRETT STREET KINGS LANGLEY**

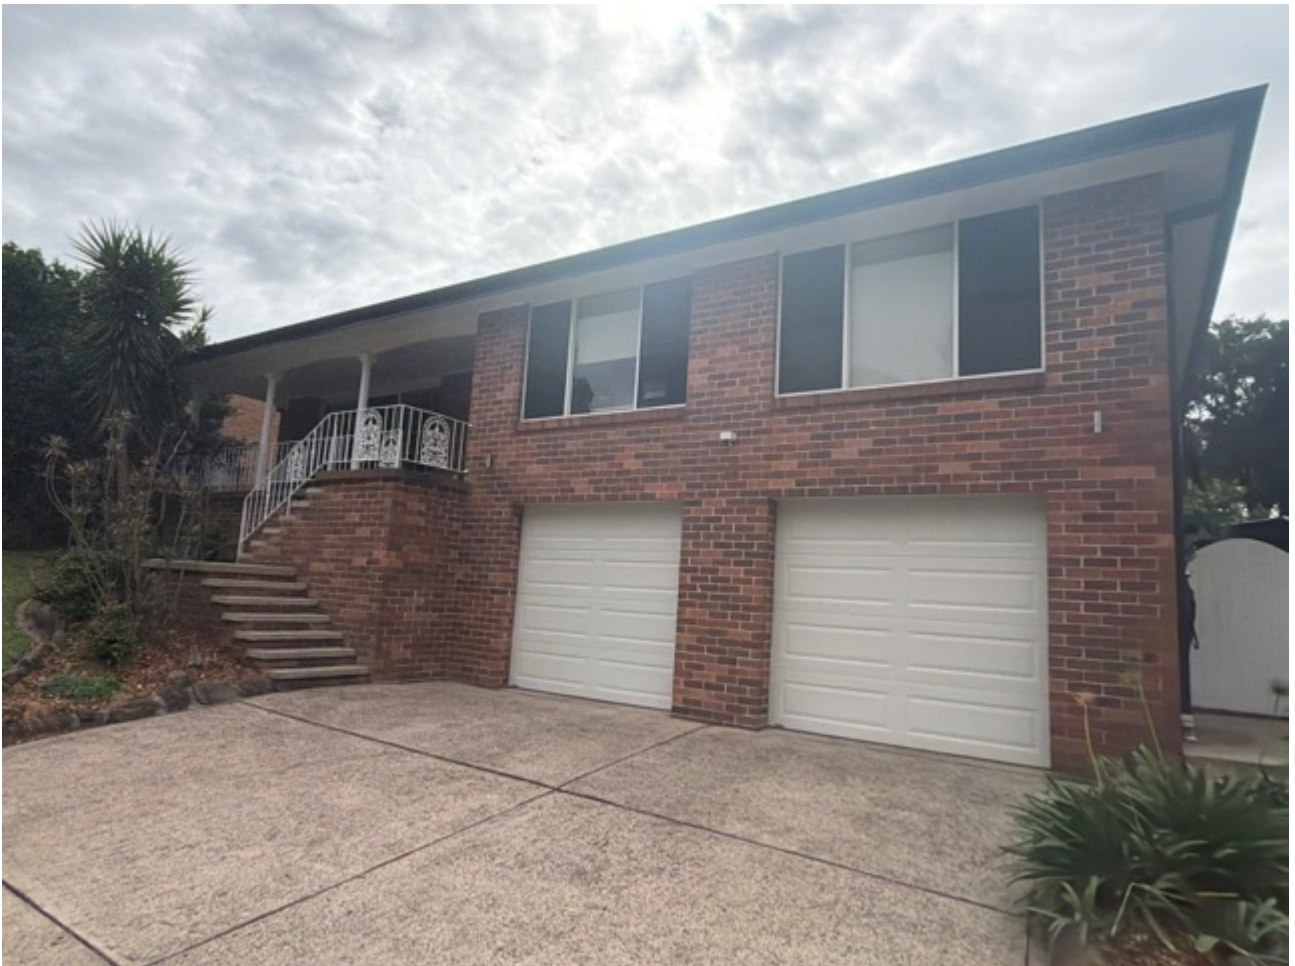
Front elevation of the Inspected property inspected.

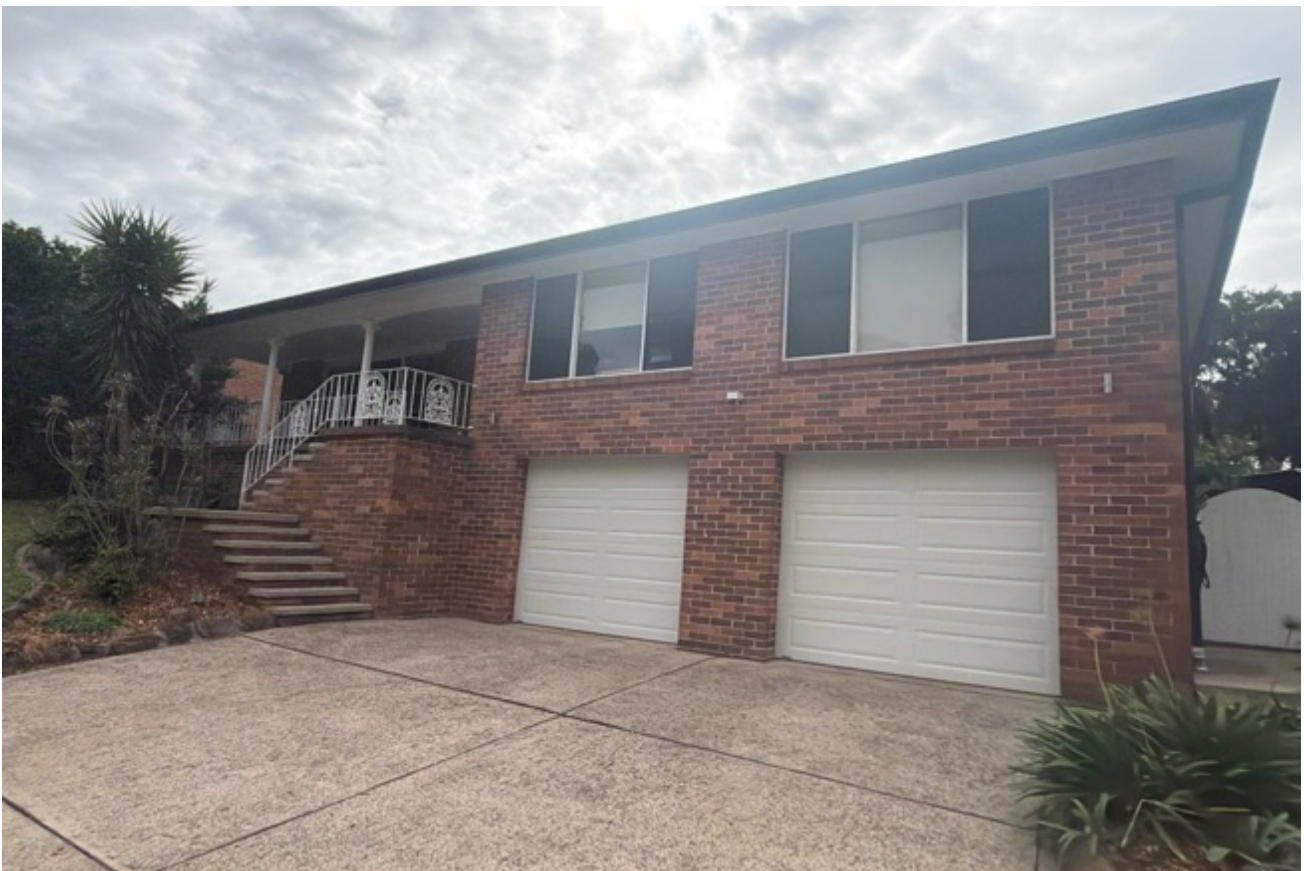
The exterior of the house presents in satisfactory condition displaying no major structural issues at the time of inspection.

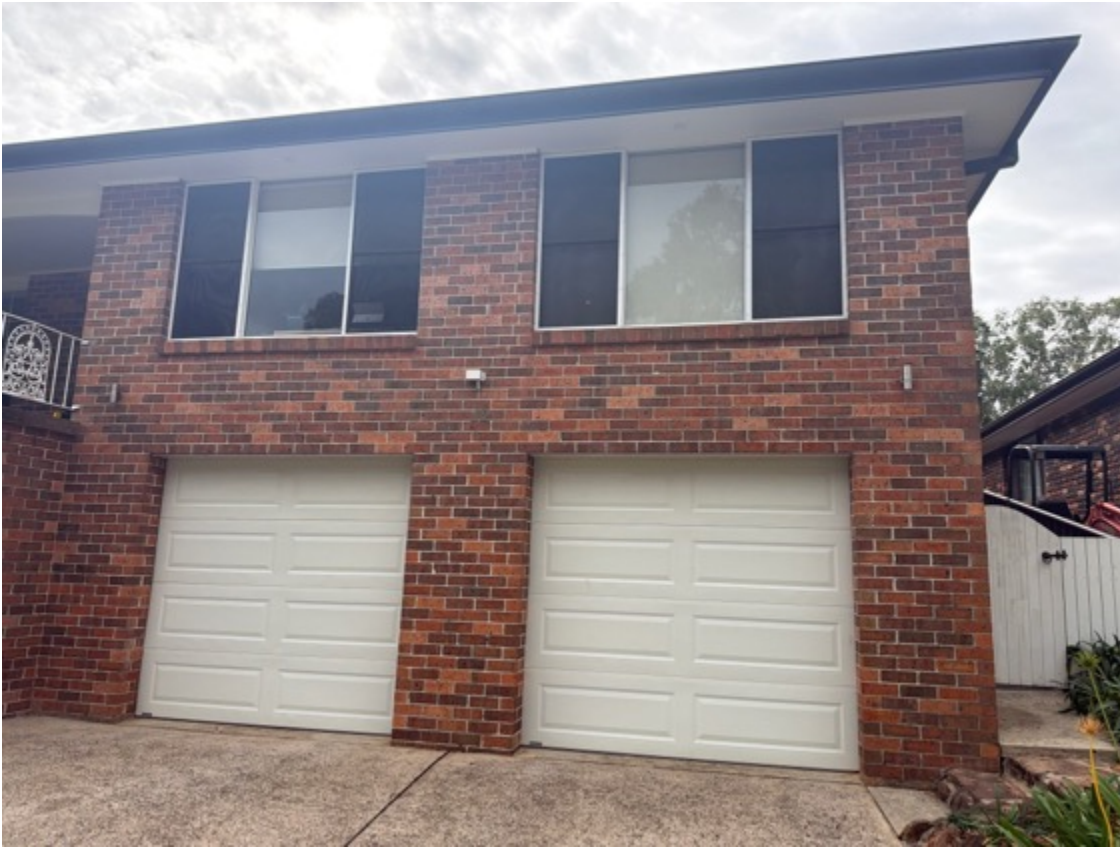
Garage roller doors tested, functioned at the time of inspection.

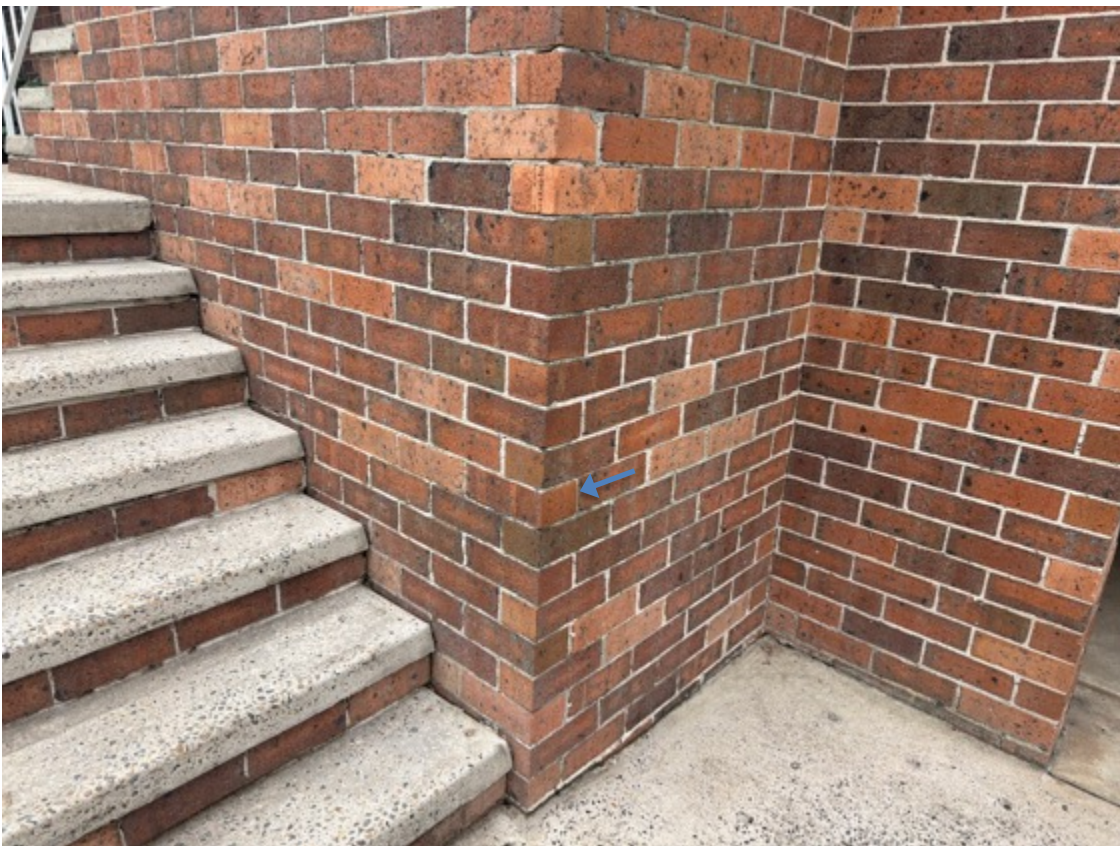
Isolated sections of external brickwork displays category one cracking (front elevation example above.)

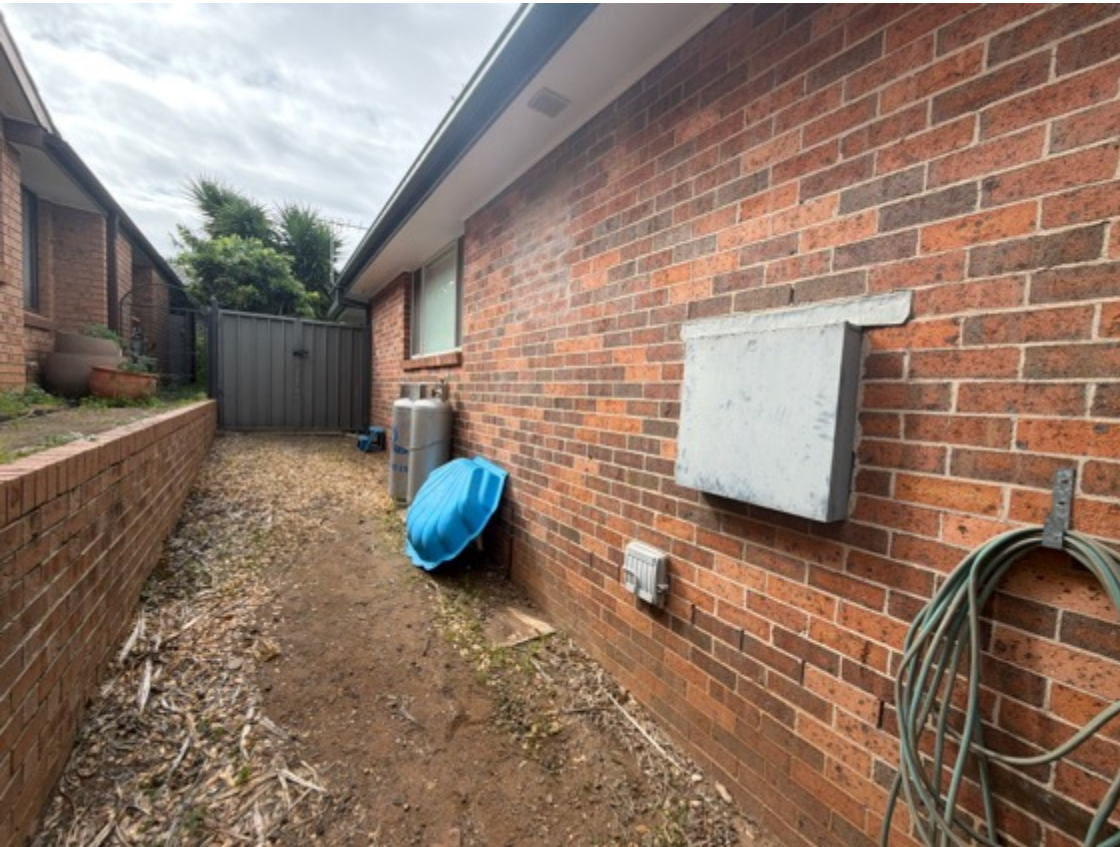
Exterior windows and doors present in satisfactory condition for the age.

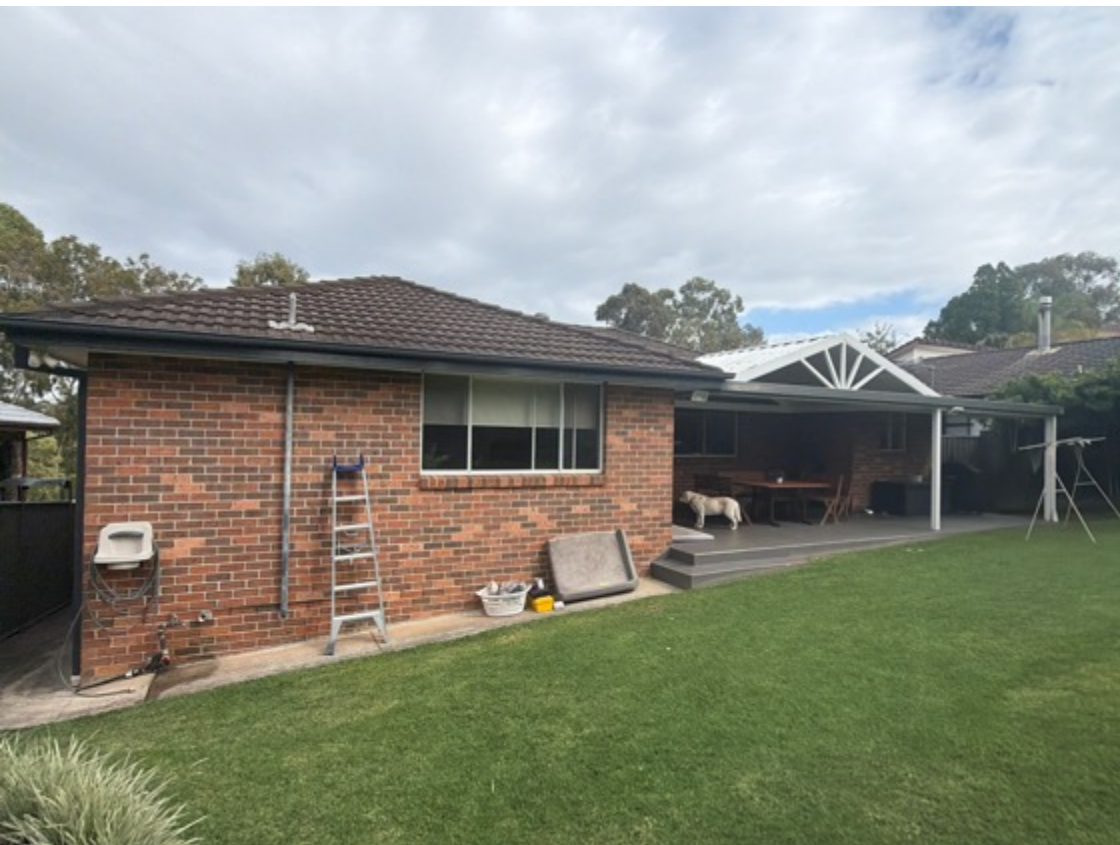
Rear elevation example above.

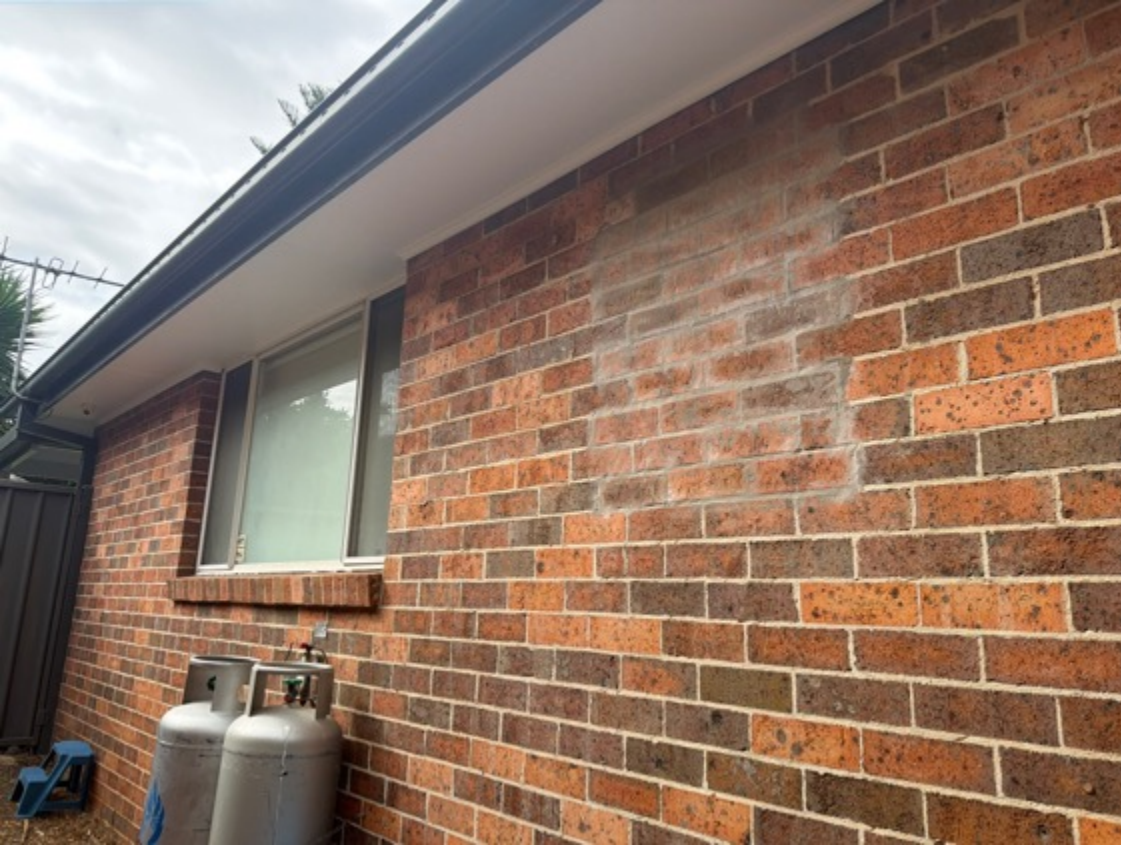
Left side elevation mid-sections n brickwork has been patched here.

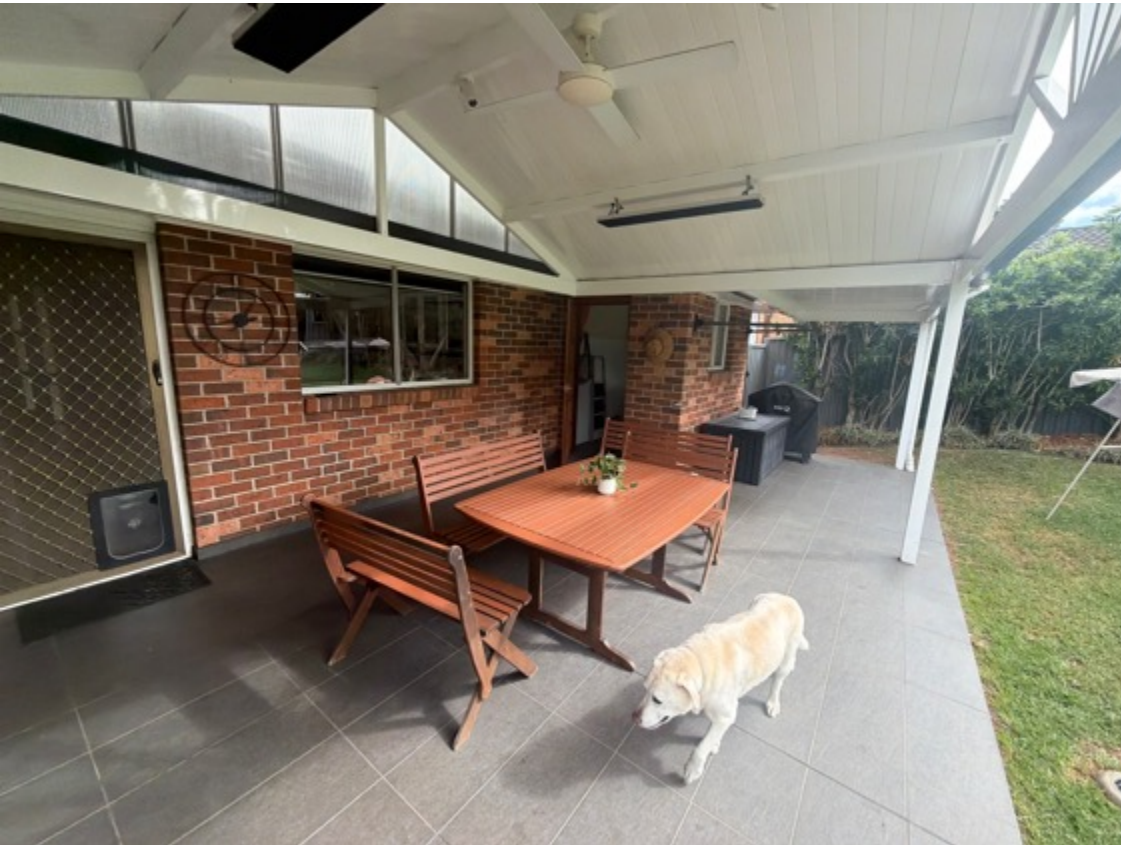
The rear pergola checked is structurally sound.

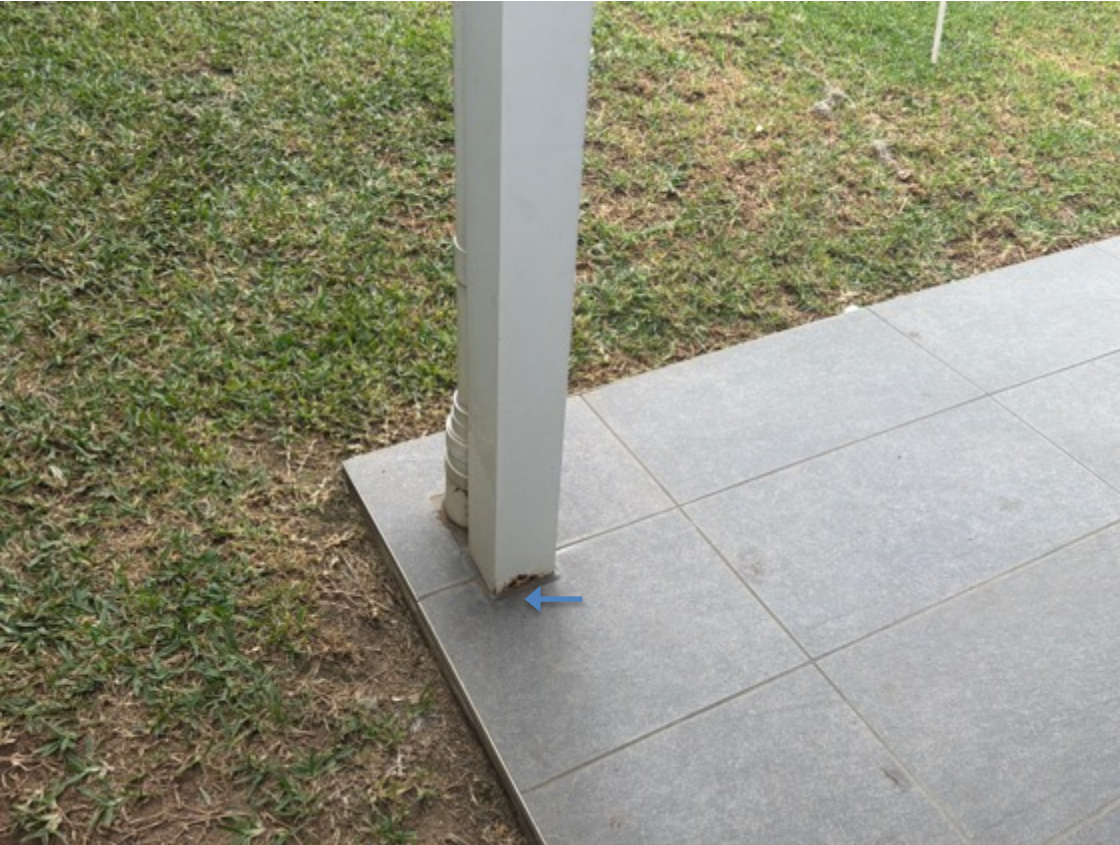
Base of pergola posts have low level surface rust visible.

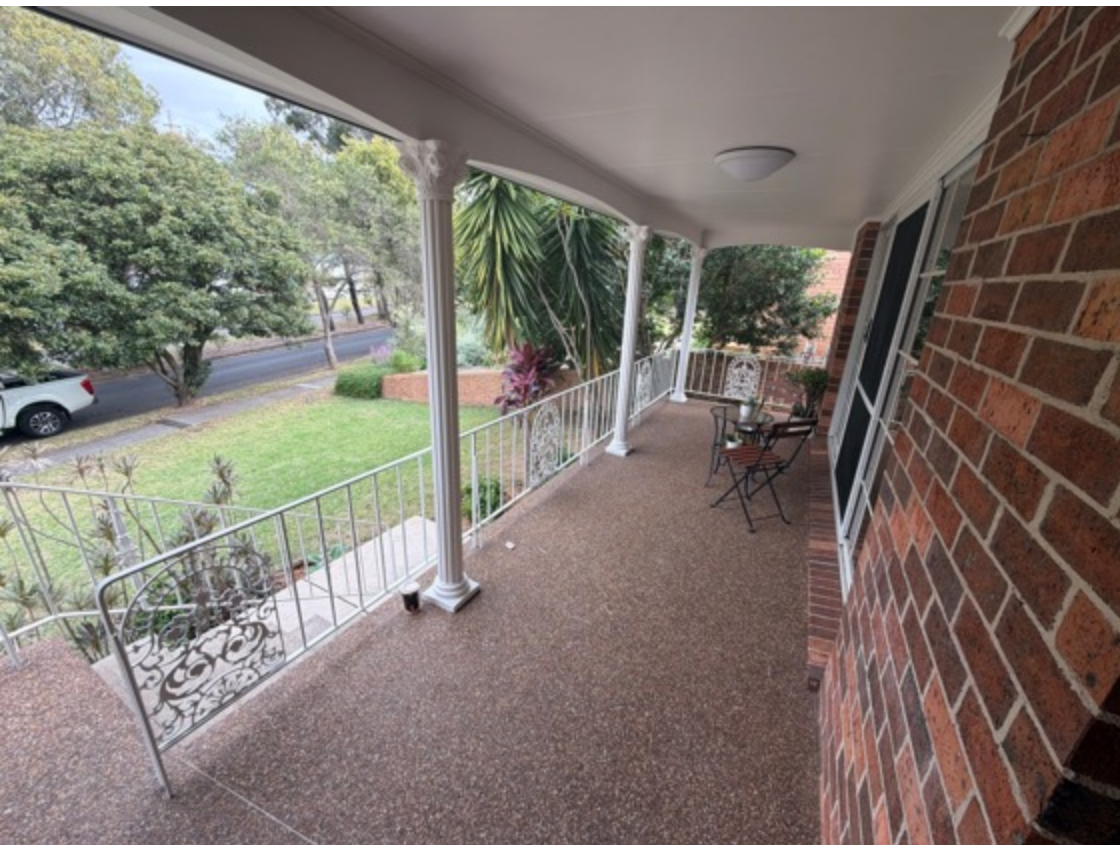
Exterior railings checked are structurally sound.

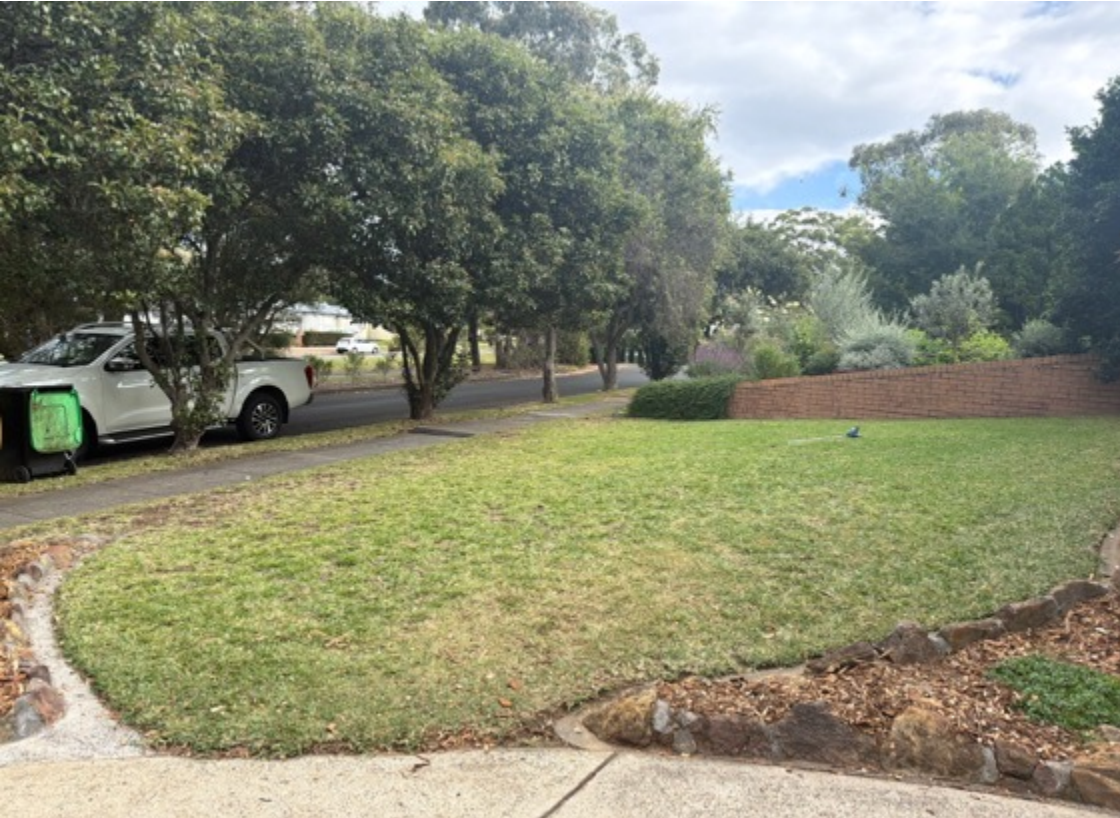
Site drainage / land overflow appears to function adequately with no signs of water laying at the time of inspection.

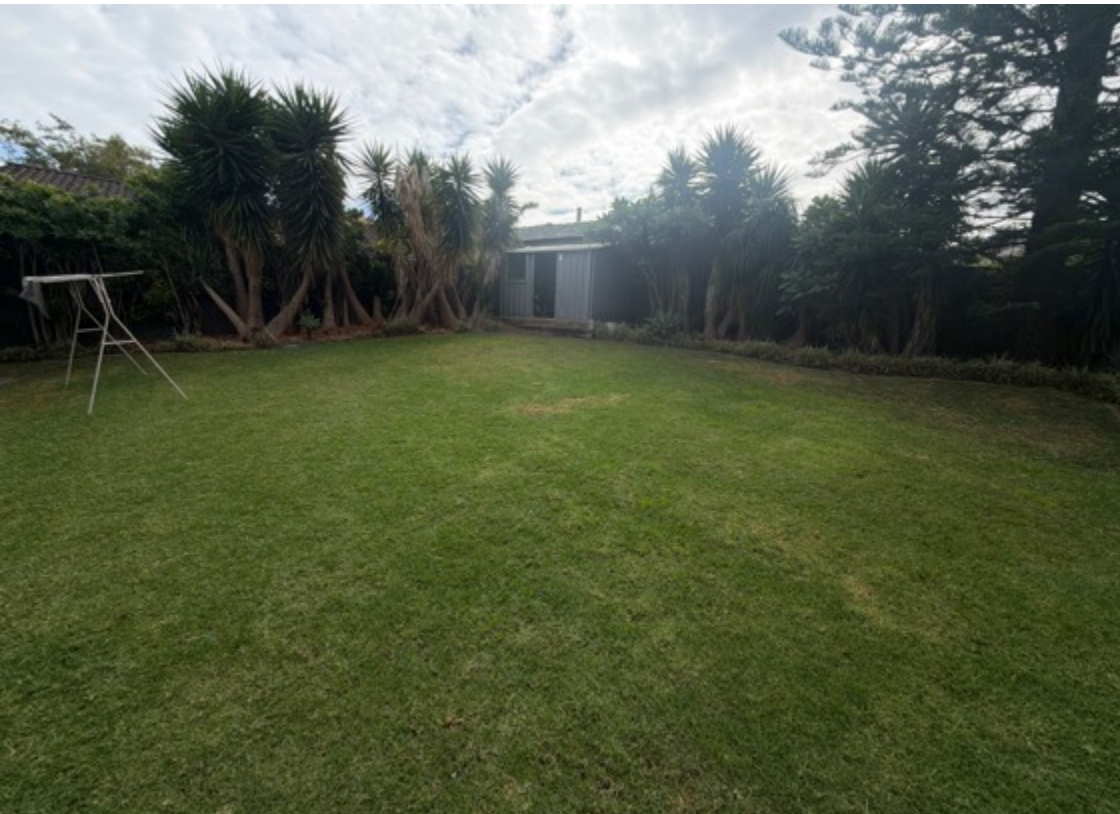
Rear yard example above.

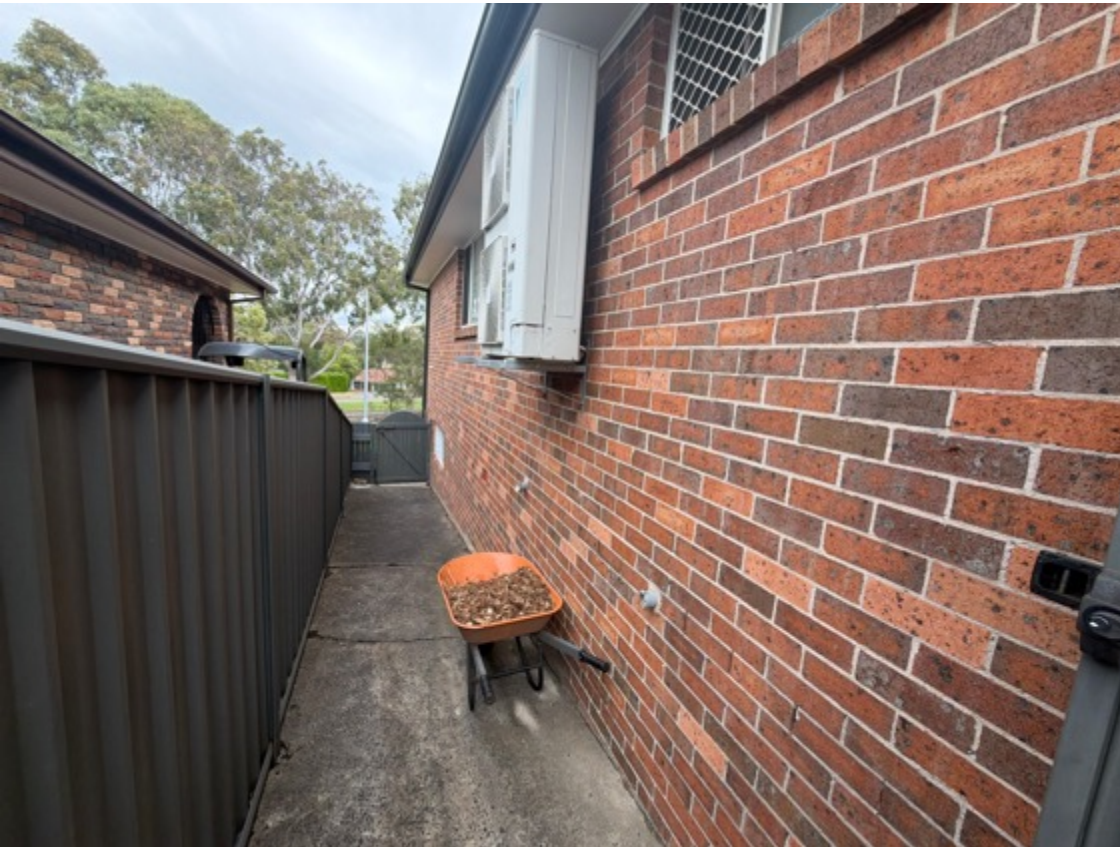
Site fences are in serviceable condition, isolated sections have a slight inward lean, consistent with age.

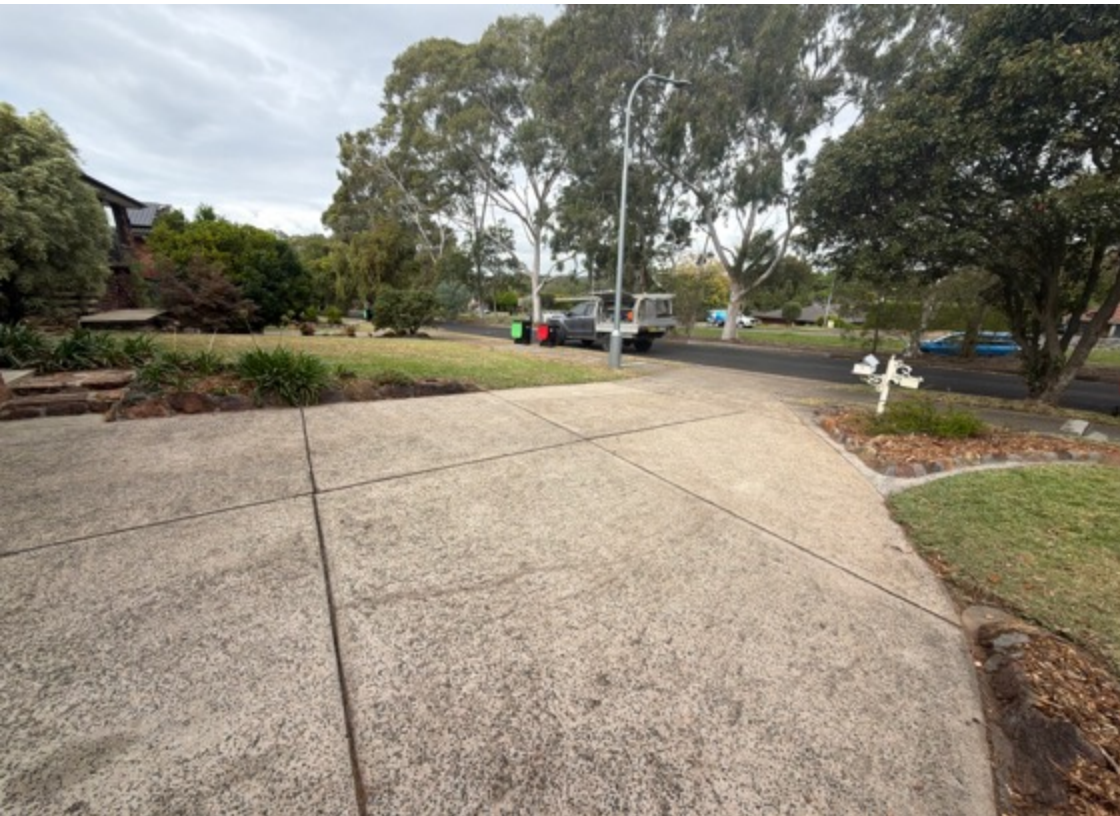
Exterior concrete presents in satisfactory condition for the age - isolated sections are cracked and undulating (consistent with age.)

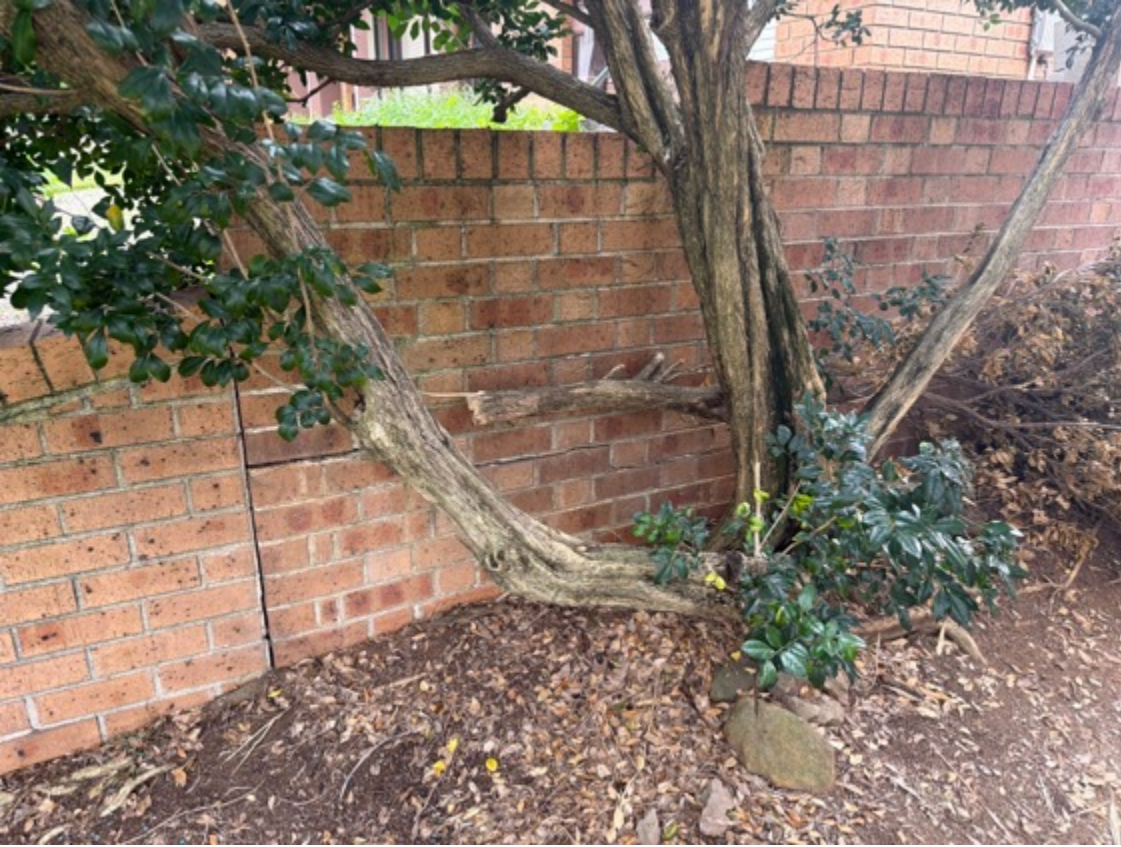
The front left side retaining wall has cracking visible - requires remedial works.

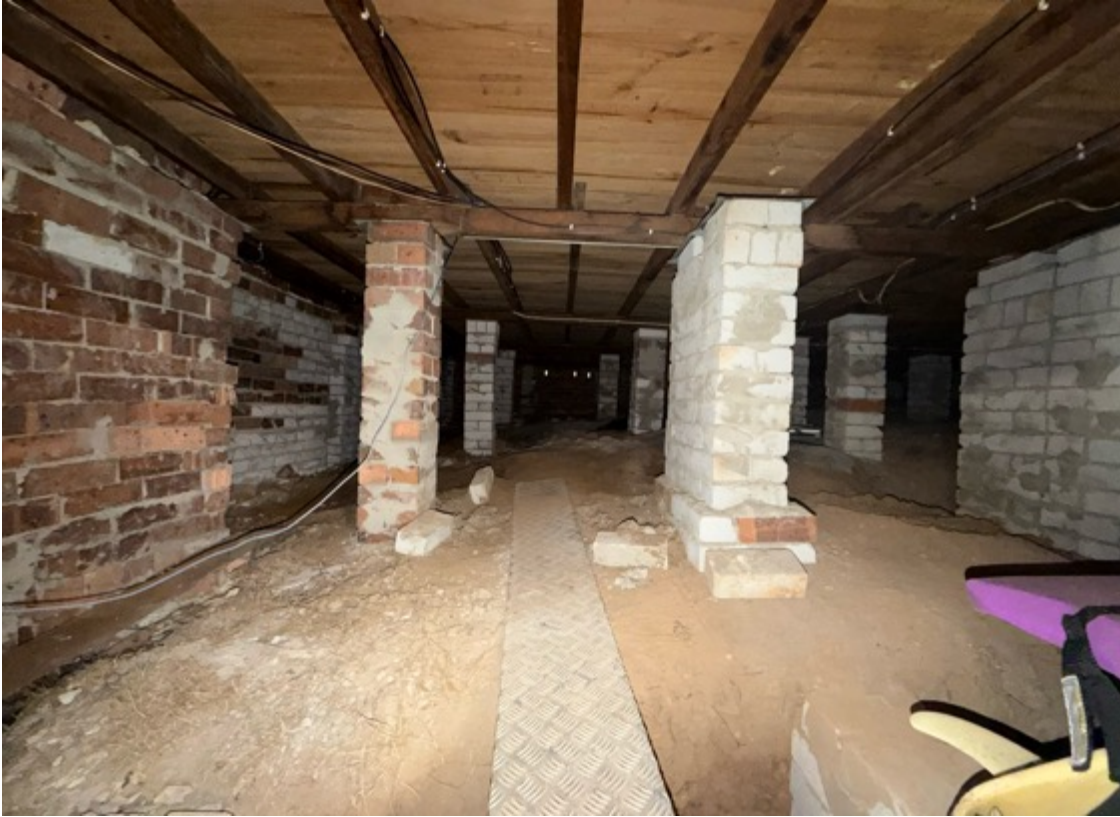
All areas within the subfloor area were dry at the time of inspection.

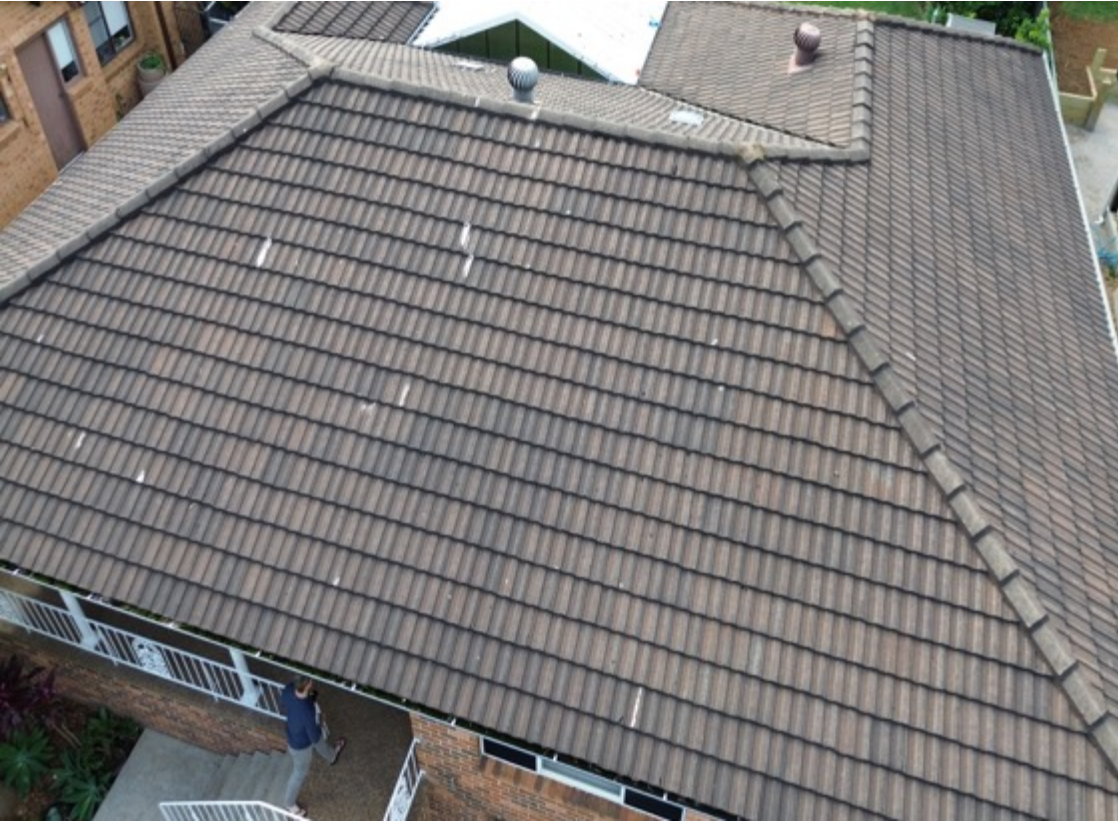
The roof exterior presents in satisfactory condition for the age.

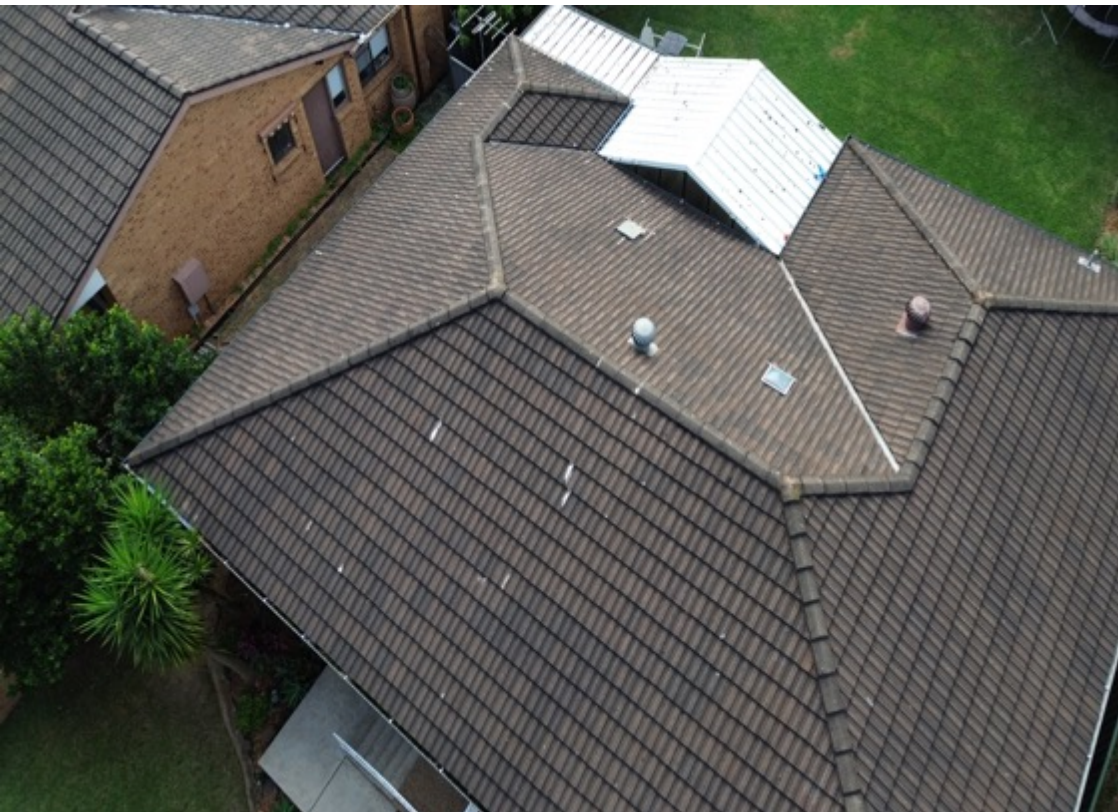
Rear sheet metal roof sheets present in satisfactory condition - isolated sections of roof tiles are chipped, consistent with age.

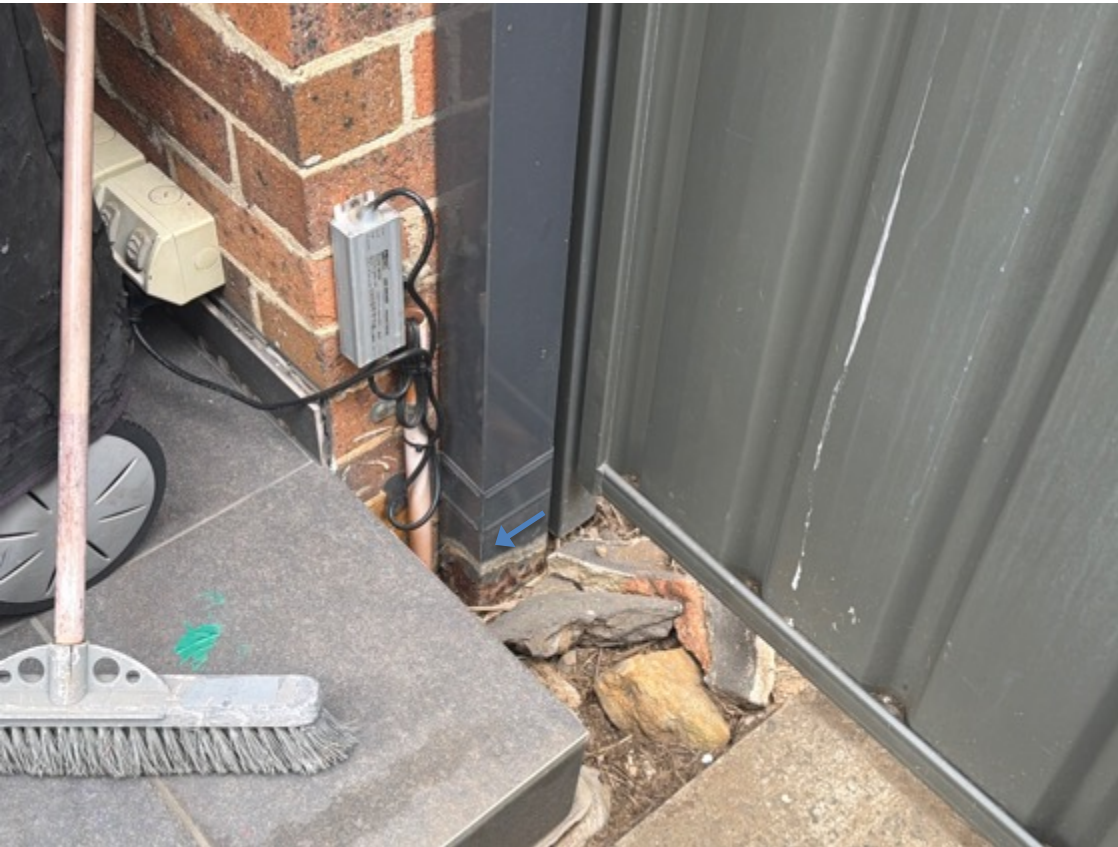
The rear left side downpipe has surface rust visible at the base.

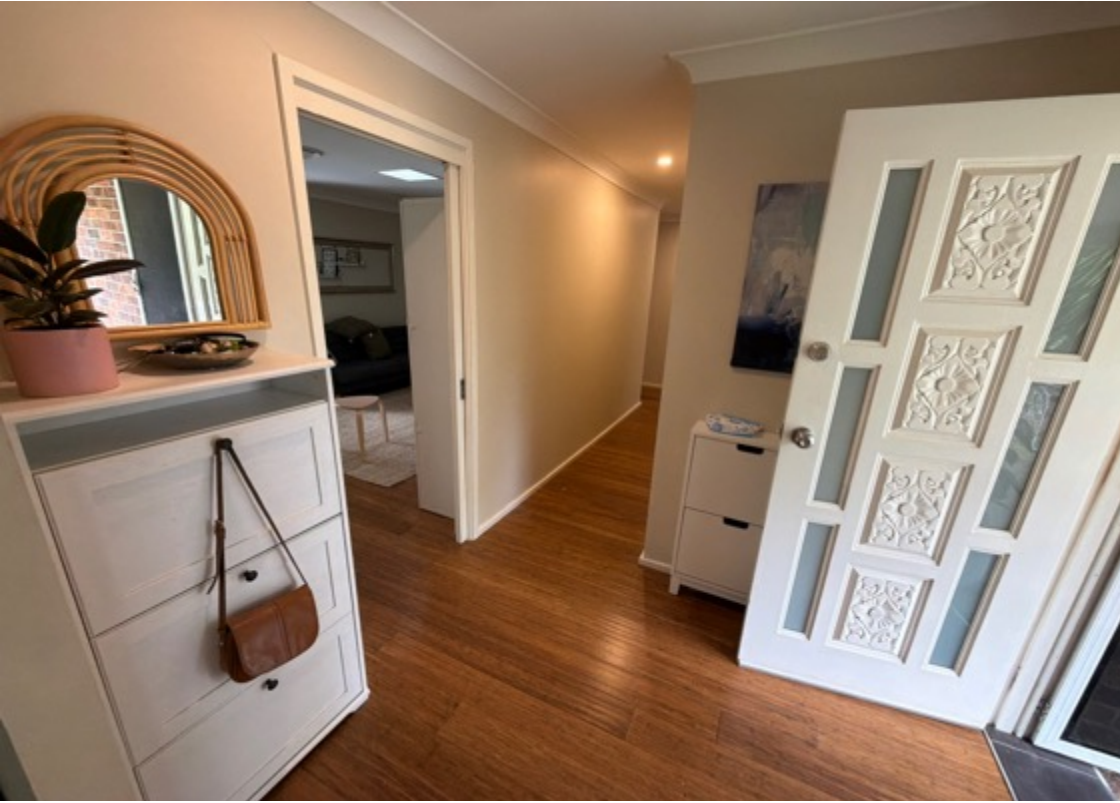
The interior of the house presents in satisfactory condition, maintained to a high level for the age.

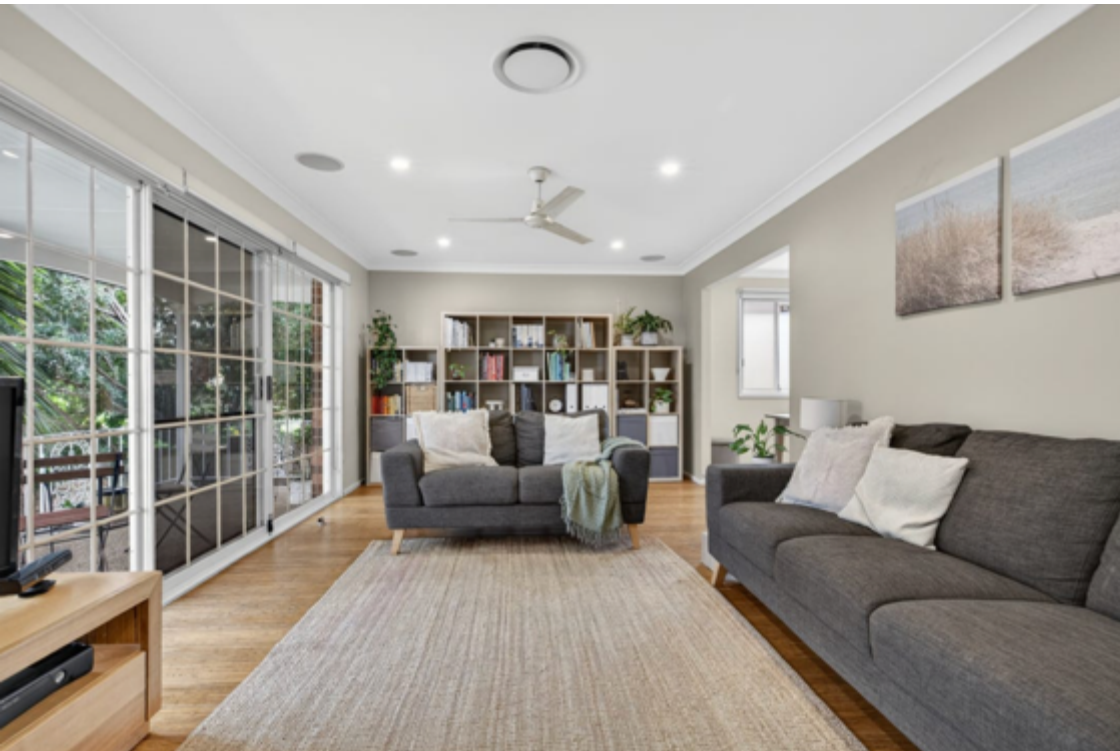
Interior living rooms present in satisfactory condition for the age.

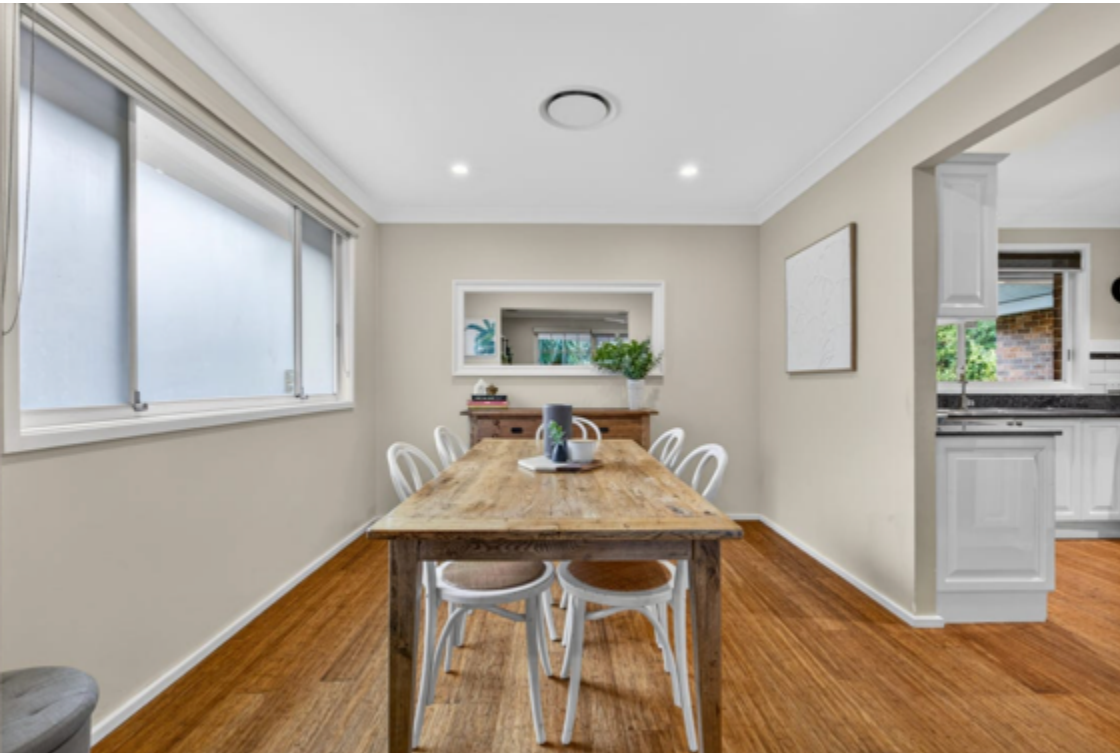
Example dining area above.

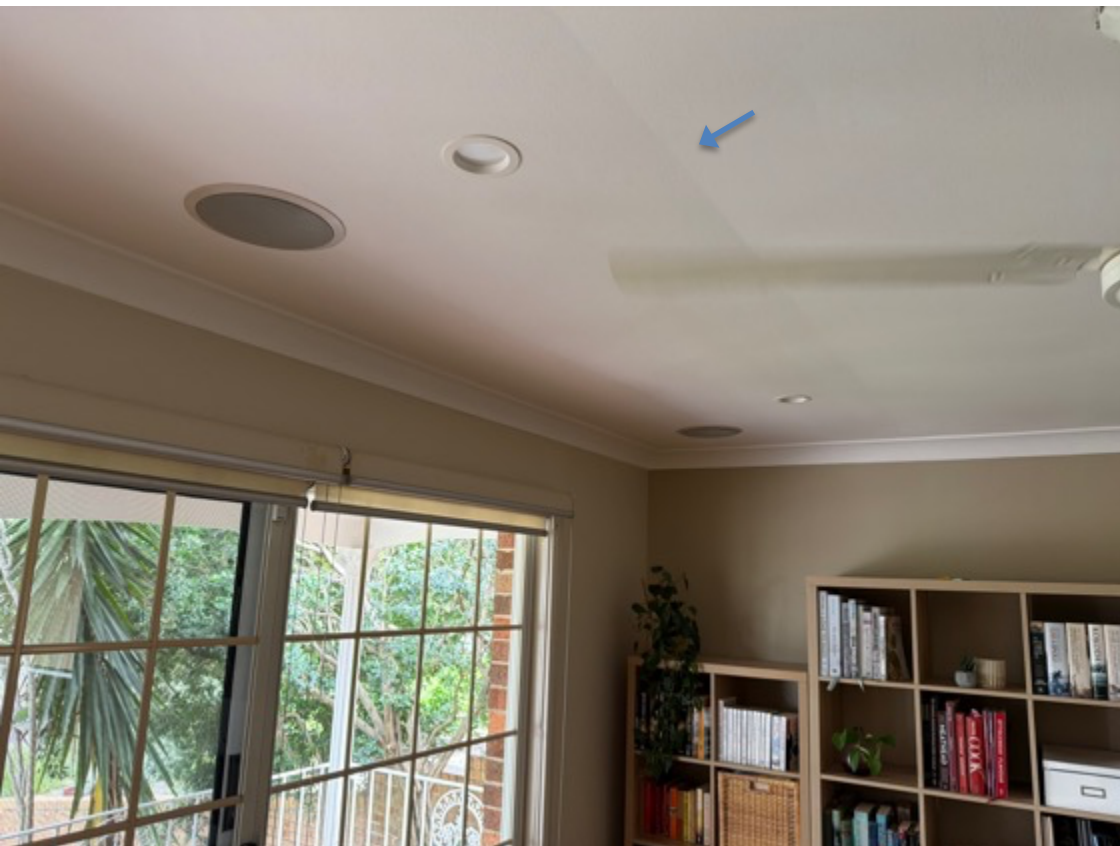
Internal plasterboard and cornices display minor imperfections.

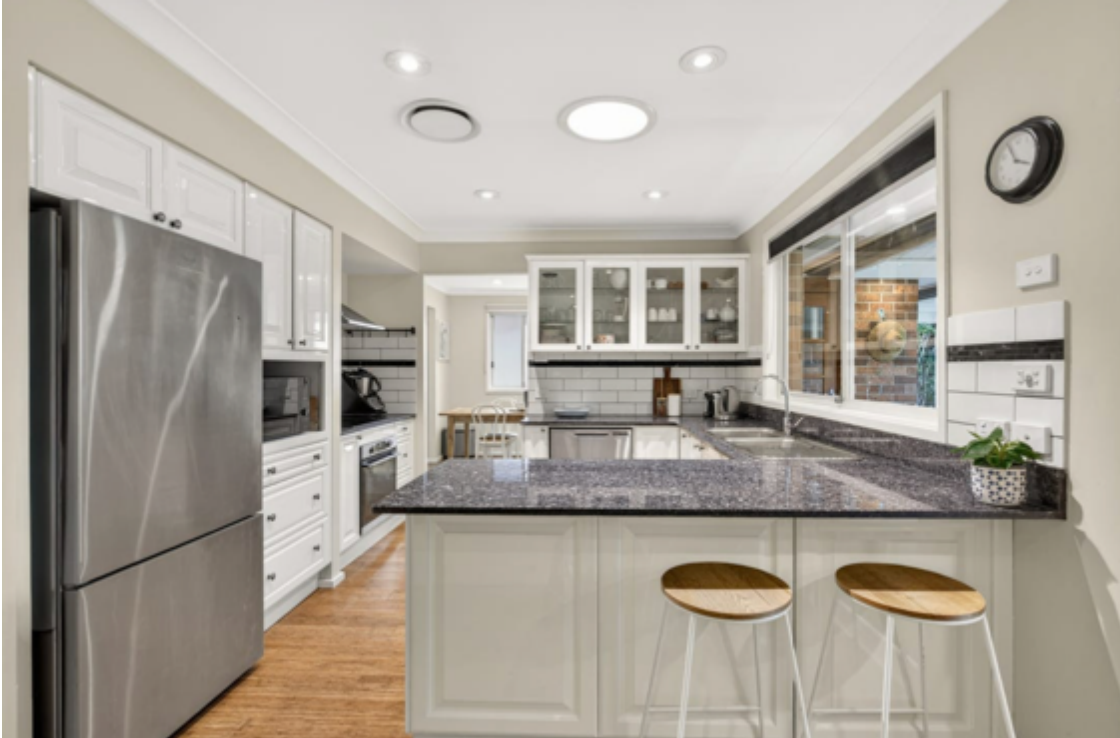
The kitchen area presents in satisfactory condition for the age.
