# PRE-PURCHASE PROPERTY INSPECTION BUILDING REPORT

**Visual Pre-Purchase Building Inspection Report.**

**12 BRETT STREET KINGS LANGLEY**

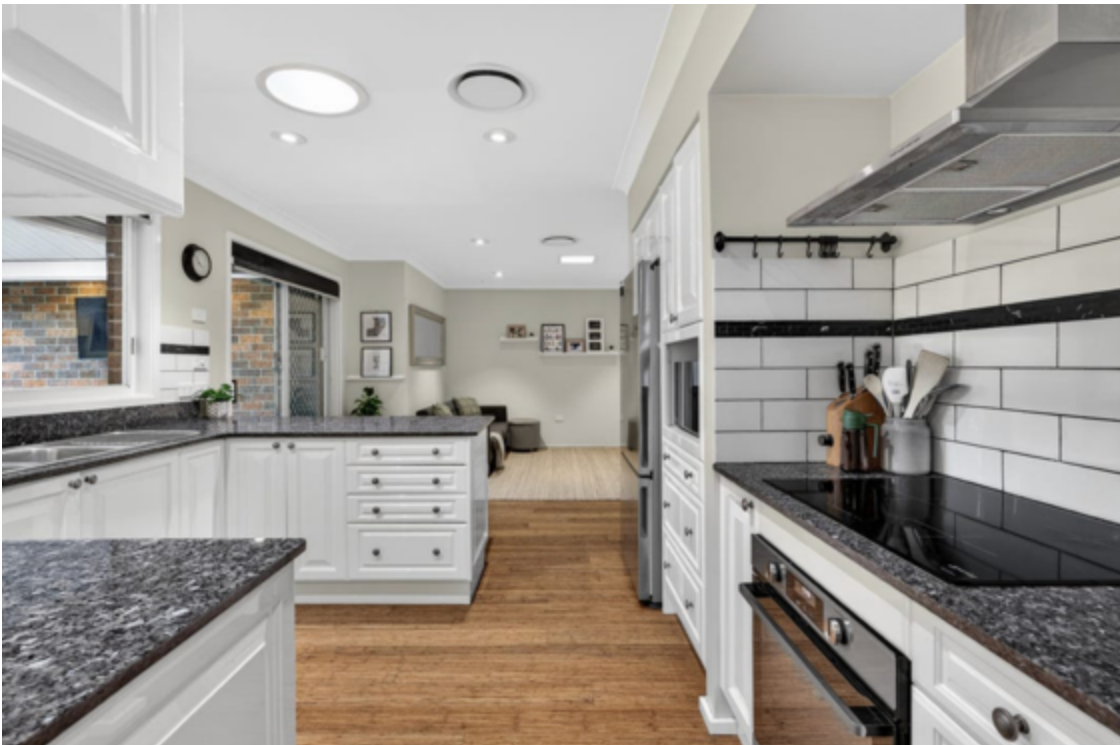
Appliances tested, functioned at the time of inspection.

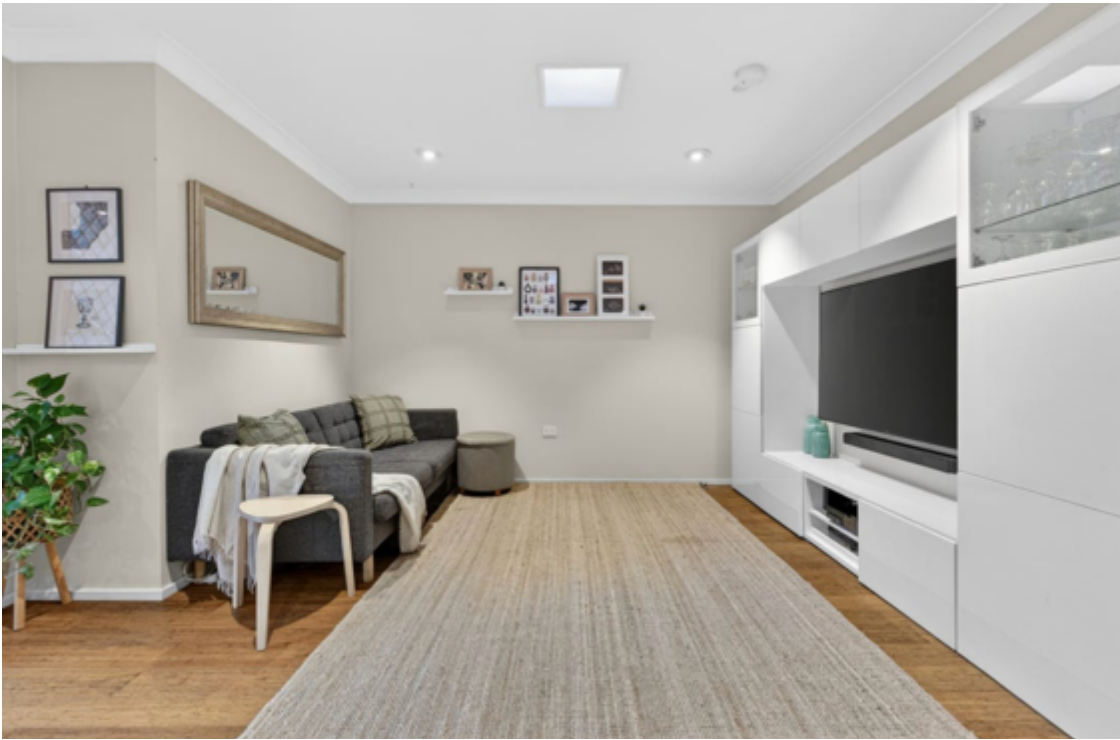
Living area lights tested, functioned at the time of inspection.

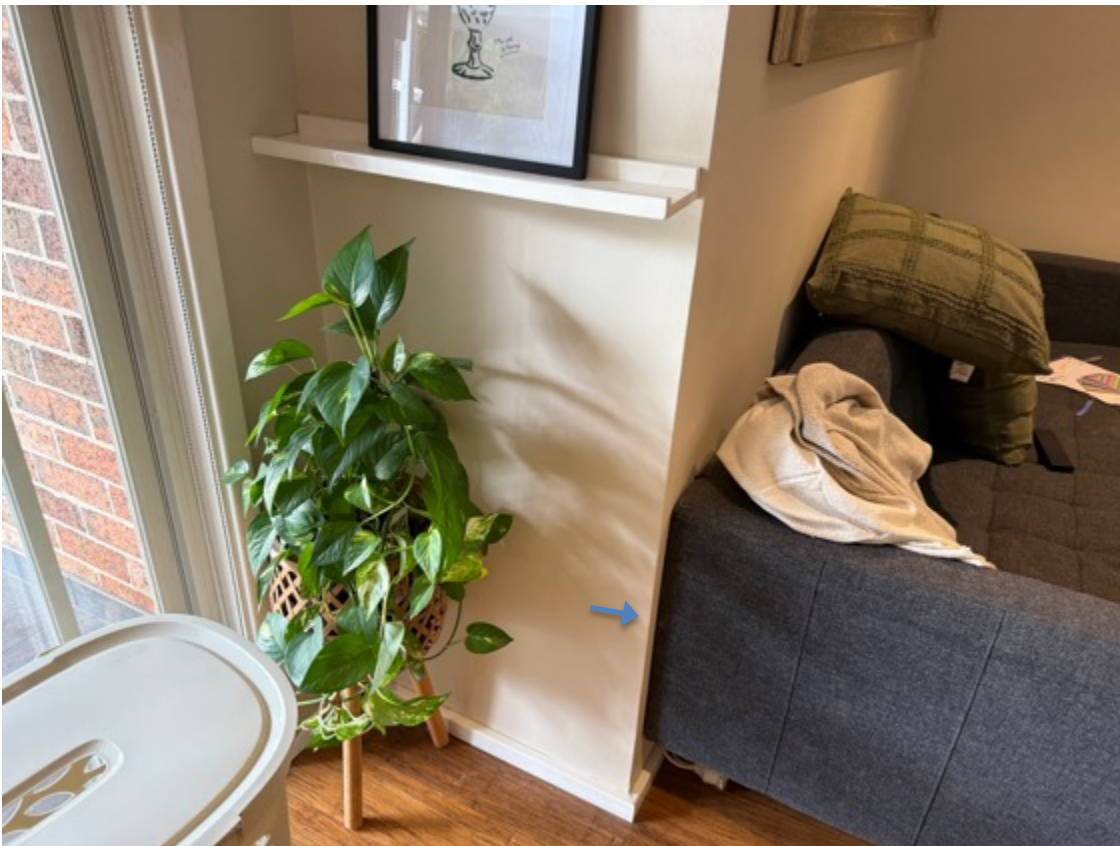
Internal surfaces display low level paint blemishes, consistent with age.

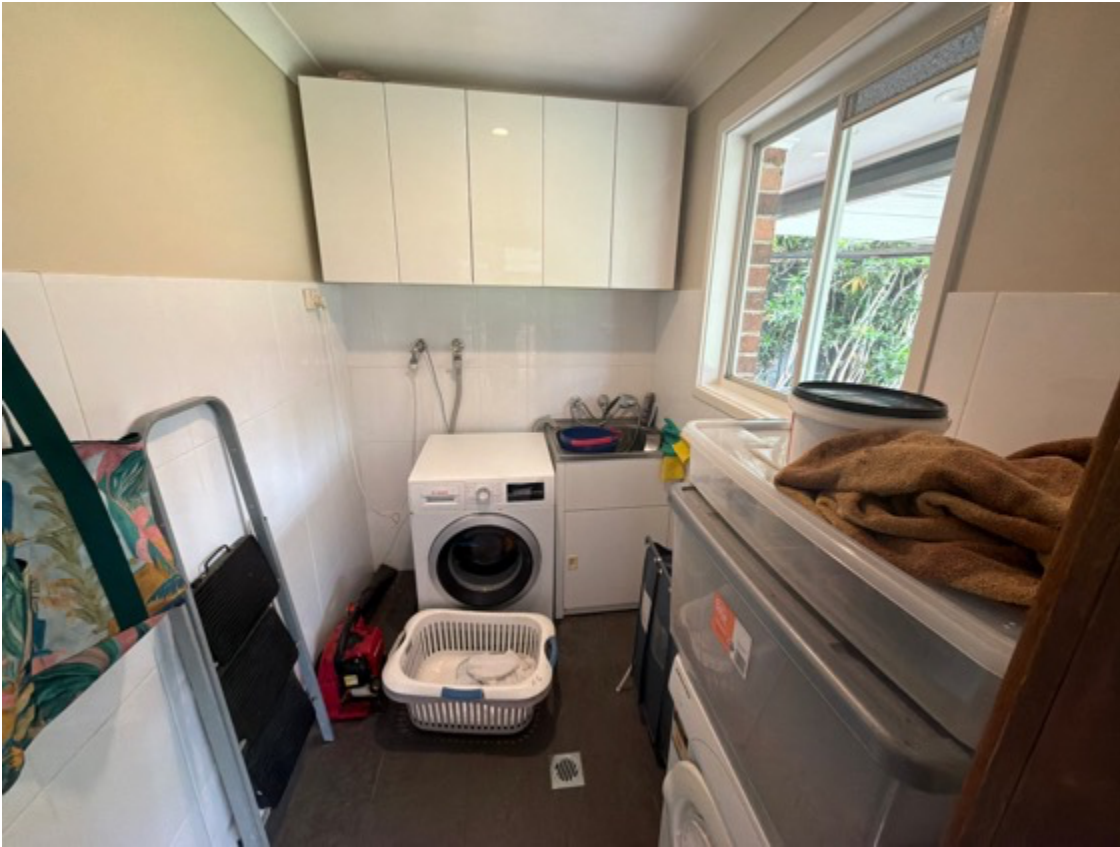
The laundry is in serviceable condition.

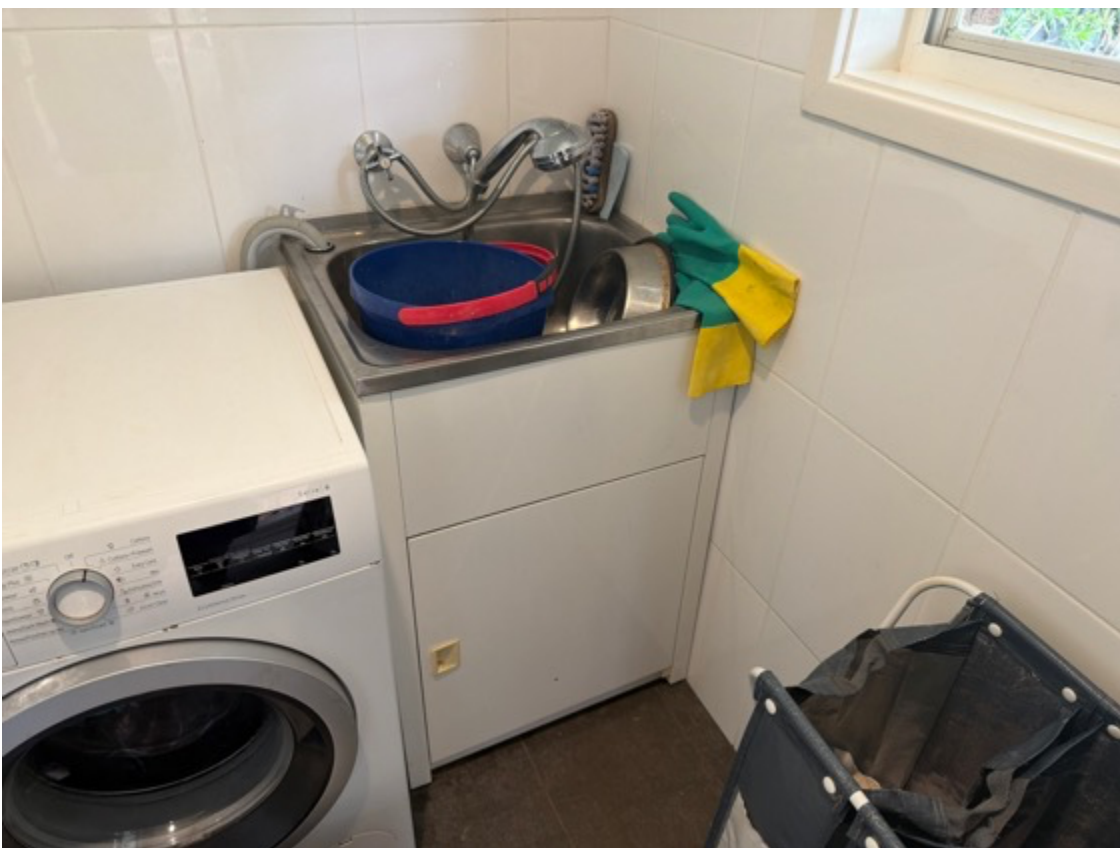
Water pressure tested, is sufficient.

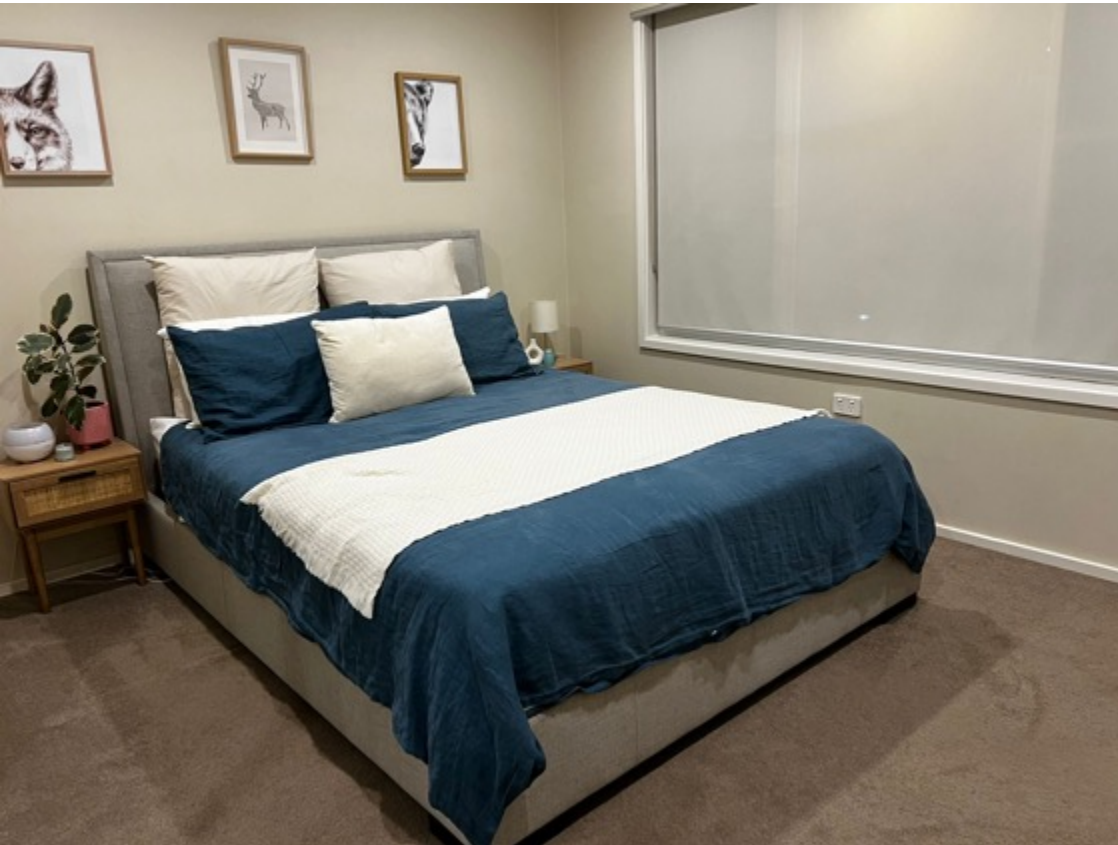
Interior bedroom areas present in satisfactory condition for the age.

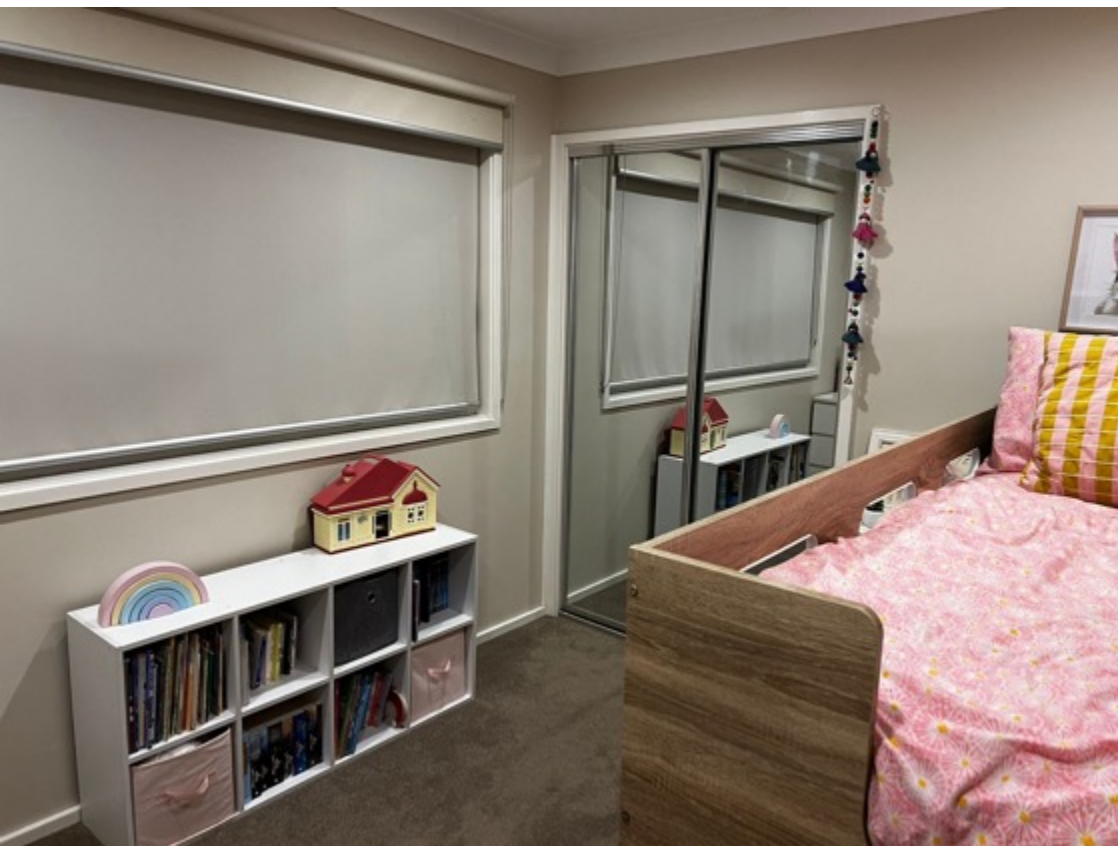
All interior lights tested, functioned as intended at the time of inspection.

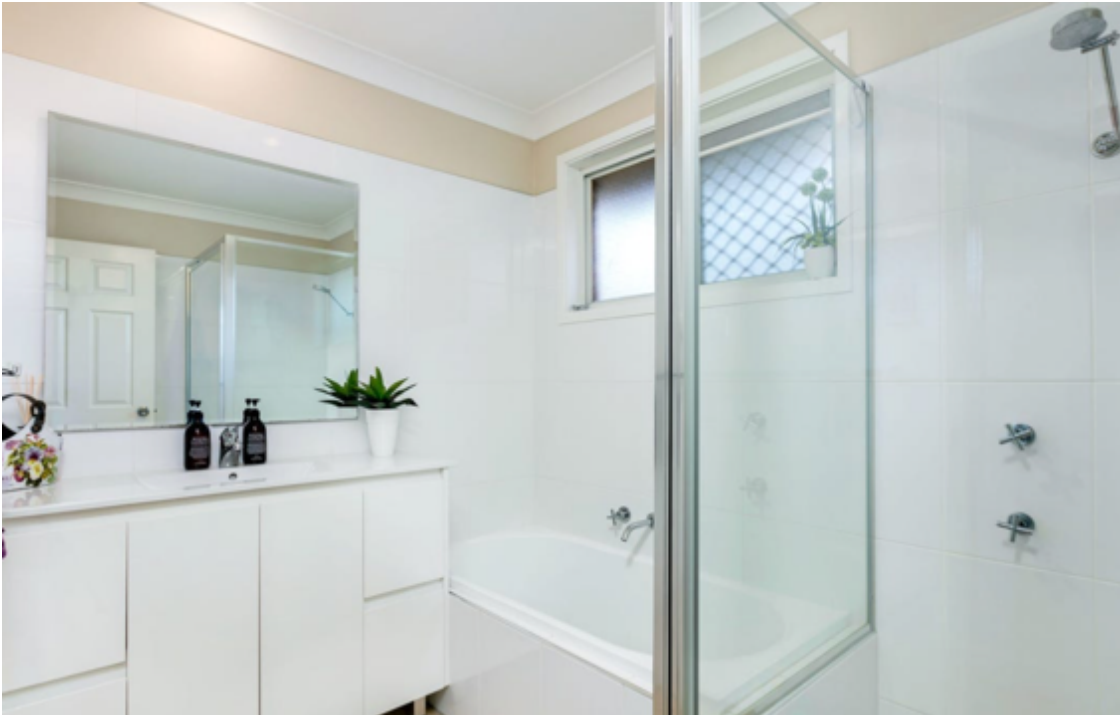
The common bathroom area tested for leaks, fixings and stability was issue free at the time of inspection.

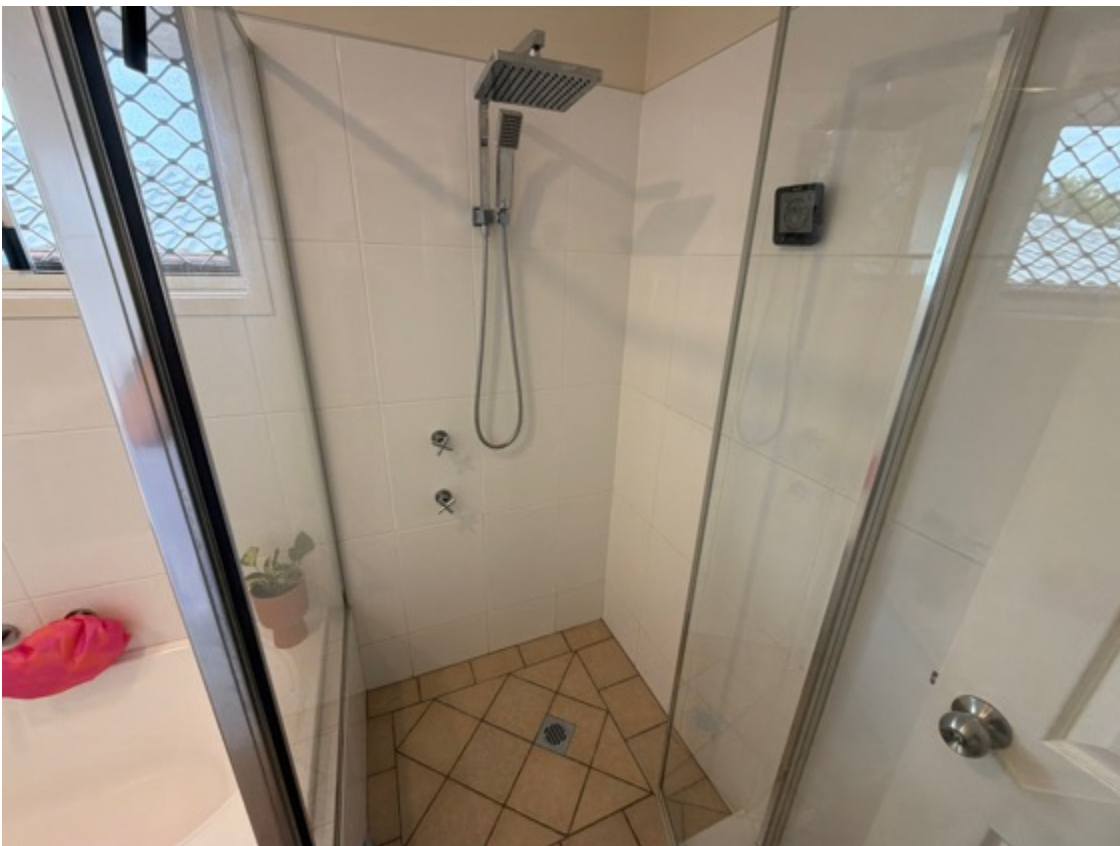
Hot and cold water services tested, functioned at the time of inspection.

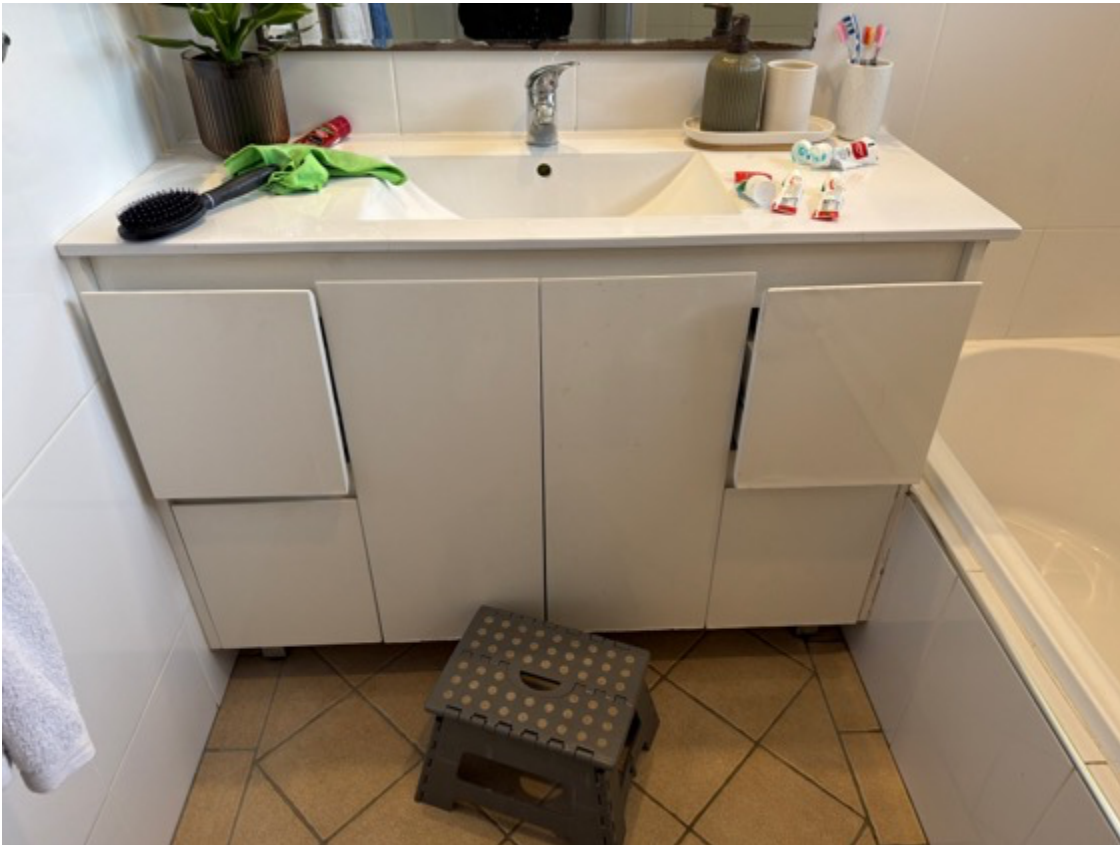
Water pressure tested, is sufficient.

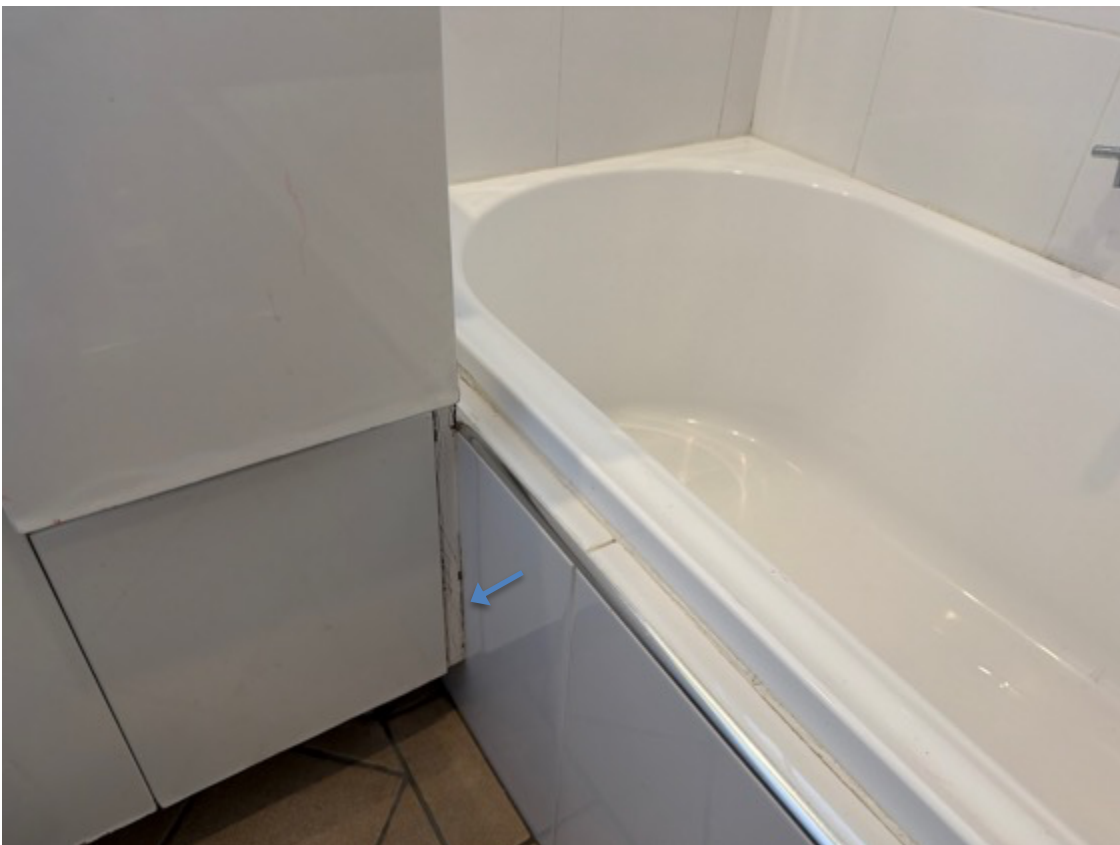
The vanity displays moderate level wear, consistent with age.

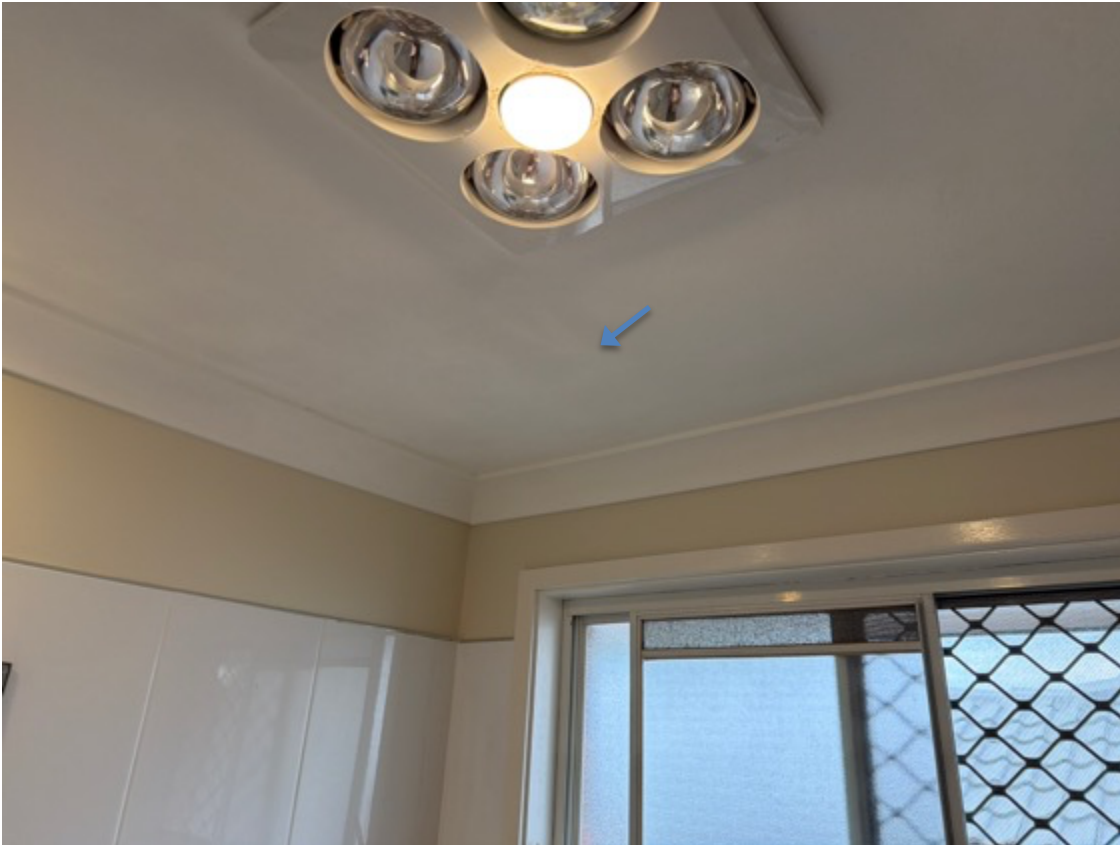
The ceiling paint is patchy.

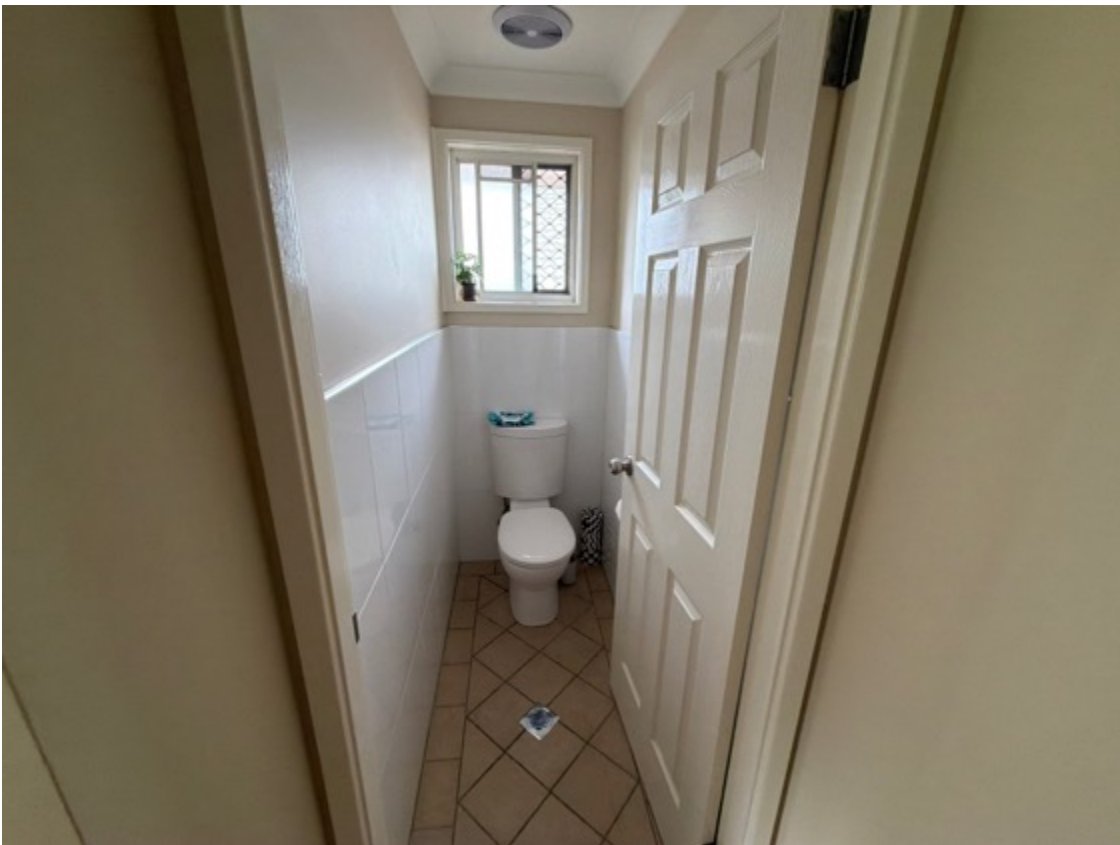
Common toilet water services tested, functioned at the time of inspection.

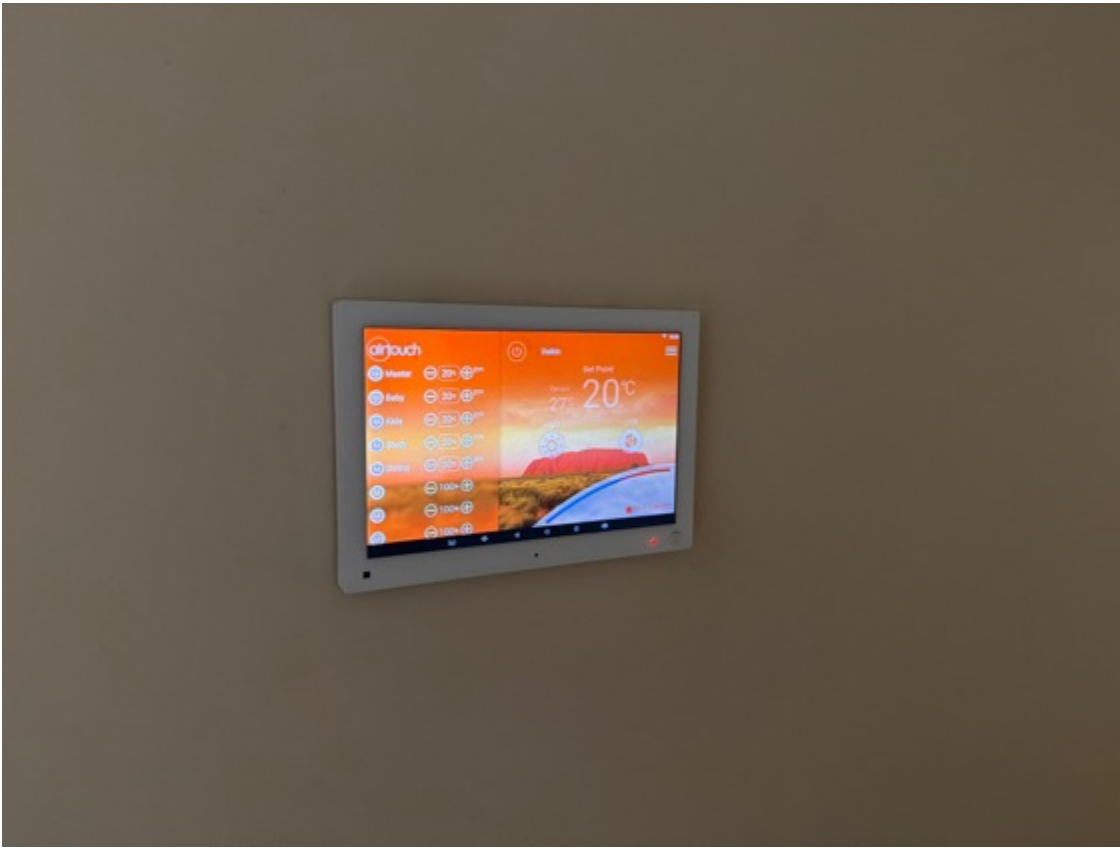
The AC tested, functioned at the time of inspection.

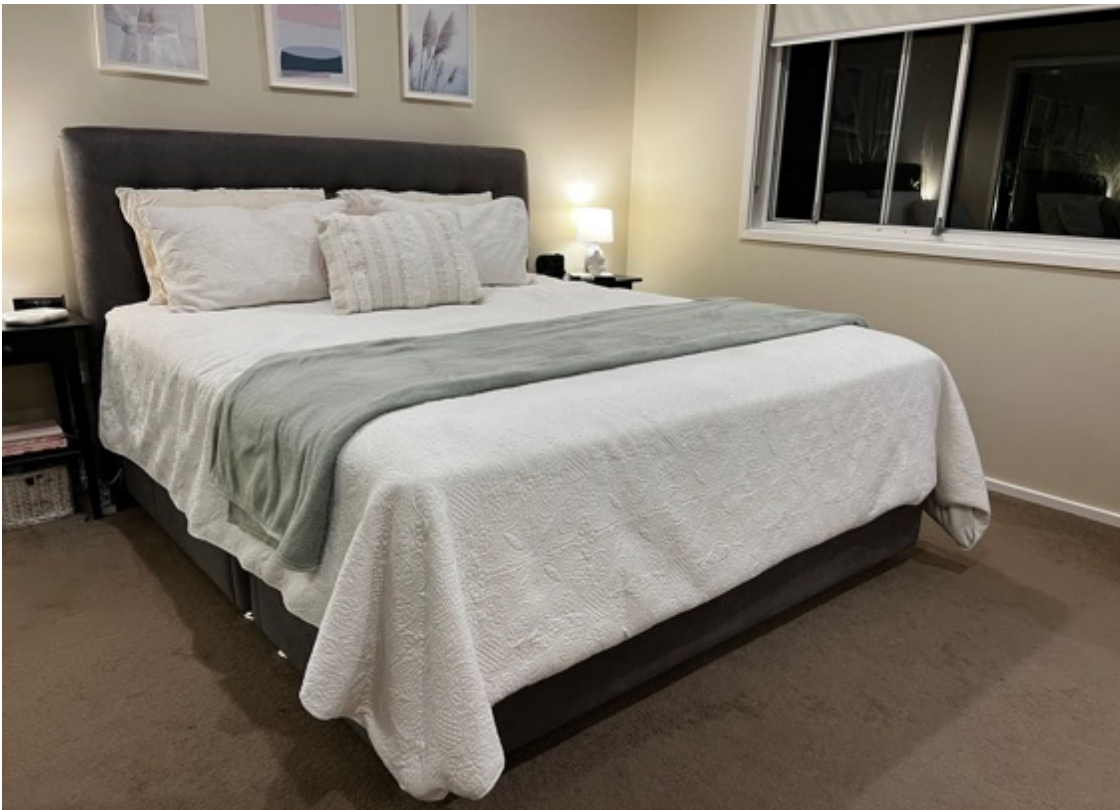
The main bedroom area presents in satisfactory condition for the age.

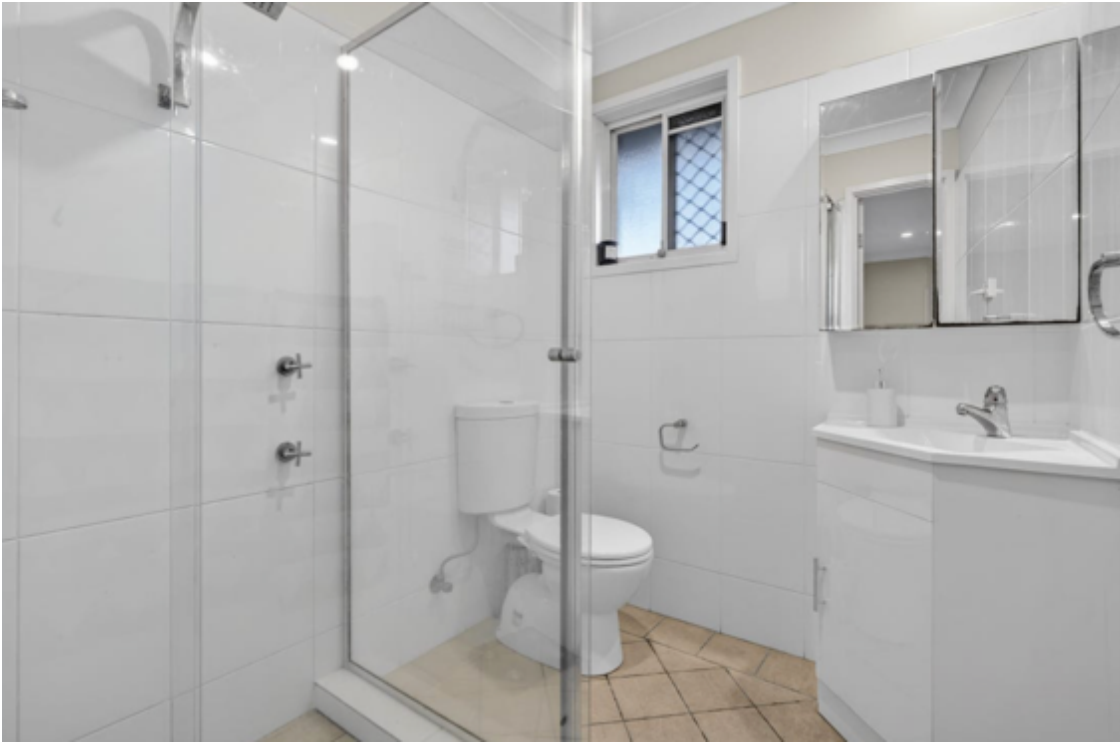
The ensuite bathroom area tested for leaks, fixings and stability was all clear at the time of inspection.

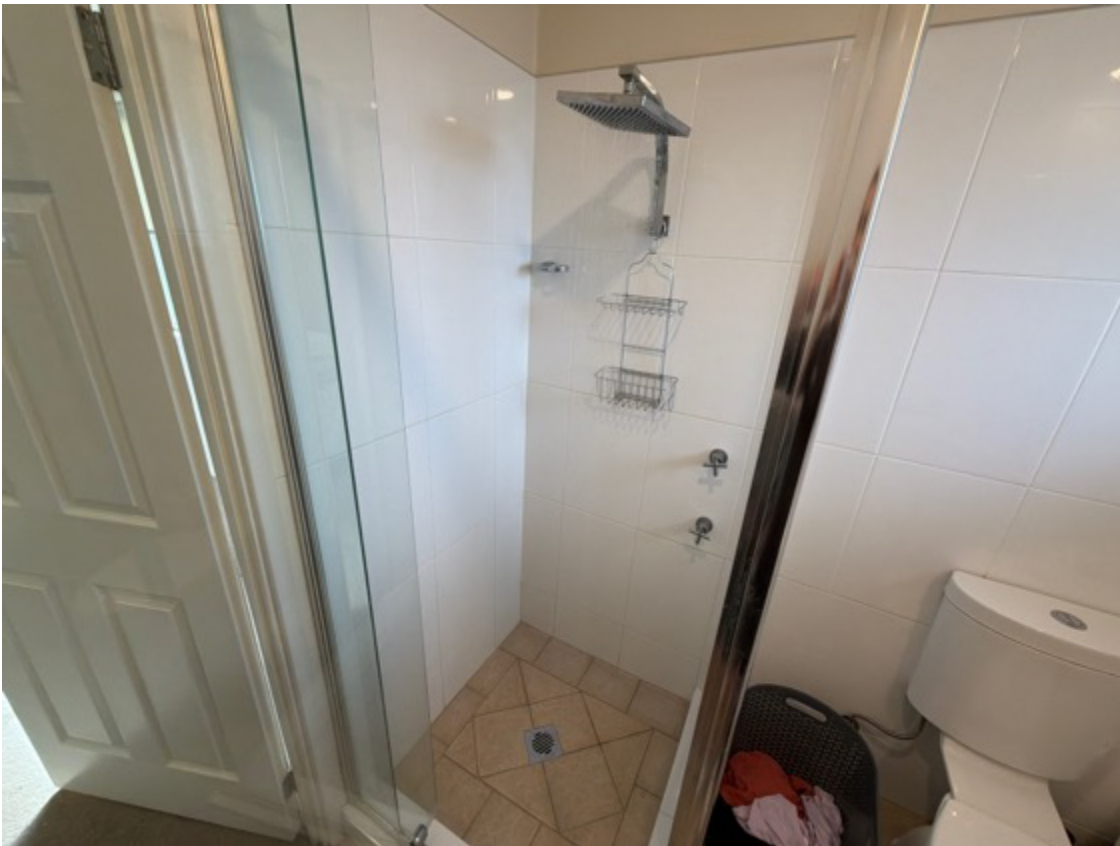
Hot and cold water services tested, functioned as intended at the time of inspection.

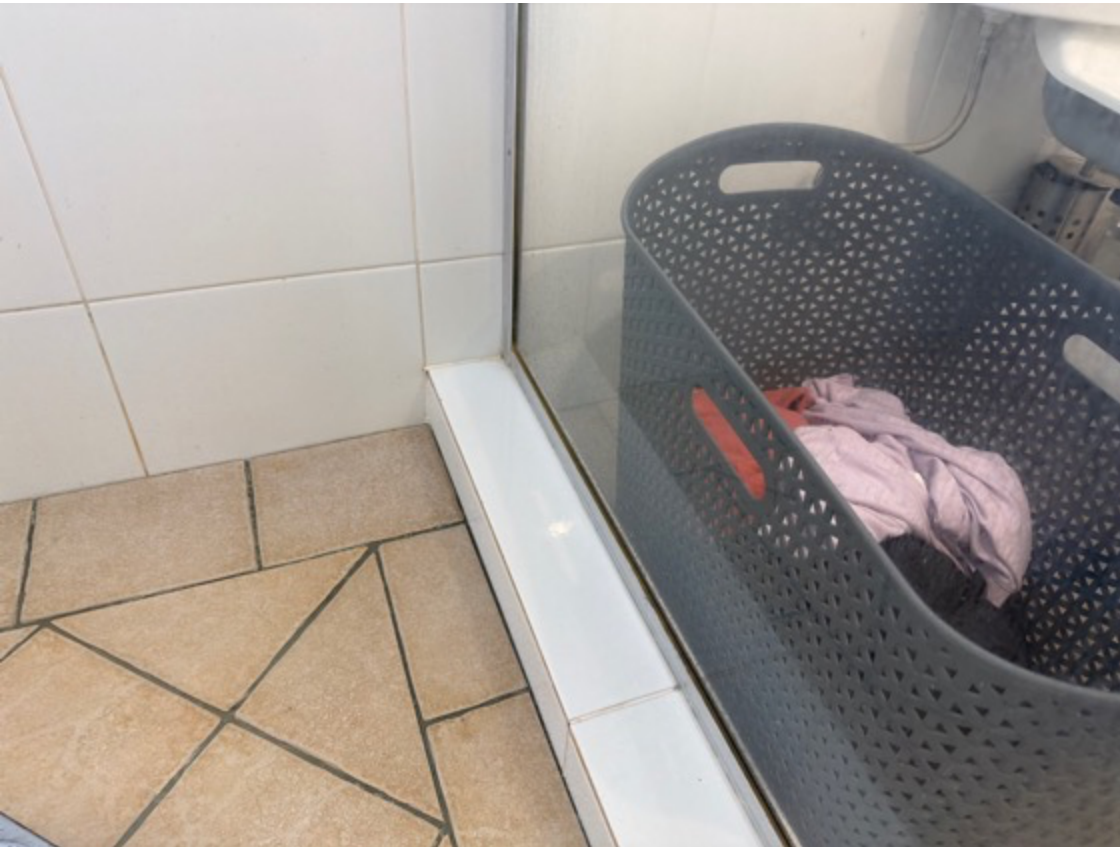
Isolated sections of tiles are chipped, consistent with age, example shower hob above.

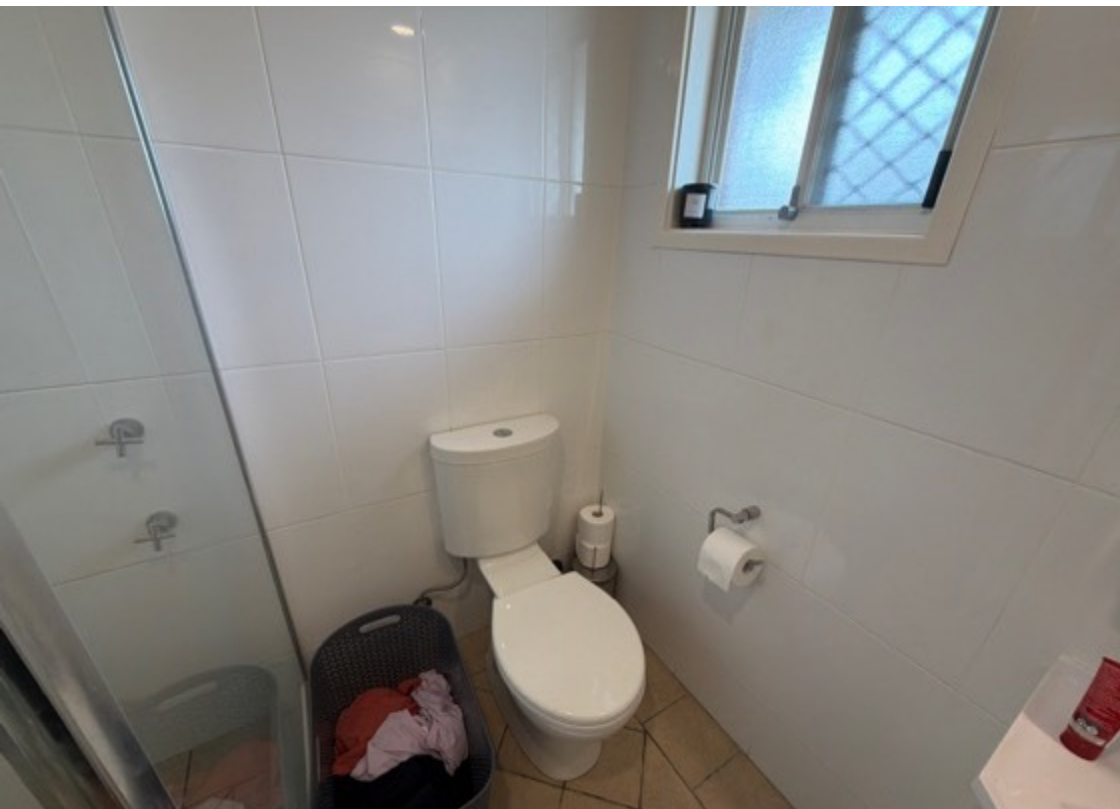
The toilet tested, functioned at the time of inspection.

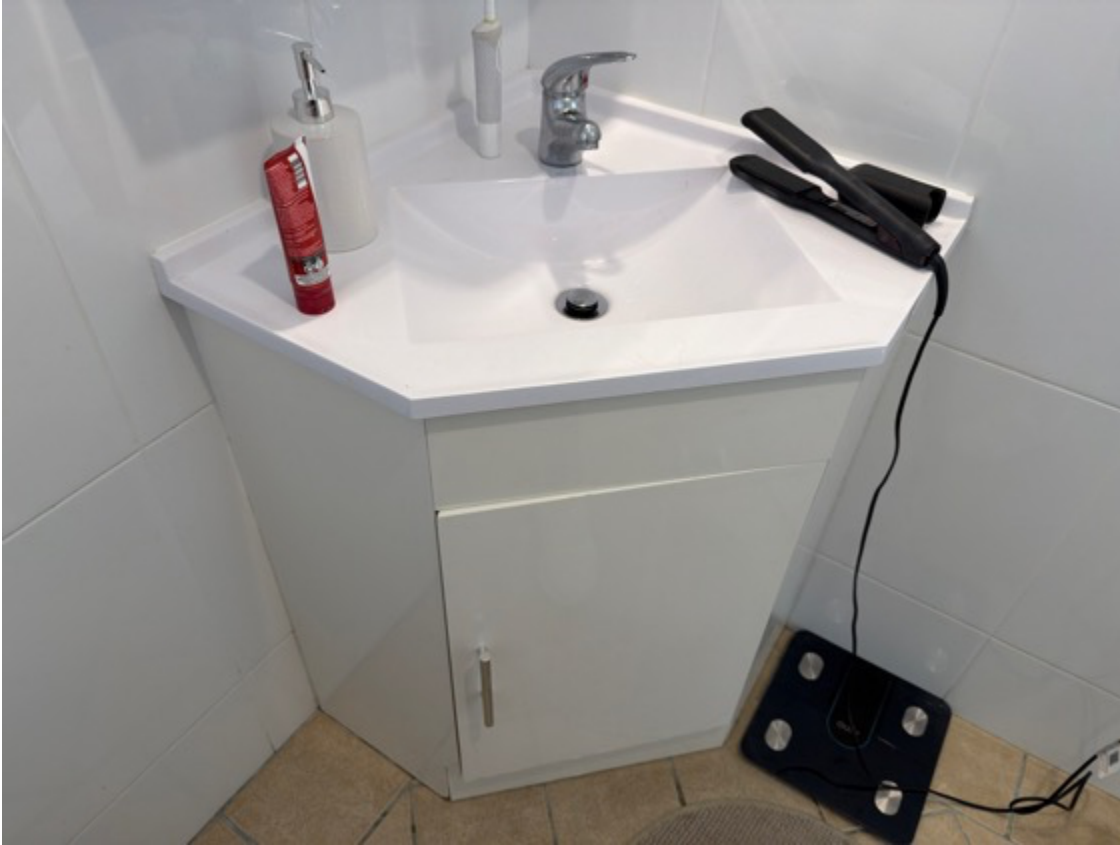
The vanity displays low level wear, consistent with age.

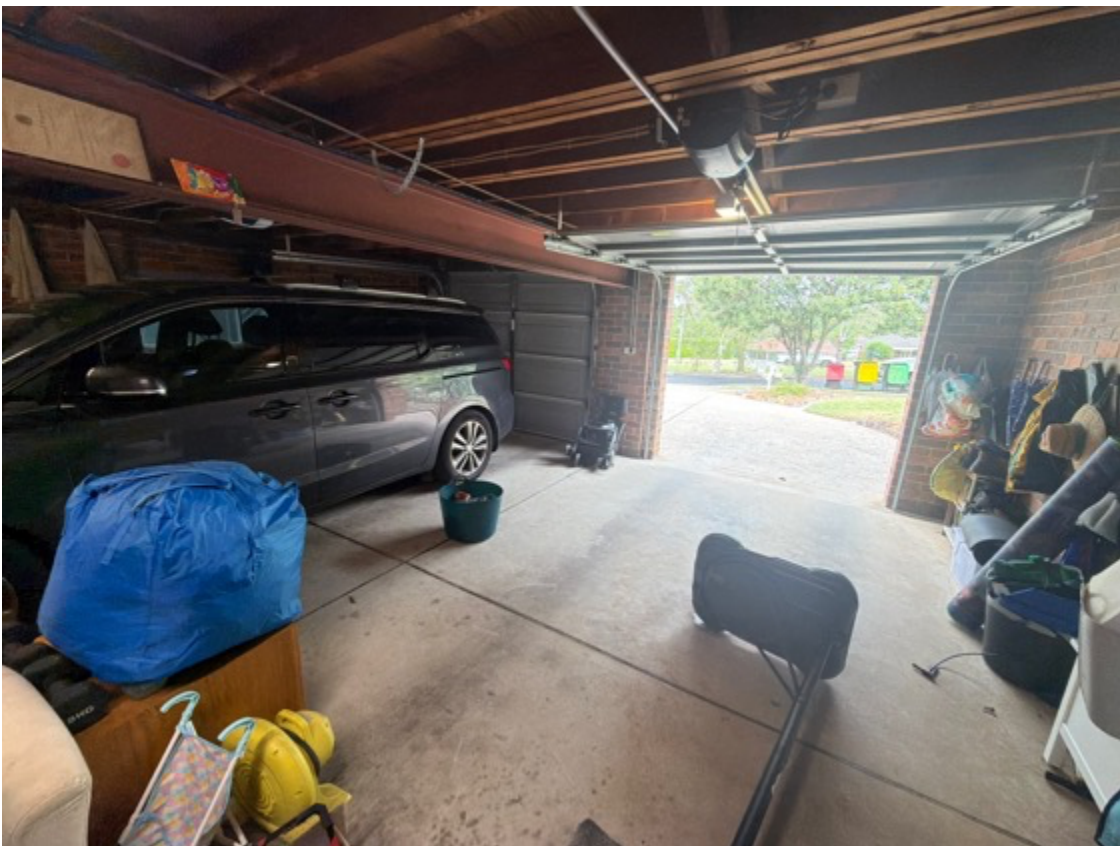
The garage area is in serviceable condition.

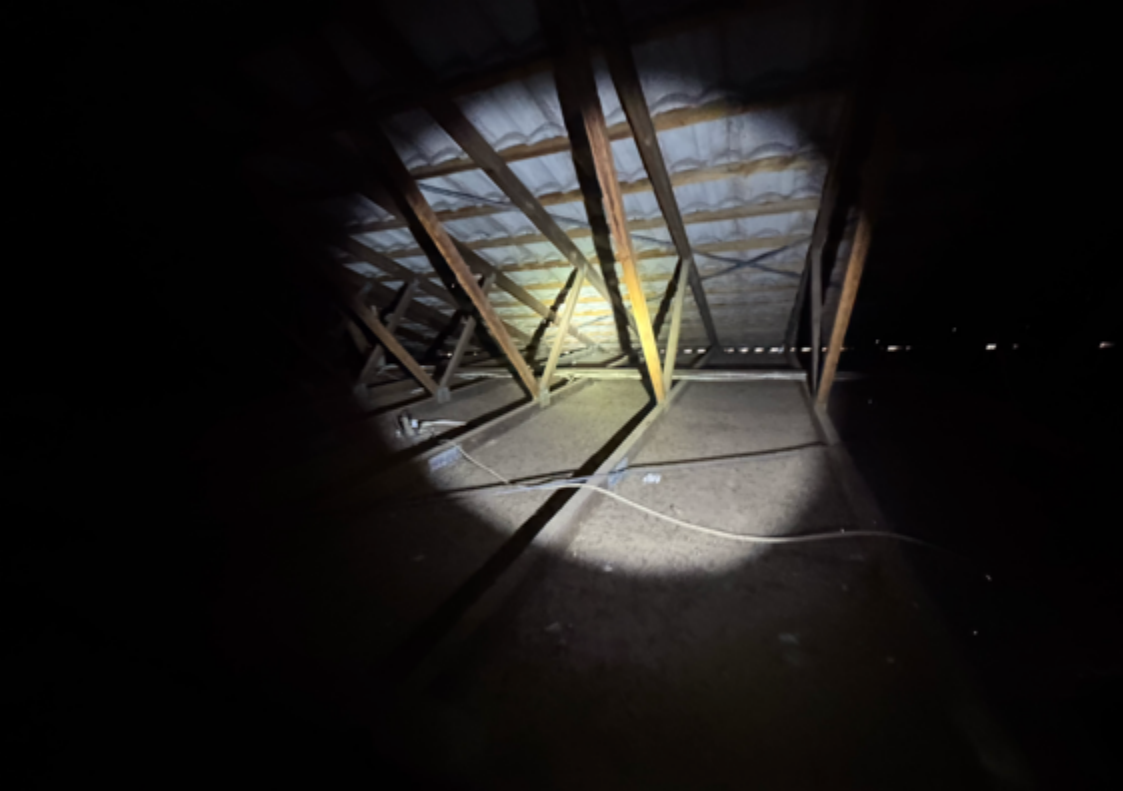
All areas within the roof space were dry at the time of inspection.
