PRE-PURCHASE PROPERTY INSPECTION BUILDING REPORT

Visual Pre-Purchase Building Inspection Report.

76 ROSINA CRESCENT KINGS LANGLEY

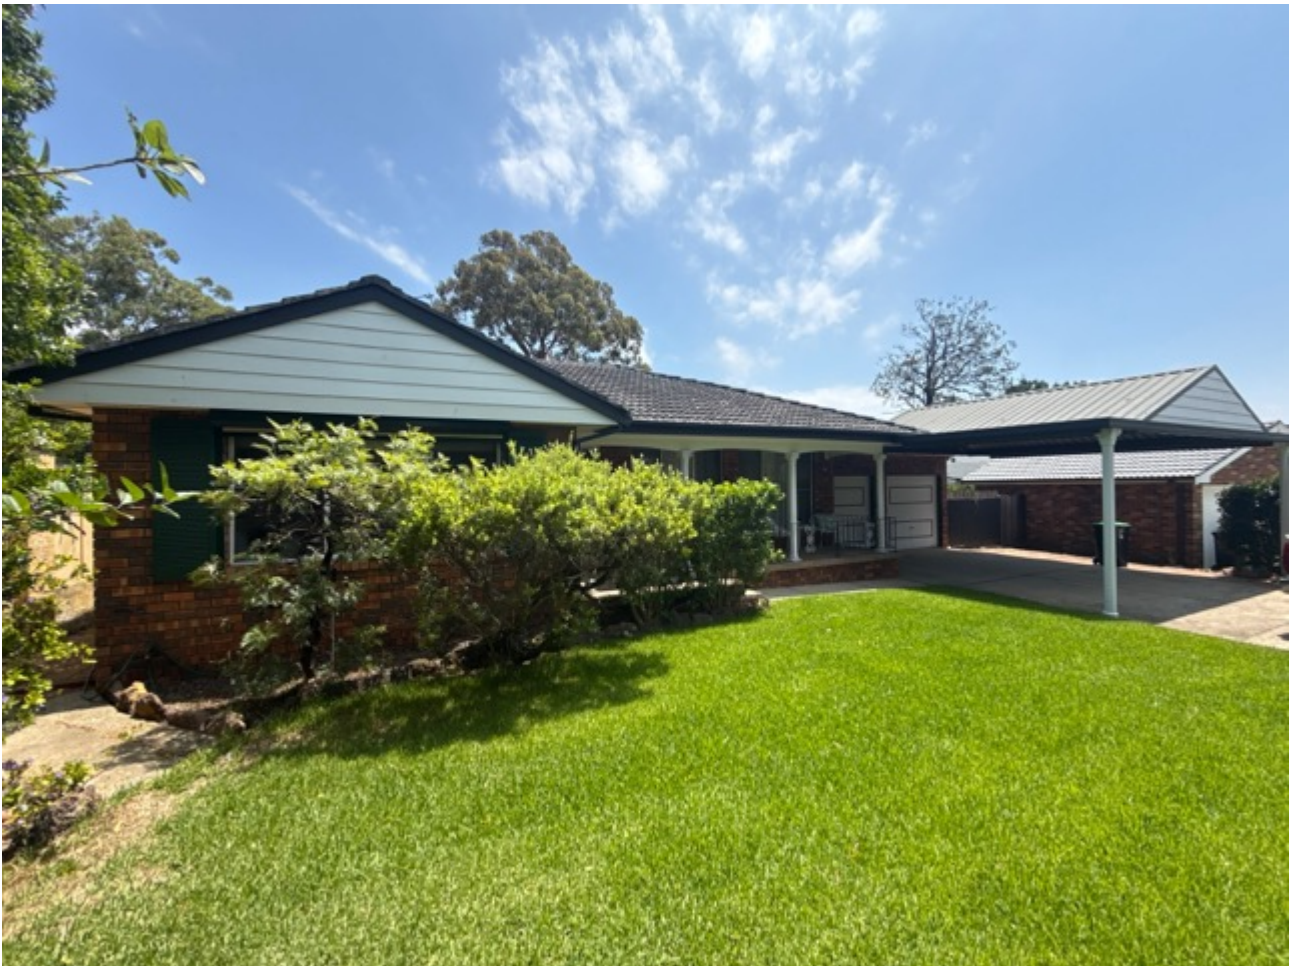
Front elevation of the Inspected property inspected.

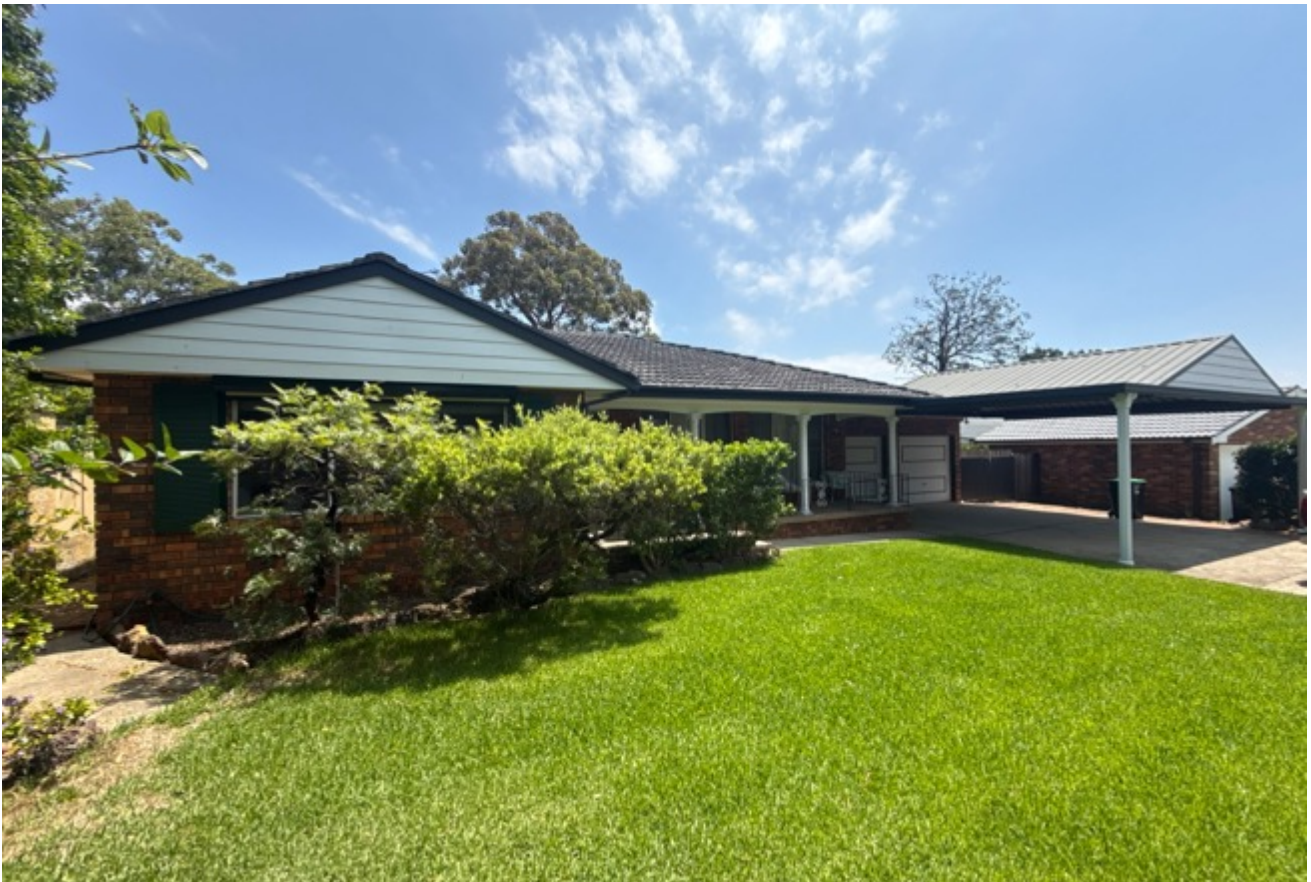
The exterior of the house presents in satisfactory condition displaying no major structural issues at the time of inspection.

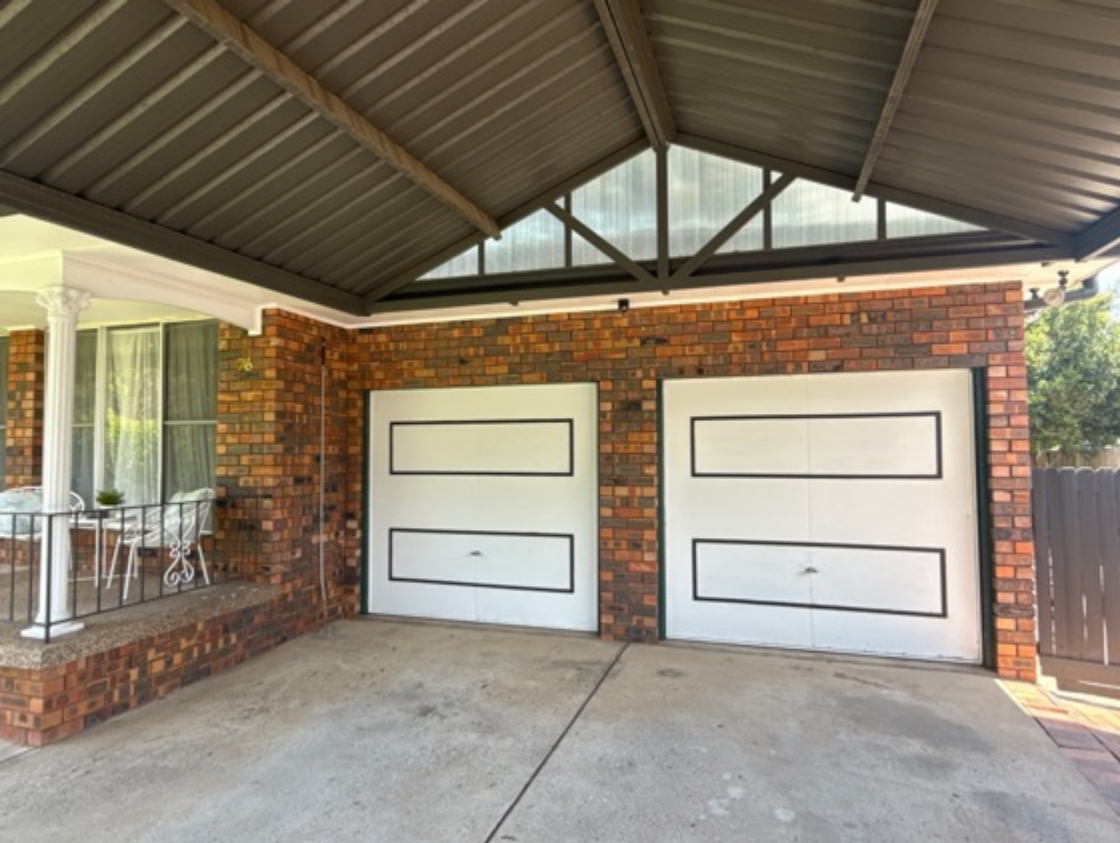
Garage roller doors tested, functioned at the time of inspection.

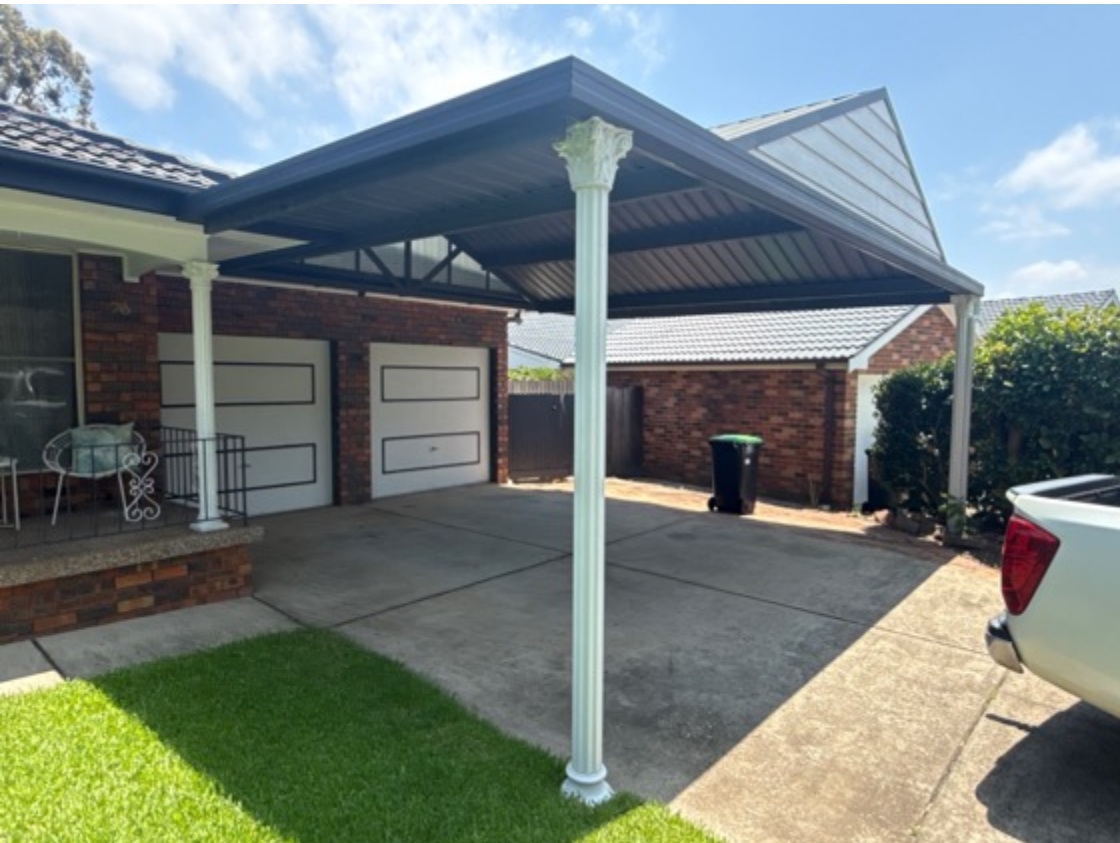
Exterior windows and doors present in satisfactory condition for the age.

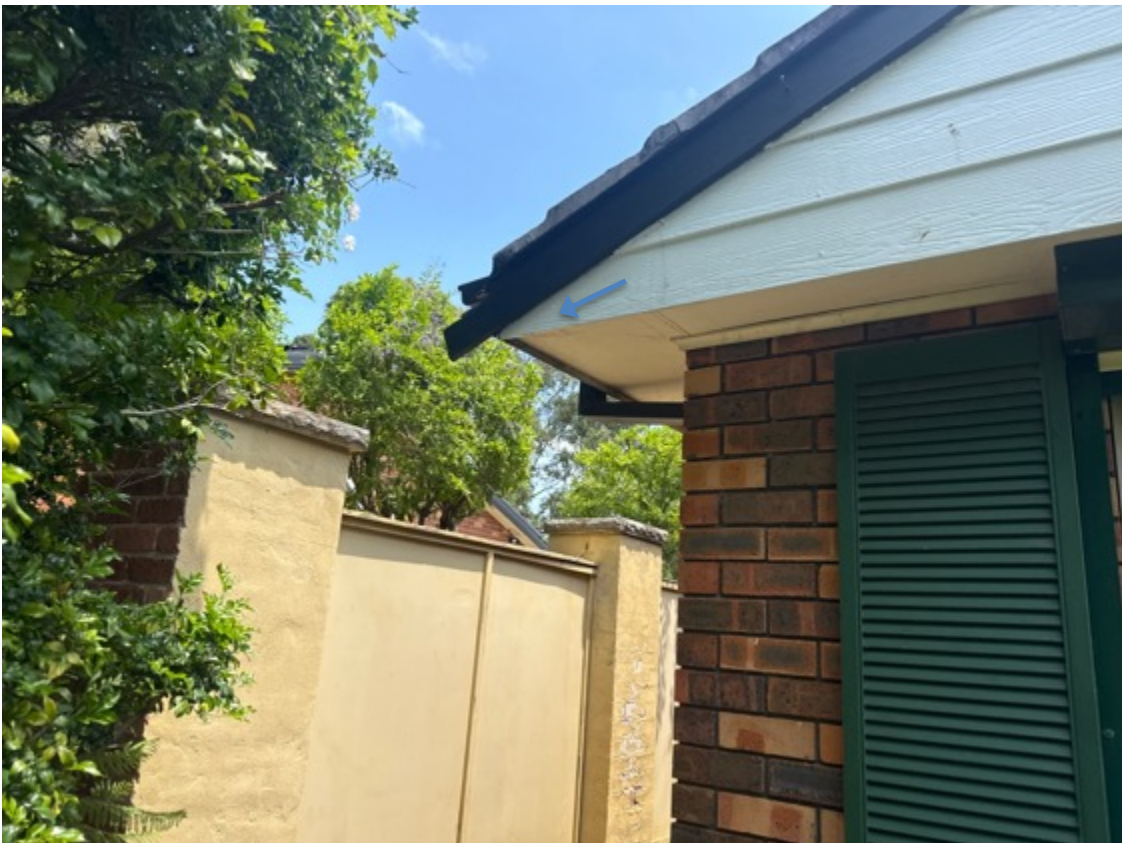
Exterior timber displays moderate level weathering - consistent with age.

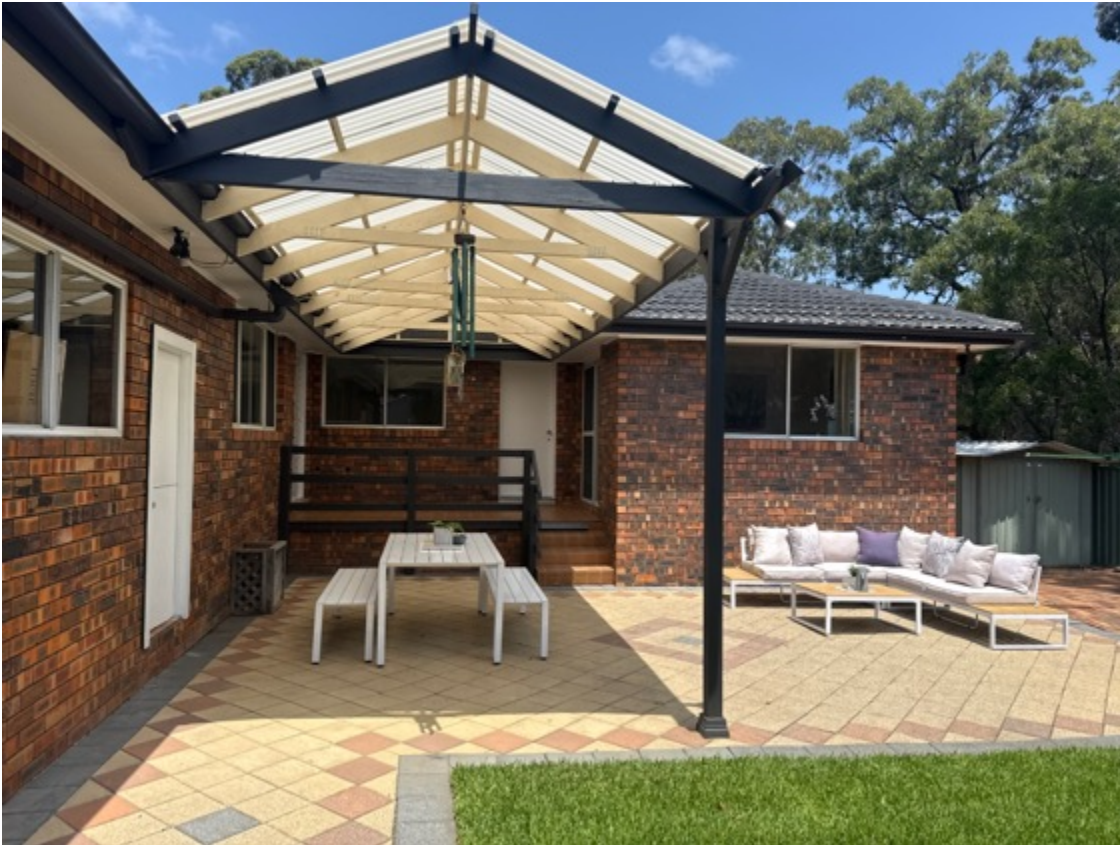
The rear pergola checked is structurally sound.

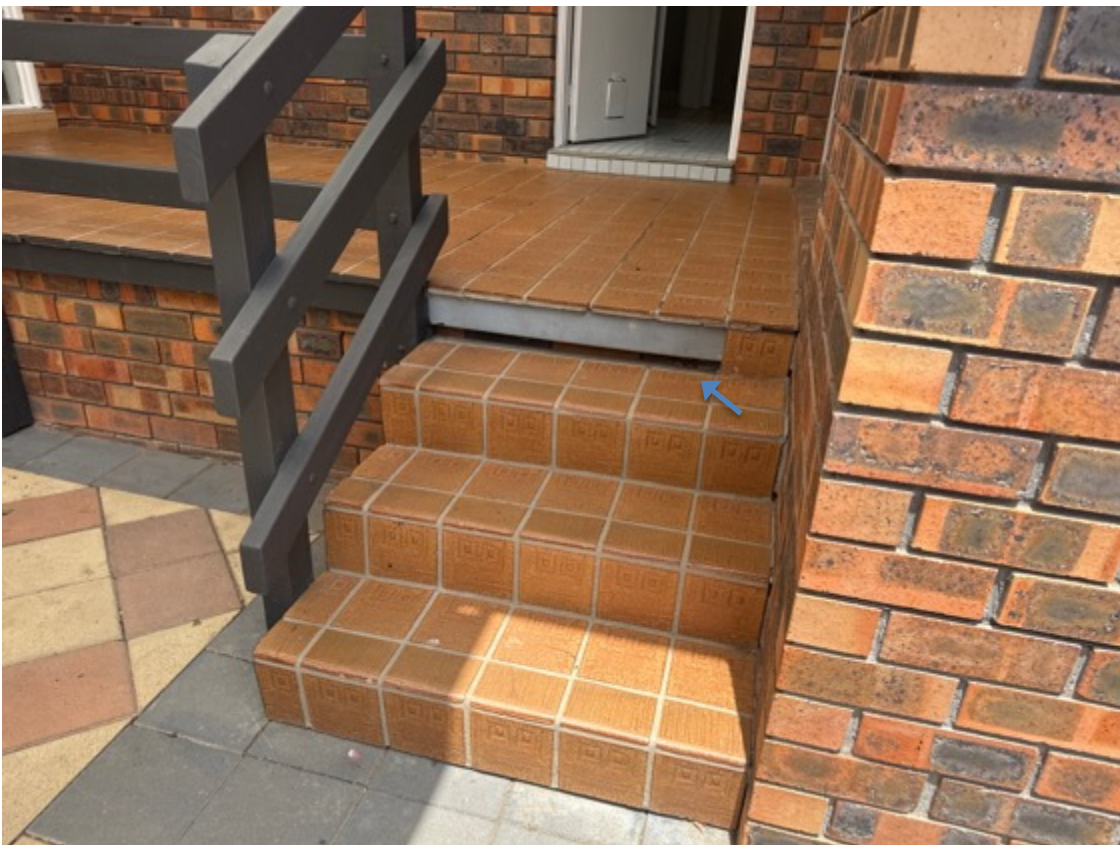
Isolated sections of tiles are cracked and display separation - there is no step to the rear of garage access door.

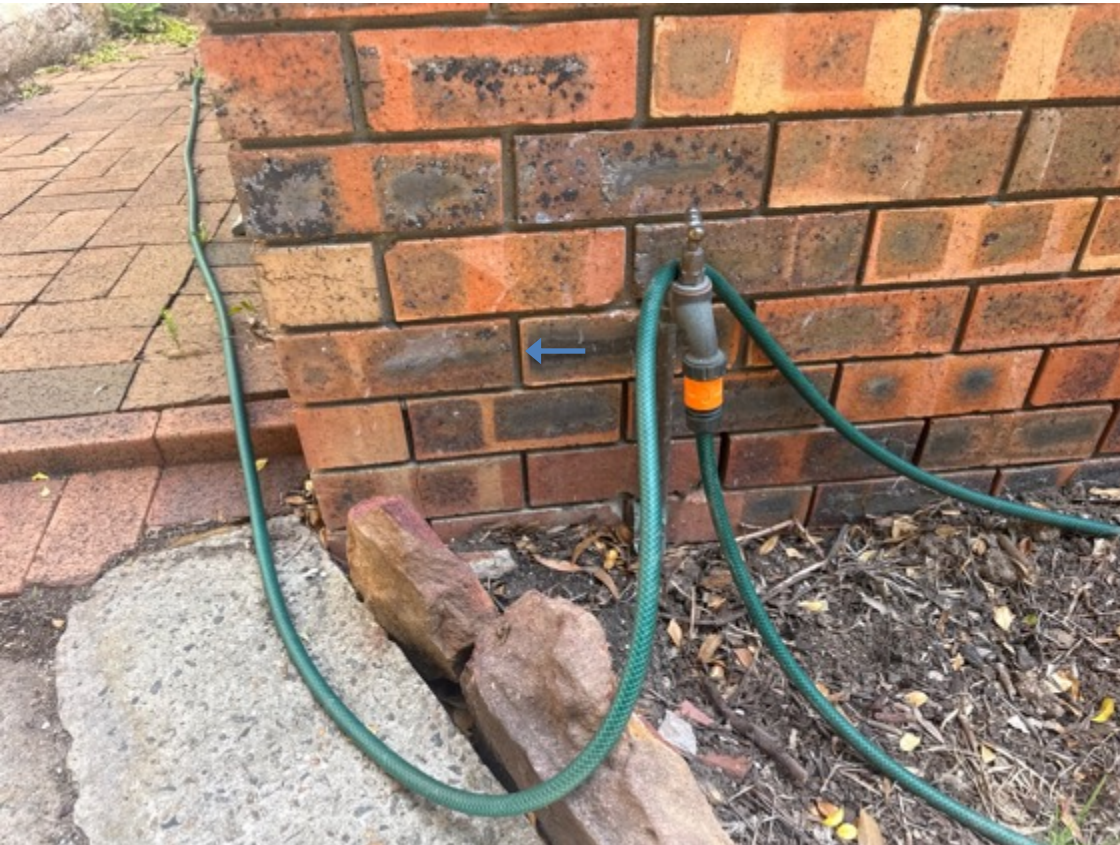
Isolated sections of external brickwork displays category one cracking (front left elevation example above.)

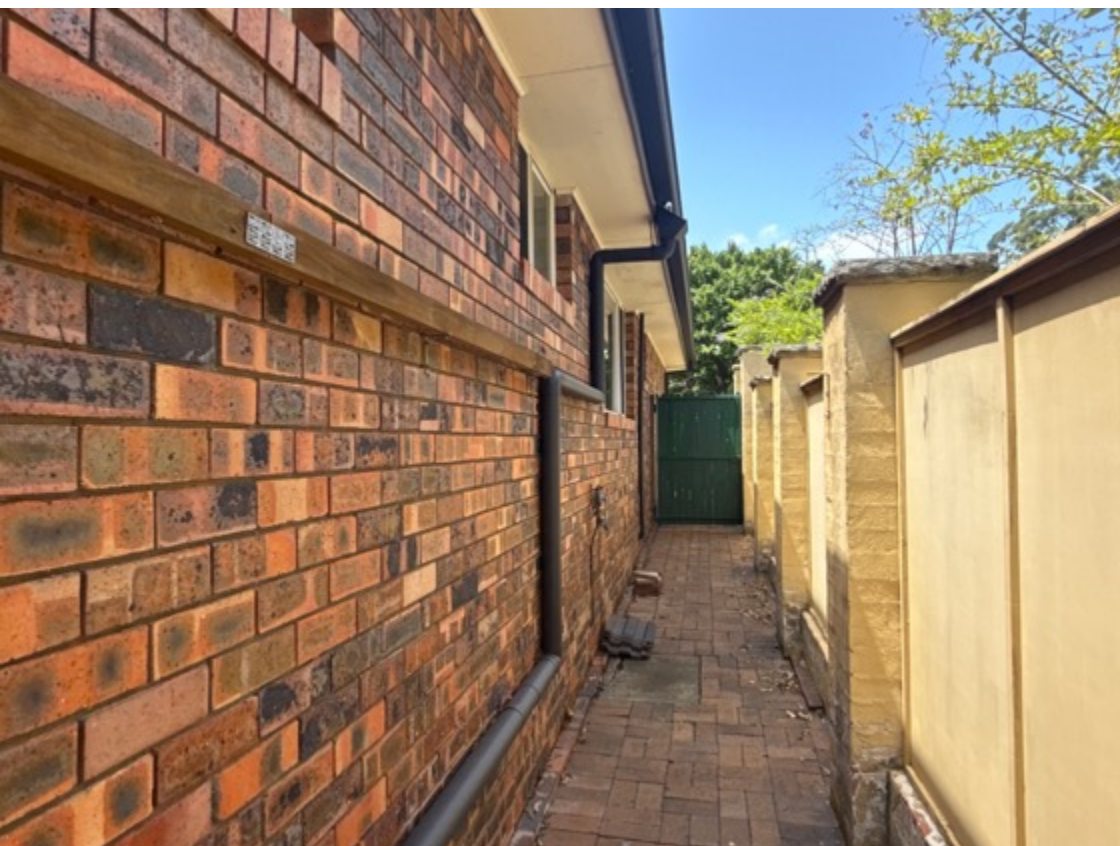
Exterior surfaces display moderate level paint blemishes, eaves lining example above.

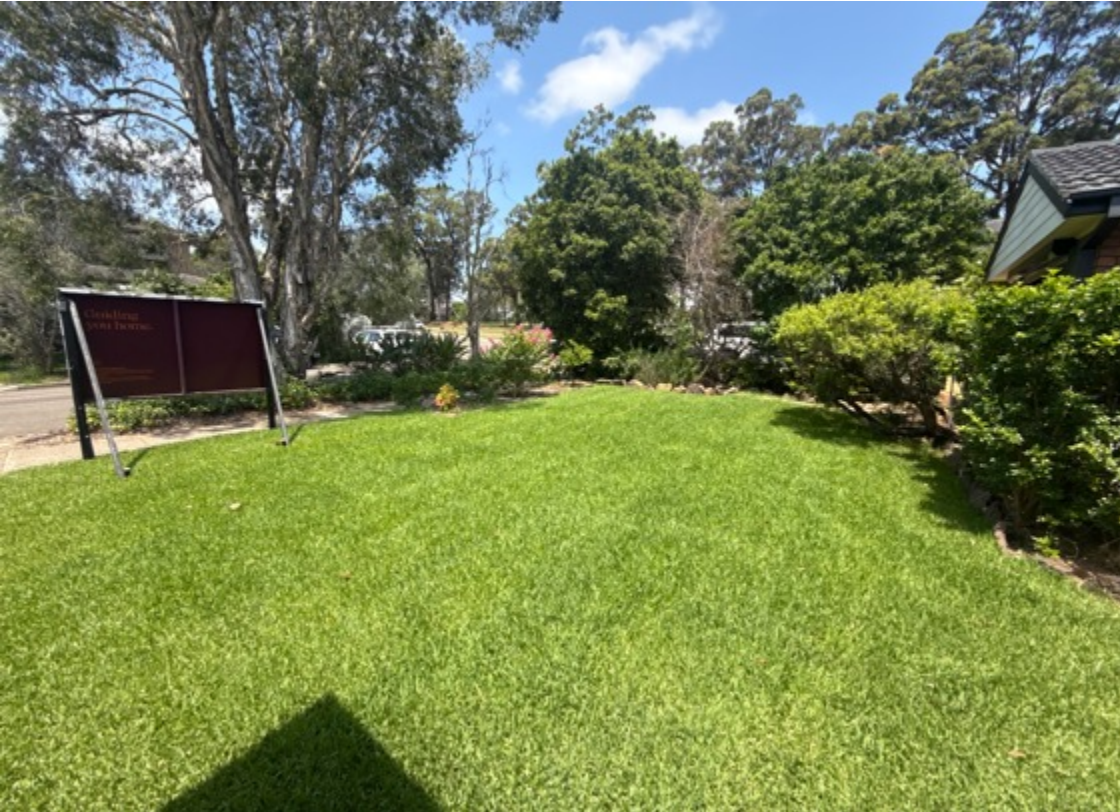
Site drainage / land overflow appears to function adequately with no signs of water laying at the time of inspection.

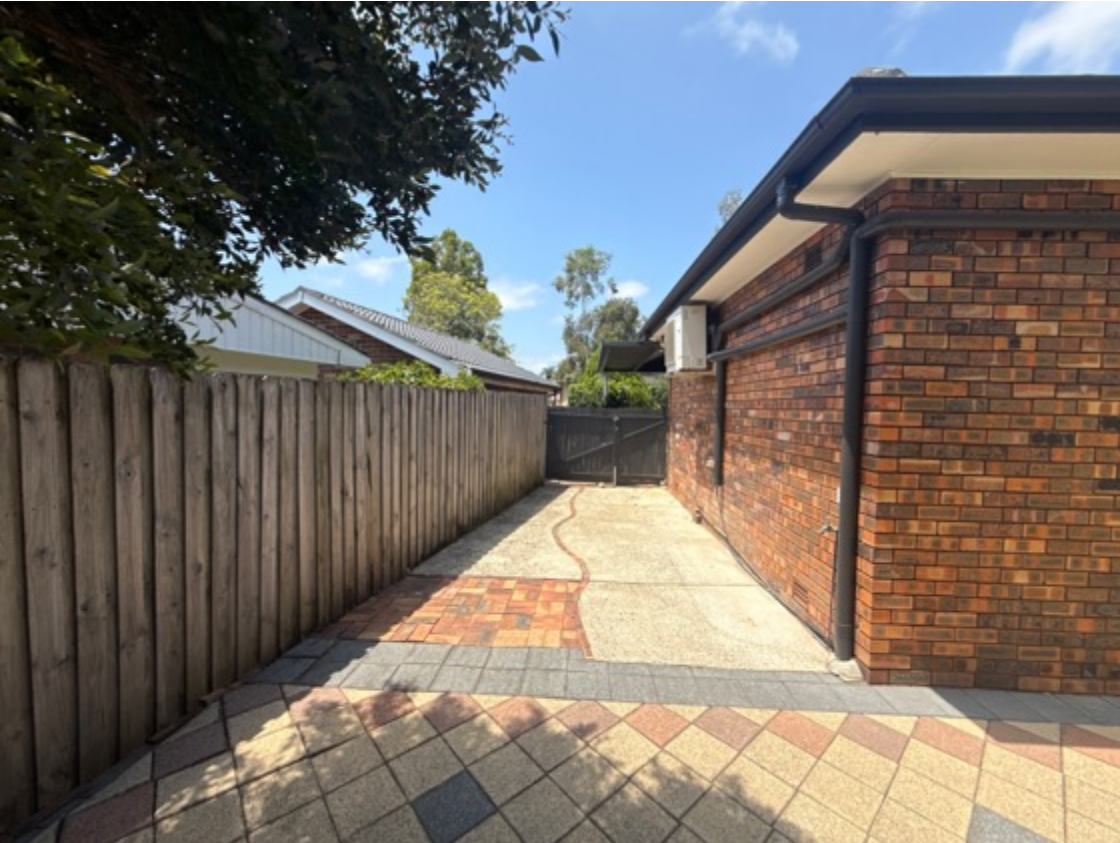
Site fences are in serviceable condition, display moderate level weathering – consistent with age.

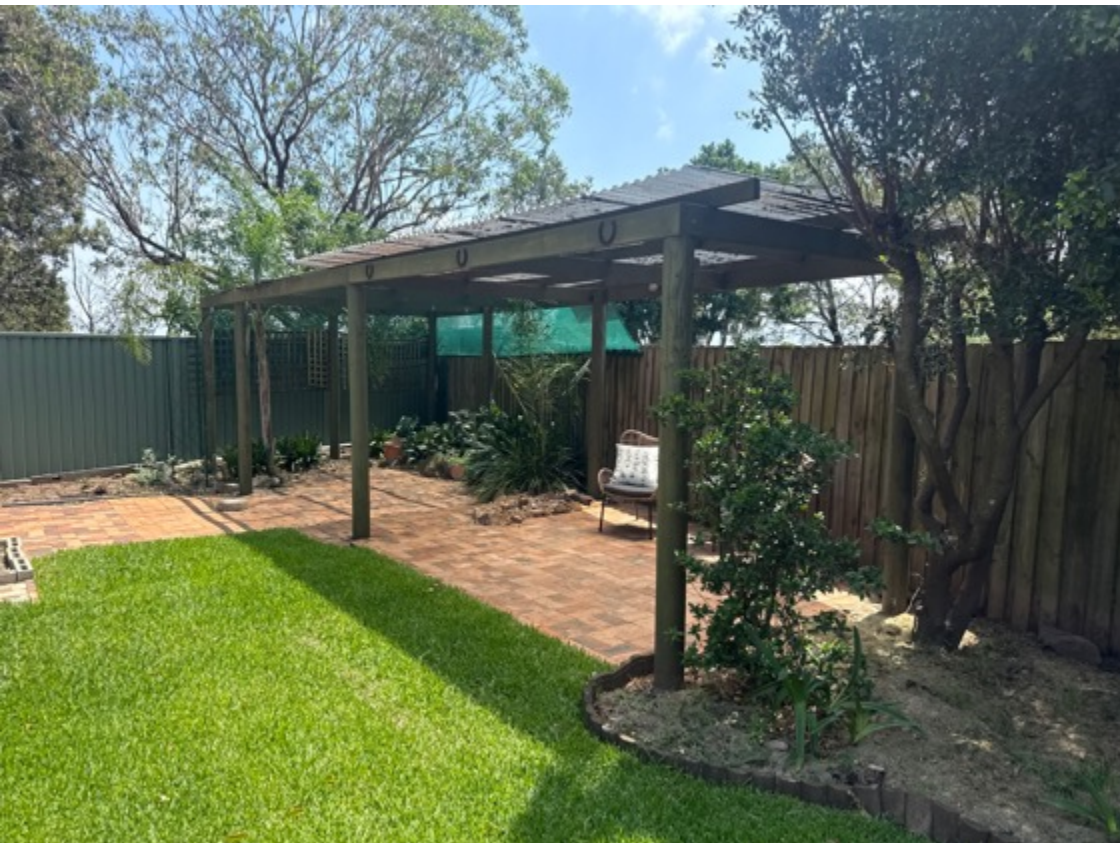
The rear pergola checked is structurally sound.

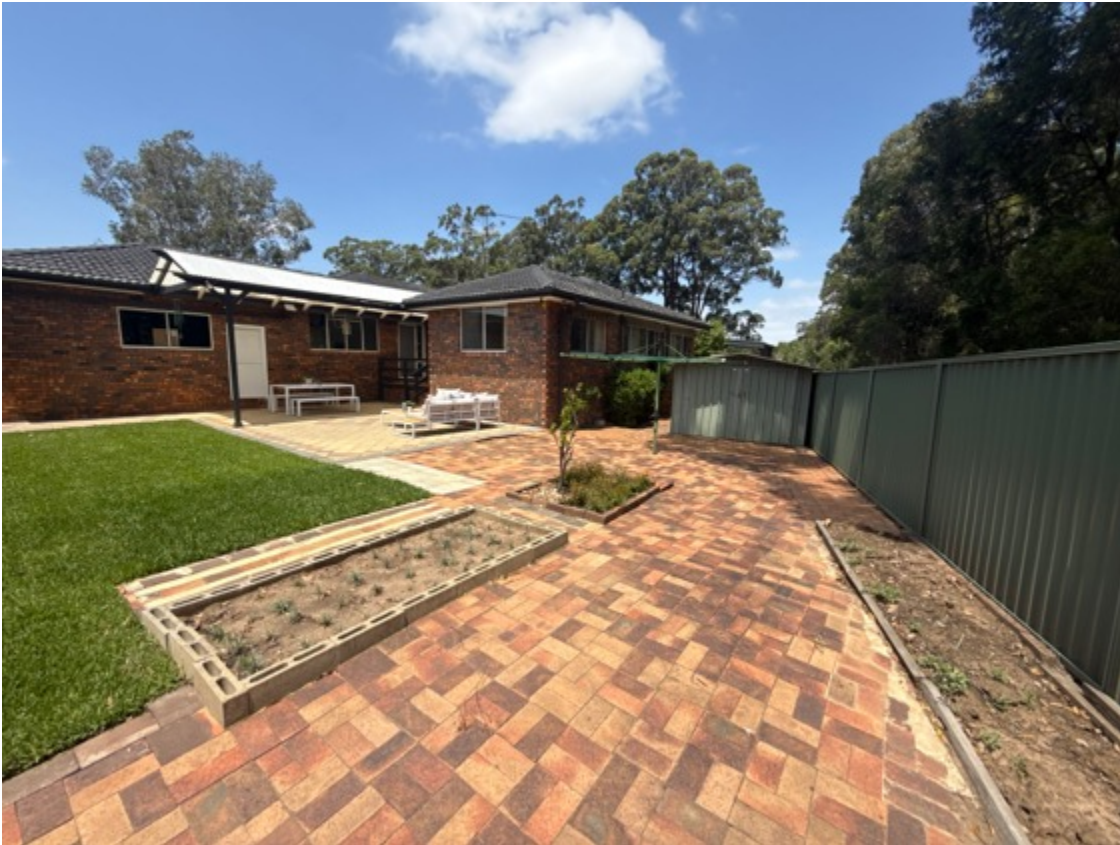
Exterior pavers present in satisfactory condition for the age, isolated sections are cracked and undulating (consistent with age.)

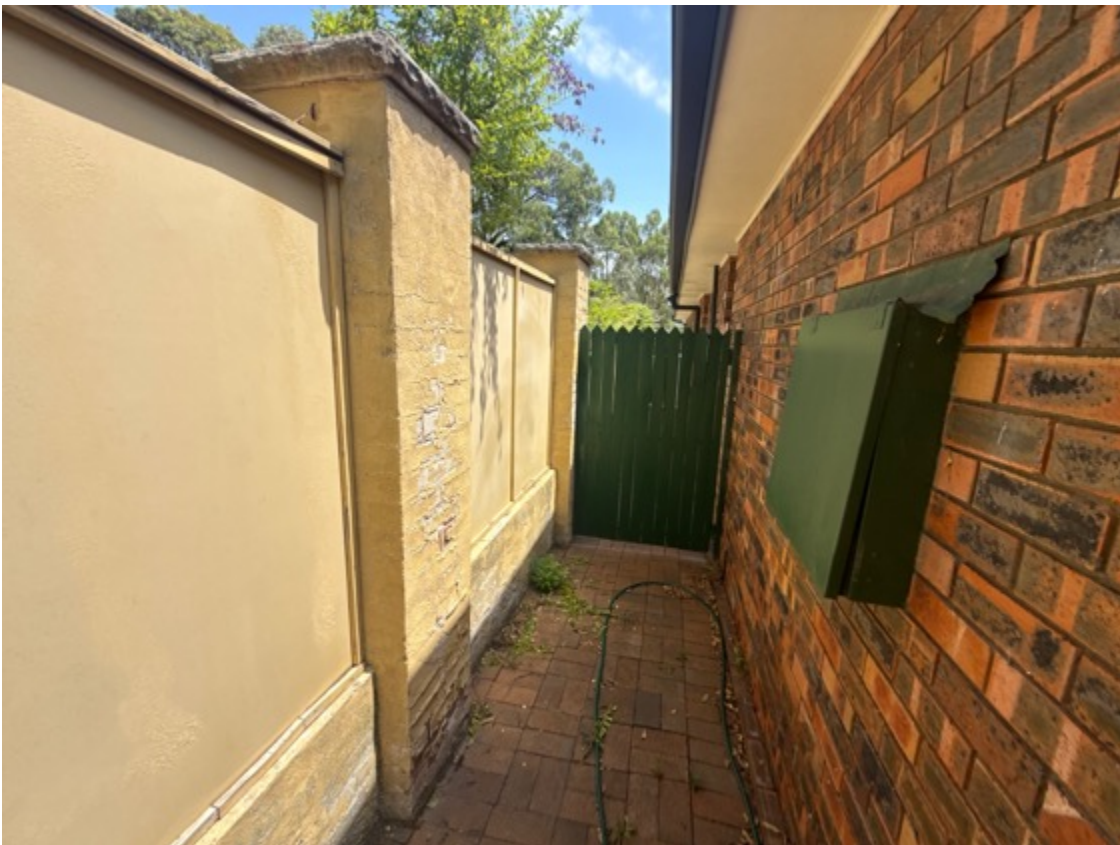
Site retaining wall render is peeling.

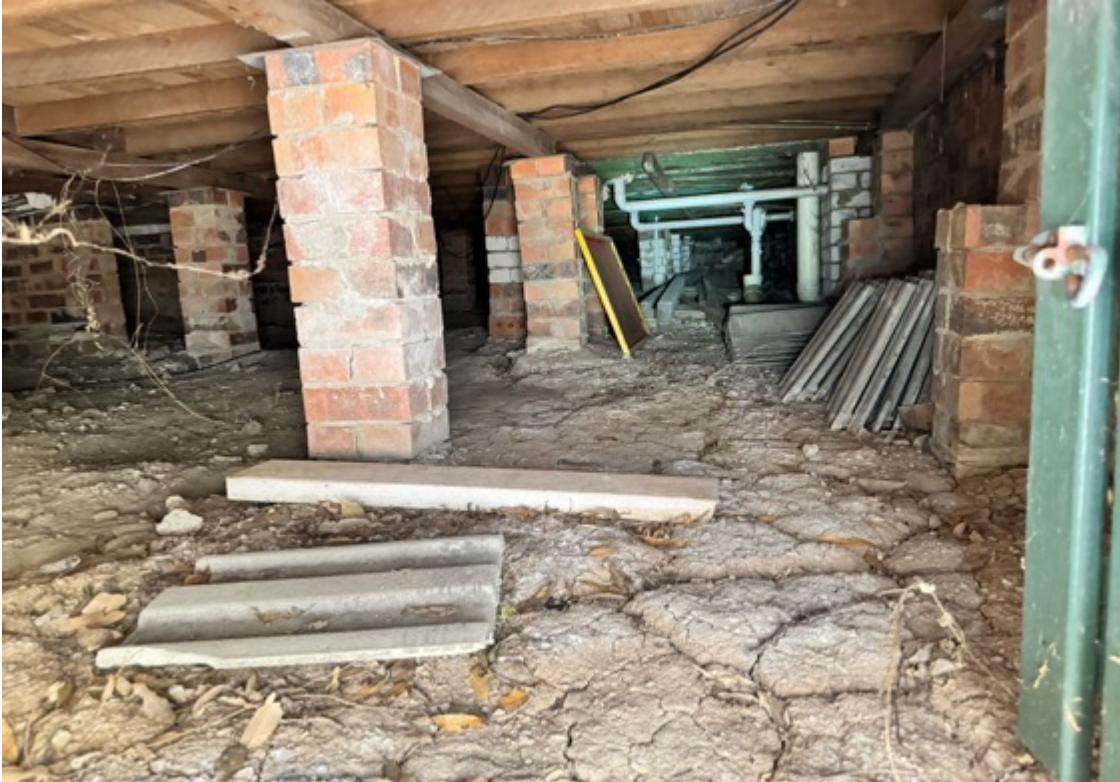
All areas within the subfloor area were dry at the time of inspection.

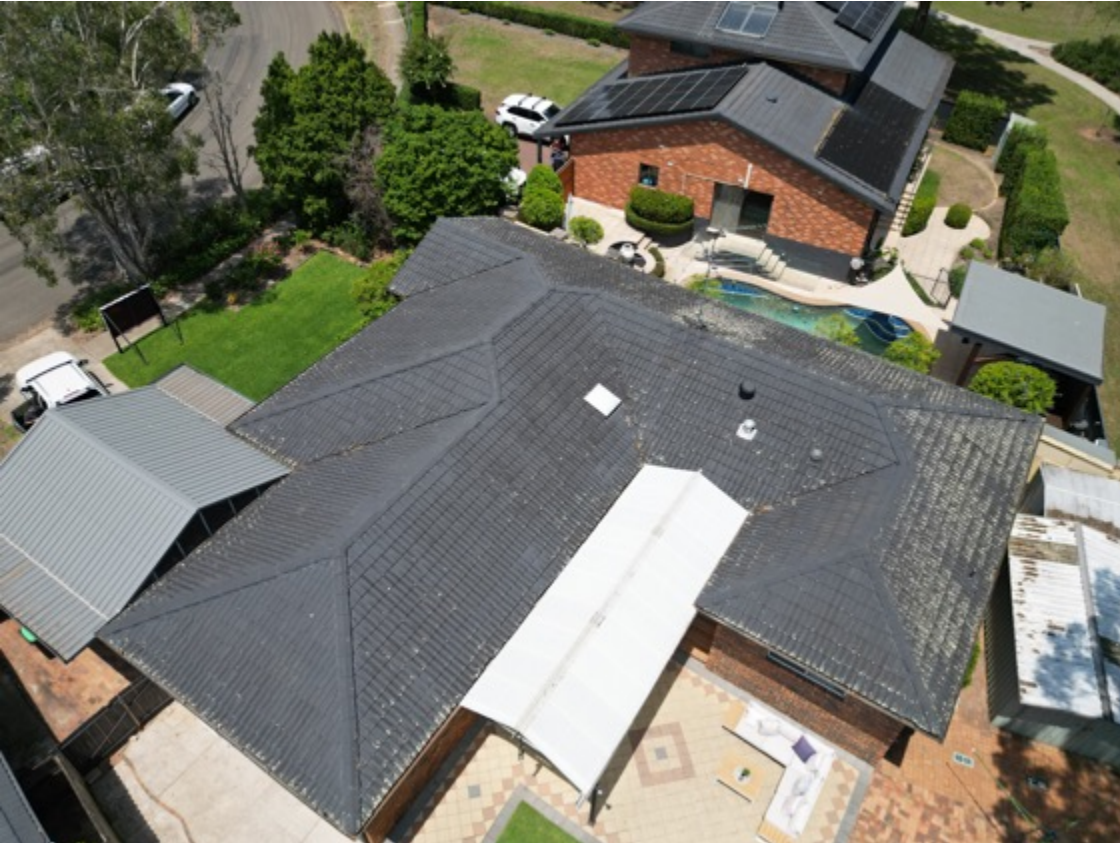
The roof exterior presents in satisfactory condition for the age.

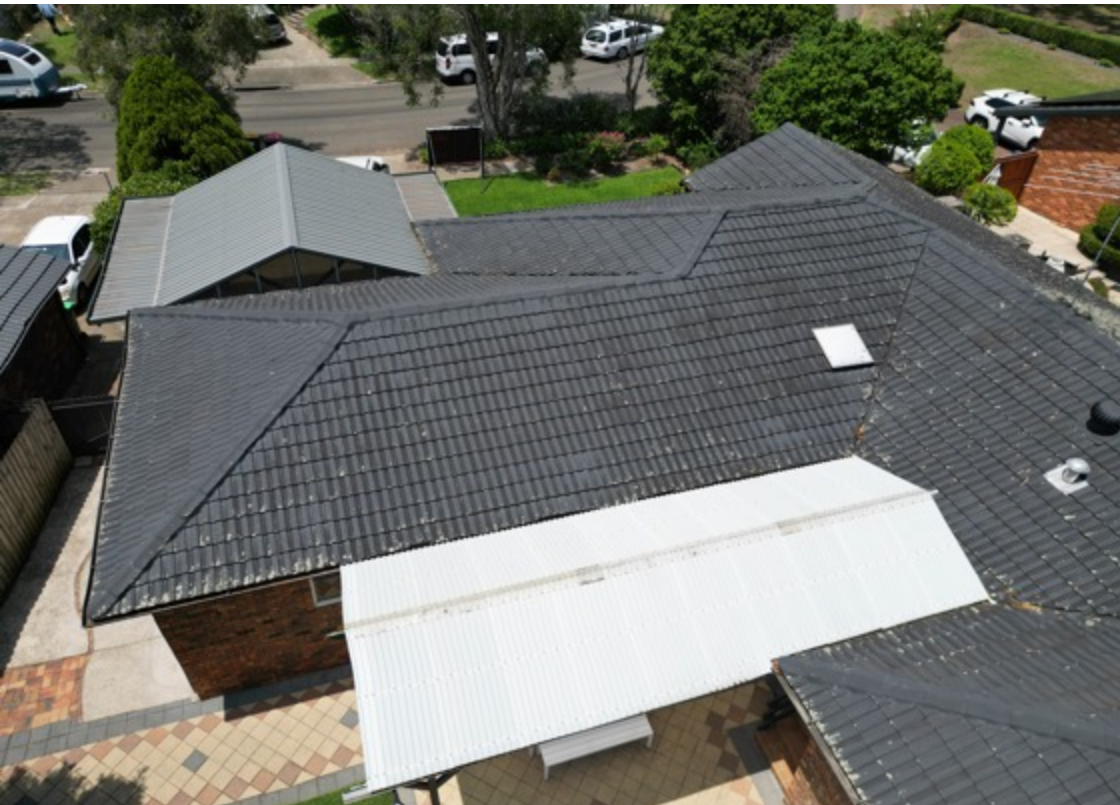
Rear sheet metal roof sheets present in satisfactory condition.

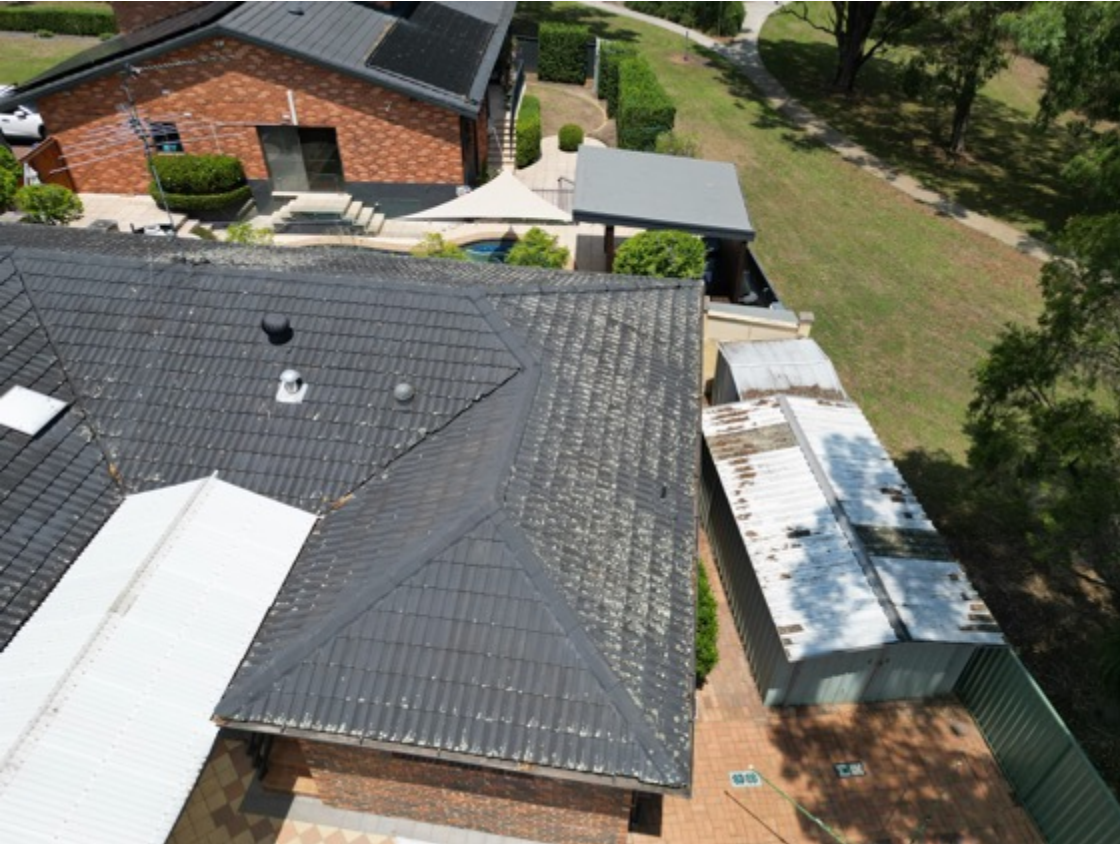
Isolated sections of roof tiles are chipped, consistent with age.

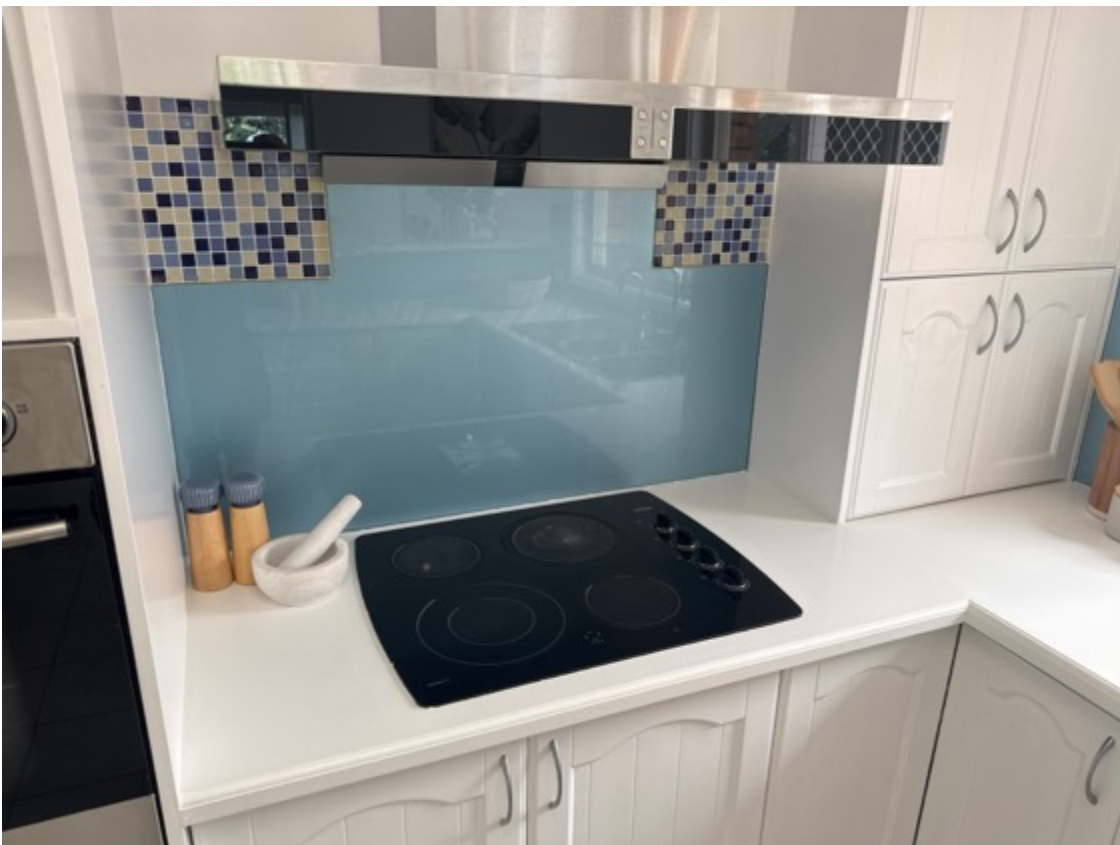
The cooktop surface displays moderate level wear, consistent with age.

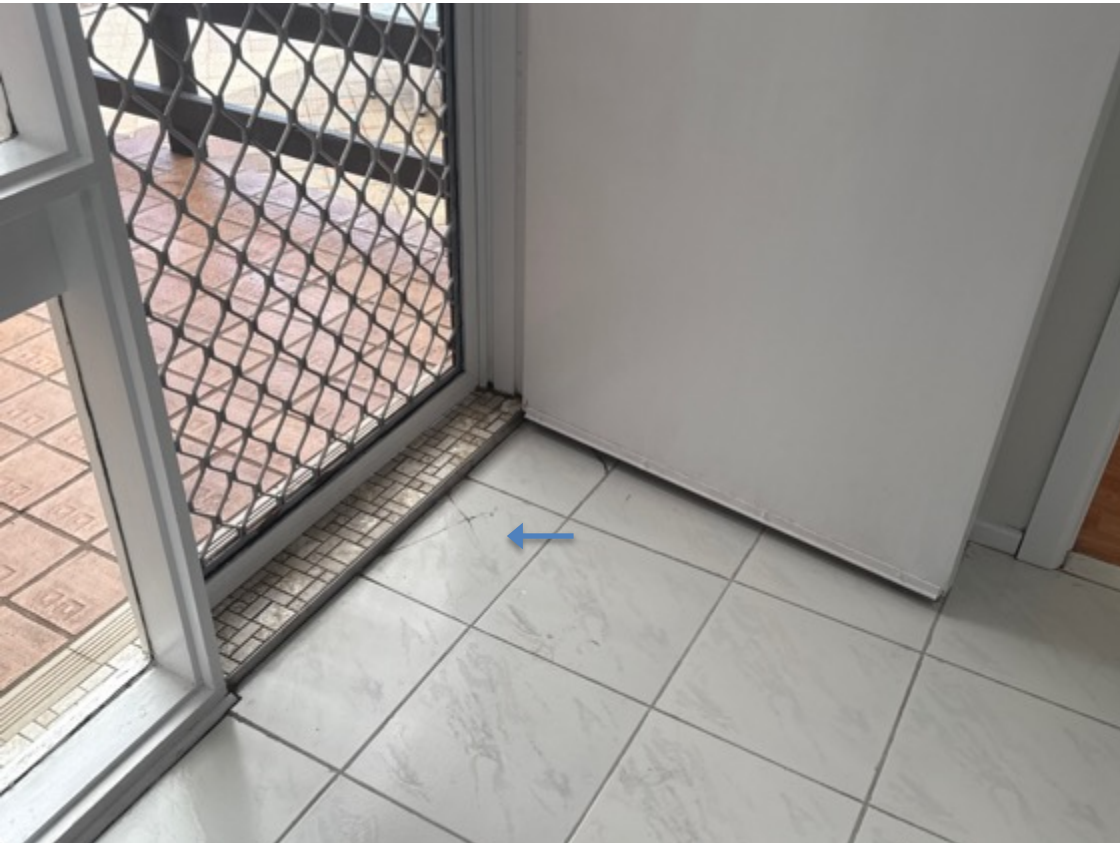
Isolated sections of tiles are cracked, consistent with age.

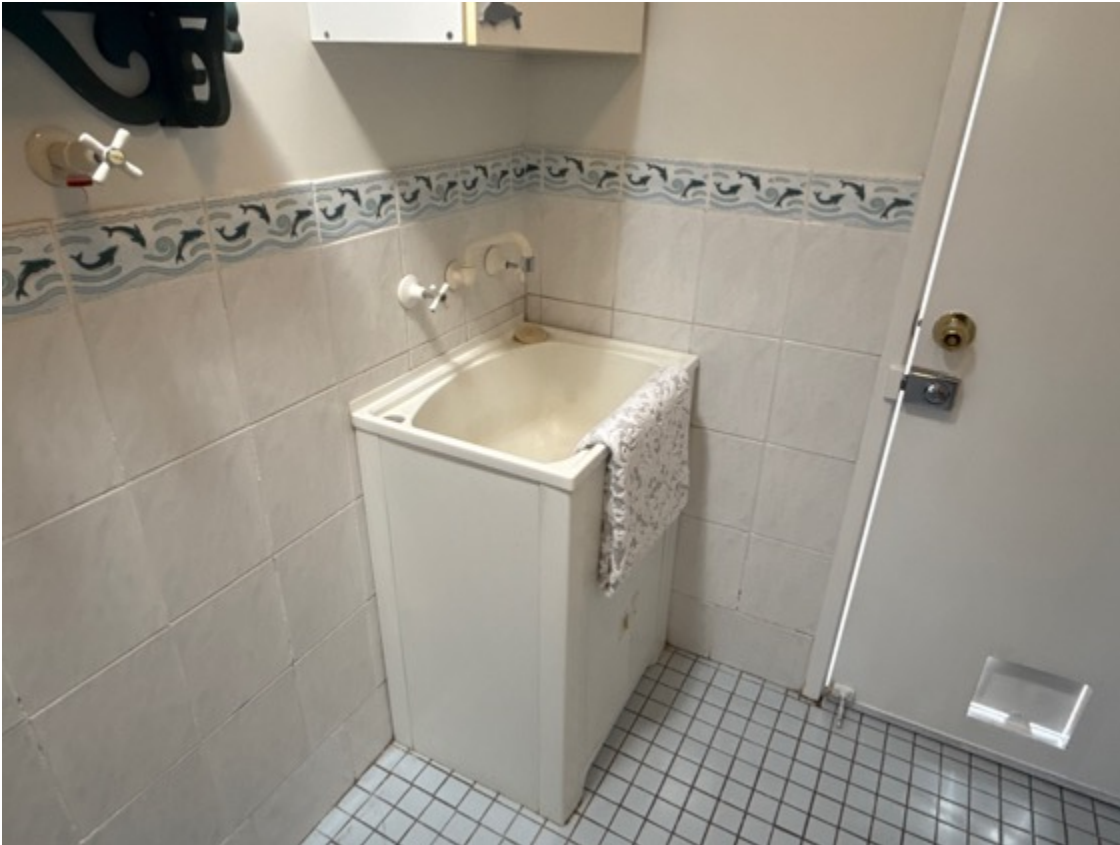
Water pressure tested, is sufficient - the tub displays low level wear, consistent with age.

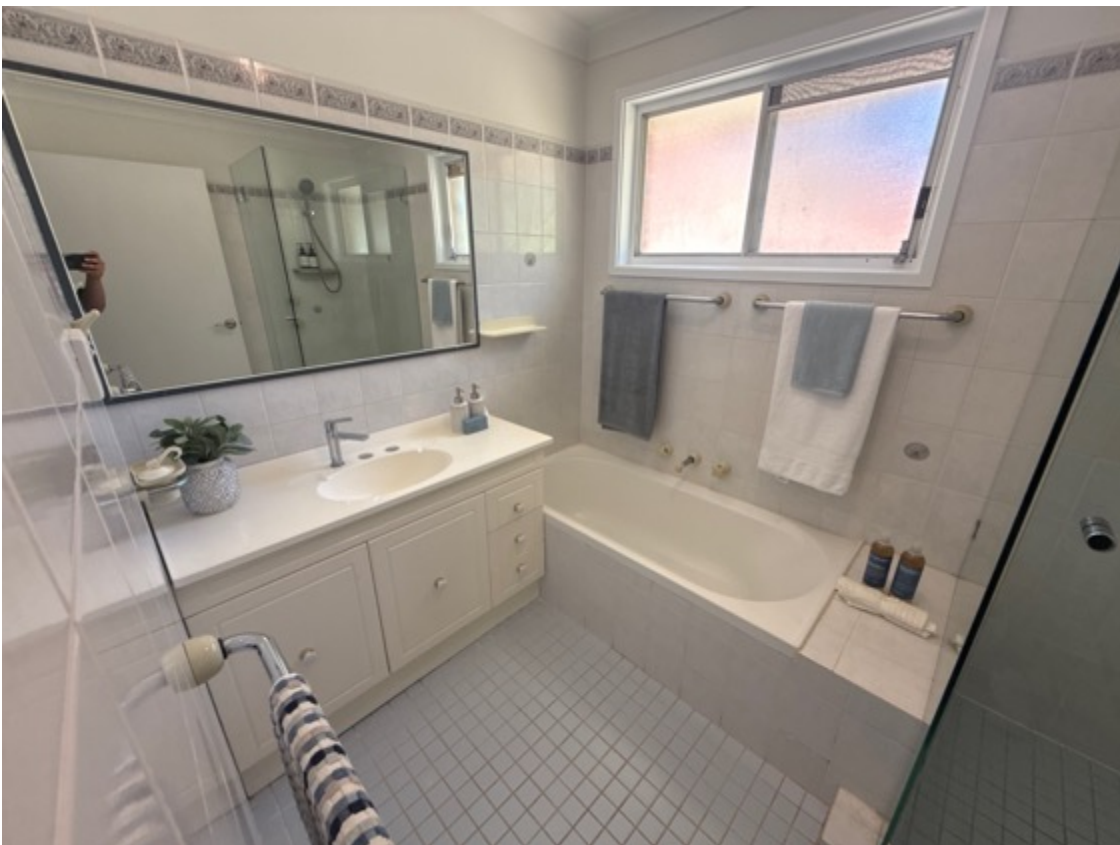
The ground floor common bathroom area tested for leaks, was issue free at the time of inspection.

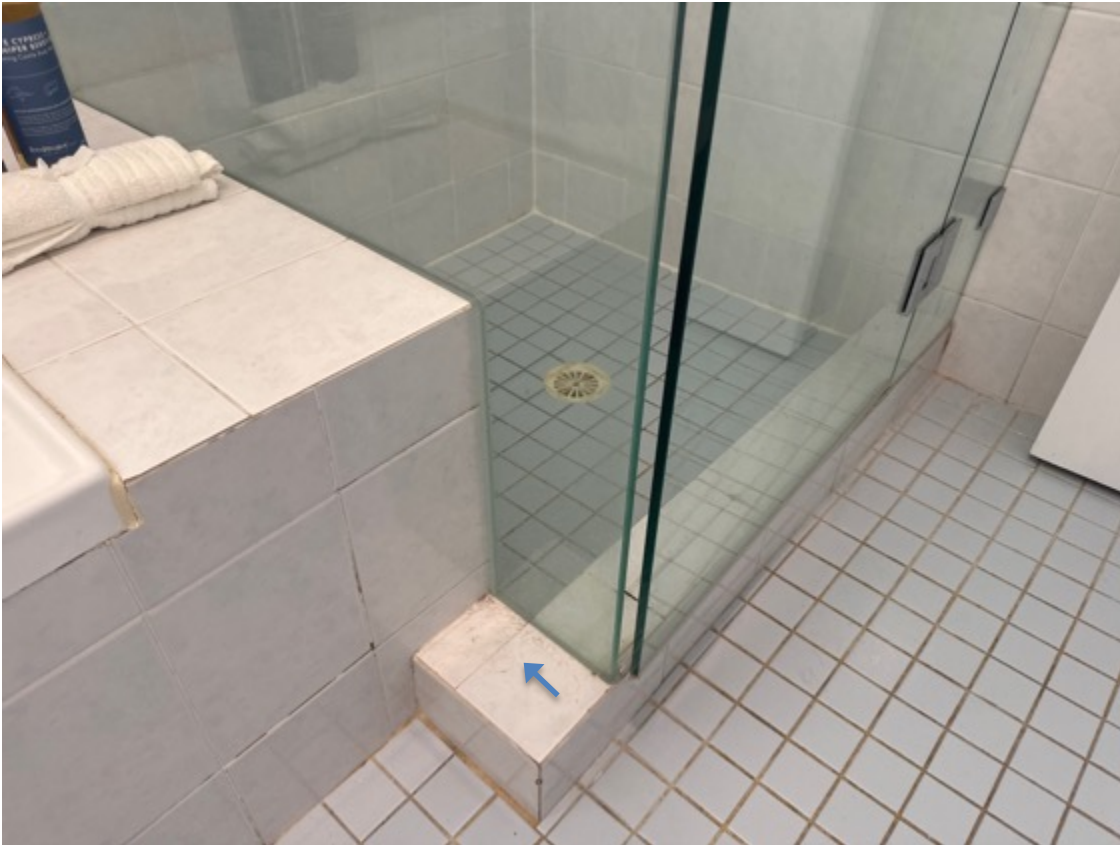
Isolated sections of tiles are cracked, consistent with age.
