PRE-PURCHASE PROPERTY INSPECTION BUILDING REPORT

Visual Pre-Purchase Building Inspection Report.

76 ROSINA CRESCENT KINGS LANGLEY

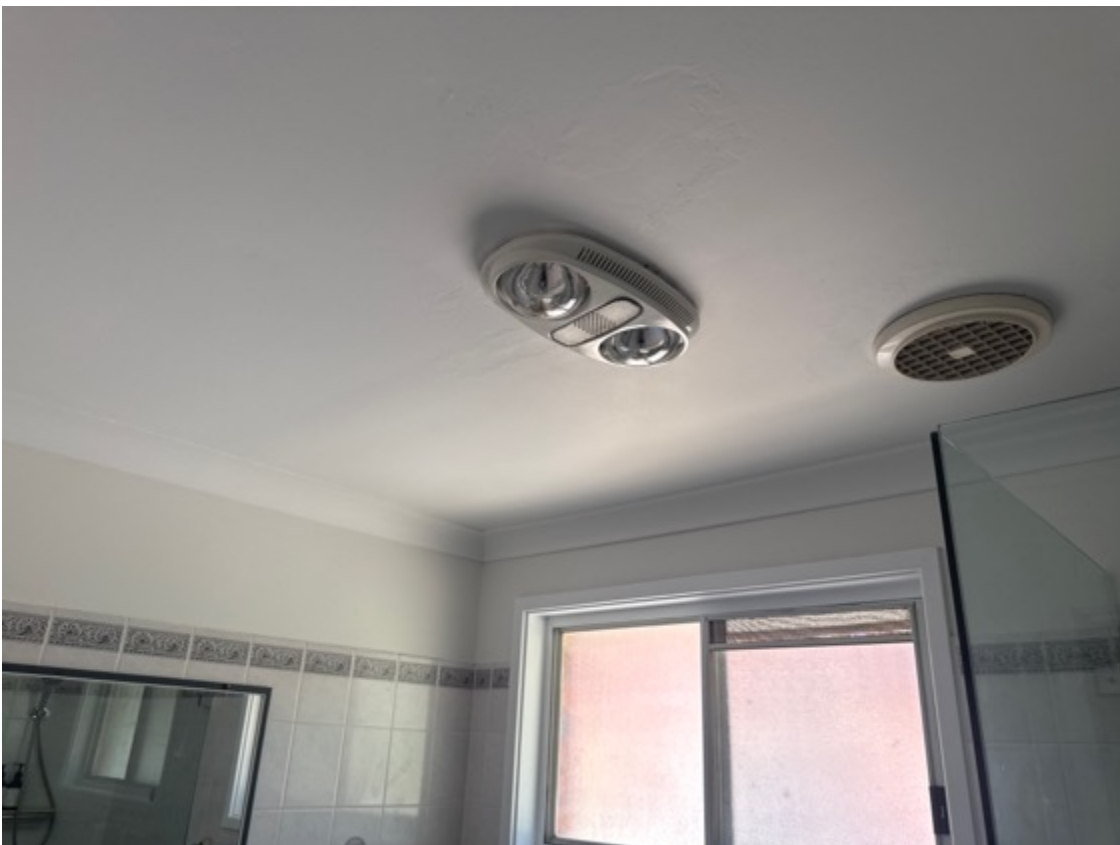
Isolated section of internal ceiling painting is patchy, consistent with age.

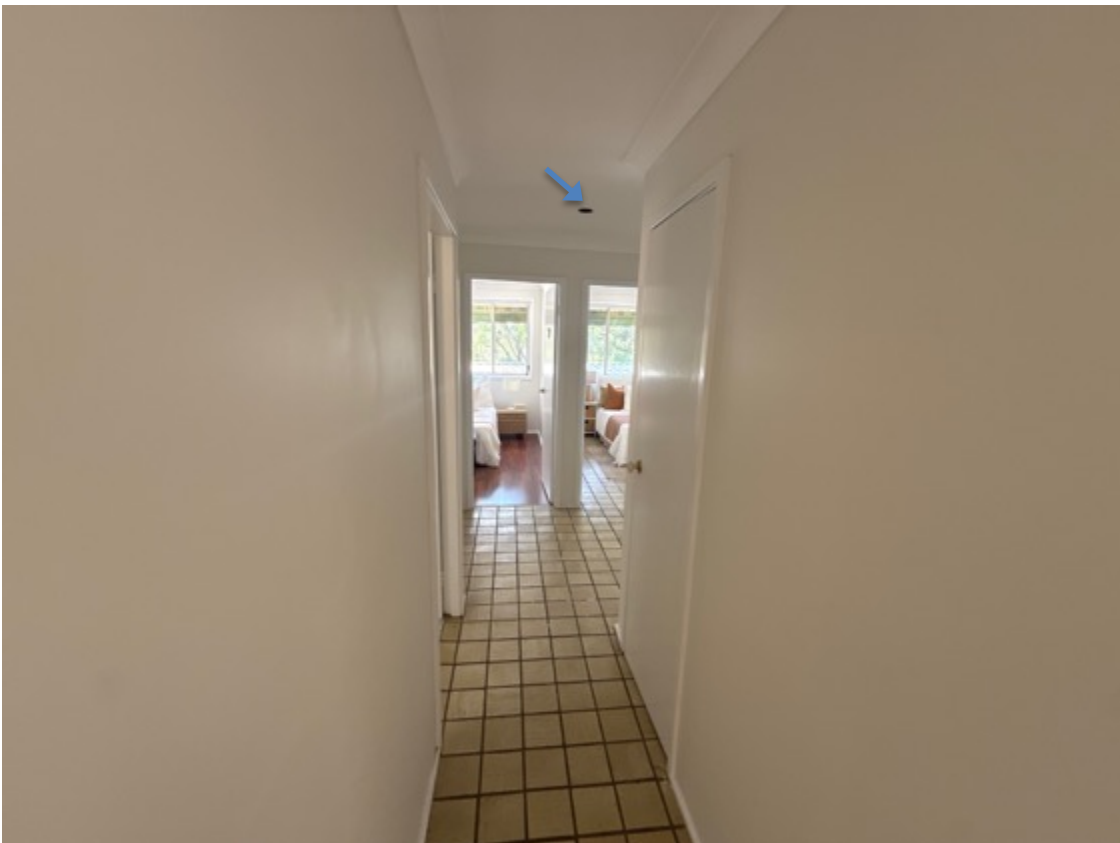
One bedroom hallway downlight is missing.

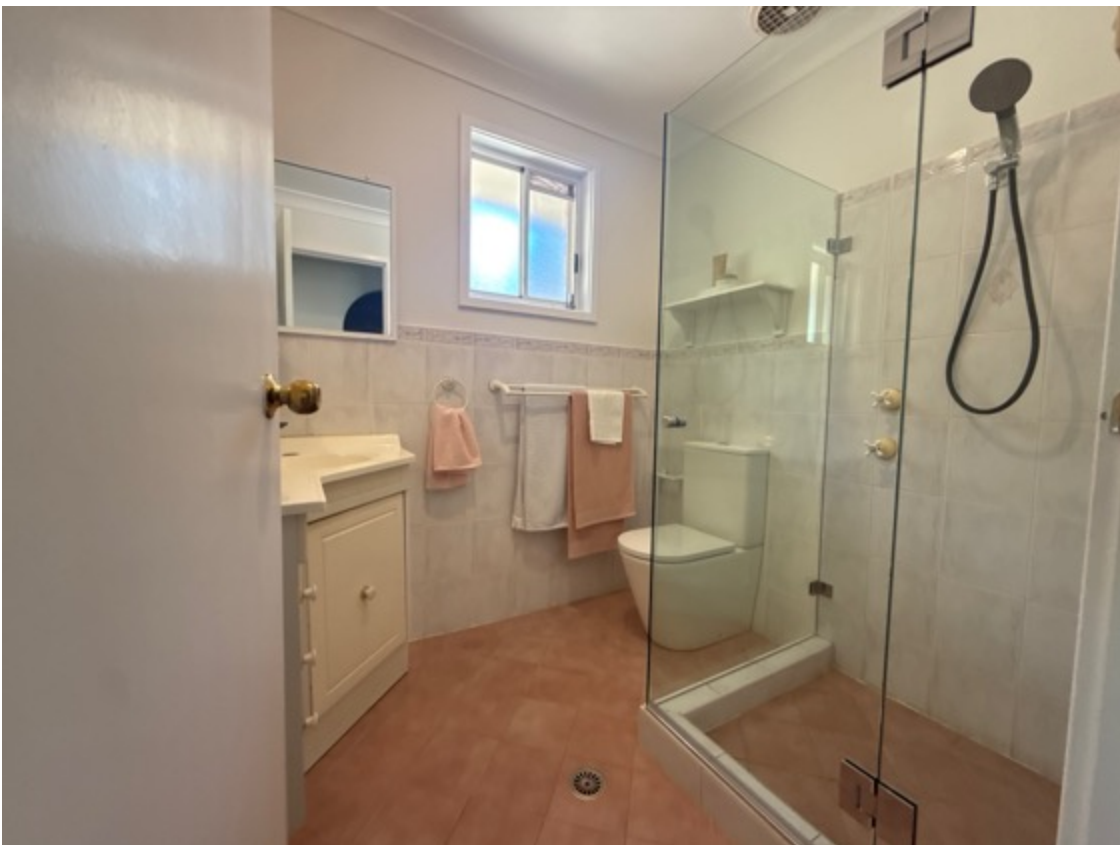
The ensuite bathroom area tested for leaks, fixings and stability was all clear at the time of inspection.

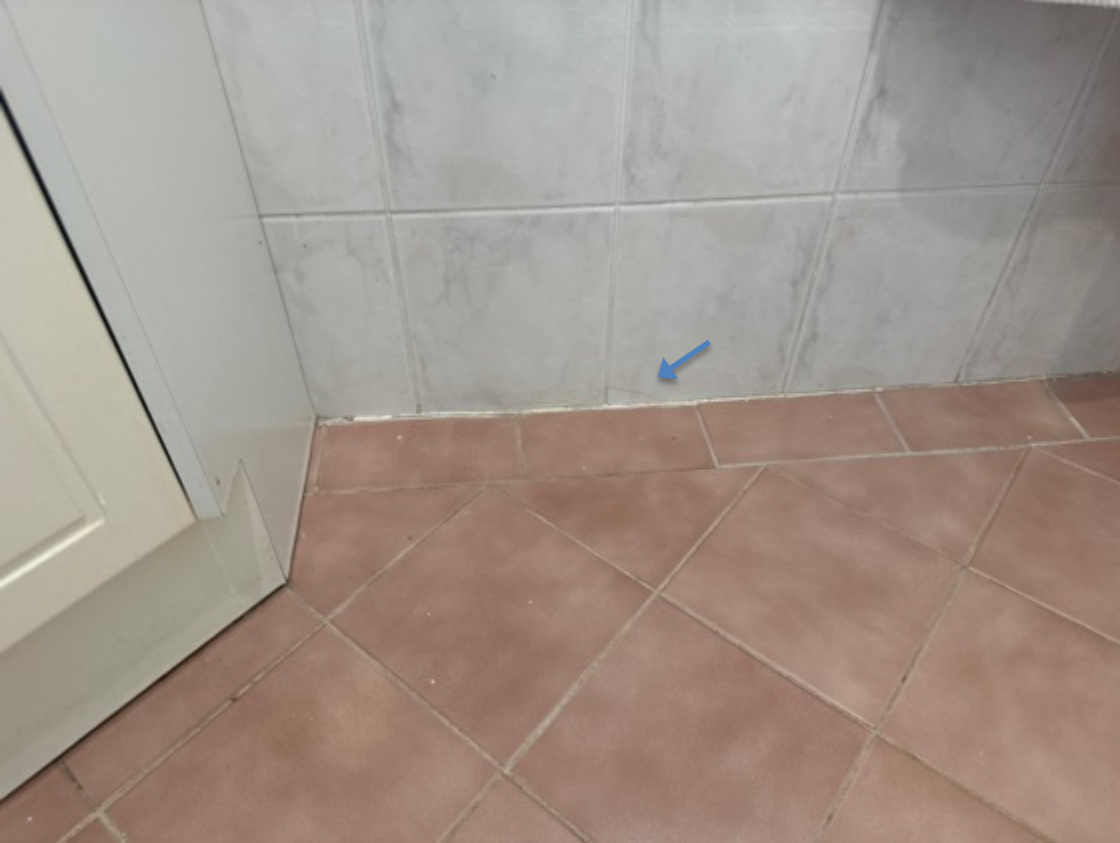
Isolated sections of tiles are cracked, consistent with age.

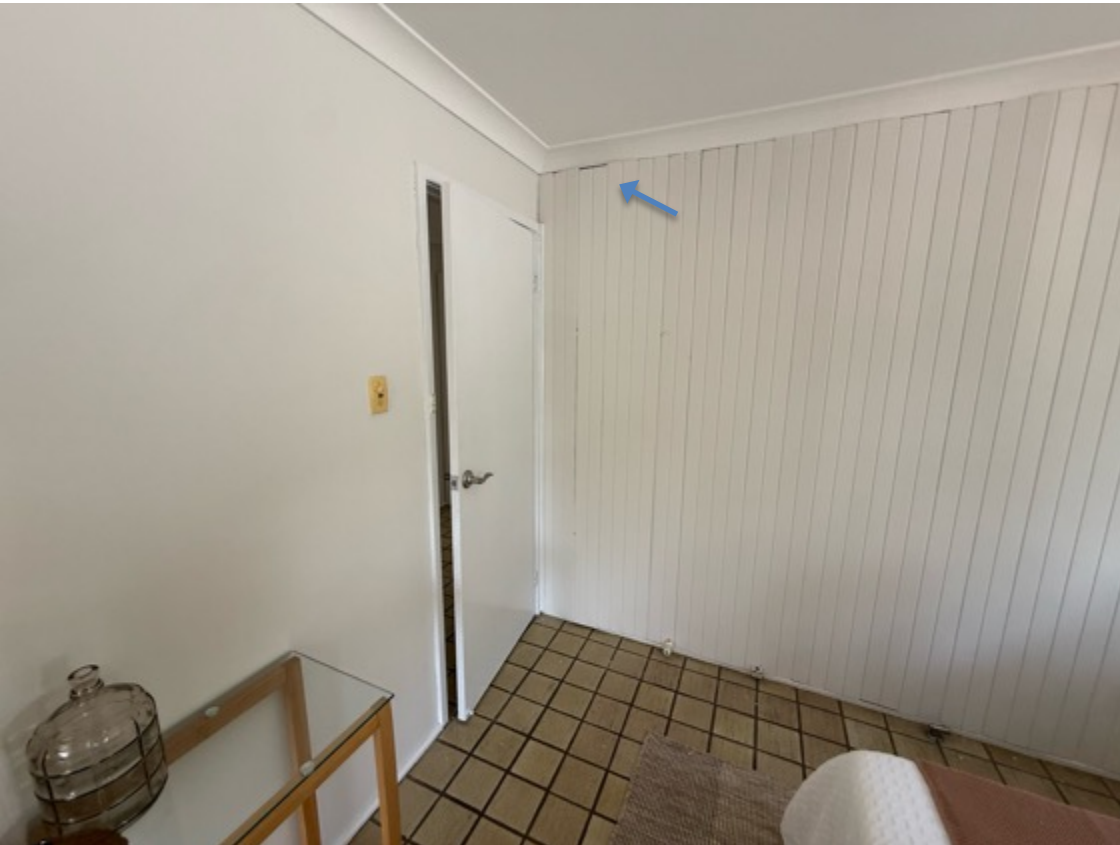
Rear bedroom wall panelling requires remedial works.

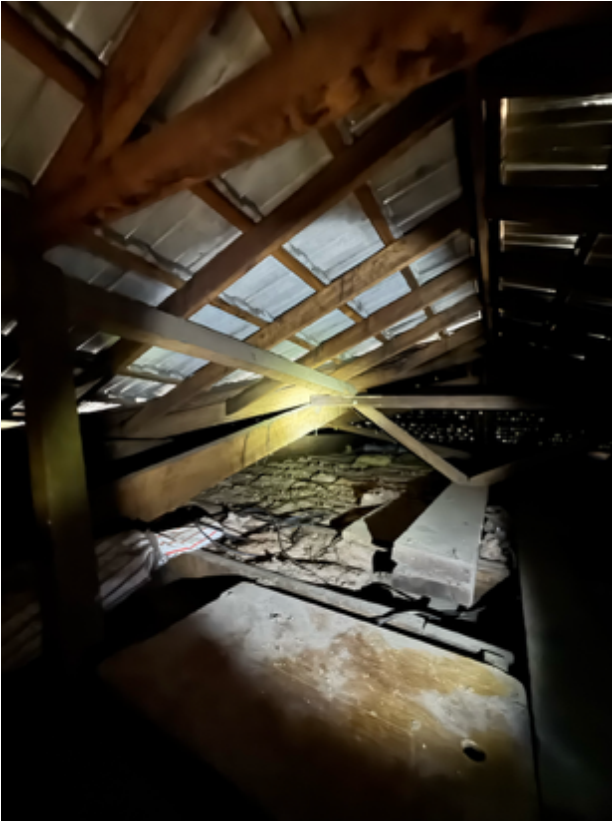
All areas within the roof space were dry at the time of inspection.
