# PROPERTY INSPECTION PEST REPORT

## **Visual Timber Pest Inspection Report.**

**76 ROSINA CRESCENT KINGS LANGLEY**

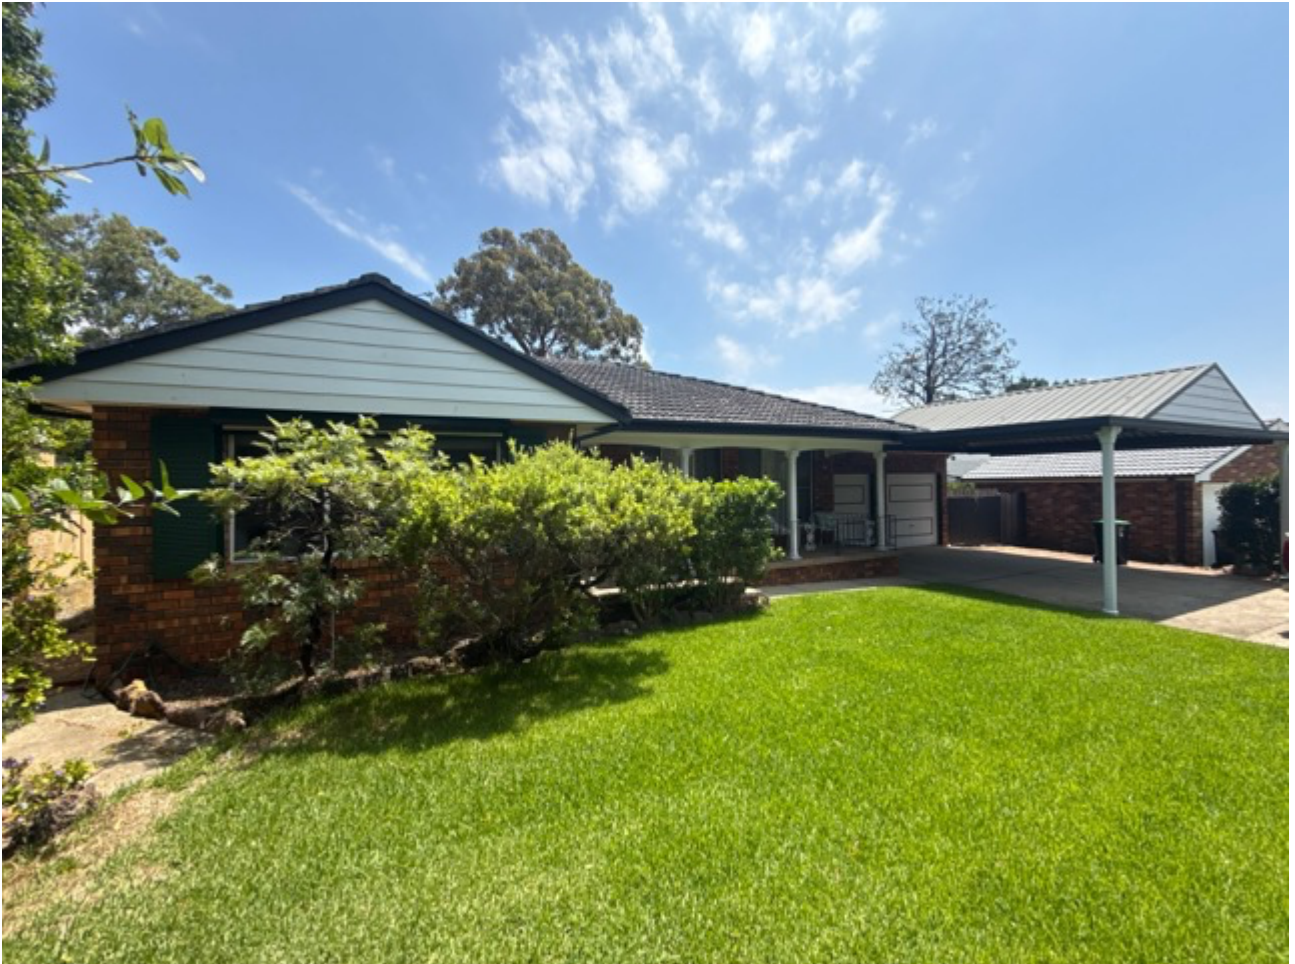
Front elevation of the Inspected property inspected.
