# PROPERTY INSPECTION PEST REPORT

## **Visual Timber Pest Inspection Report.**

**86 MELVILLE ROAD ST CLAIR**

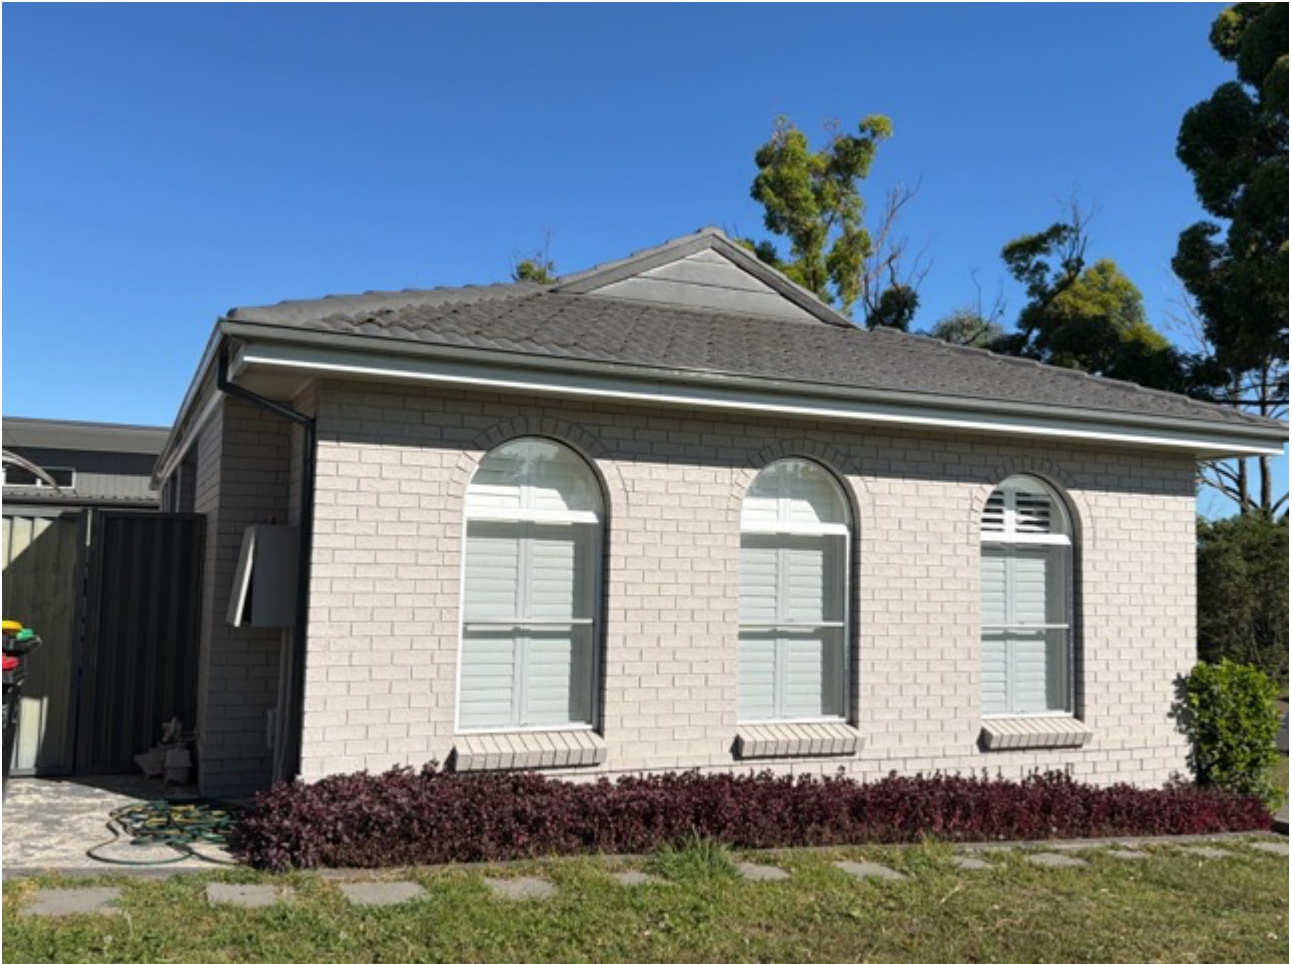
Front elevation of the Inspected property inspected.
