PRE-PURCHASE PROPERTY INSPECTION BUILDING REPORT

Visual Pre-Purchase Building Inspection Report.

51 KNIGHT AVENUE KINGS LANGLEY

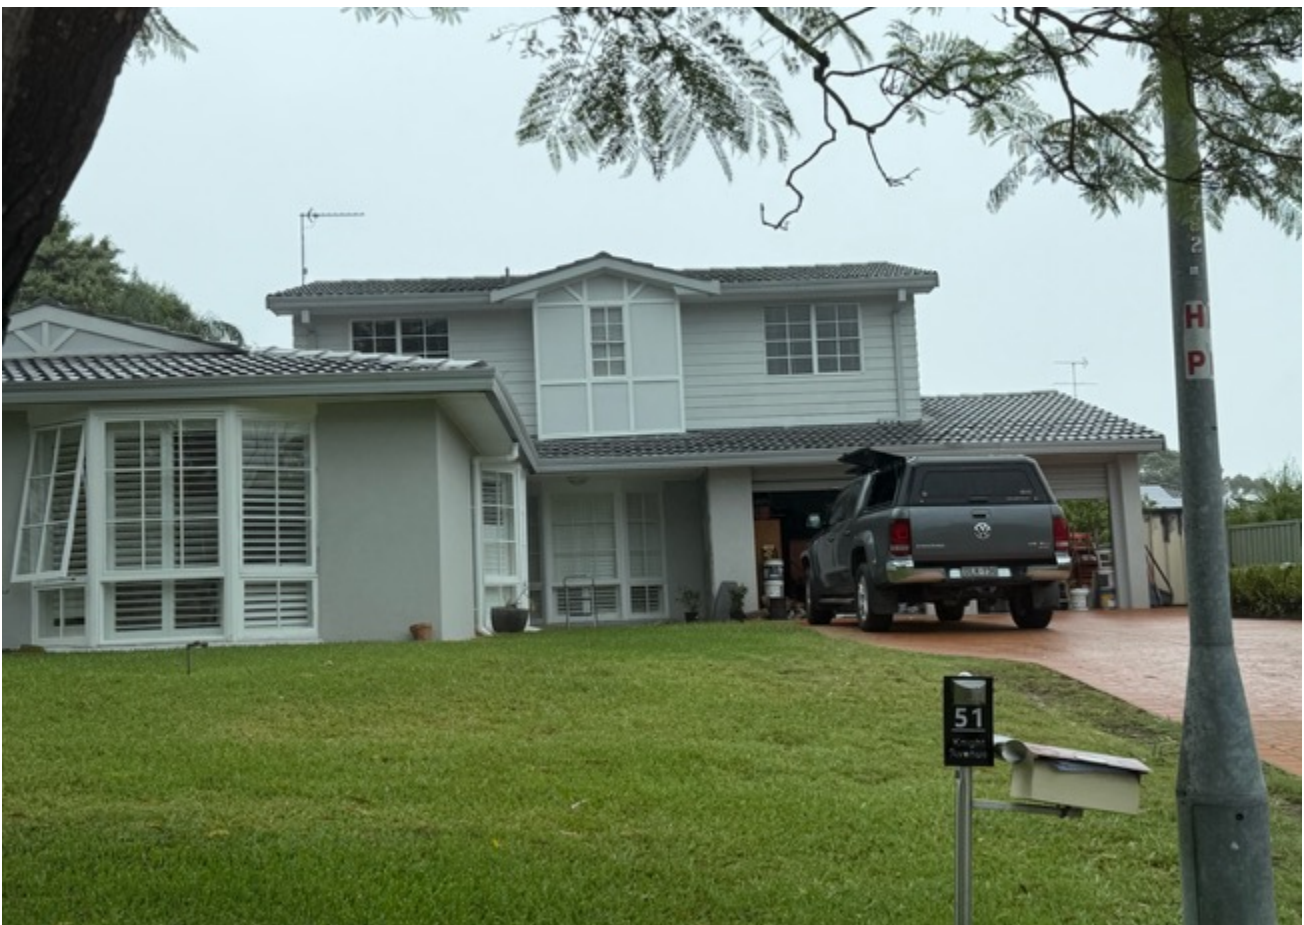
The exterior of the house presents in satisfactory condition displaying no major structural issues at the time of inspection.

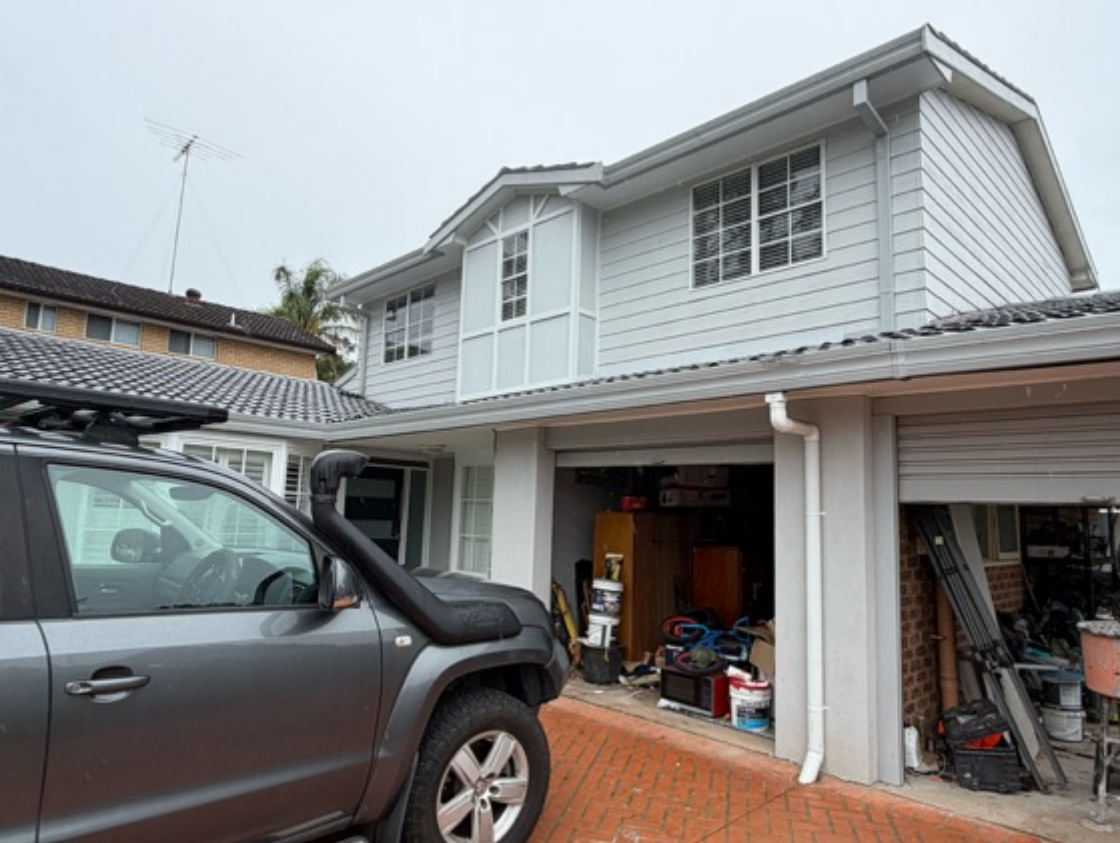
Garage roller doors tested, functioned at the time of inspection.

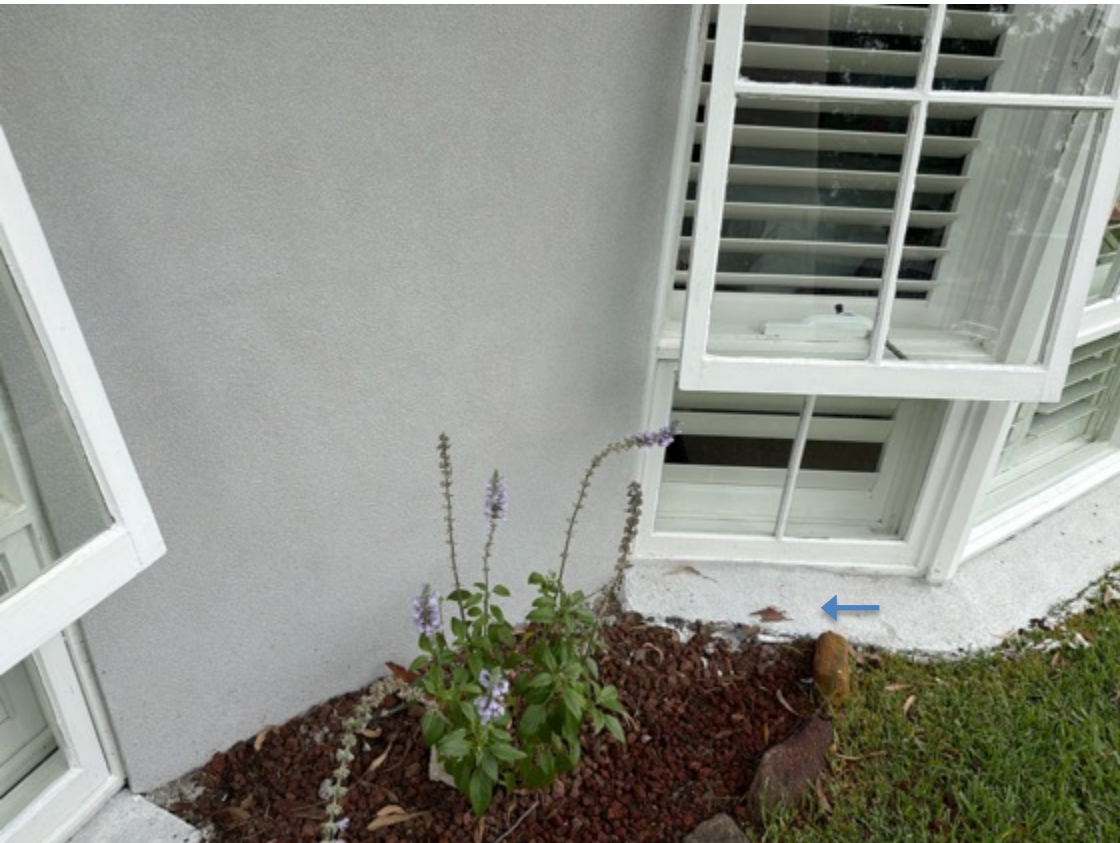
Isolated sections of external render is cracking and has minor damage, consistent with age.

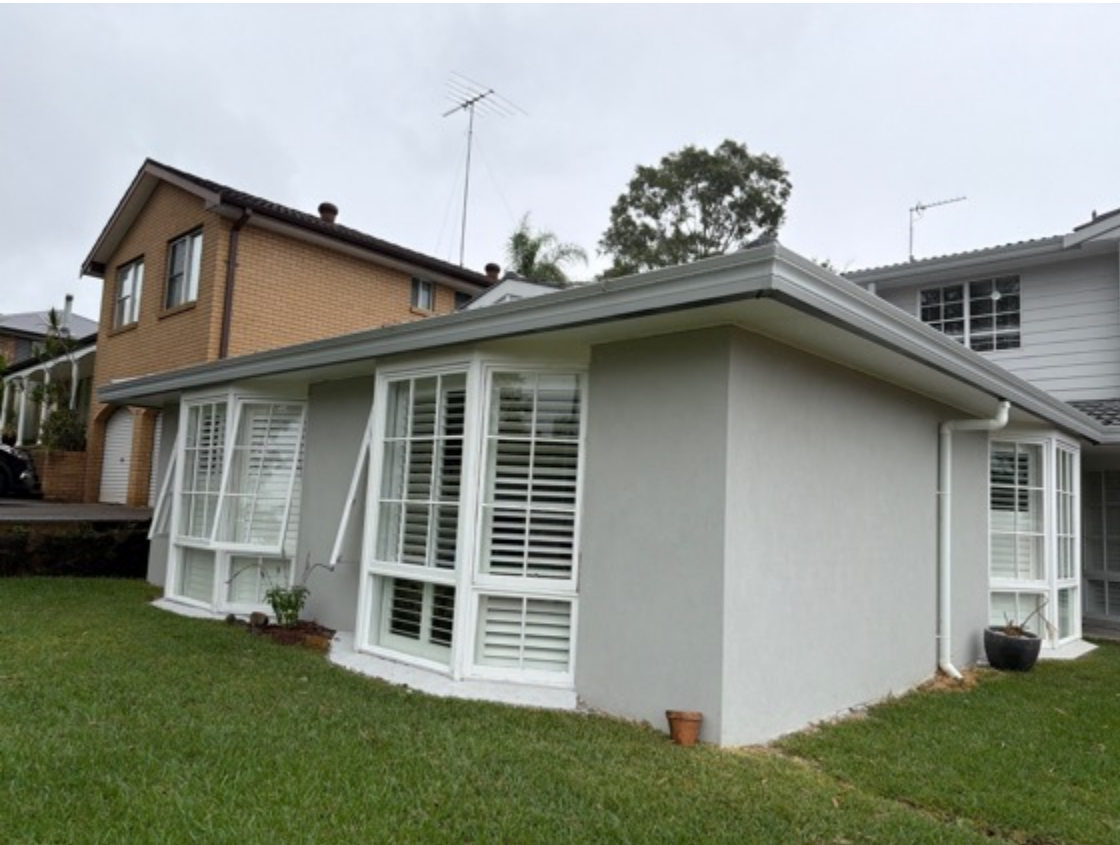
Exterior windows and doors present in satisfactory condition for the age.

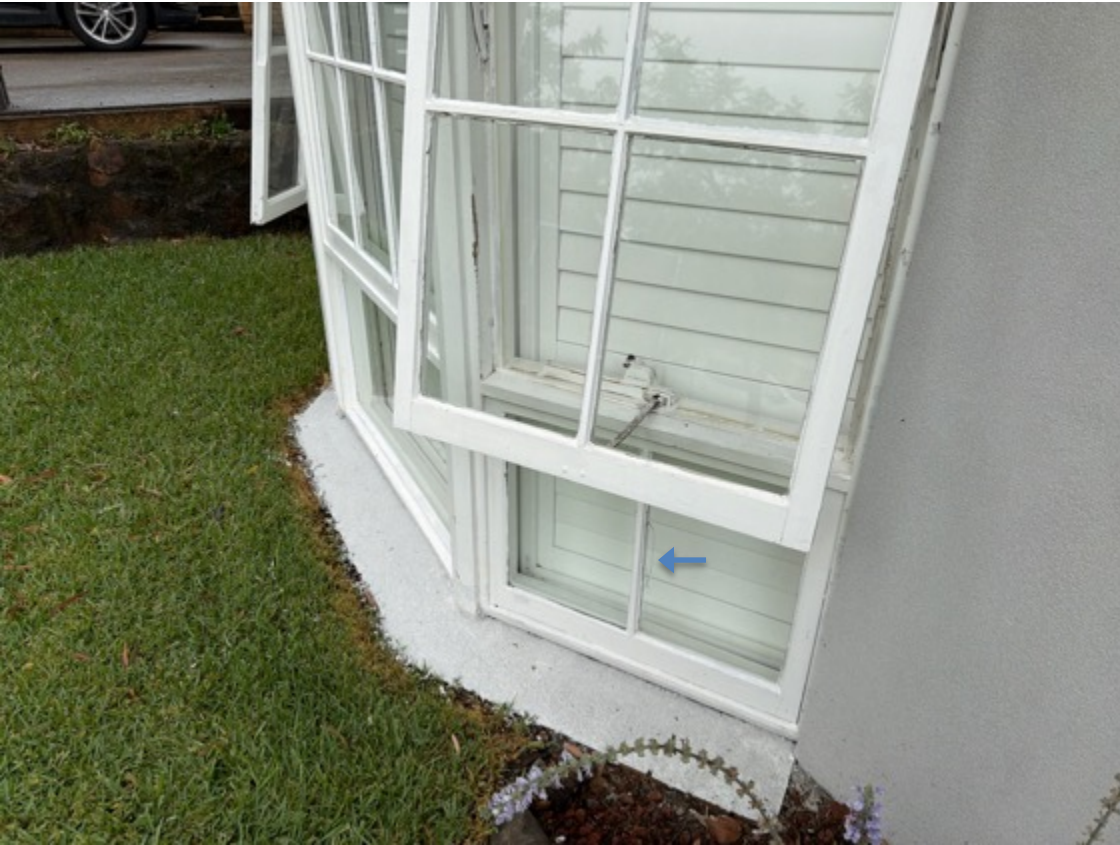
The front left window glass has a minor crack here.

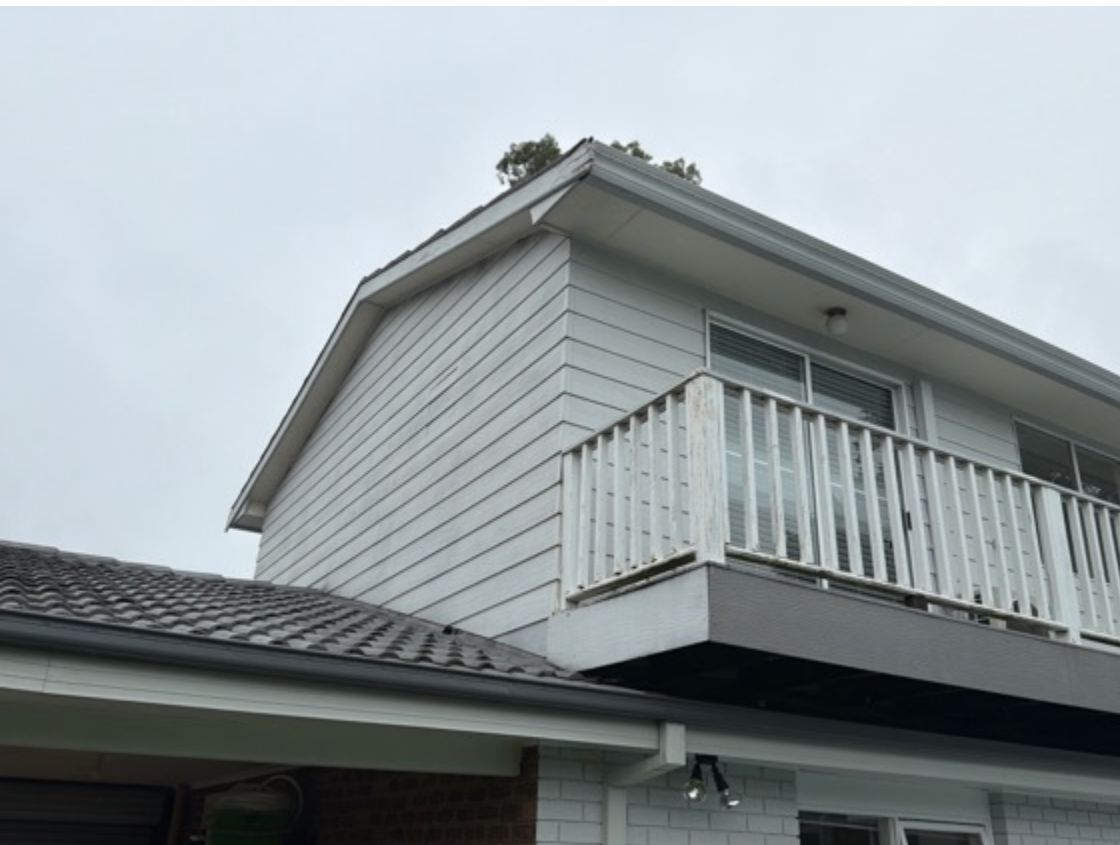
Exterior timber displays moderate to heavy signs of weathering – the rear balcony will require remedial works.

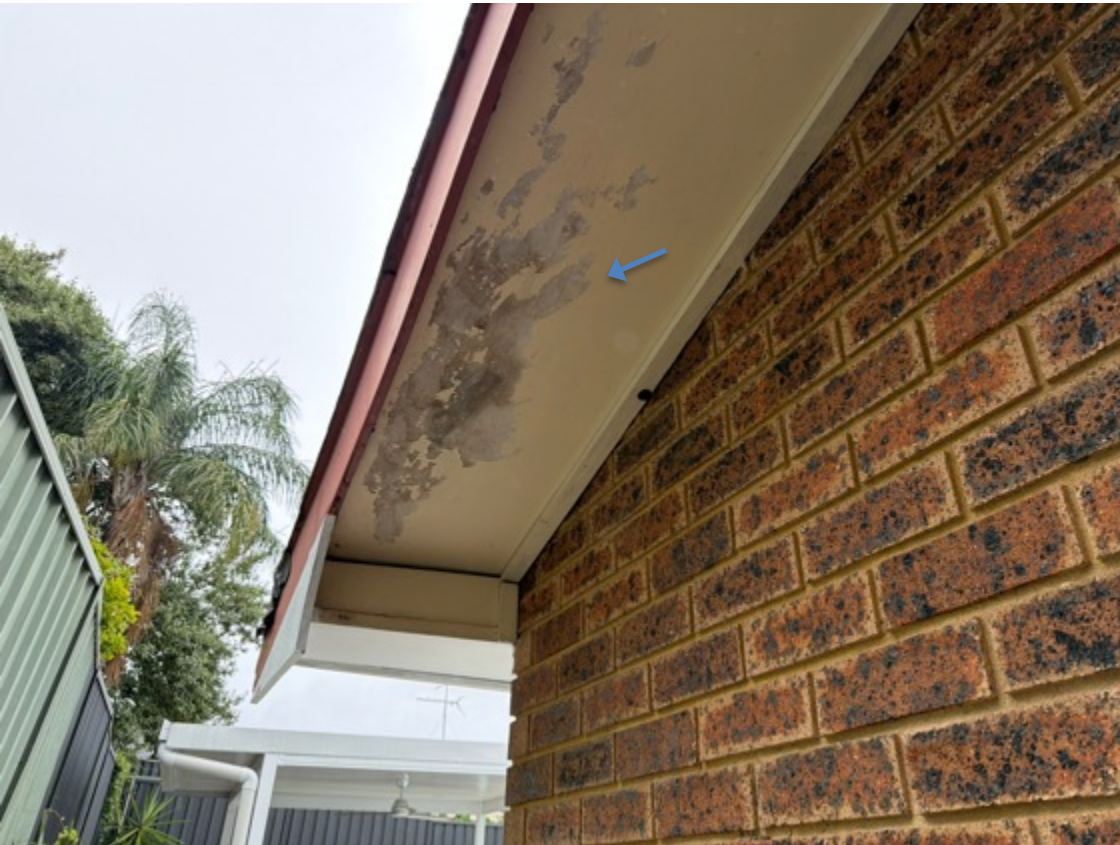
External paint is peeling, a fresh coat of paint is recommended on each elevation.

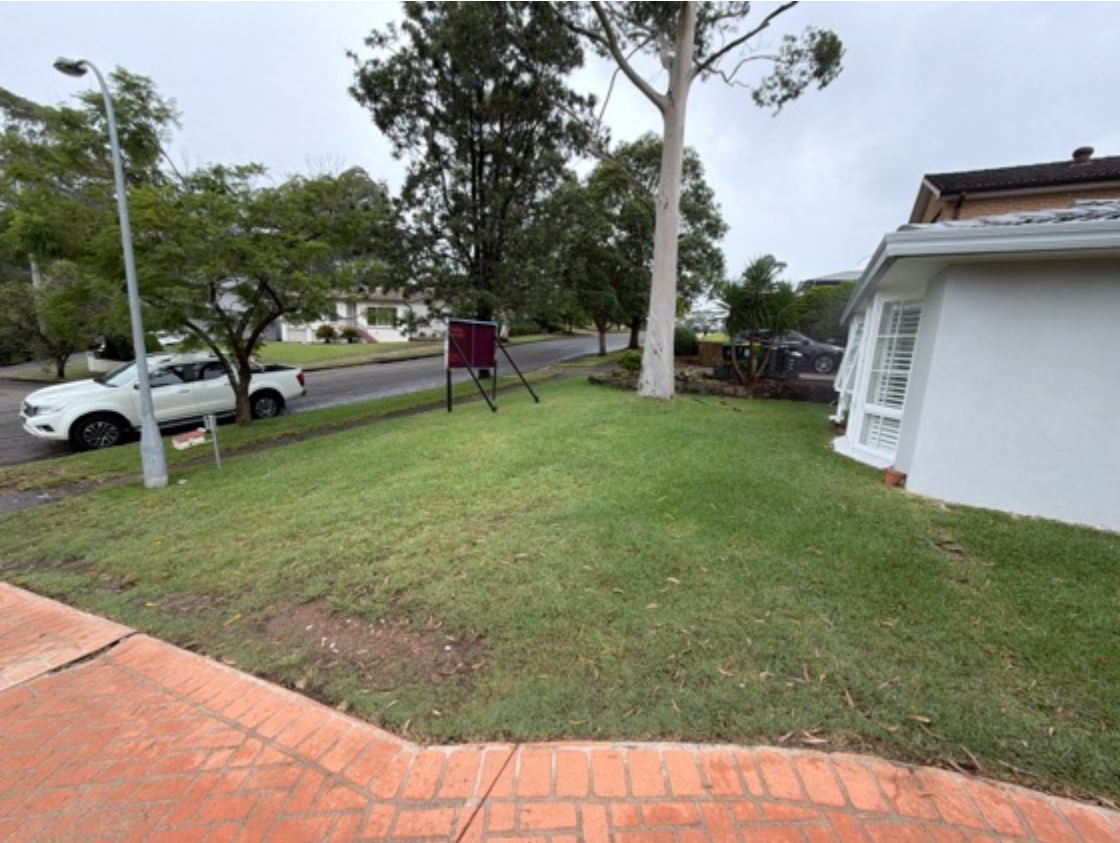
Site drainage / land overflow appears to function adequately with no signs of water laying at the time of inspection.

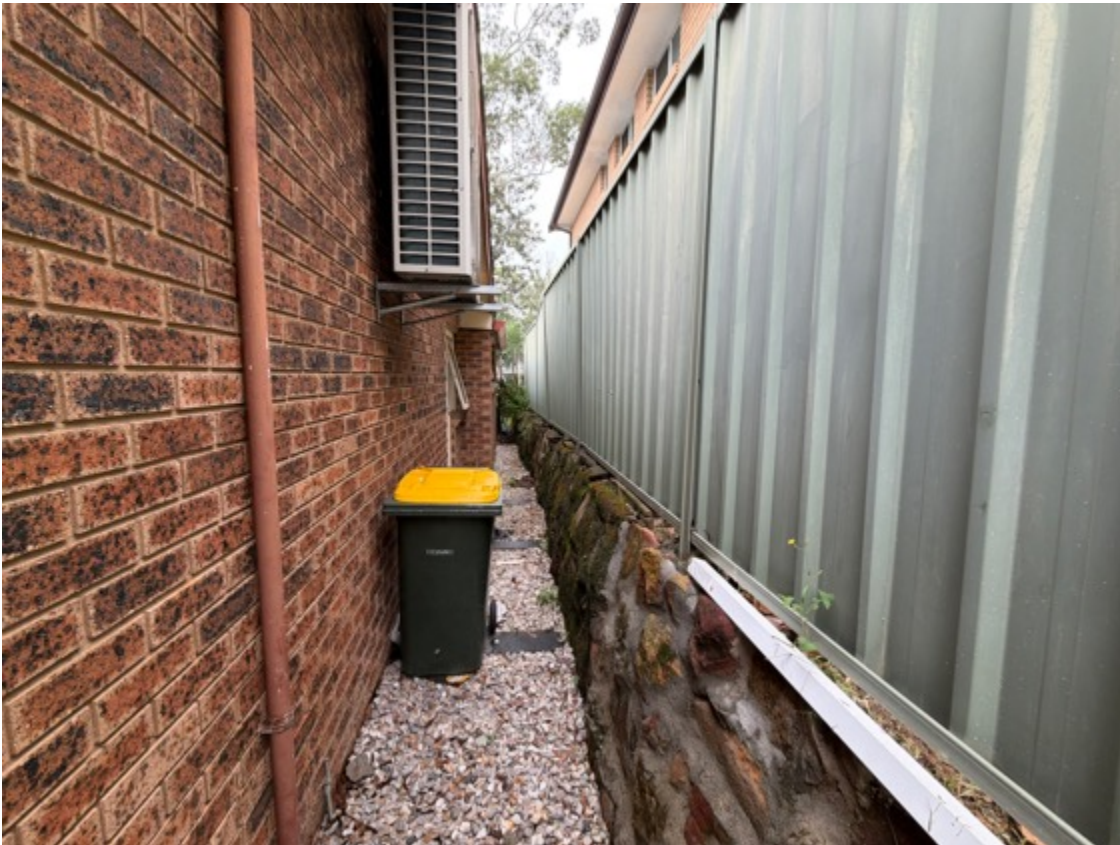
Site fences are in serviceable condition, isolated sections have minor damage and are leaning (consistent with age.)

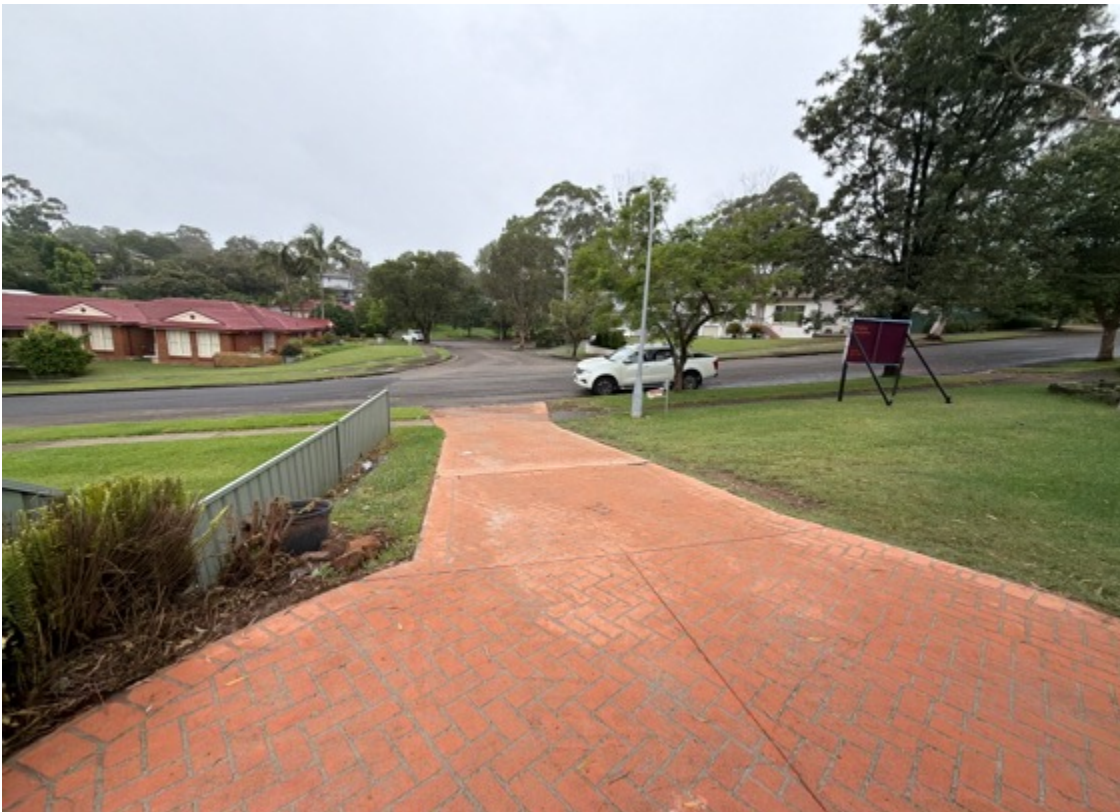
Isolated sections of exterior concrete displays typical shrinkage cracks and undulations - consistent with age.

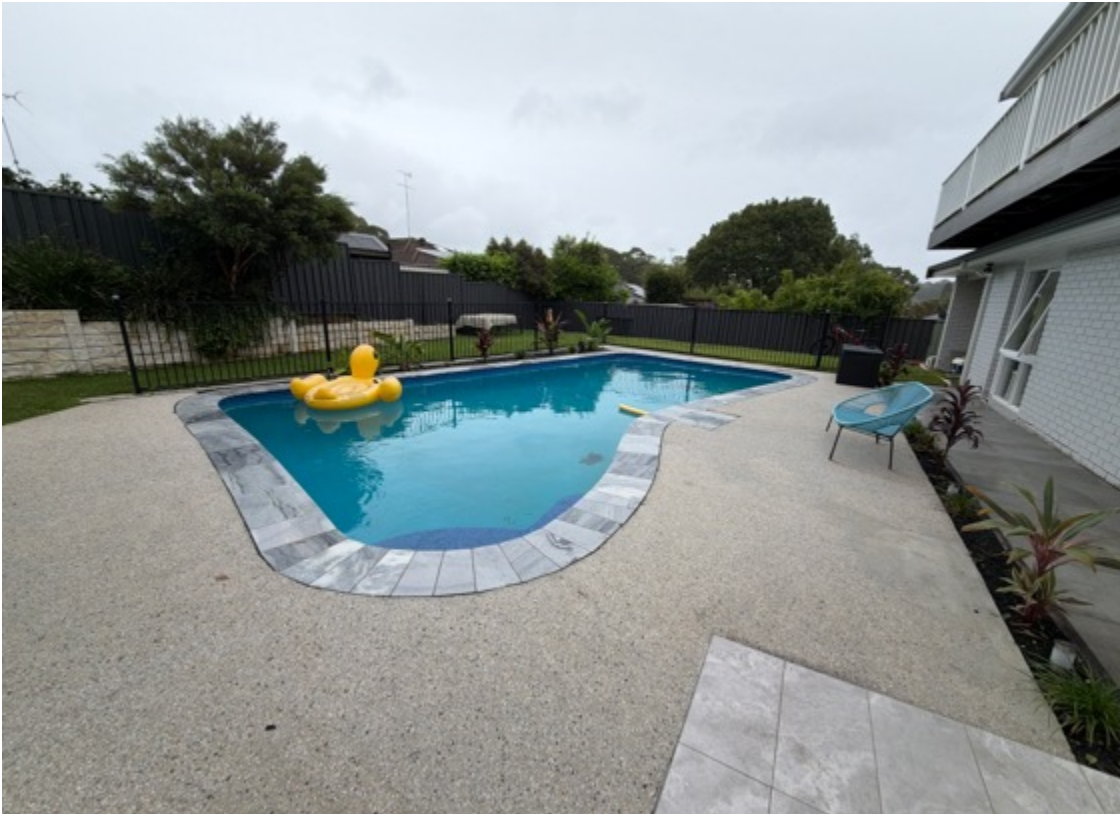
The pool area presents in satisfactory condition for the age.

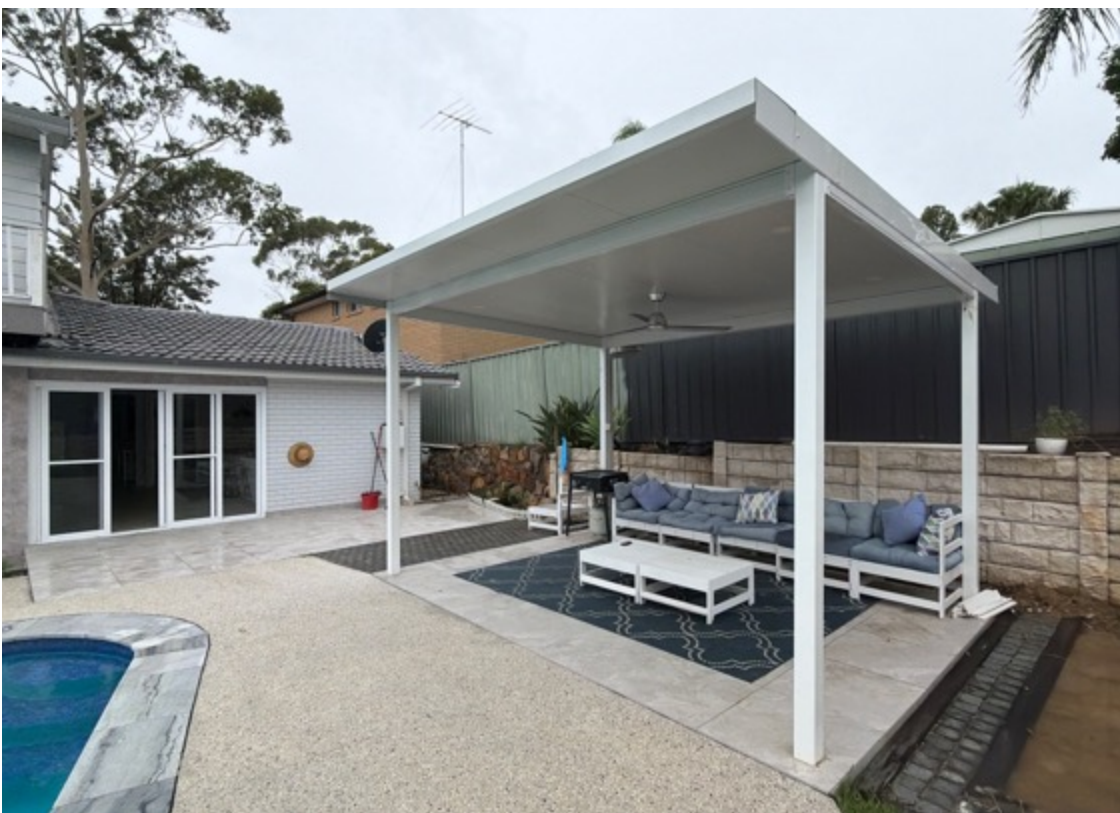
The rear pergola checked is structurally sound.

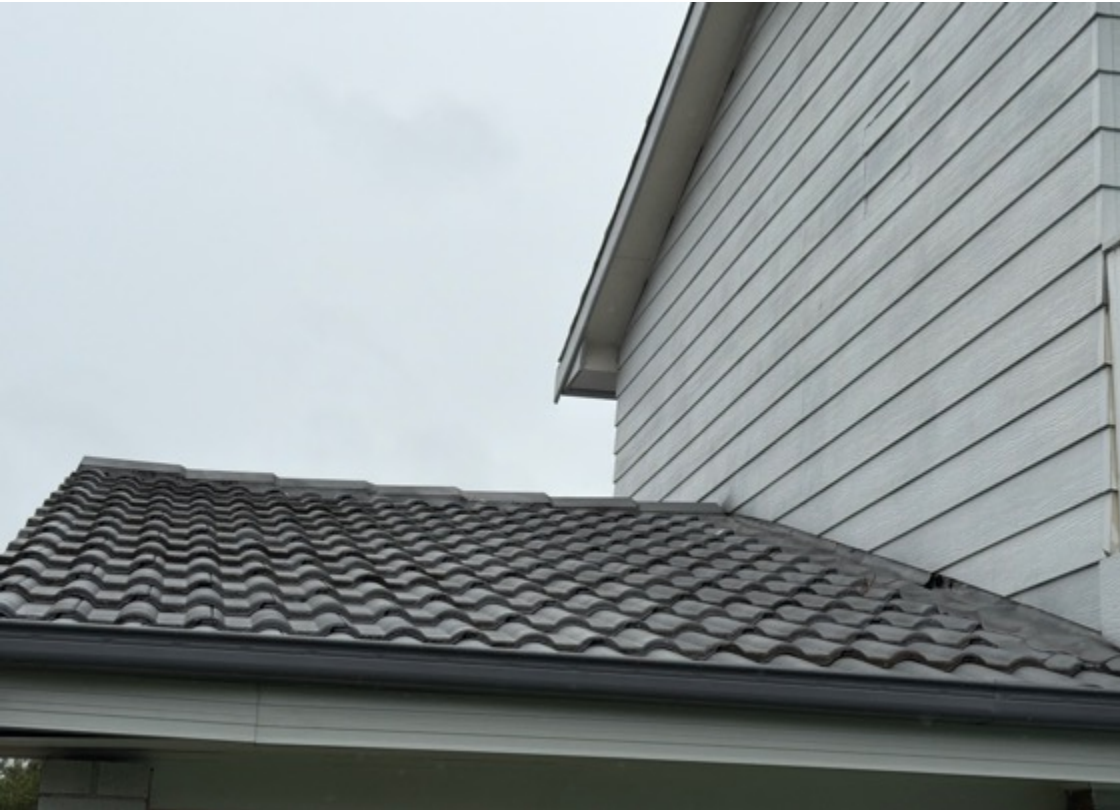
The roof exterior presents in satisfactory condition for the age.

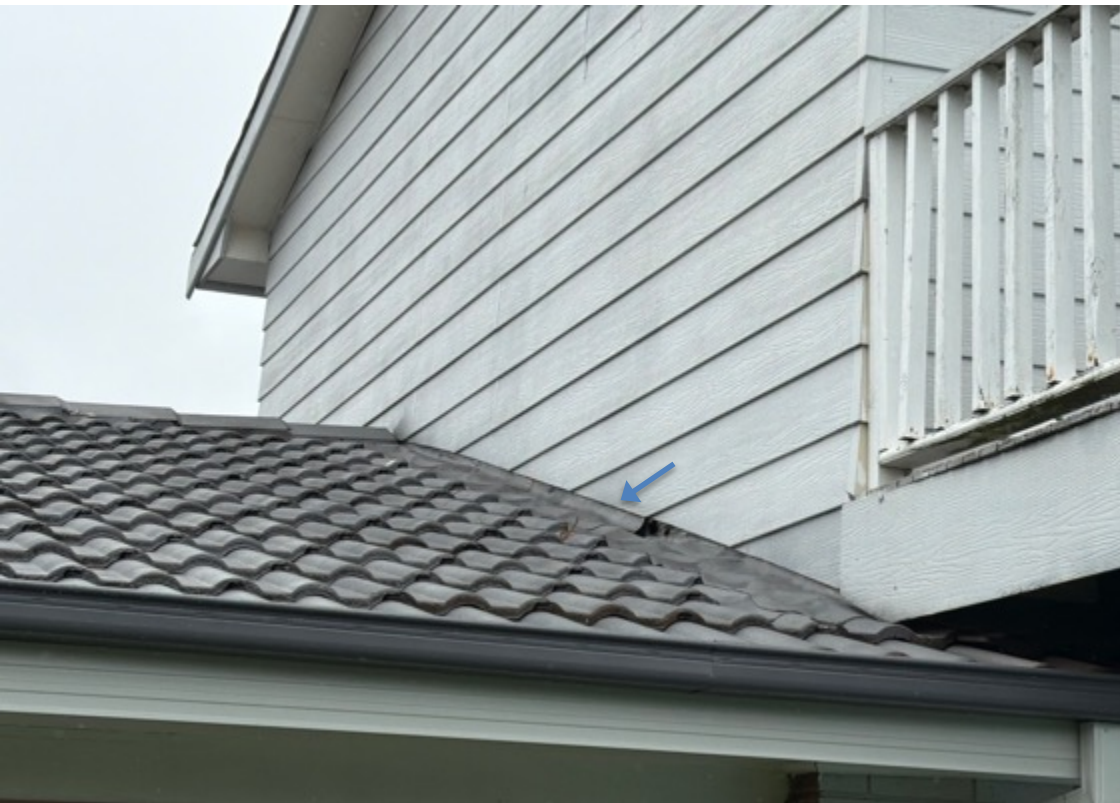
Lead flashing displays low level weathering, and isolated sections of tiles are chipped (consistent with age.)

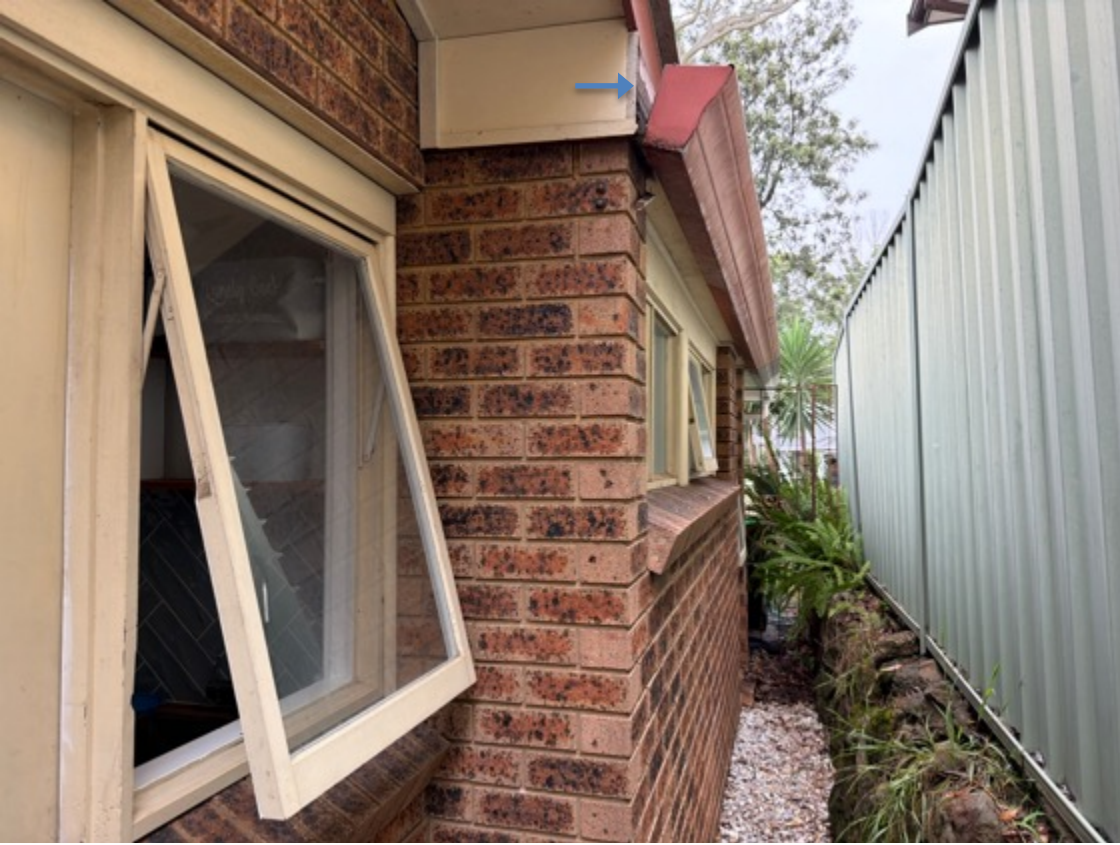
The left side elevation gutter requires remedial works.

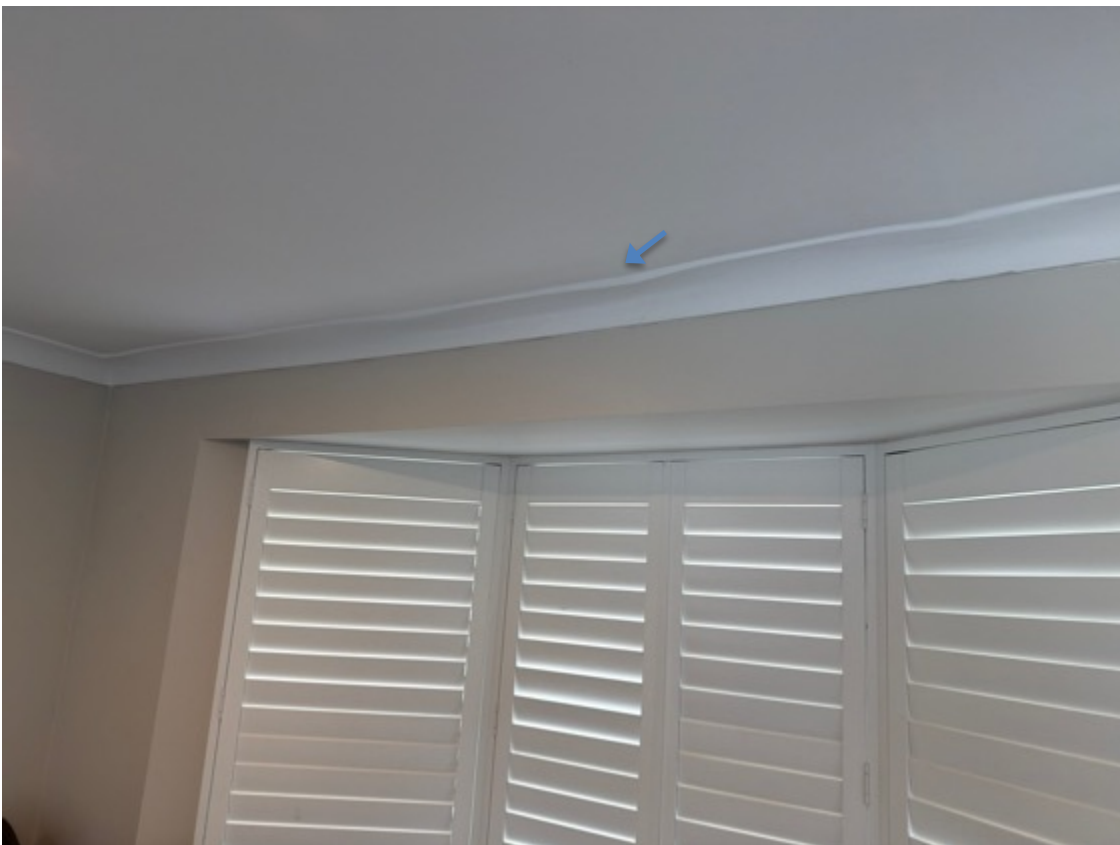
Plasterboard and cornices display imperfections – appear wavy (lower level television room example above.)

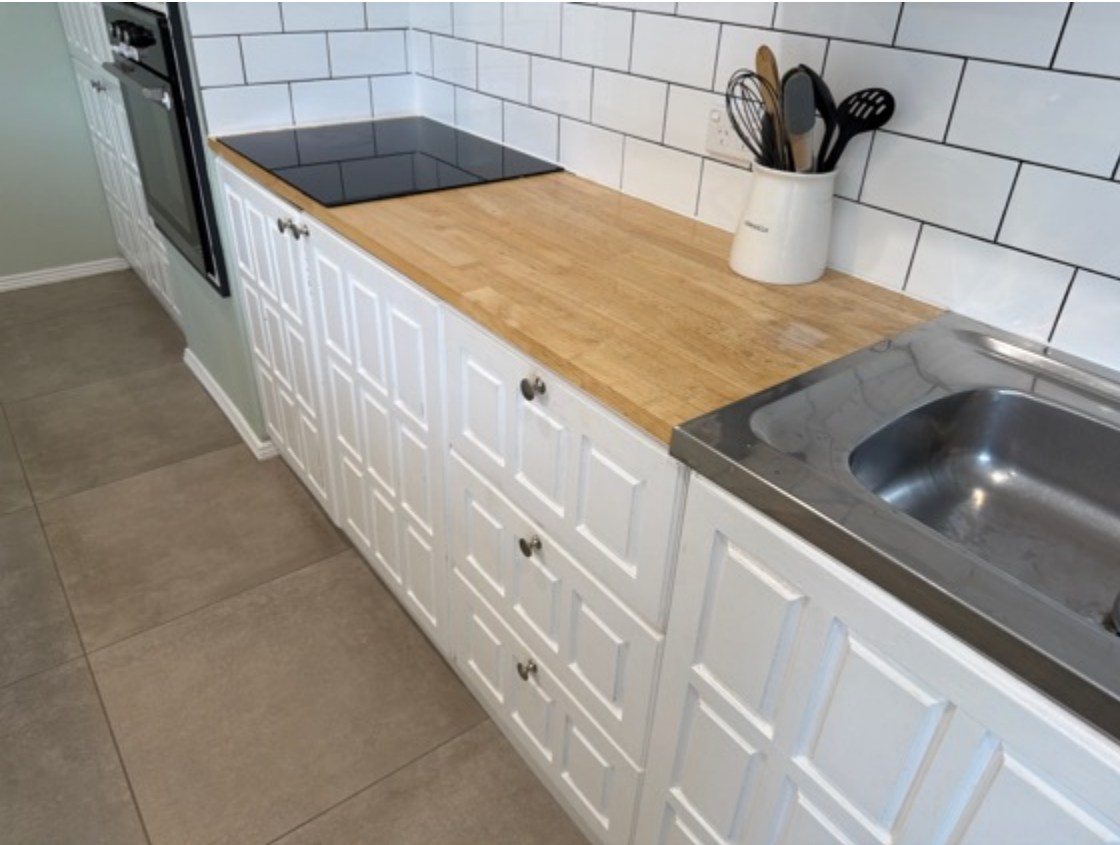
Cabinetry displays moderate level wear, consistent with age.

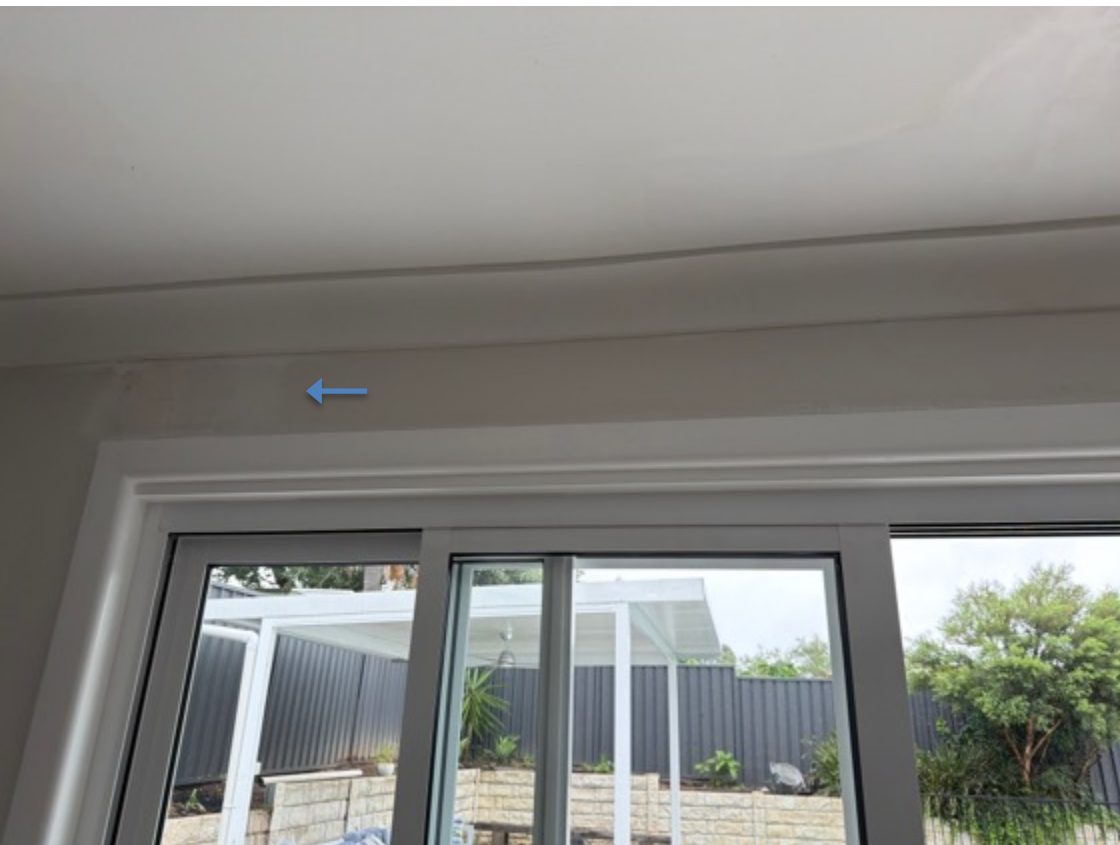
Internal painting works are incomplete, consistent with age.

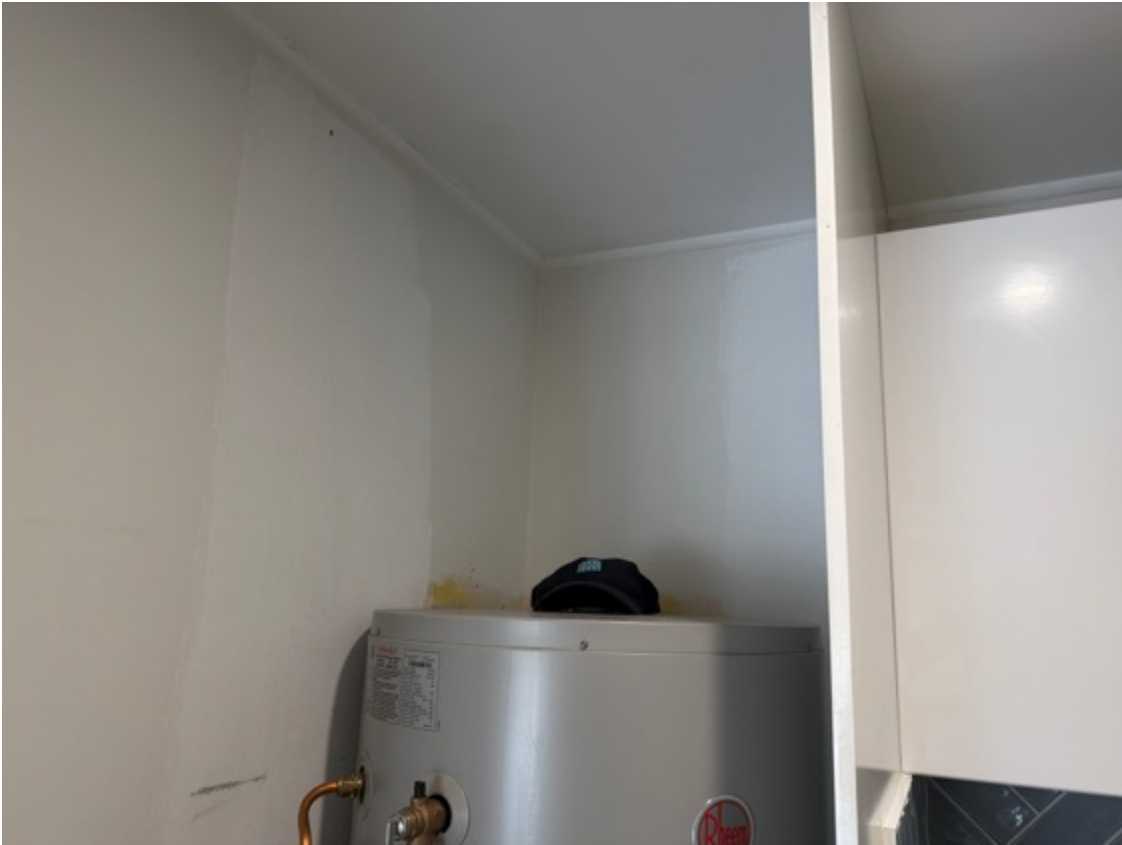
Painting works are incomplete in the laundry.

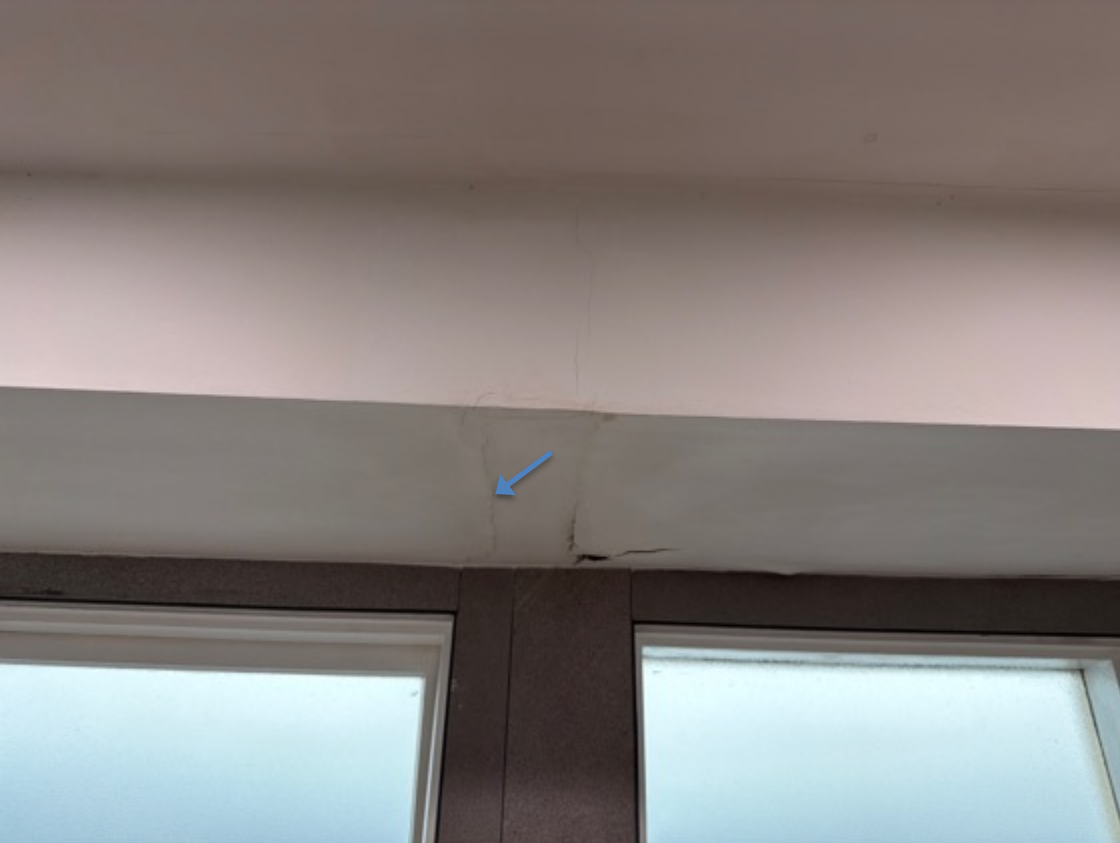
Plasterboard has past water damage visible here – will require remedial works.

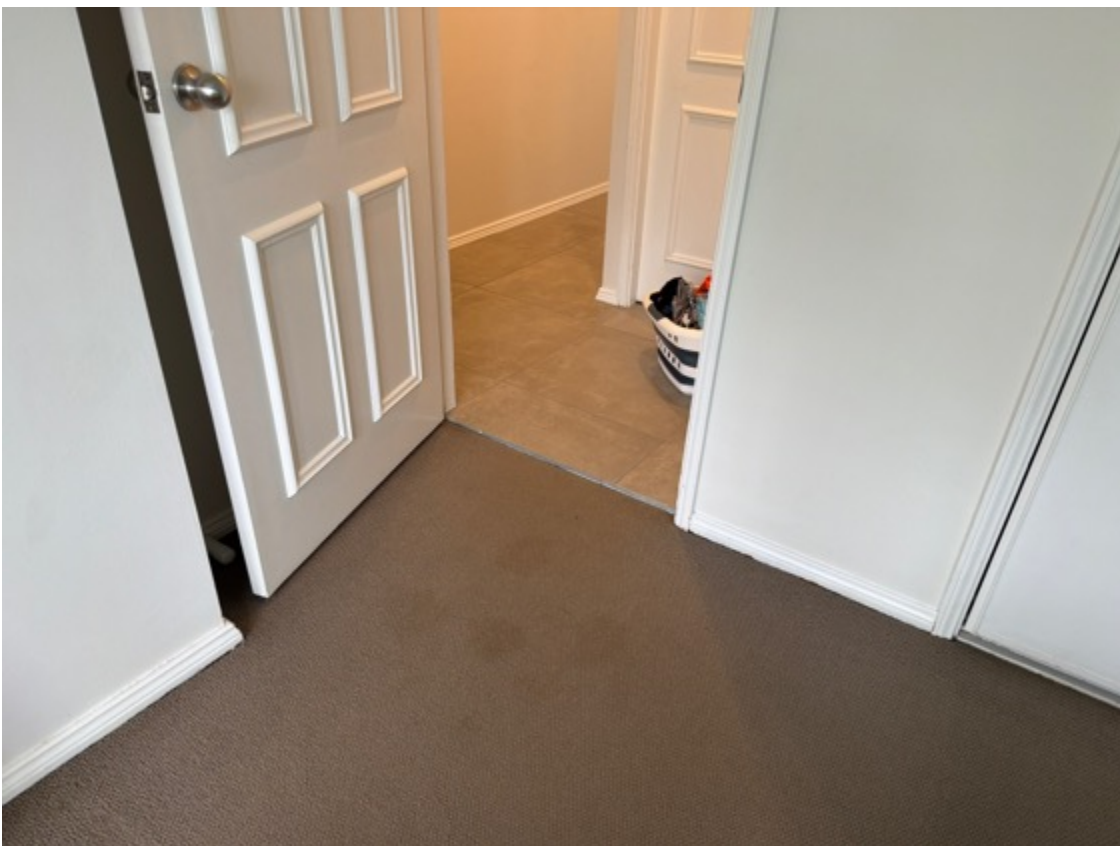
Internal carpet displays low level wear and surfaces are paint blemished, consistent with age.

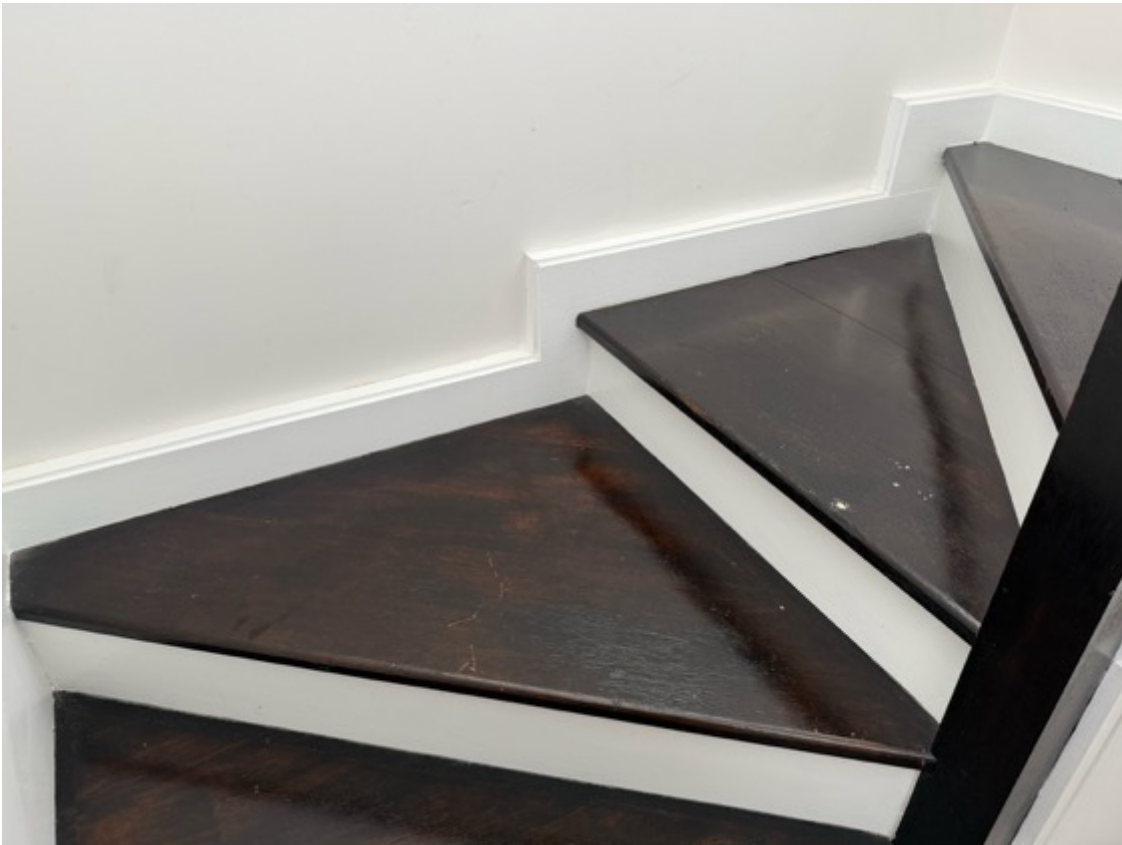
Sections of staircase steps feel uneven under foot.

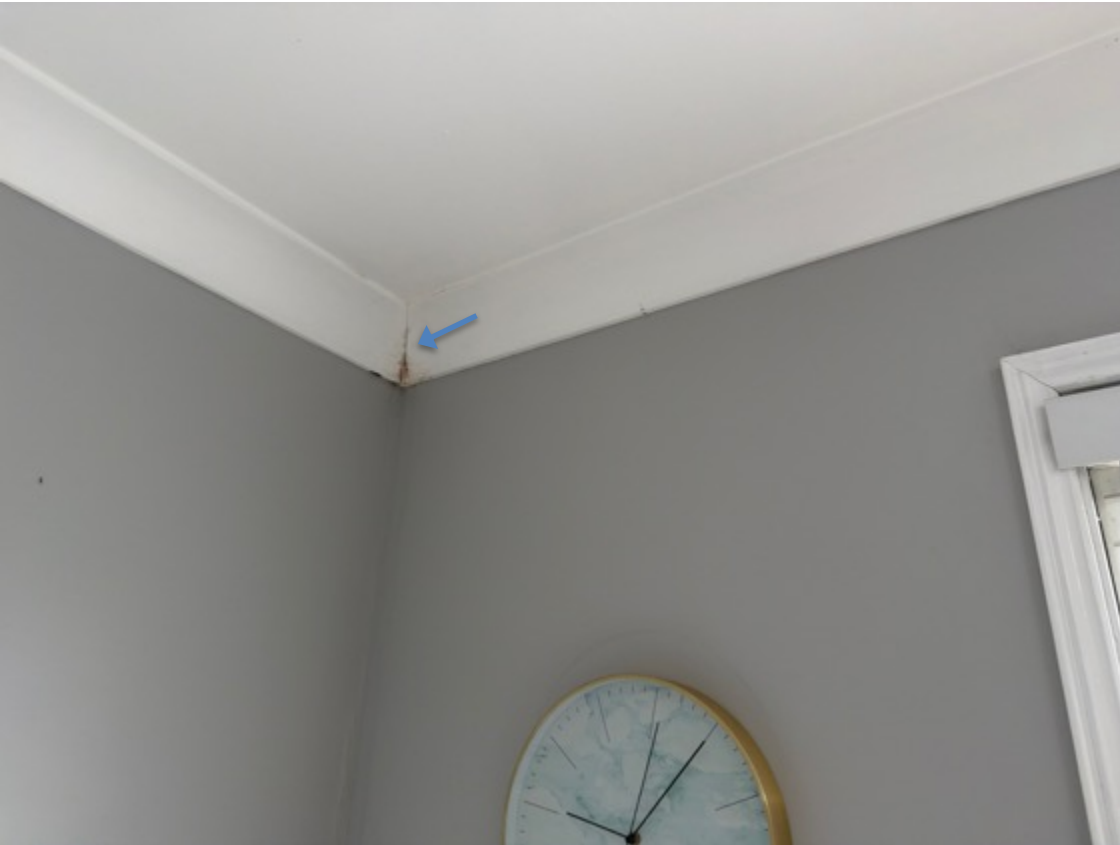
Cornices have past water staining.

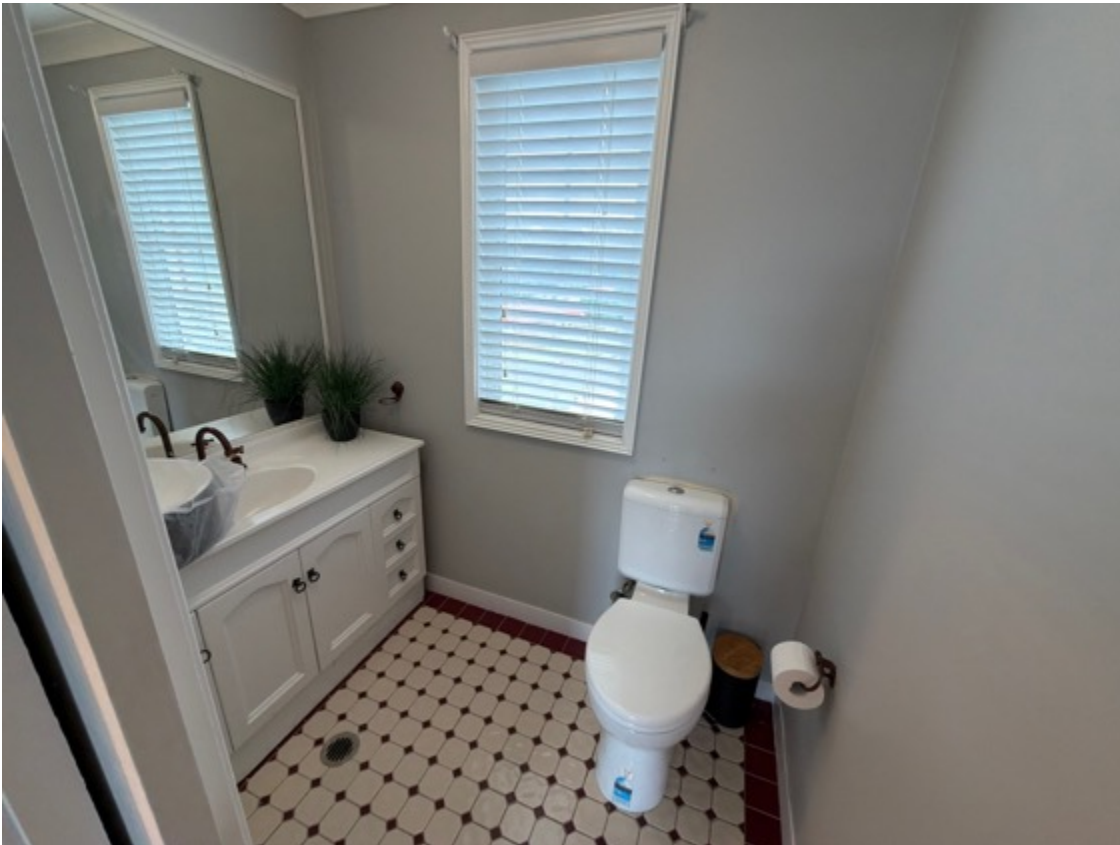
Hot and cold water services tested, functioned at the time of inspection - the vanity displays low level wear, consistent with age.
