PRE-PURCHASE PROPERTY INSPECTION BUILDING REPORT

Visual Pre-Purchase Building Inspection Report.

51 KNIGHT AVENUE KINGS LANGLEY

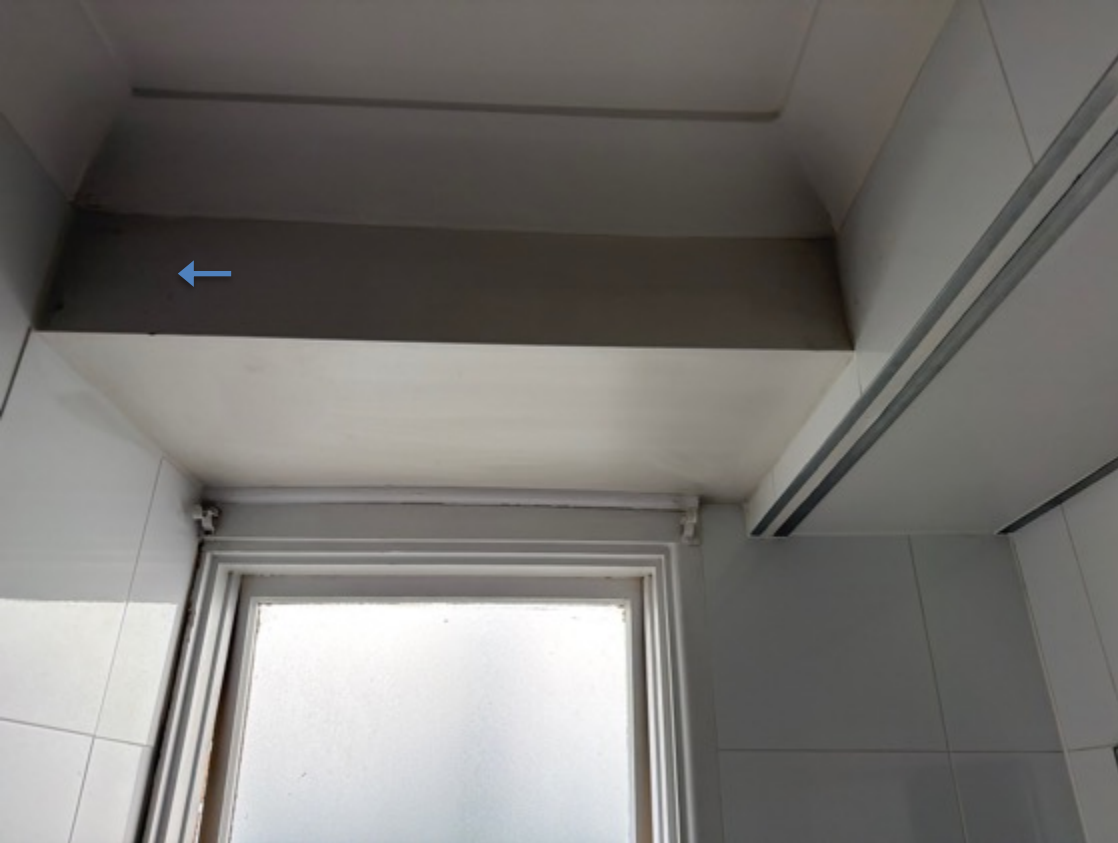
Surfaces display low level paint blemishes, consistent with age.

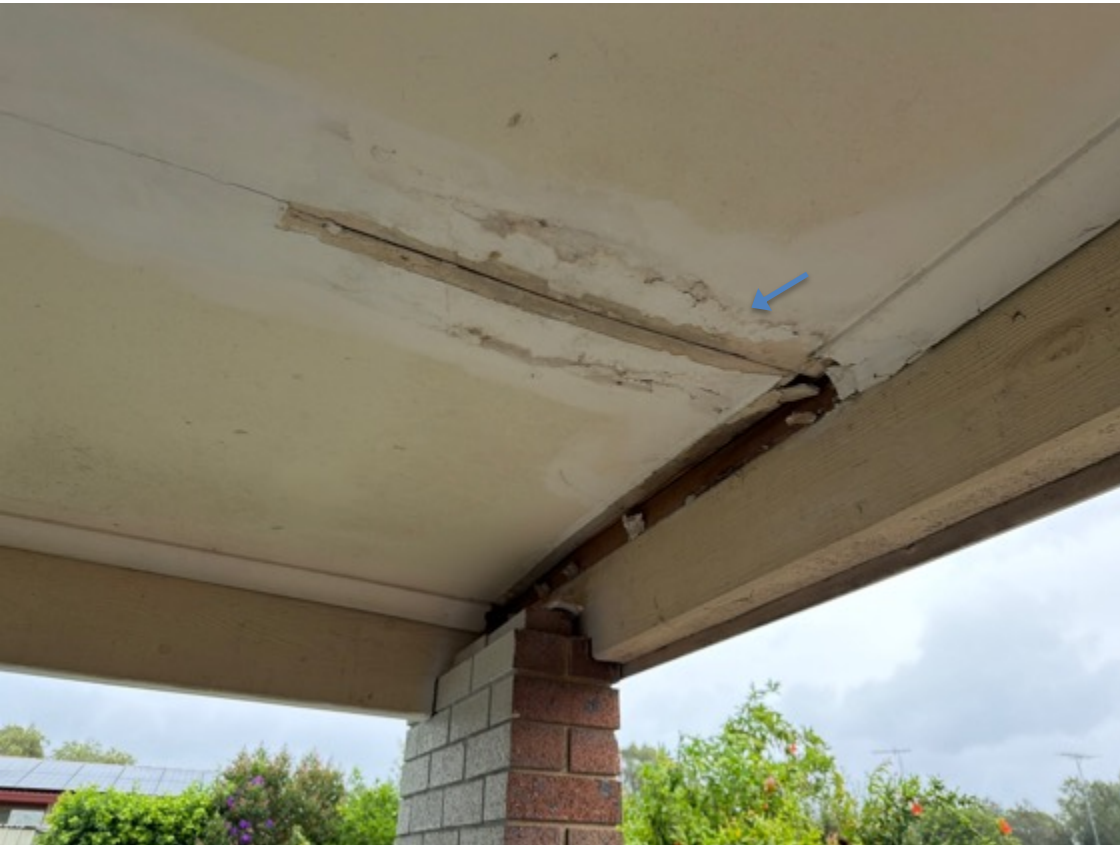
Plasterboard has water damage visible and works are incomplete (cornices, painting etc.)

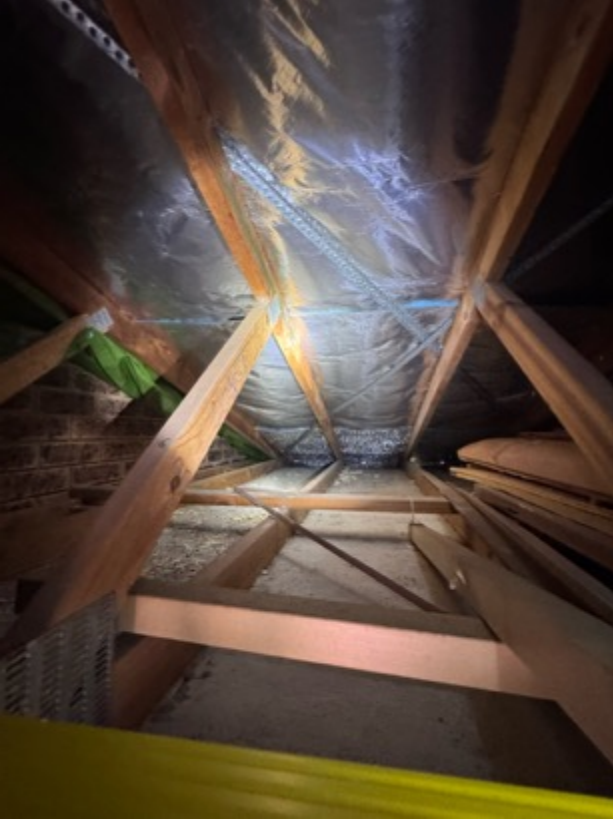
All areas within the roof space were dry at the time of inspection.
