# BUILDING AND TIMBER PEST INSPECTION - VR

Complies with Australian Standard AS 4349.1-2007 & AS 4349.3-2010  
Inspection of Buildings Part 1 & Part 3: Pre-Purchase  
Inspections of Residential Buildings - Appendix C

Jul 30, 2026

3 Clerke Pl  
Kings Langley, NSW 2147, Australia

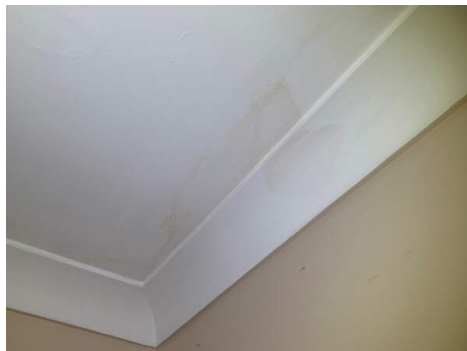
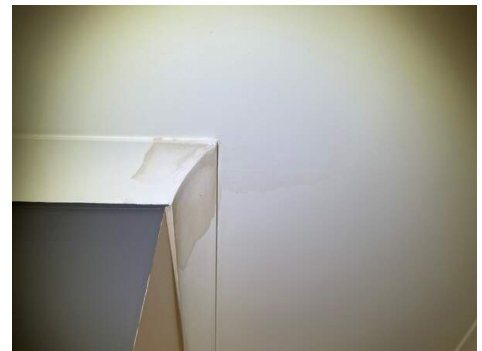
### 7.3.1 Ceiling - Water Stained

There is evidence of water staining to the ceiling linings in this area. Water staining shows that surfaces have been exposed to excess moisture over time. The minerals and other elements in the water can cause staining and may lead to corrosion and deterioration if not addressed.

While mainly an appearance issue, water staining can also indicate underlying problems that may be hidden behind the ceiling. It is advisable to engage a licensed plumber to investigate the cause of the staining and to advise on any necessary repair works. Addressing the source of moisture promptly can help prevent further damage and deterioration

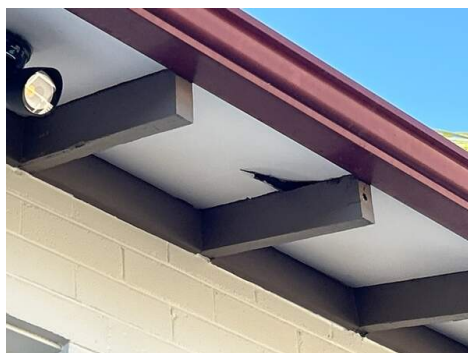
Photo Ref #3

### 7.3.2 Eave Linings Damage

The observed condition of this building element or photographic finding is provided for informational purposes only. It highlights an area that may benefit from further assessment and maintenance.

The client is advised to engage the appropriate trade specialist to review and address the issue at their discretion. Prompt attention can help prevent further deterioration and reduce the risk of secondary defects.

Recommended trade to be contacted: Handyman/Painter

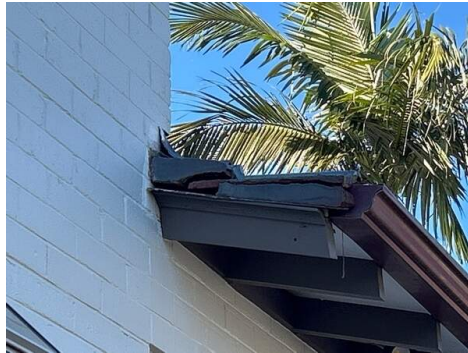
Photo Ref #4

### 7.3.3 Barge Pointing - Cracked or Damaged

Upon inspection of the exterior roof covering, cracked or damaged roof pointing was identified.

Cracked or damaged pointing is generally the result of ageing and weathering of what is essentially a porous material. If left to further deteriorate, damaged pointing is likely to lead to water penetration via the roof into the ceiling space, causing secondary damage to ceiling linings, insulation and roof structures.

Missing pointing also is likely to detract from the effectiveness of the roof drainage system, creating potential for secondary damage to the exterior roof covering and roof plumbing.

Replacement of pointing is required and should be performed by a roofing contractor as soon as possible.

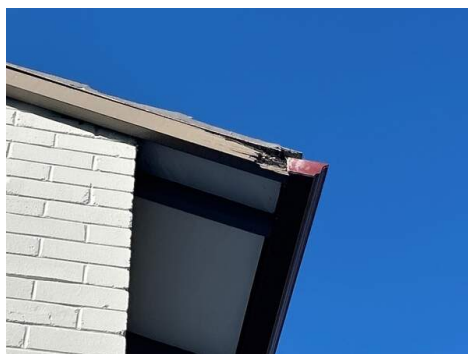
Photo Ref #5

### 7.3.4 Fungal Decay (Wood Rot) - Observed

This building element shows evidence of wood rot.

Wood rot, also known as Fungal Decay, occurs when timbers and other cellulose building materials are exposed to damp conditions on an ongoing basis. This could be the result of exposure to weathering over a prolonged period of time, or the attraction of excessive moisture from other abutting building materials. Contributing factors also include poor air ventilation in the area.

Early intervention and regular maintenance, particularly of exterior timbers, will prolong the useful life of these building elements. Prior to any works being performed, the cause of the moisture that has created the visible wood rot should be identified and addressed in a suitable manner.

Replacement of affected timbers may then be a necessary step in protecting surrounding building elements from such deterioration.

A qualified carpenter or registered builder may also be required to replace affected building materials.

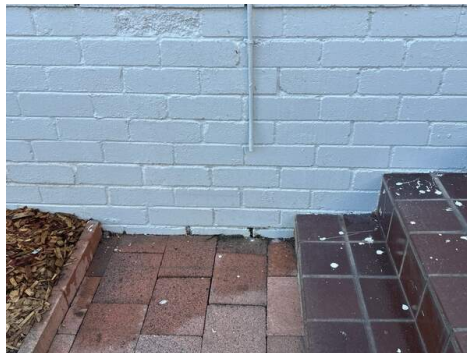
Photo Ref #6

The Hot Water System (HWS) overflow pipe was observed to be ground discharging, allowing water to release directly onto the surrounding surface when draining. This may result in excess moisture potentially pooling around the base of the unit or adjacent walls, which over time could contribute to rust, corrosion, or minor dampness-related issues.

In some cases, this excess moisture may create conducive conditions for timber pest activity, particularly where discharge occurs near building elements or garden areas adjoining the dwelling.

It is recommended that a licensed plumber or handyman be engaged to divert the overflow pipe away from the dwelling or connect it to a suitable nearby drainage point as required.

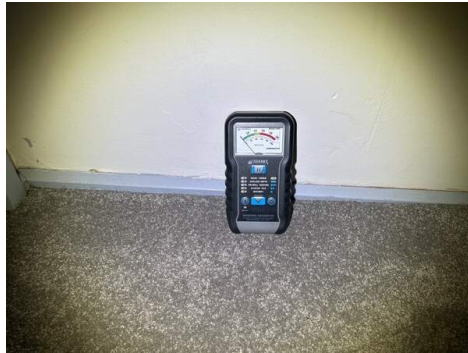
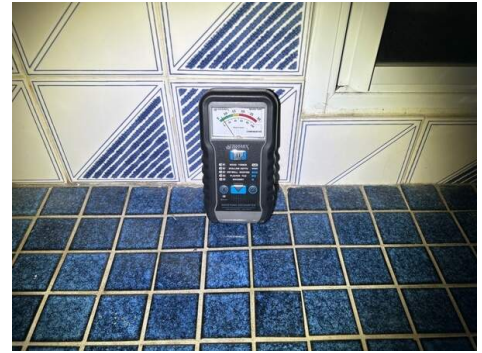
### 7.7.2 Moisture Meter Reading: Low or Zero

Upon inspecting the wall and door frames as shown, there was no evidence or only low levels of moisture detected.

Recommended action: No immediate action required; monitor as needed.

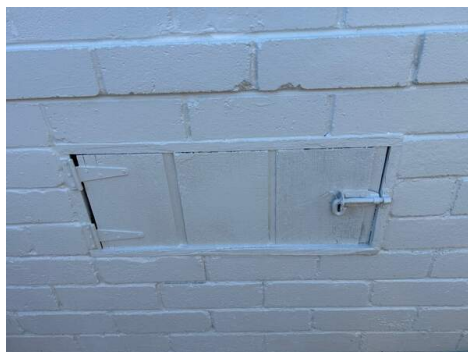
Photo Ref #29

Building: Main Building  
 Area: Exterior  
 Location: Subfloor  
 Finding Significance: For Information Purposes  
 Comments: Low Clearance/Limited Access

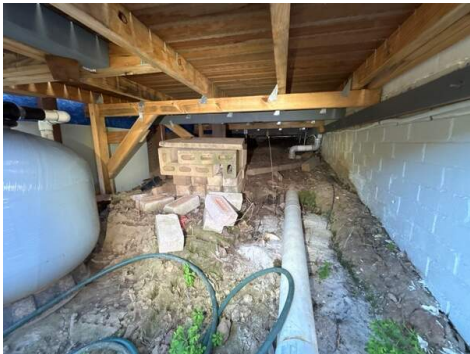
Photo Ref #30

Building: Main Building  
Area: Exterior  
Location: Under Deck  
Finding Significance: For Information Purposes  
Comments: Stored Items, Services and Low Clearance
