**PRE-PURCHASE  
PROPERTY  
INSPECTION  
BUILDING REPORT**

**Visual Pre-Purchase Building Inspection Report.**

| <b>Inspection address:</b> | 38 Knight Avenue Kings Langley. |

**38 KNIGHT AVENUE KINGS LANGLEY.**

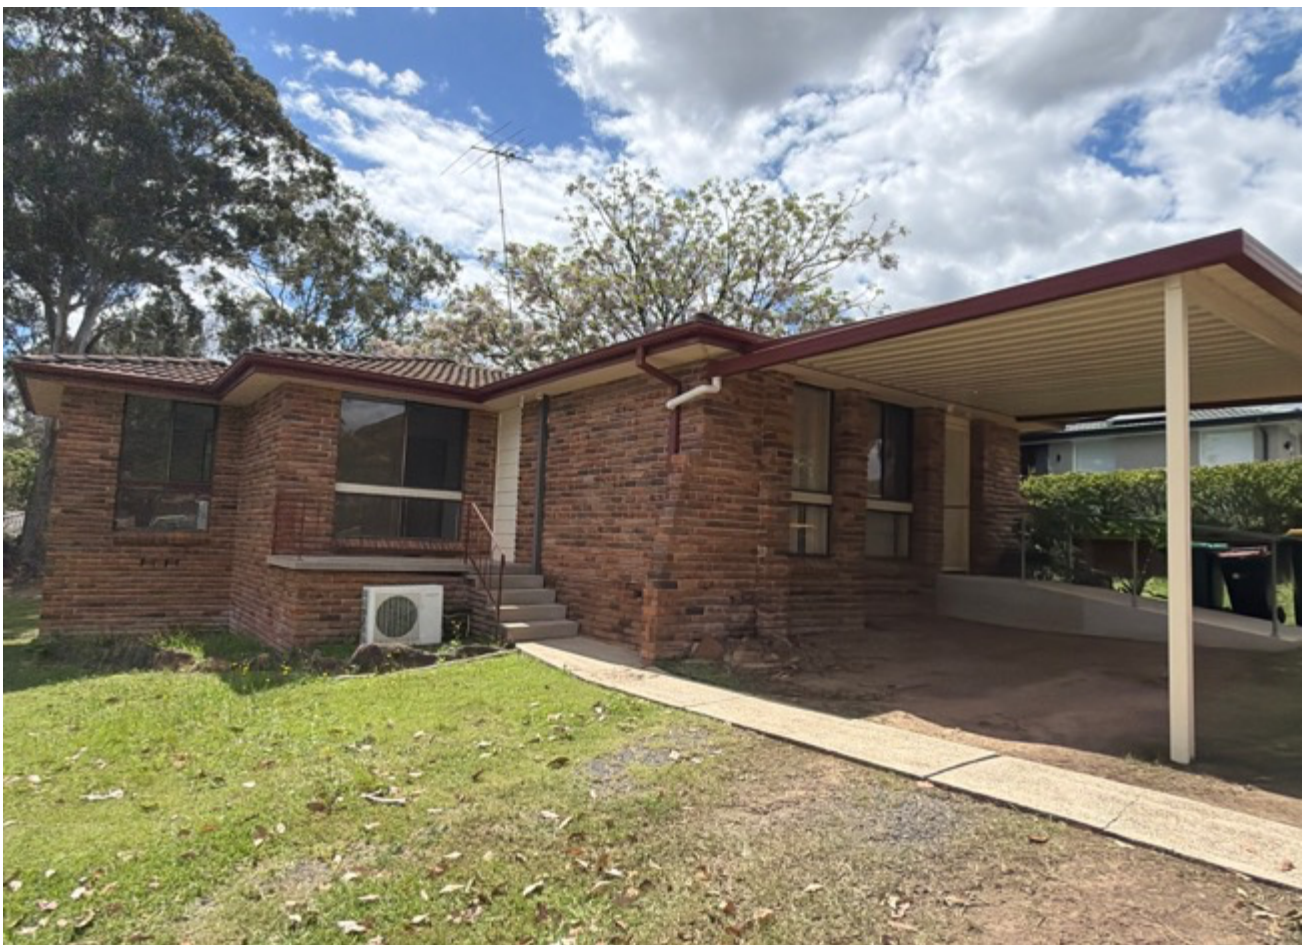
The exterior of the house presents in serviceable condition for the age.

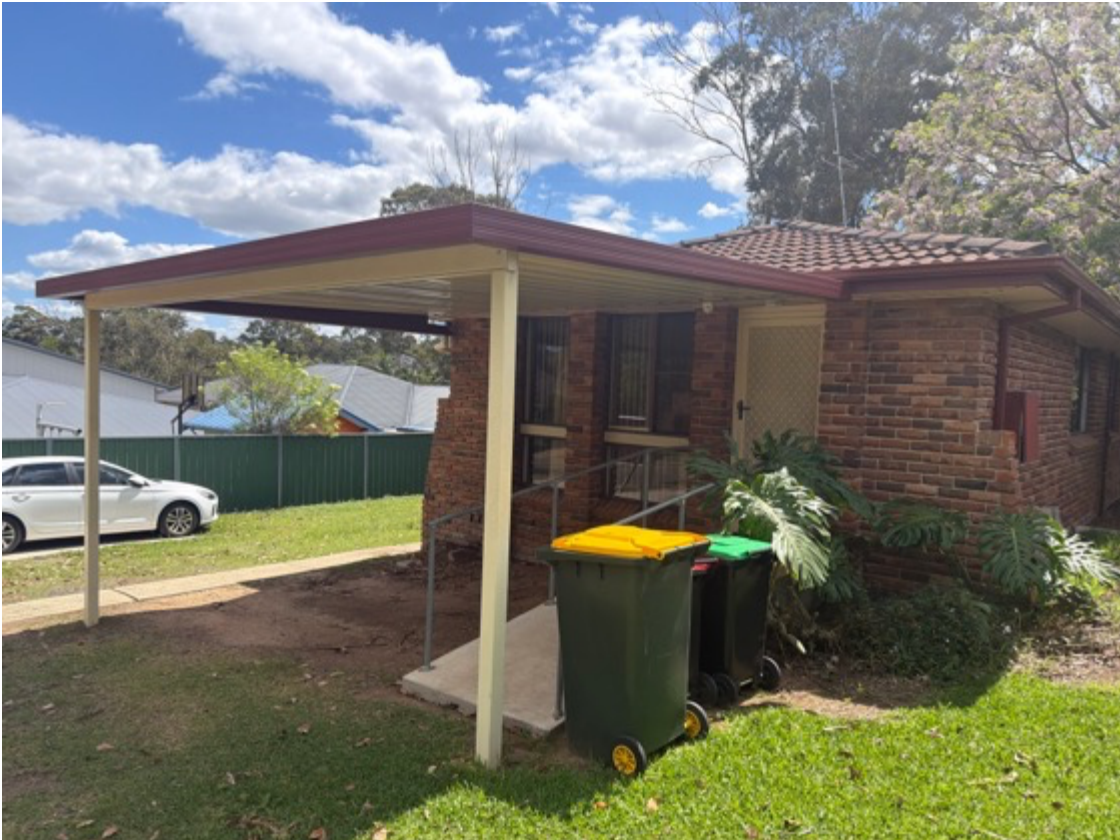
The carport checked is structurally sound.

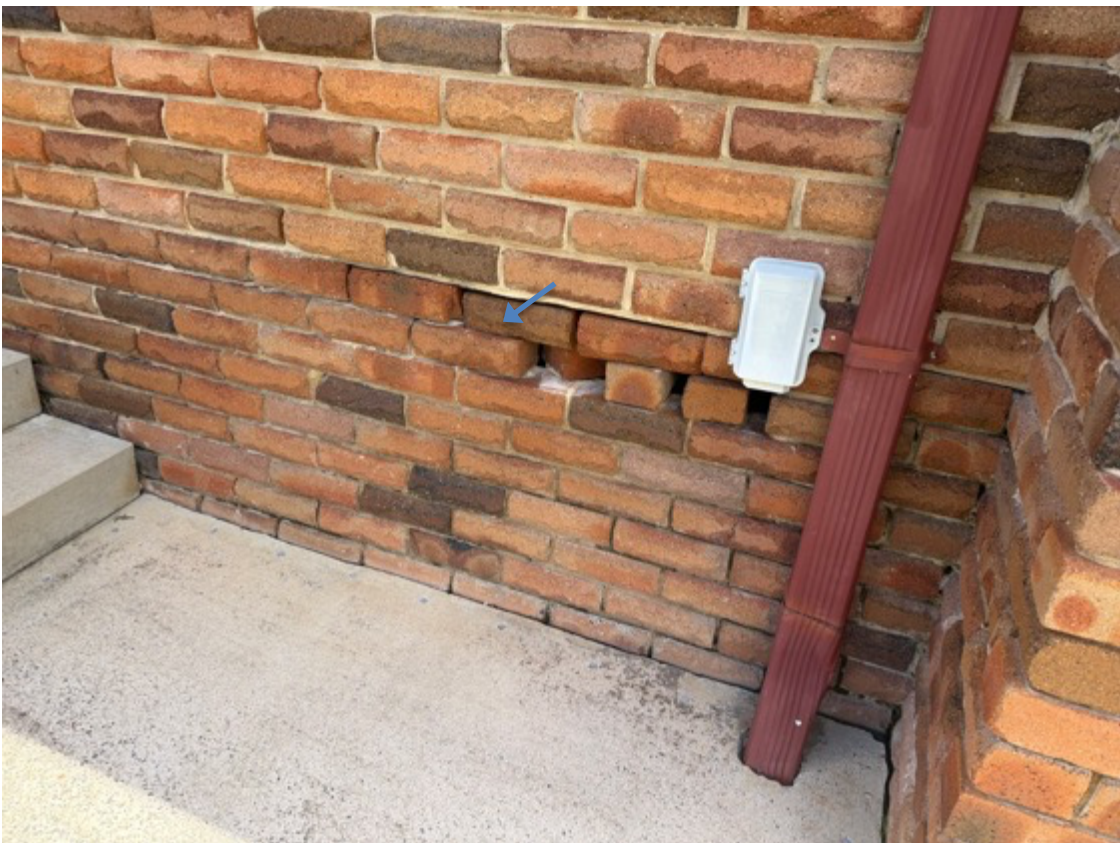
Sections of external brickwork displays salt attack and rising damp, front elevation example above.

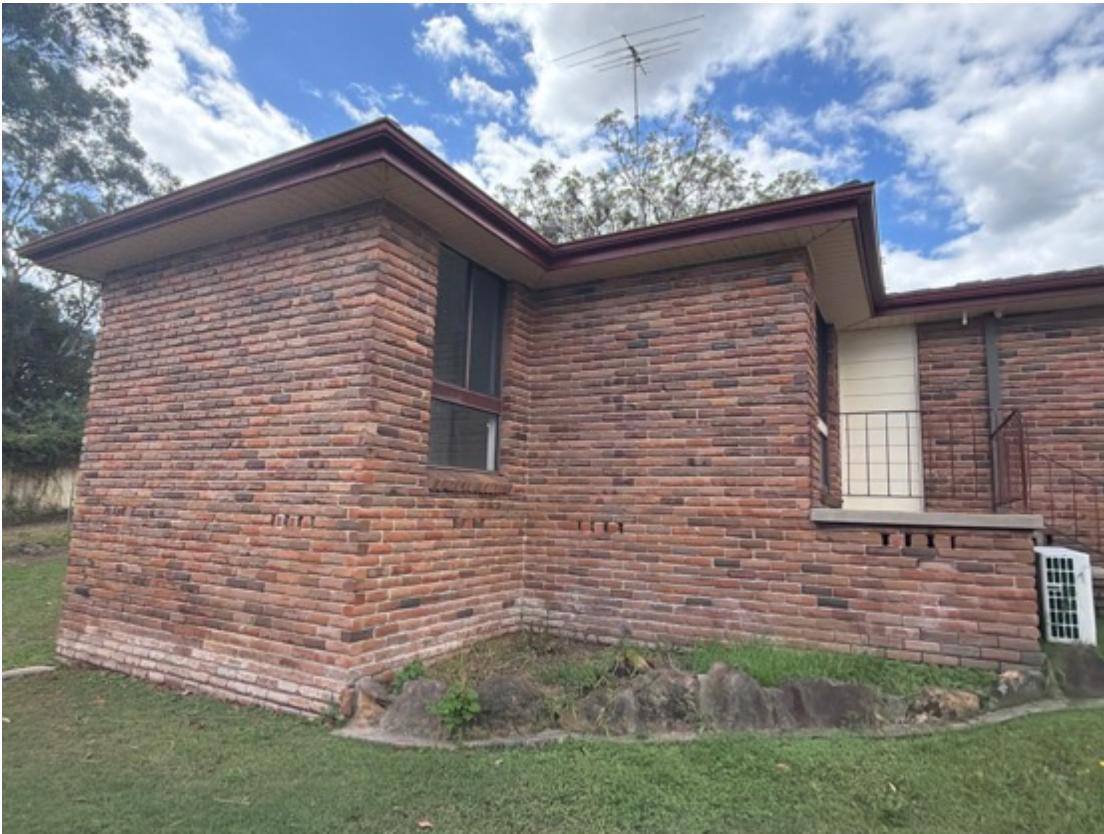
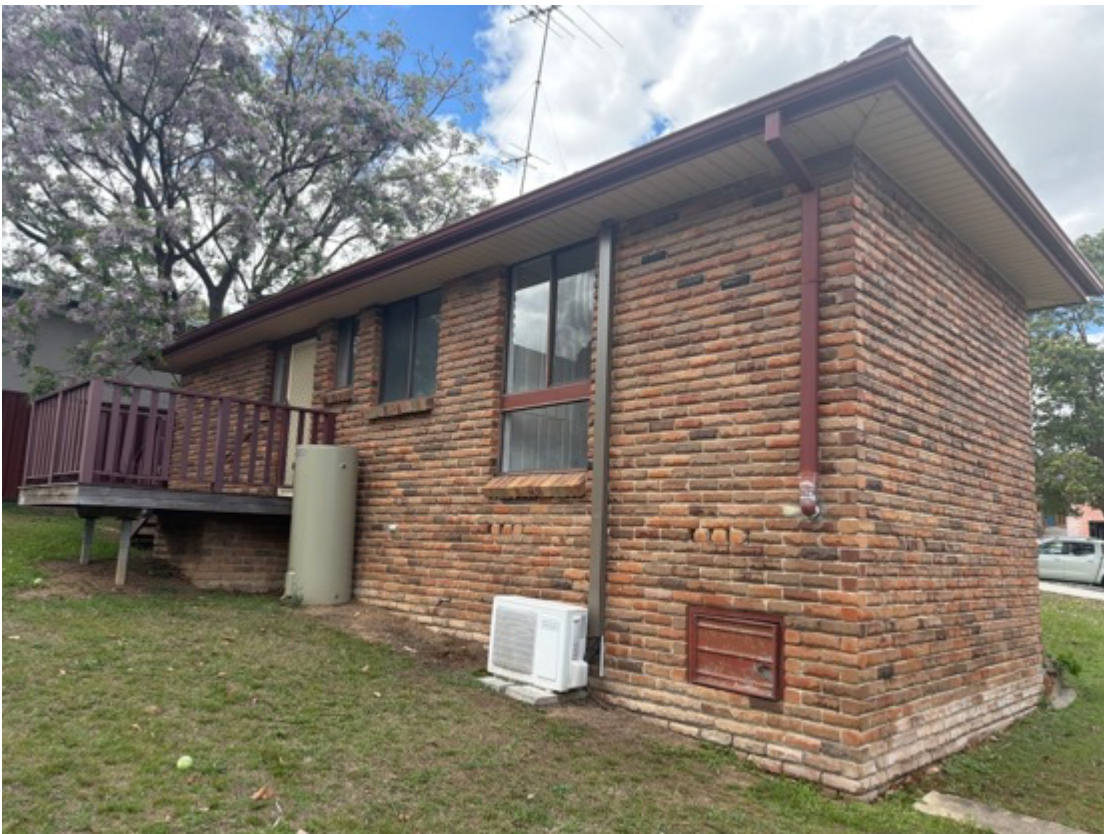
Exterior windows and doors present in serviceable condition for the age.

Rear elevation example above.

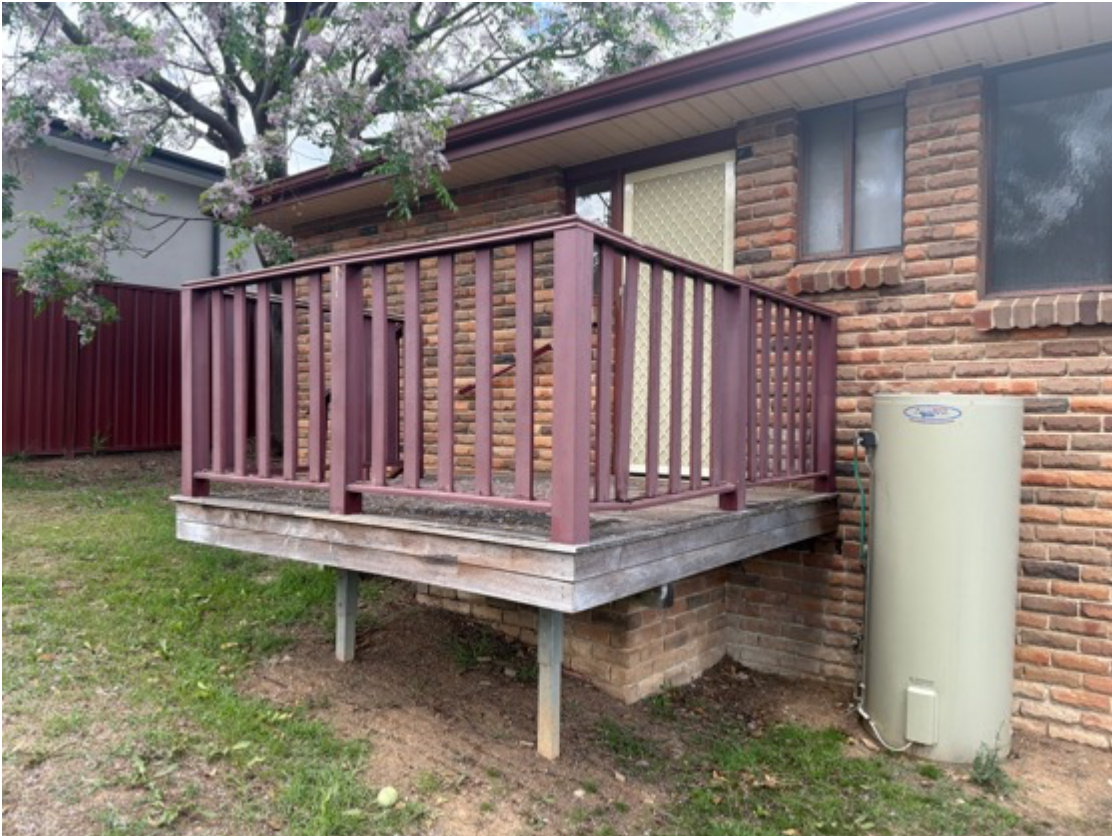
Exterior timber displays moderate to heavy signs of weathering - consistent with age.

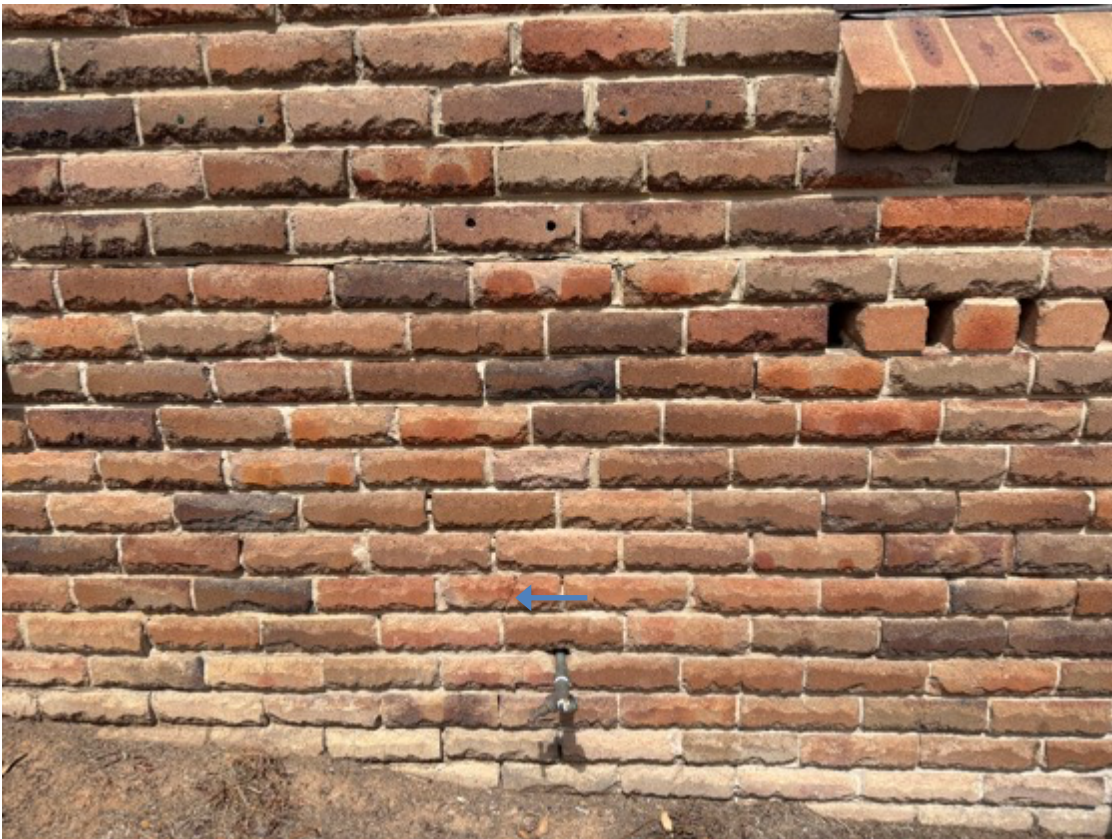
Isolated sections of external brickwork displays category one hairline cracking, rear elevation mid section example above.

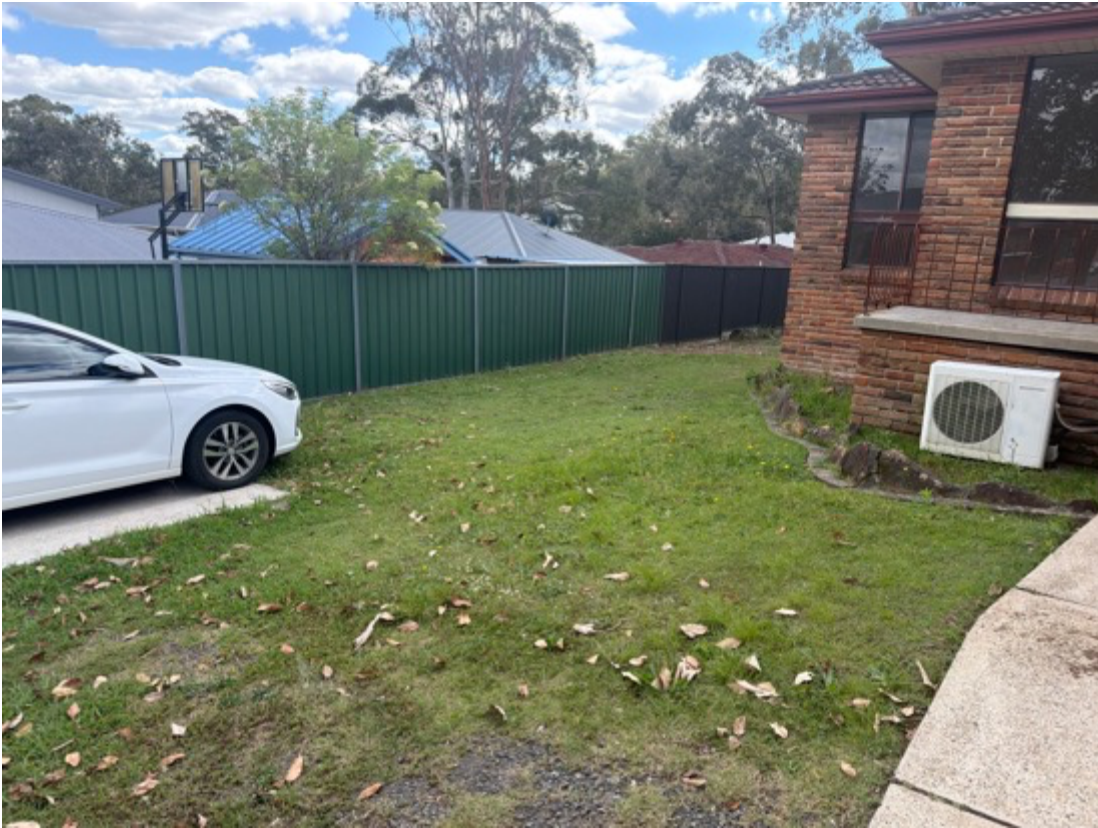
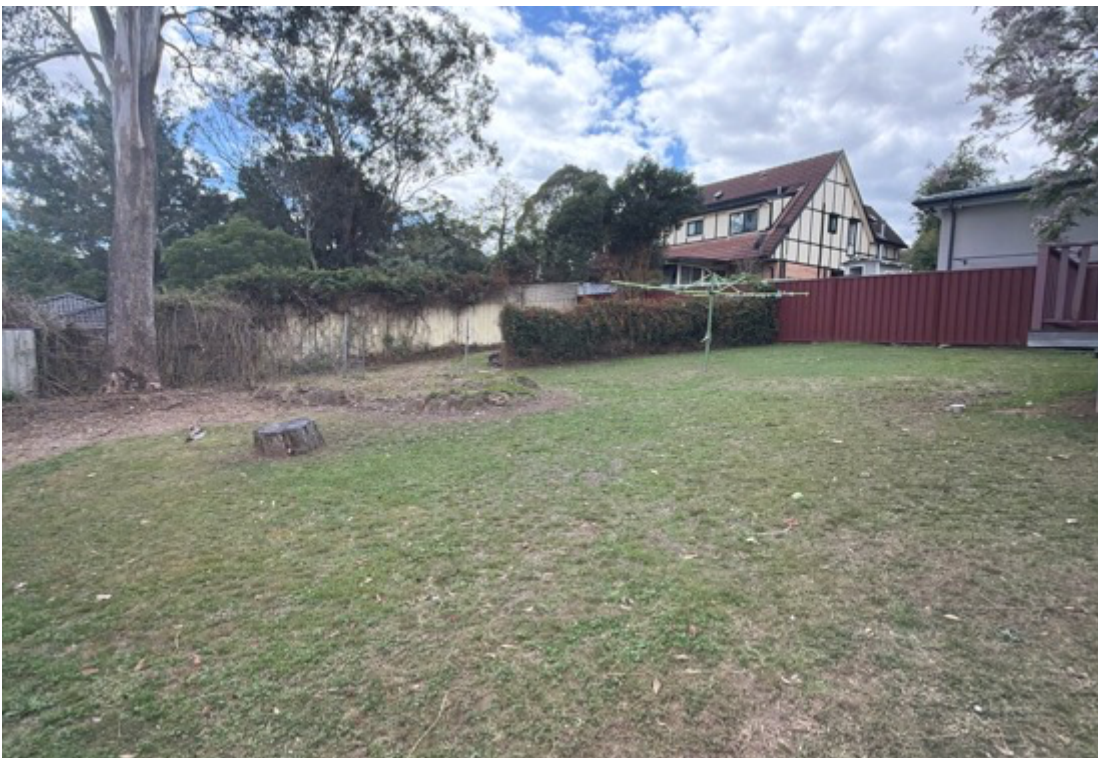
Site drainage / land overflow appears to function adequately with no signs of water laying at the time of inspection.

Rear yard example above.

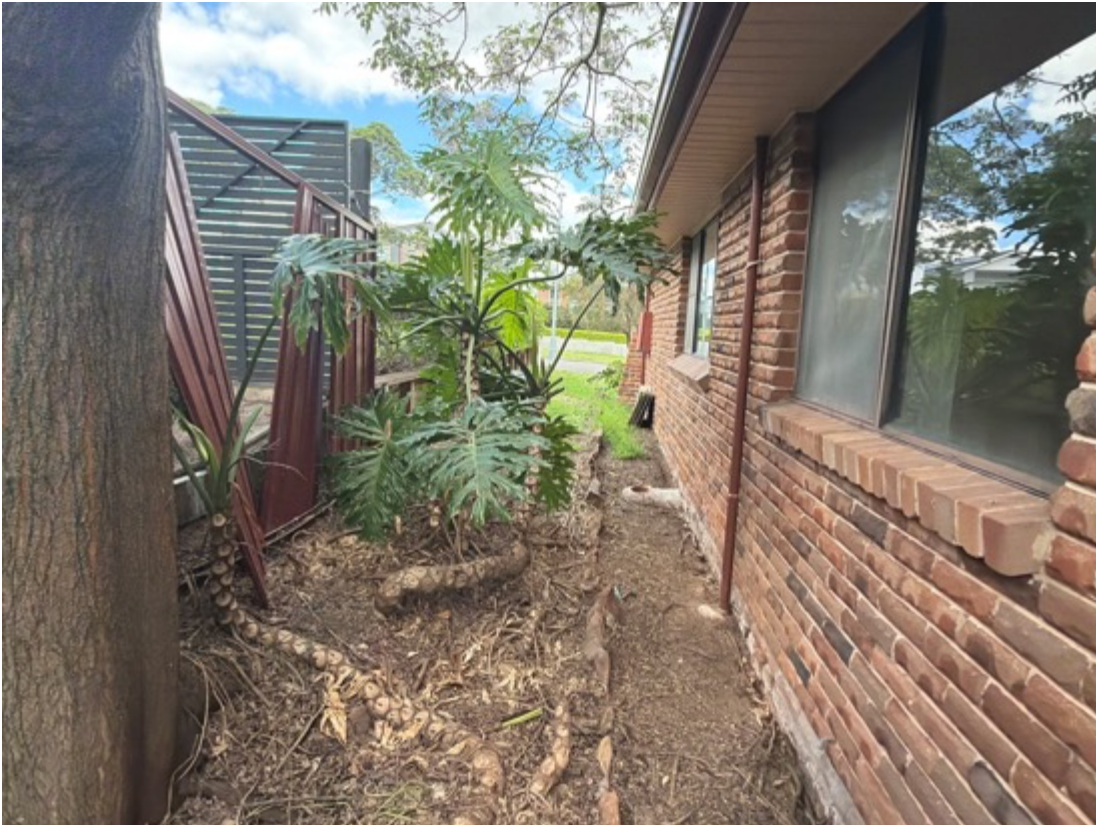
Site fences are in serviceable condition, isolated sections are dented and leaning, consistent with age, right side footpath example above.

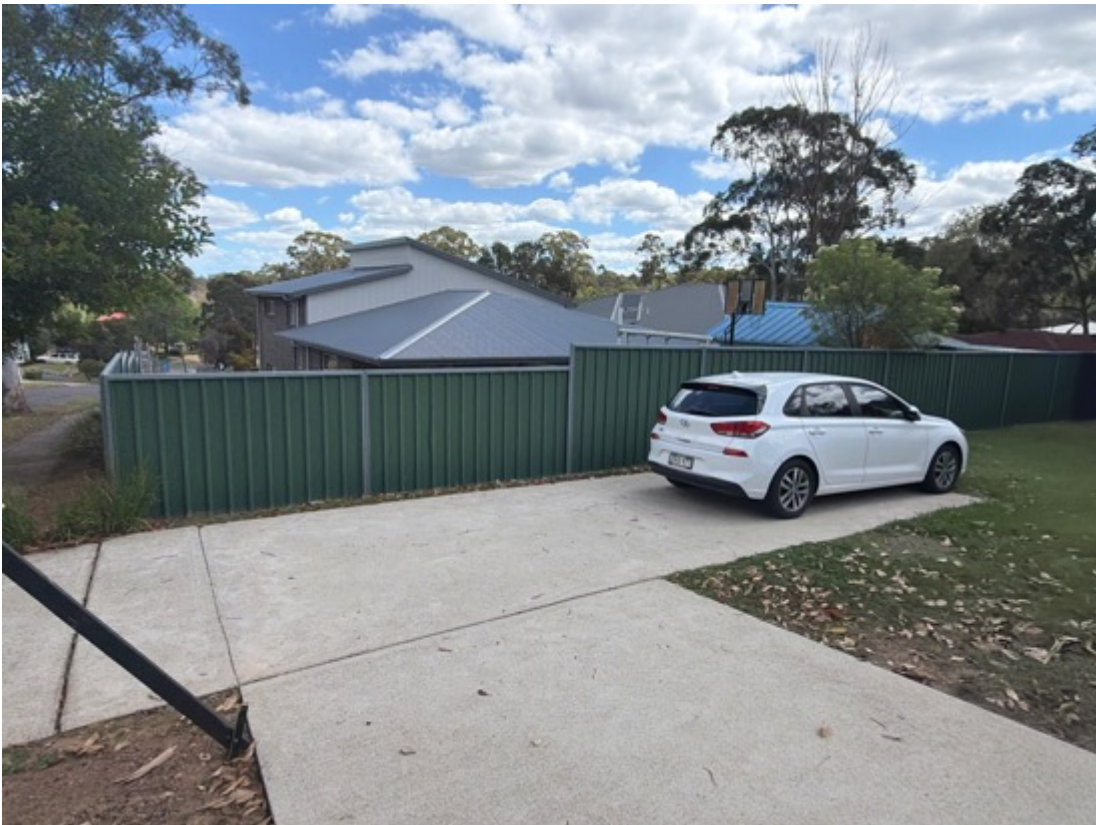
Exterior concrete presents in satisfactory condition for the age - isolated sections are cracked and undulating (consistent with age.)

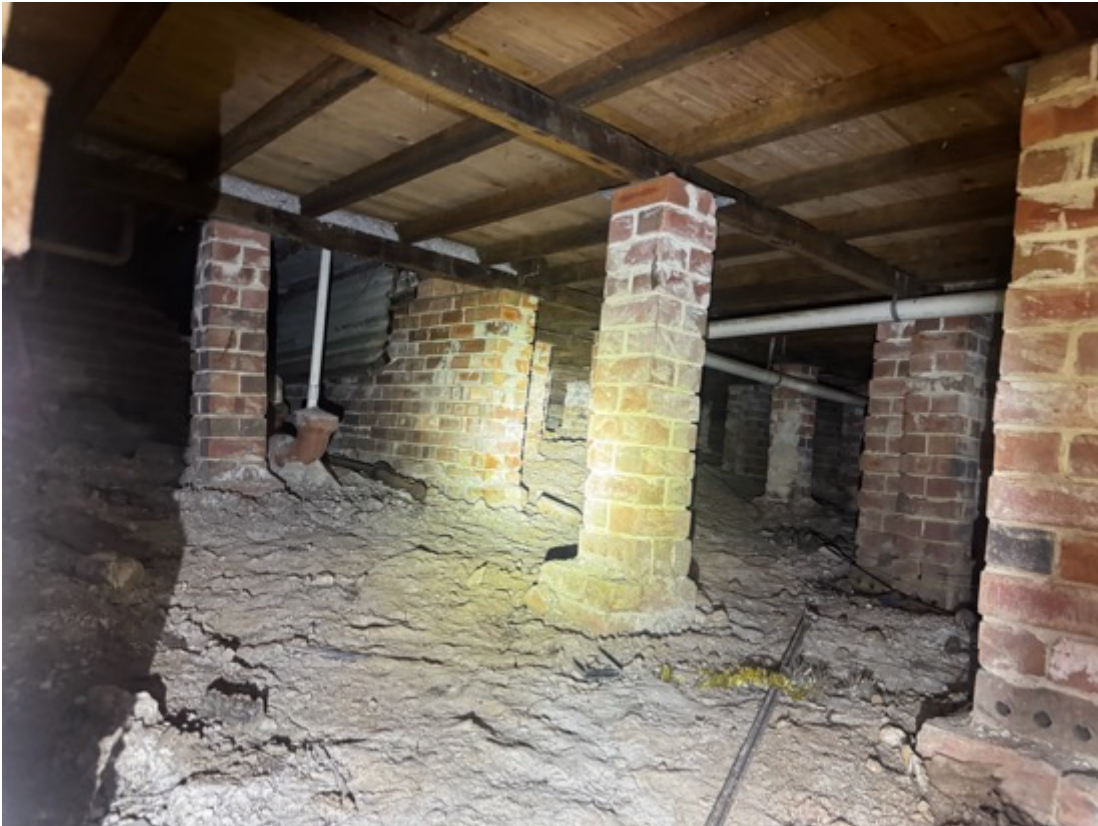
Extensive termite damage is evident - refer to pest report.

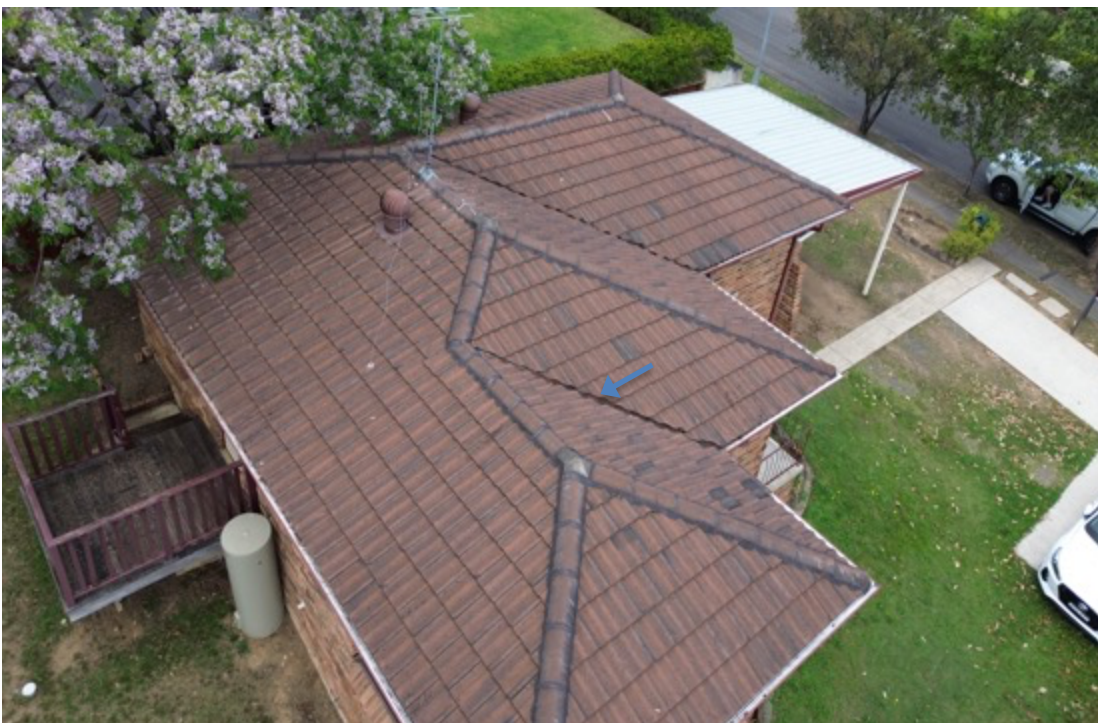
Sections of roof tiles are chipped and valleys display surface rust.

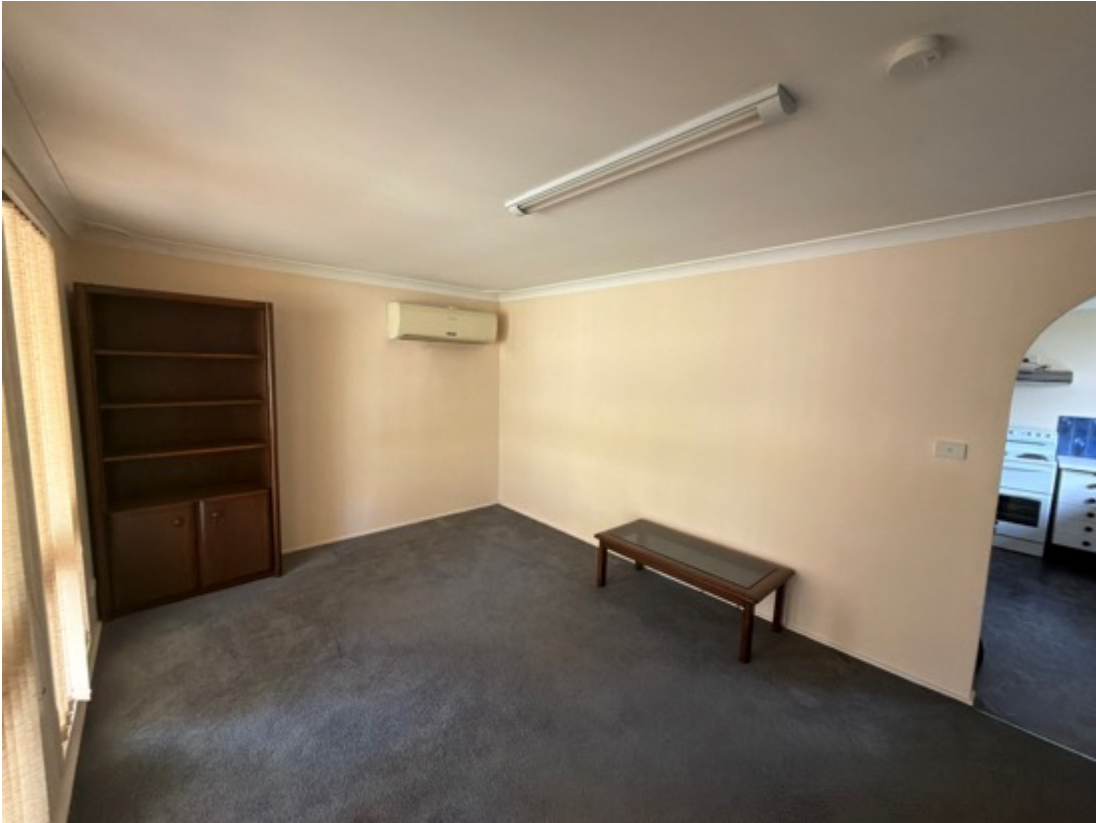
Interior walls and ceilings require painting.

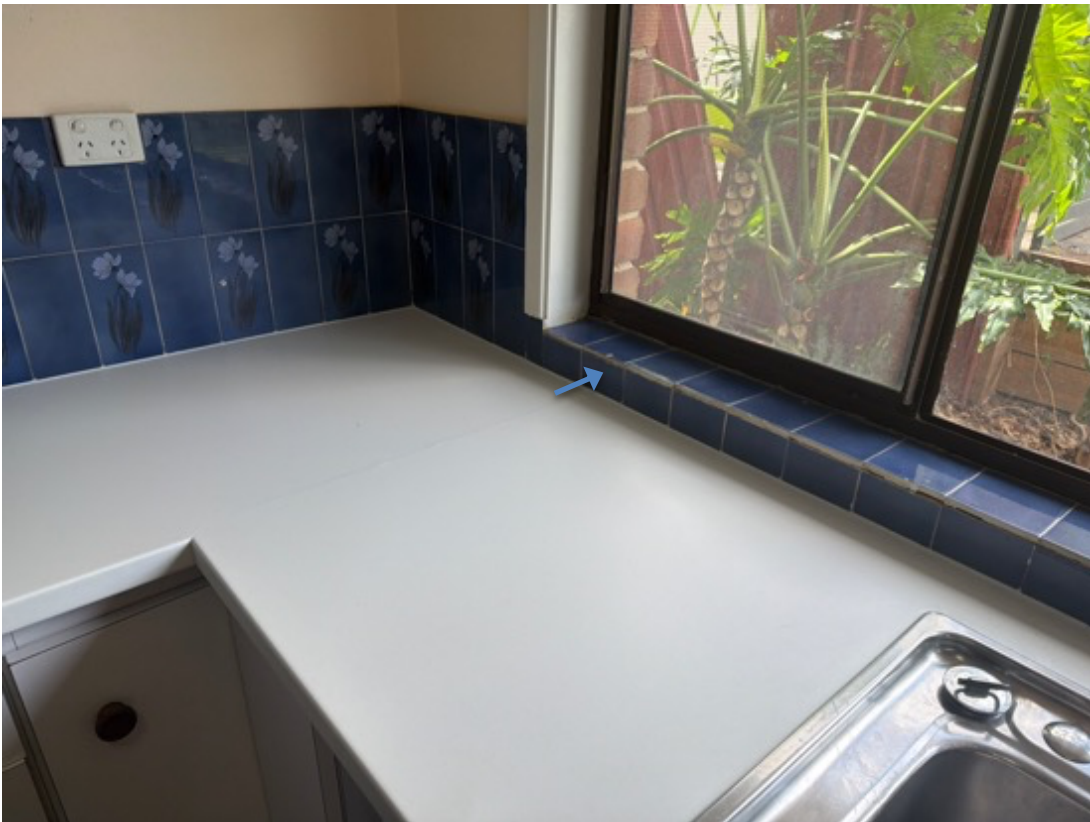
Sections of kitchen tiles are cracked and chipped, consistent with age.

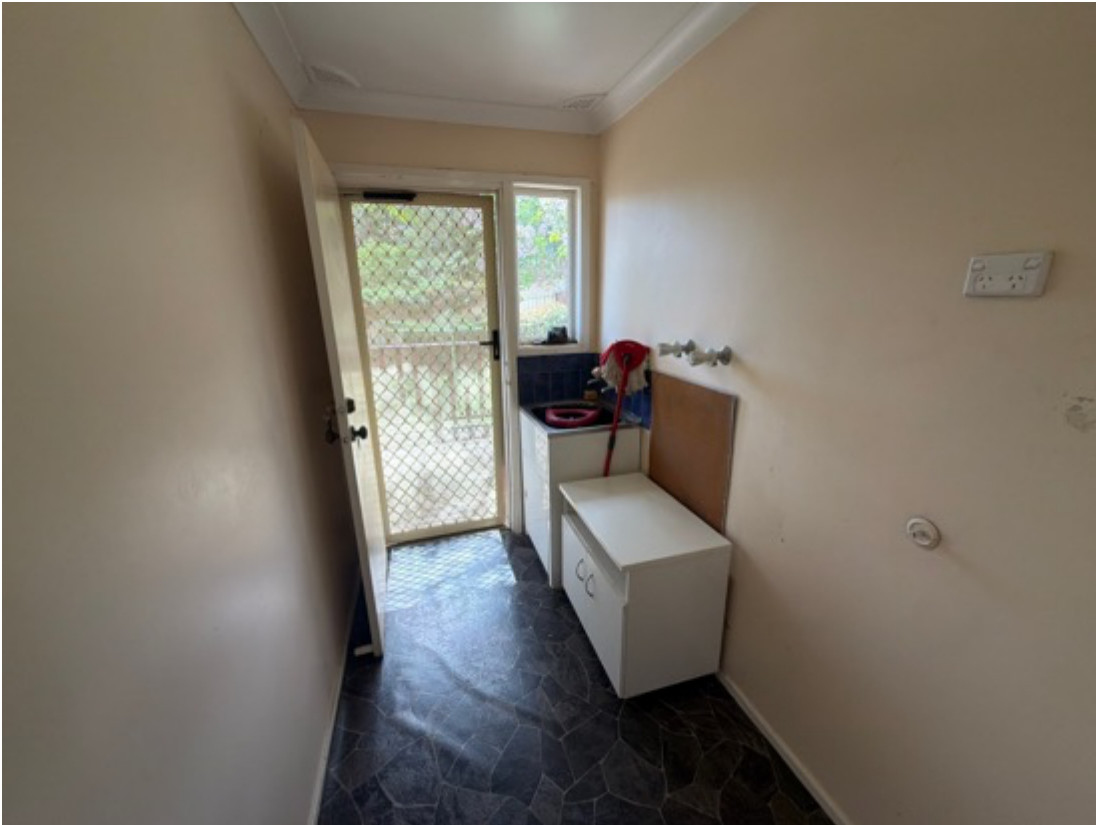
The laundry walls display signs of pest damage, refer to pest report.

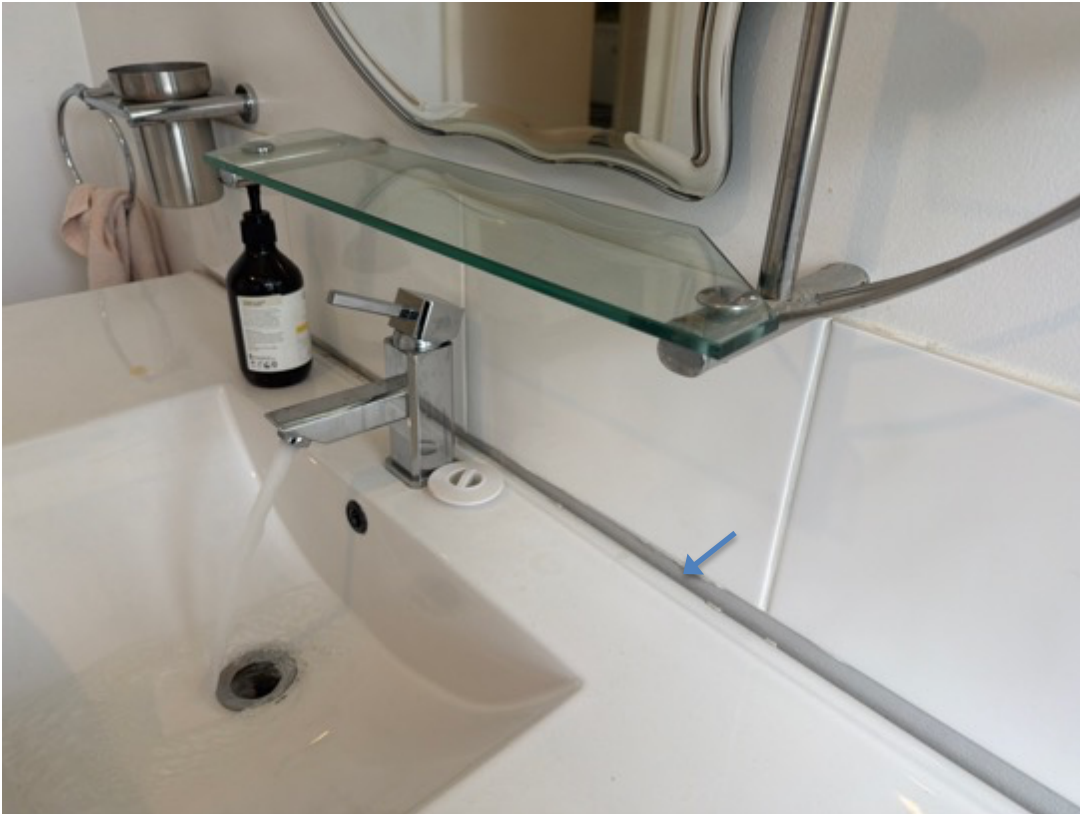
The vanity has separation away from splashback tiles.

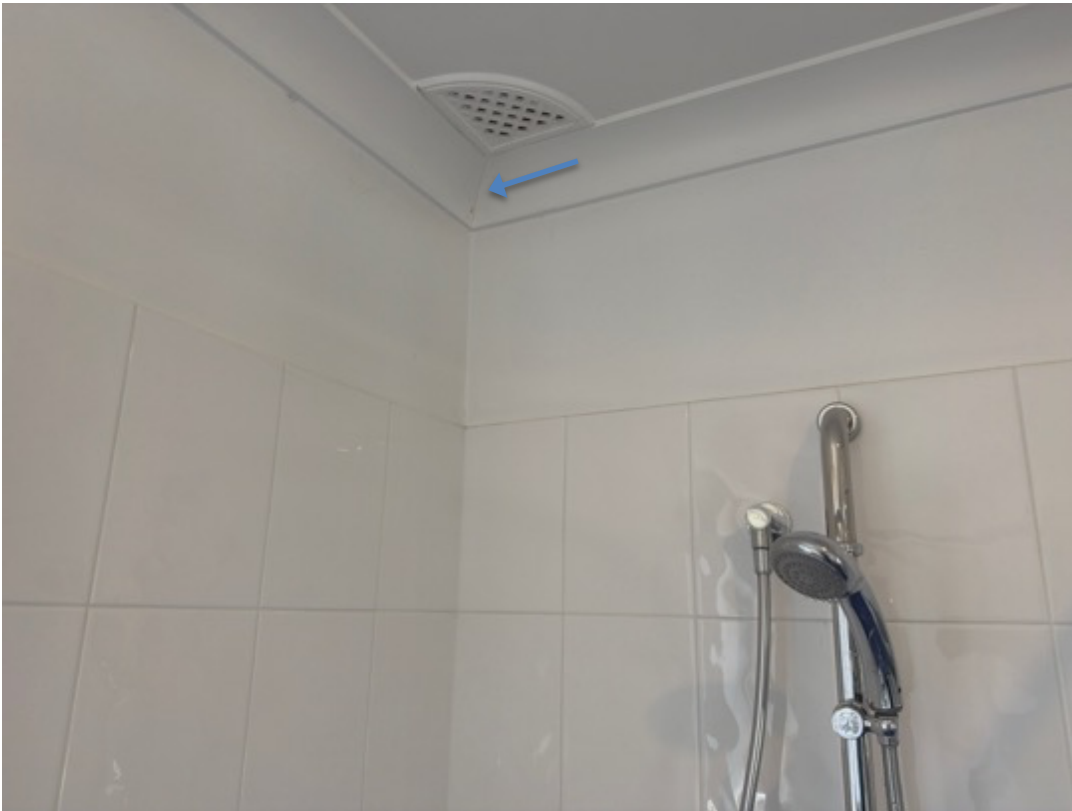
Sections of internal plasterboard and cornices display hairline cracking, example above the bathroom shower.

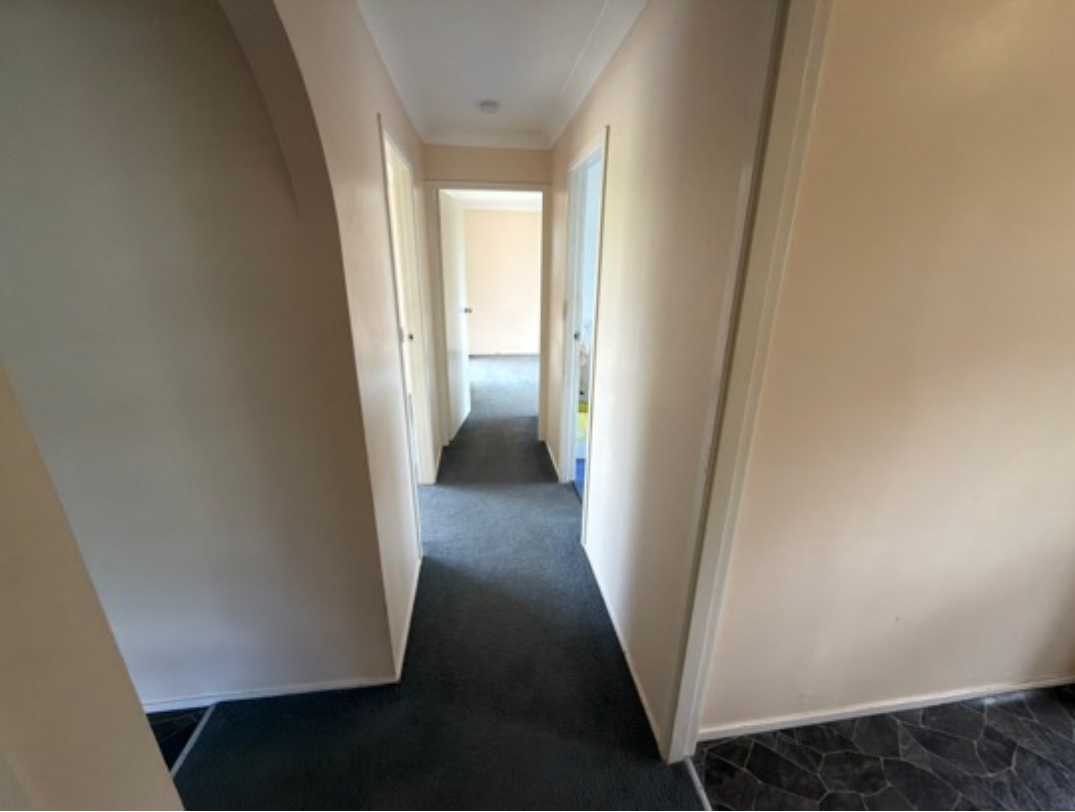
Bedroom floors and doorways are termite affected.

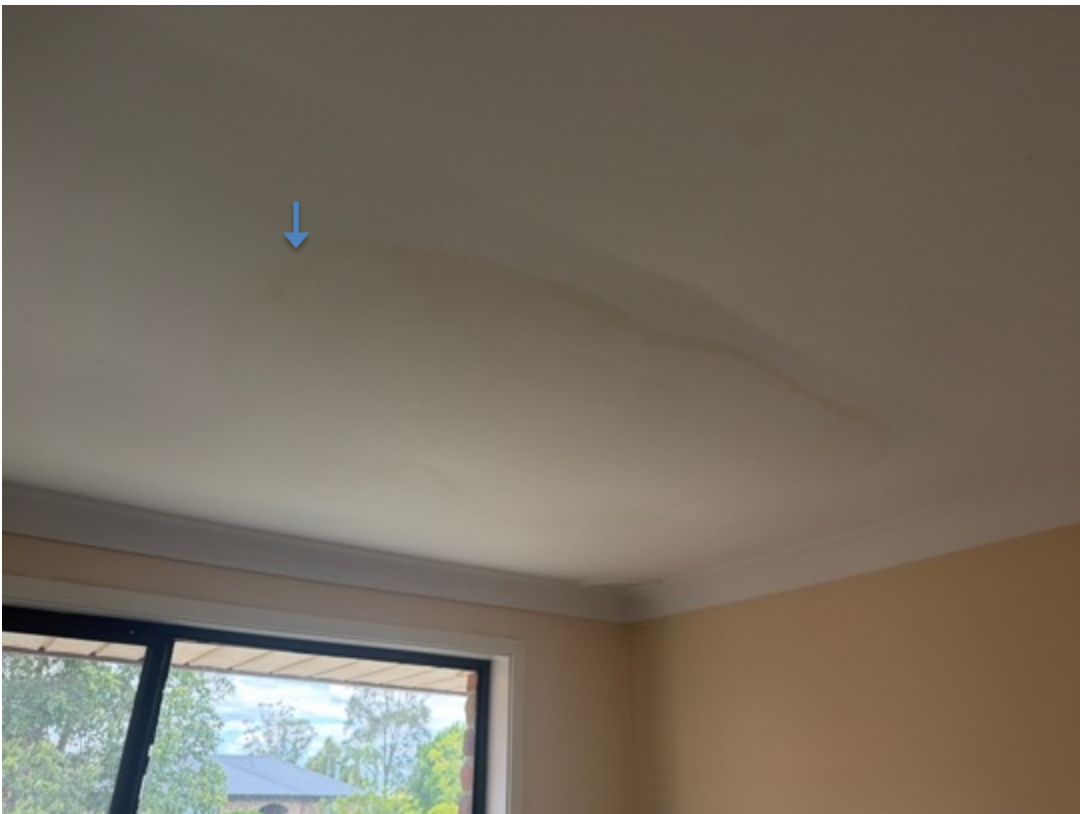
The front facing bedroom ceiling is water stained here.

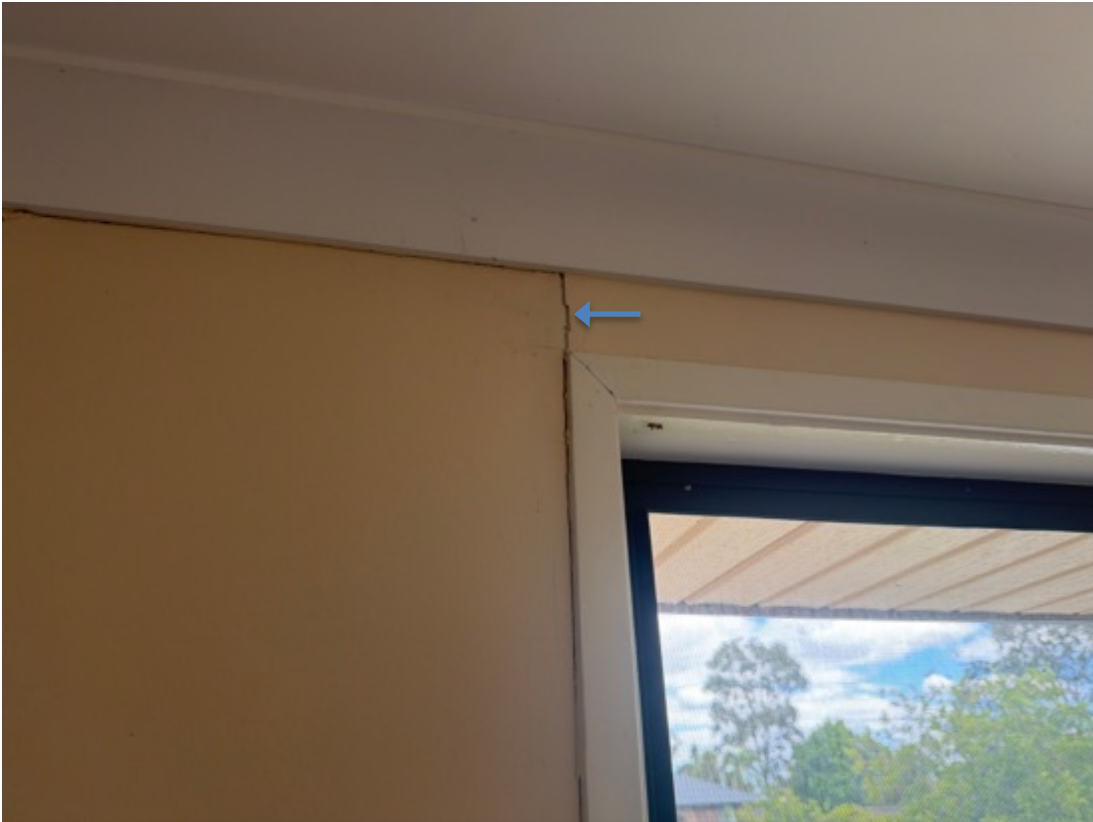
Bedroom plasterboard and cornices display cracking, front mid section bedroom example above.
