# **PRE-PURCHASE PROPERTY INSPECTION BUILDING REPORT**

**Visual Pre-Purchase Building Inspection Report.**

| <b>Inspection address:</b> | 14 Sherridon Crescent Quakers Hill. |
| <b>Inspection Date:</b> | <u>Date: 12.3.26 Arrival time: 2:00pm - Departure time: 3:30pm.</u> |

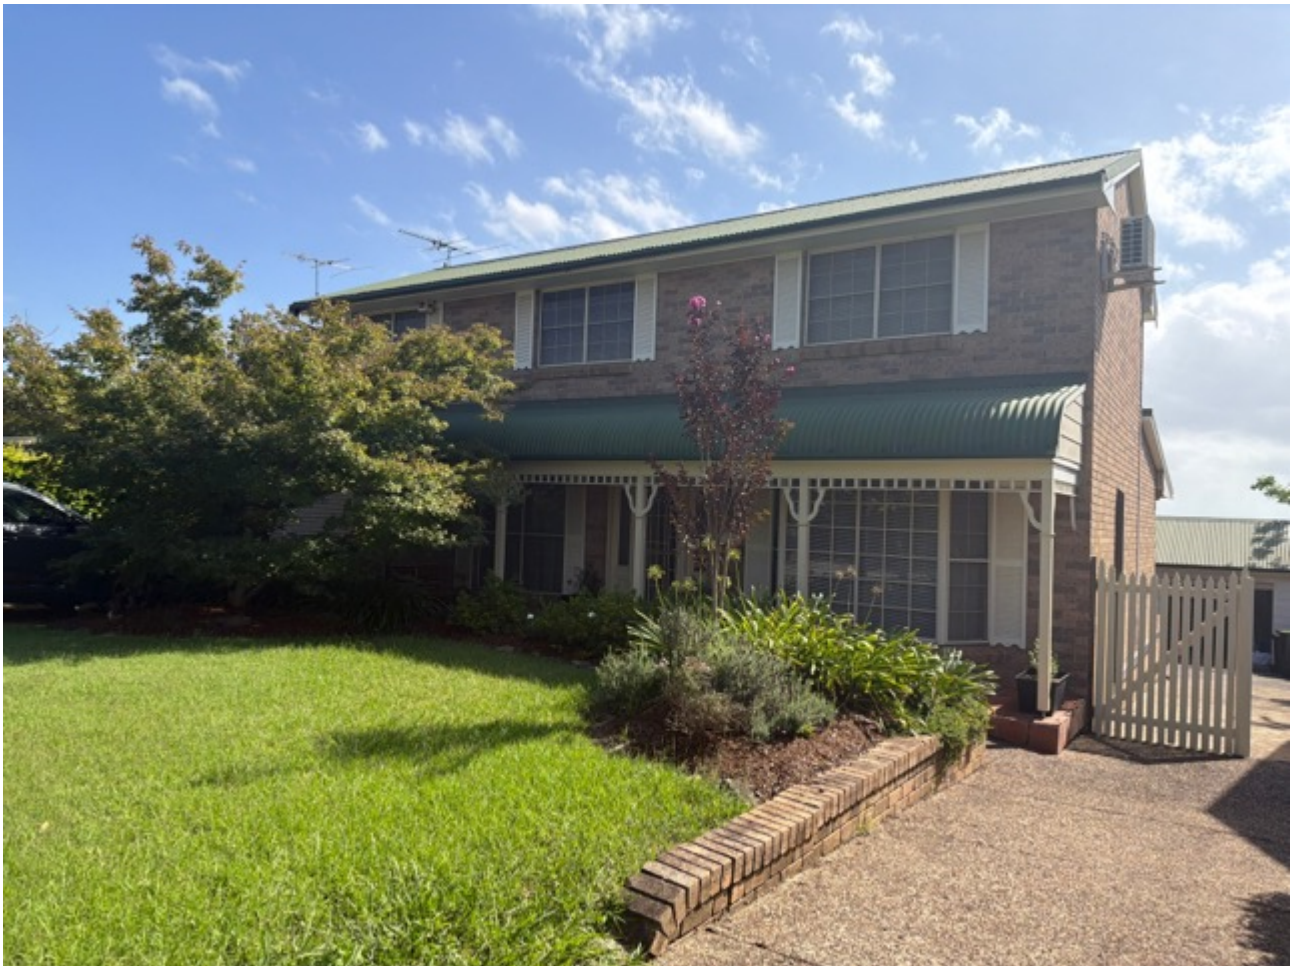
**14 SHERRIDON CRESCENT QUAKERS HILL.**

Front elevation of the Inspected property inspected.

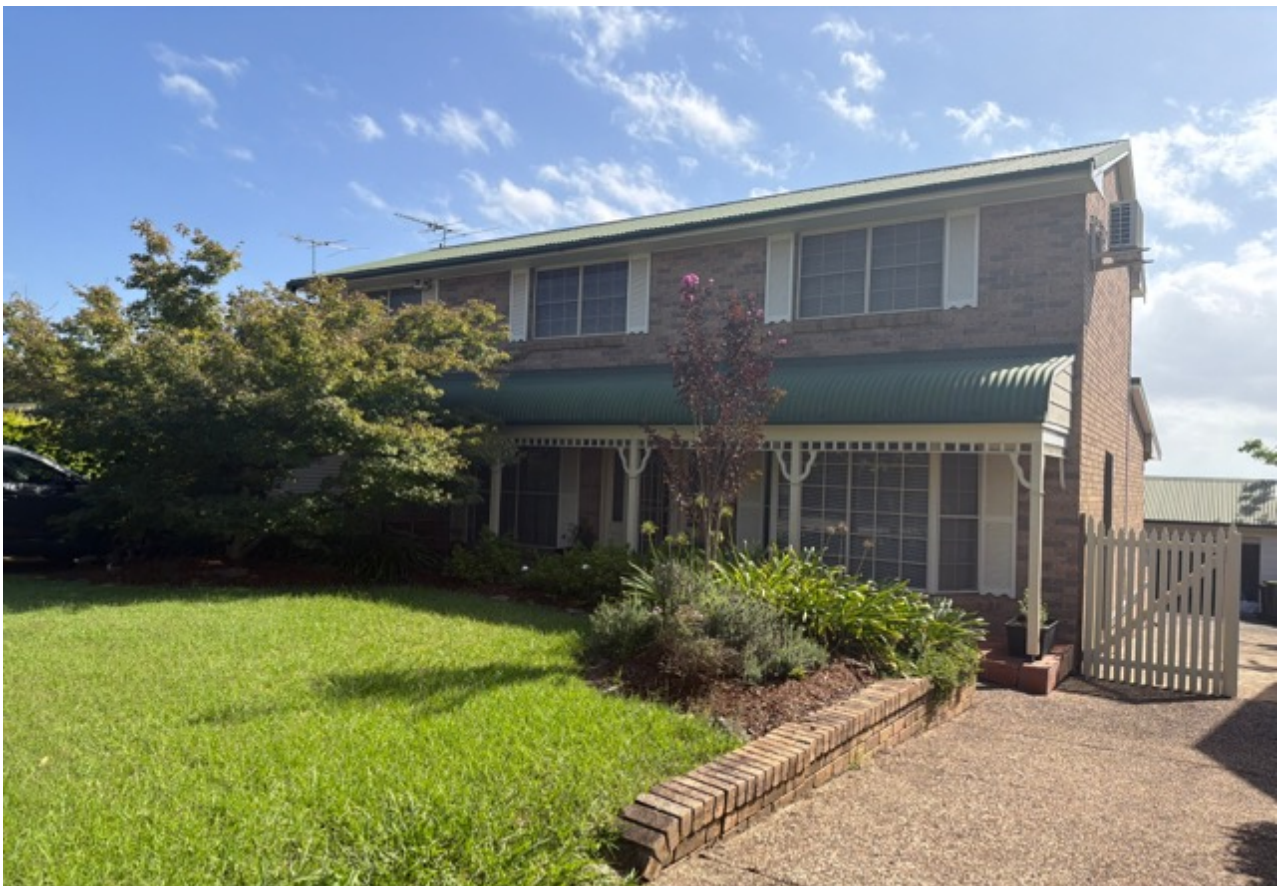
The exterior of the house presents in satisfactory condition displaying no major structural issues at the time of inspection.

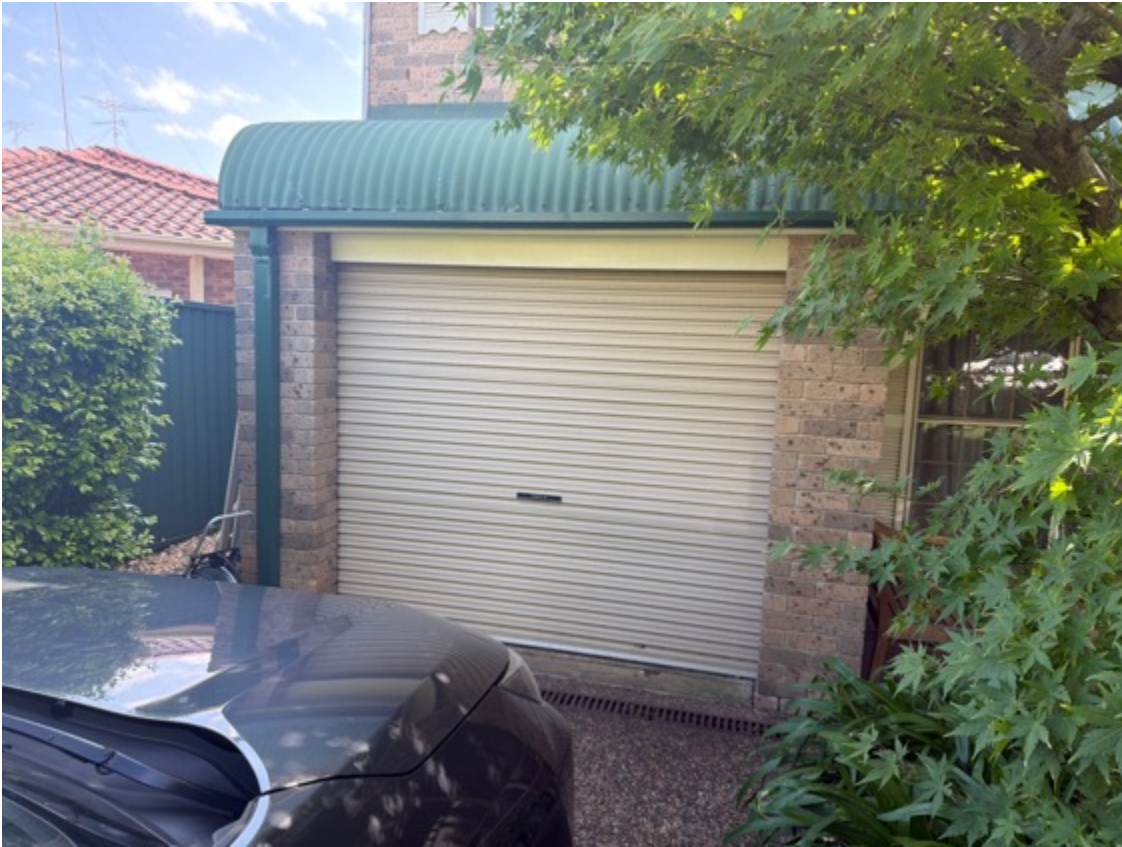
The garage roller door tested, functioned at the time of inspection (manual function.)

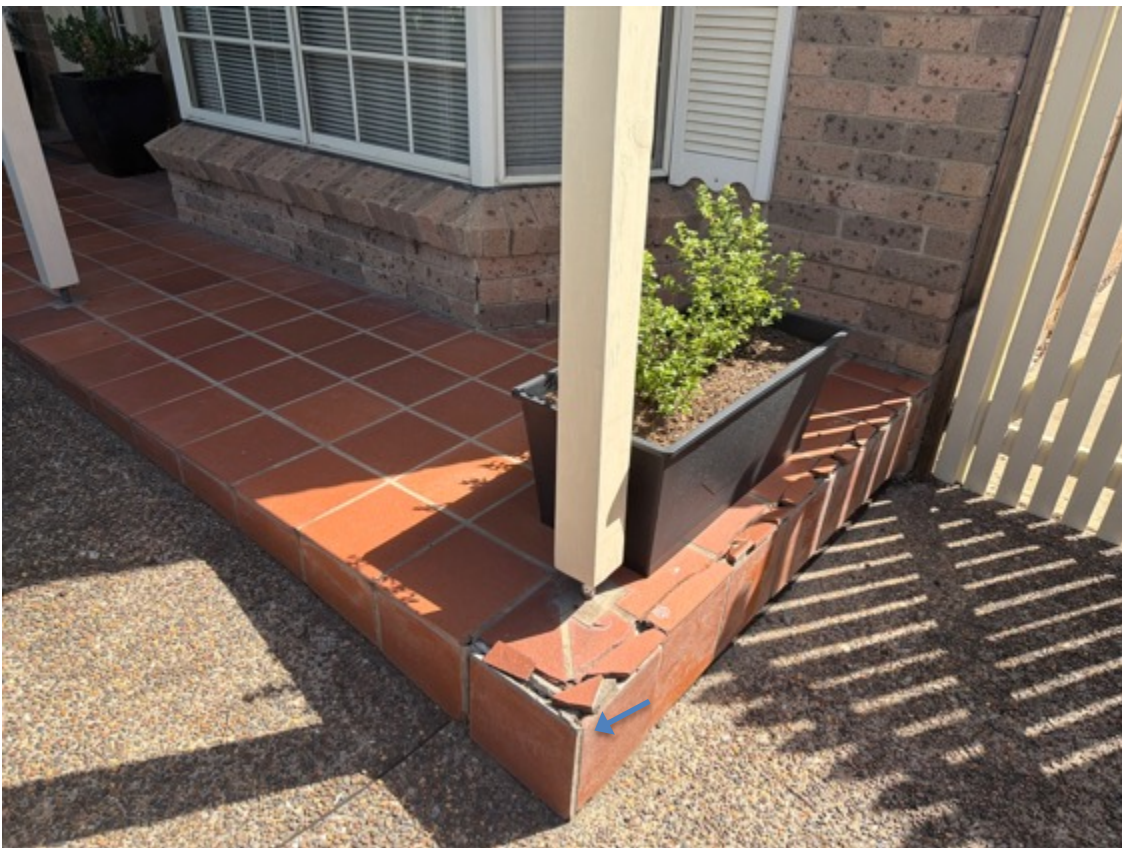
Isolated sections of external tiles are cracked, consistent with age.

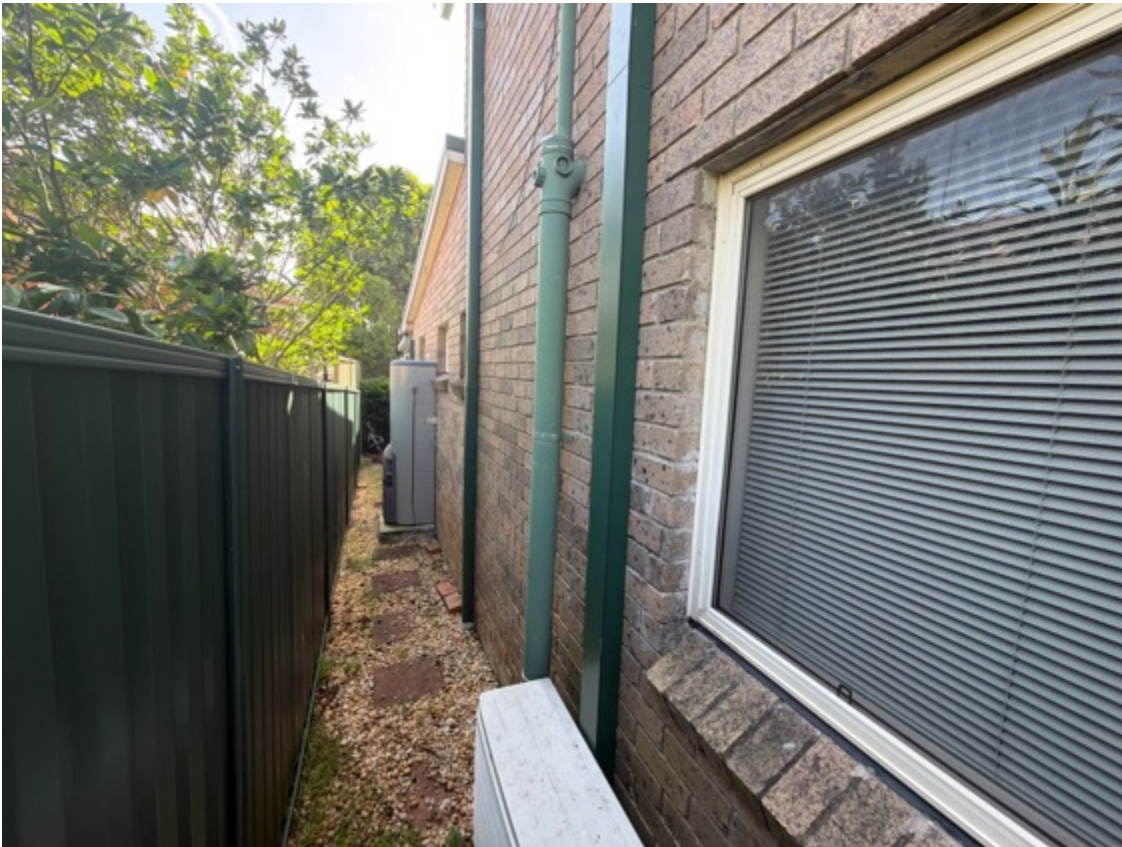
Exterior windows and doors present in satisfactory condition for the age.

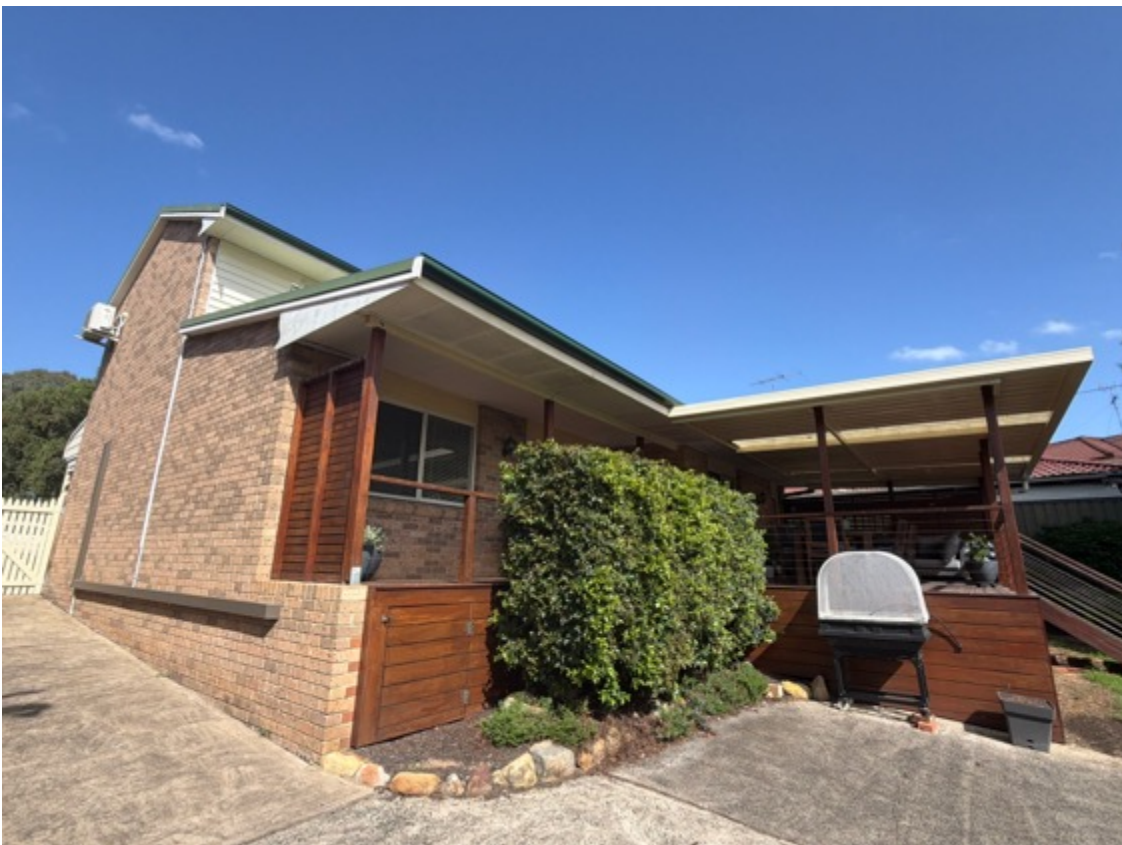
Rear elevation example above.

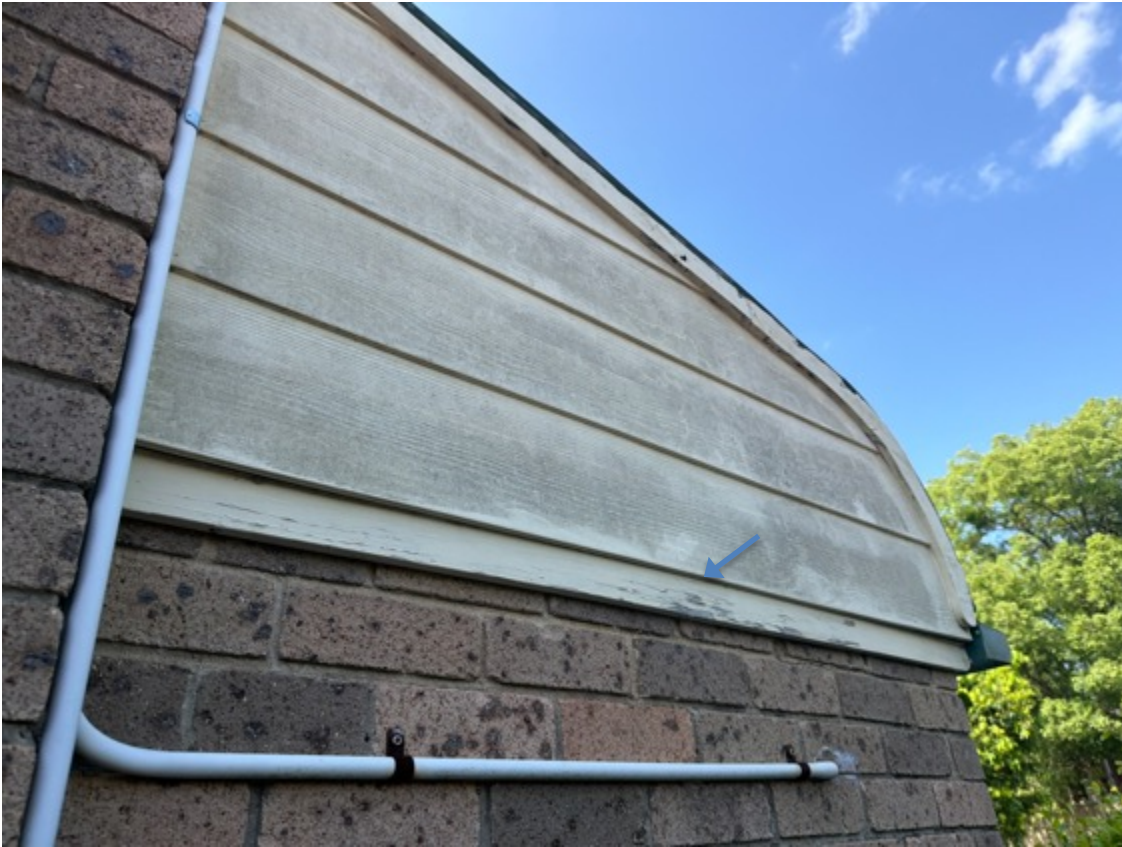
Exterior timber displays moderate level weathering - consistent with age.

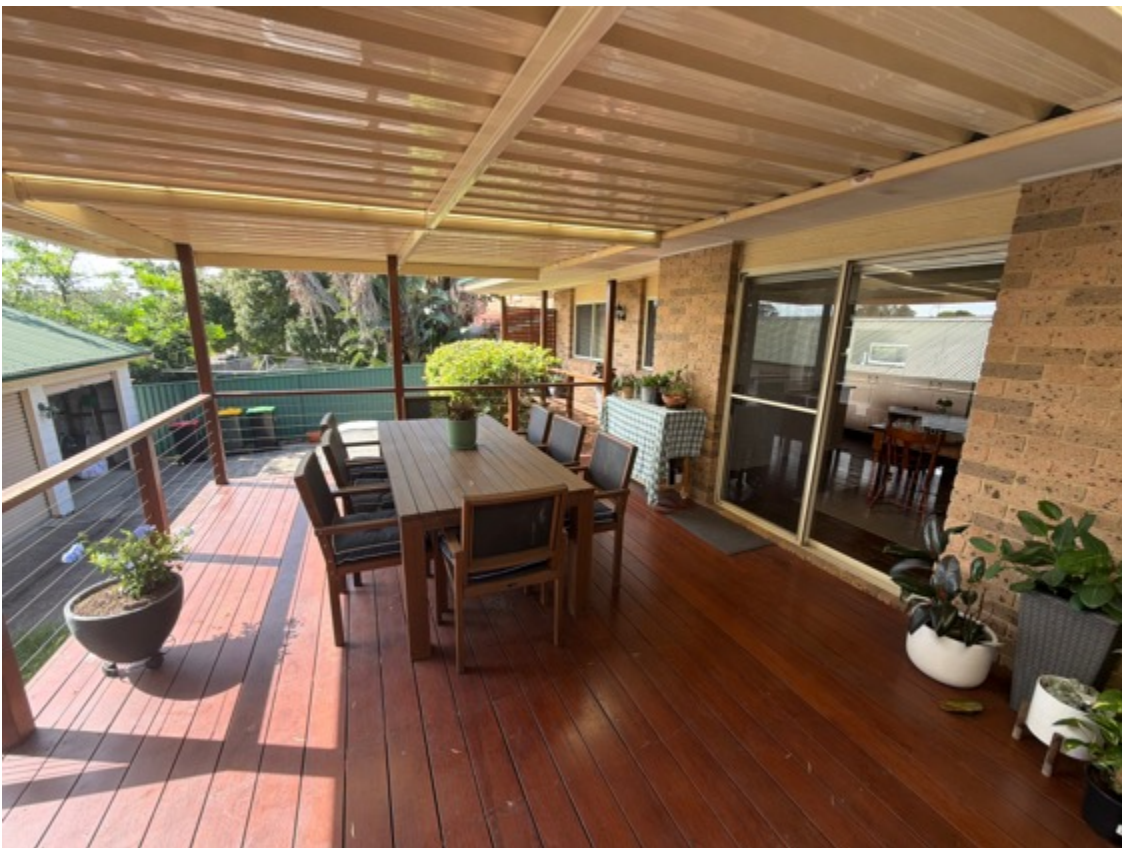
The rear pergola checked is structurally sound.

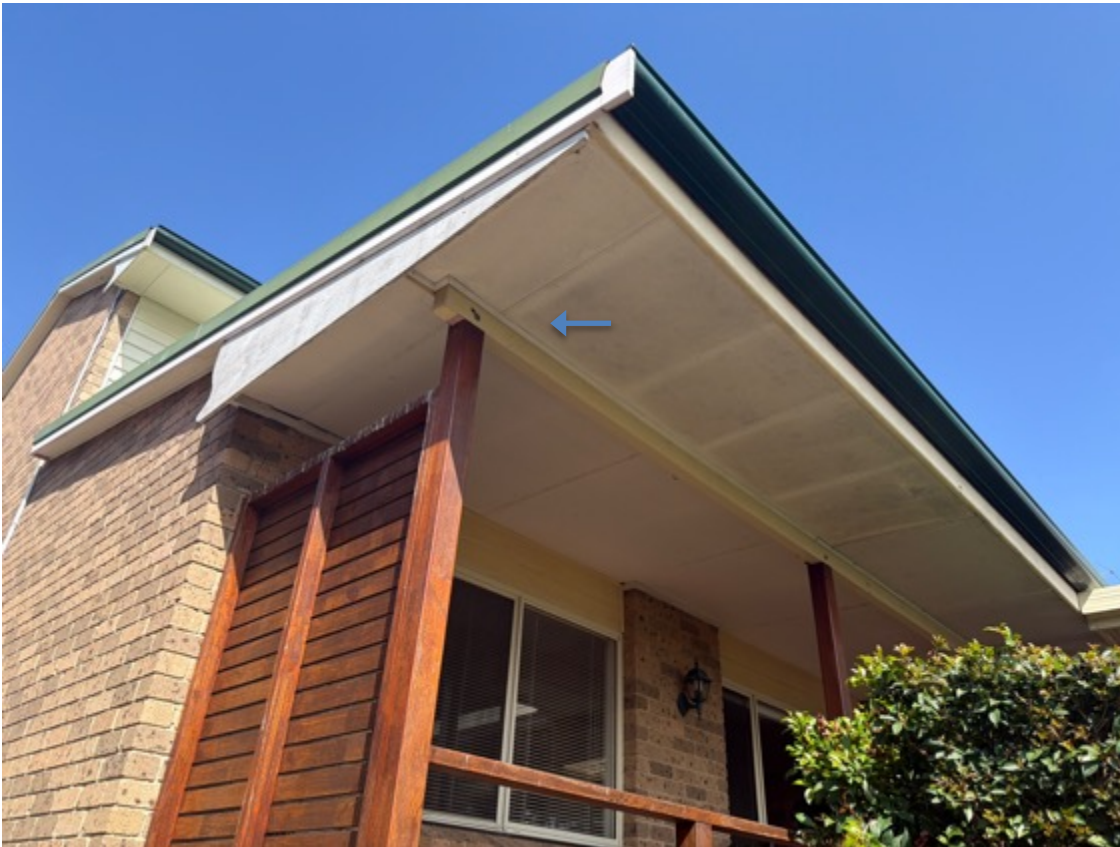
External surfaces are moderately paint blemished, consistent with age.

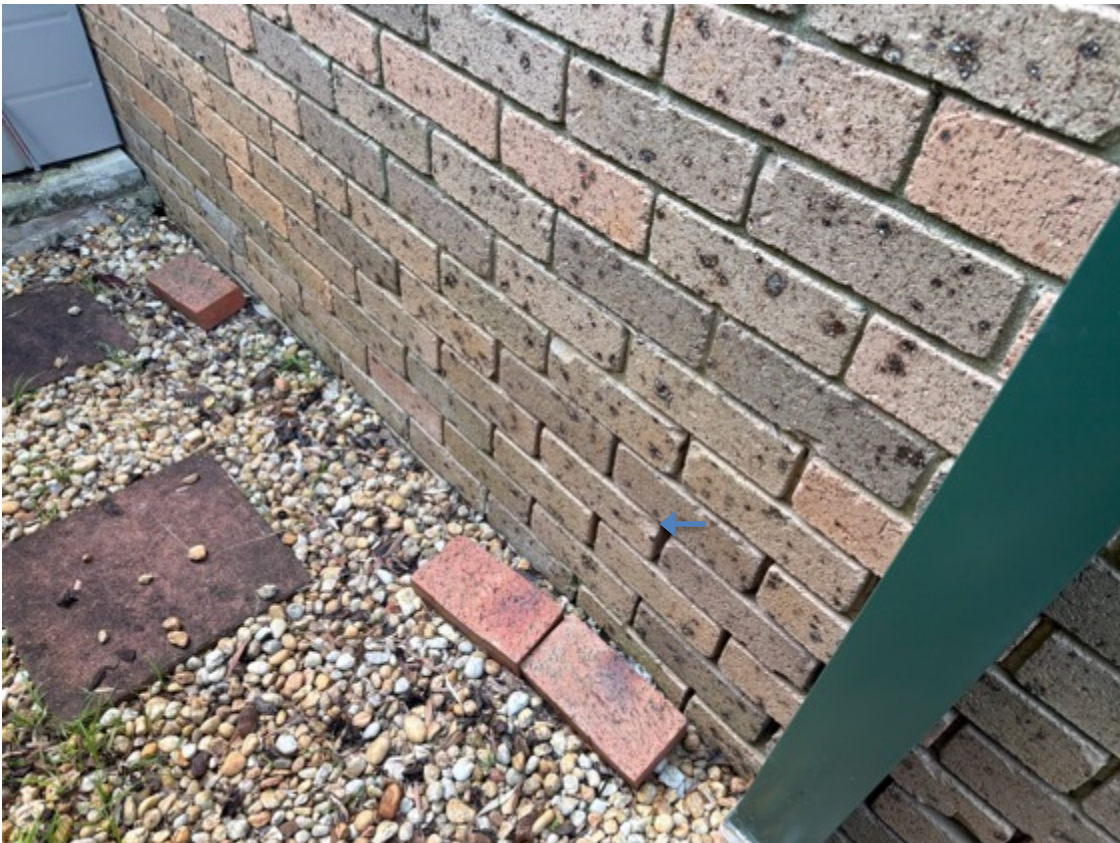
Left side elevation mortar is crumbling, remedial works are required.

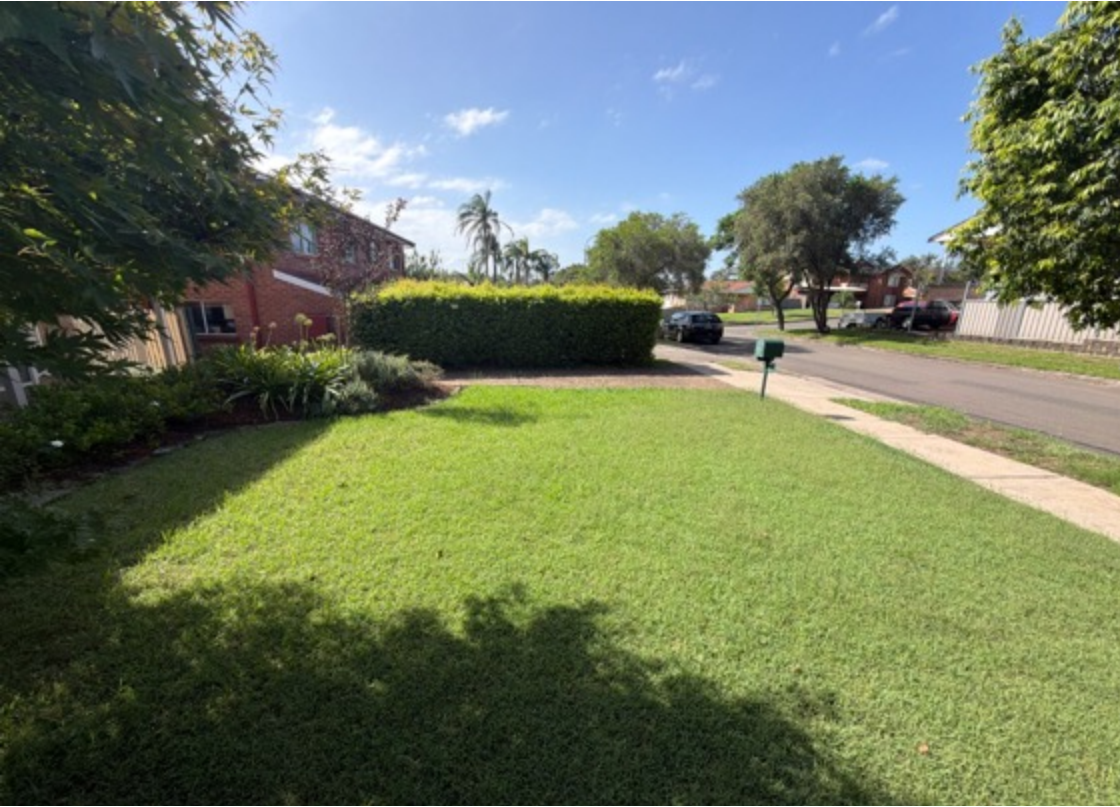
Site drainage / land overflow appears to function adequately with no signs of water laying at the time of inspection.

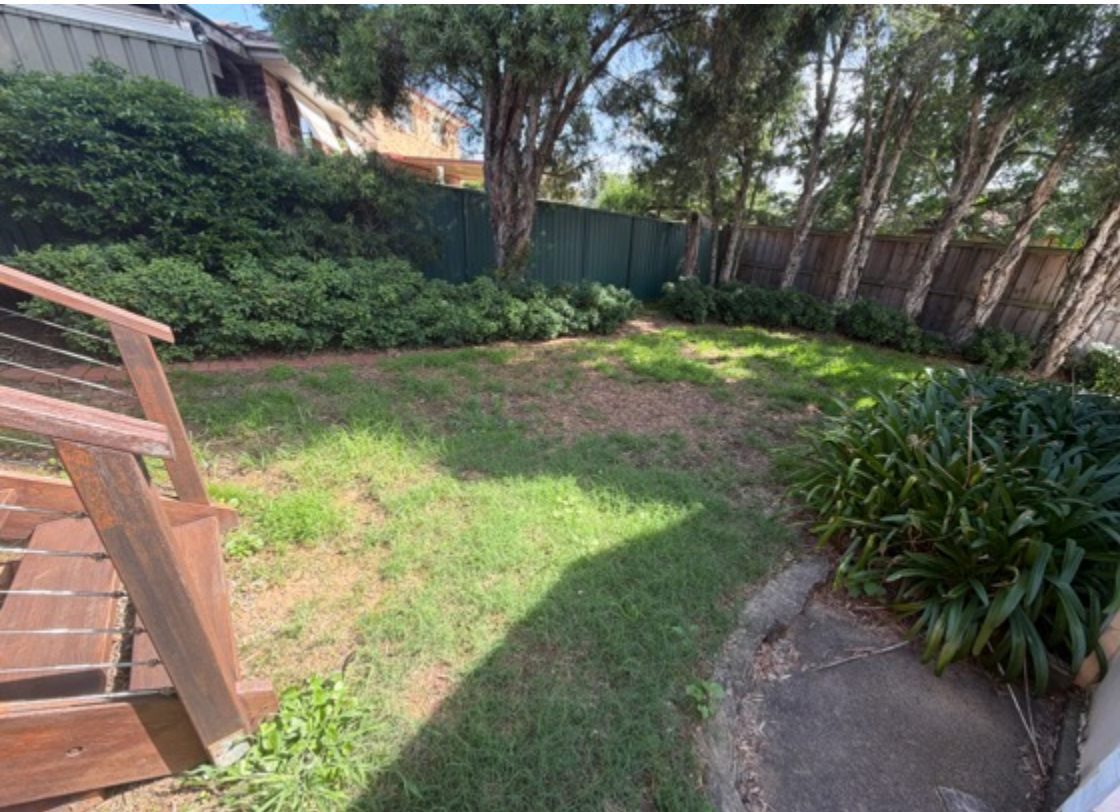
Rear yard example above.

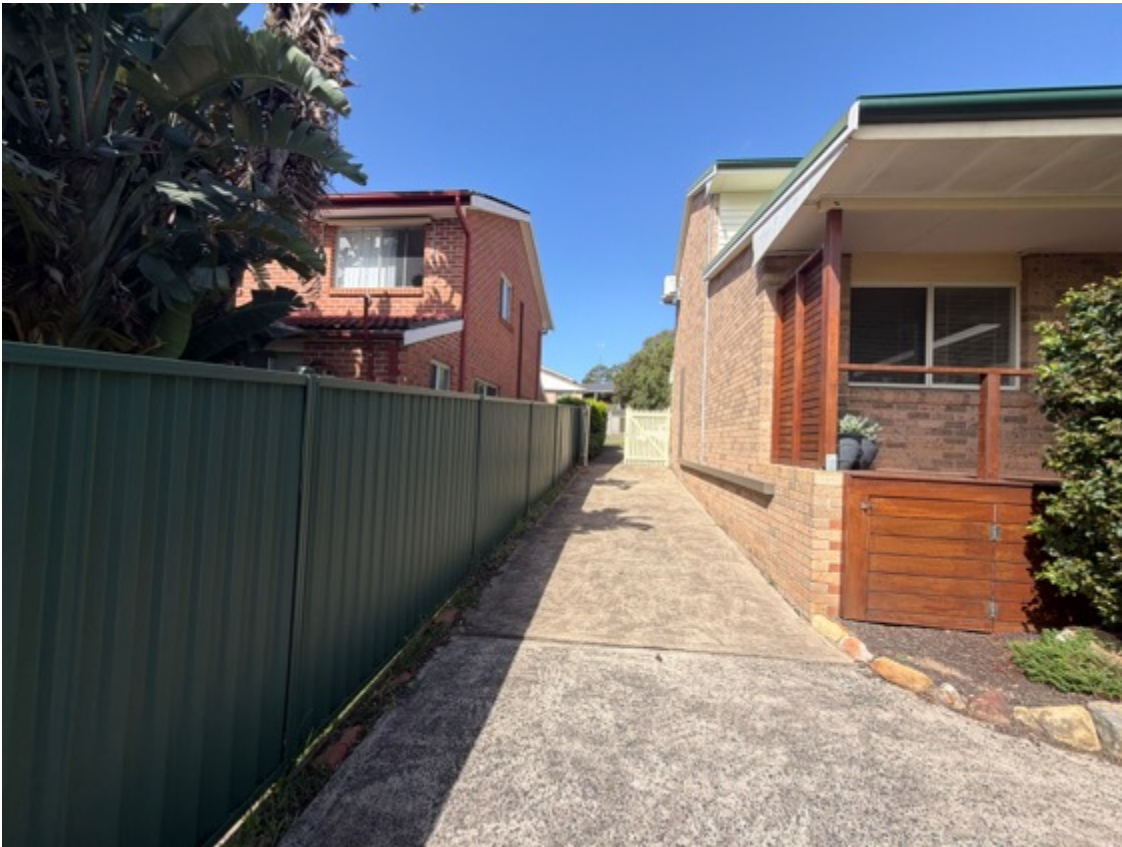
Site fences are in serviceable condition, isolated sections have minor dents and are leaning (consistent with age.)

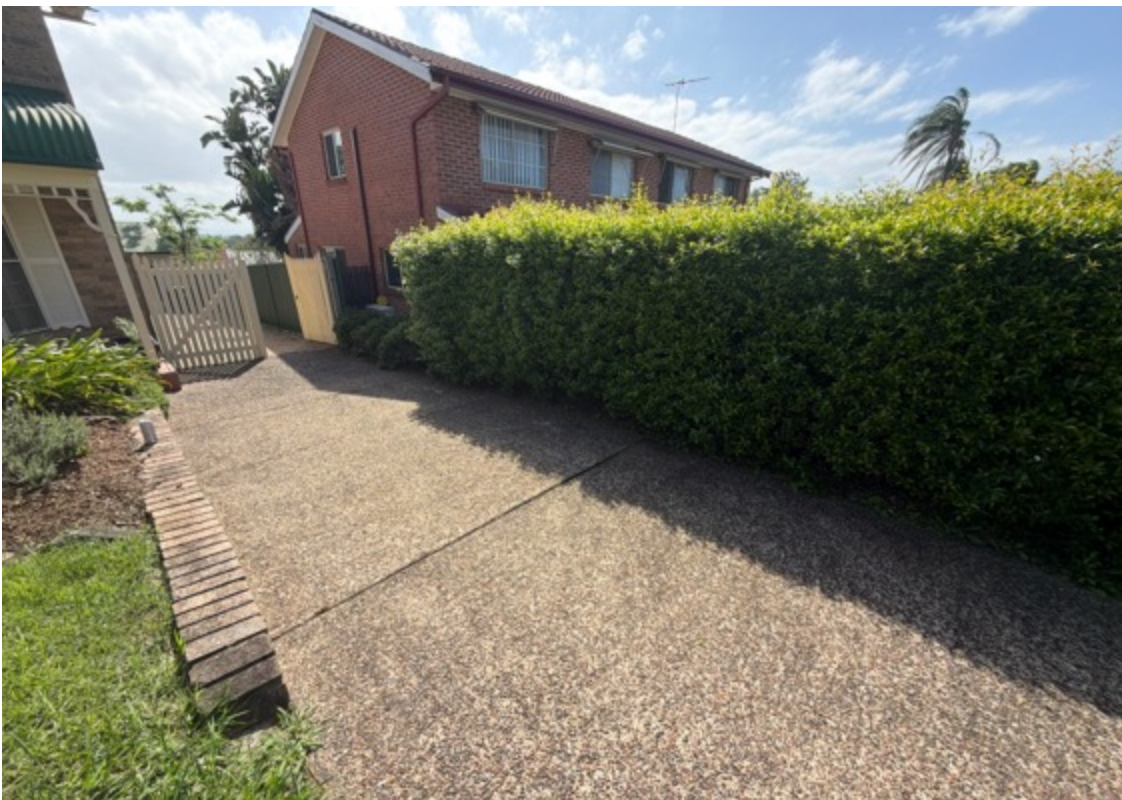
Isolated sections of exterior concrete displays typical shrinkage cracks and undulations - consistent with age.

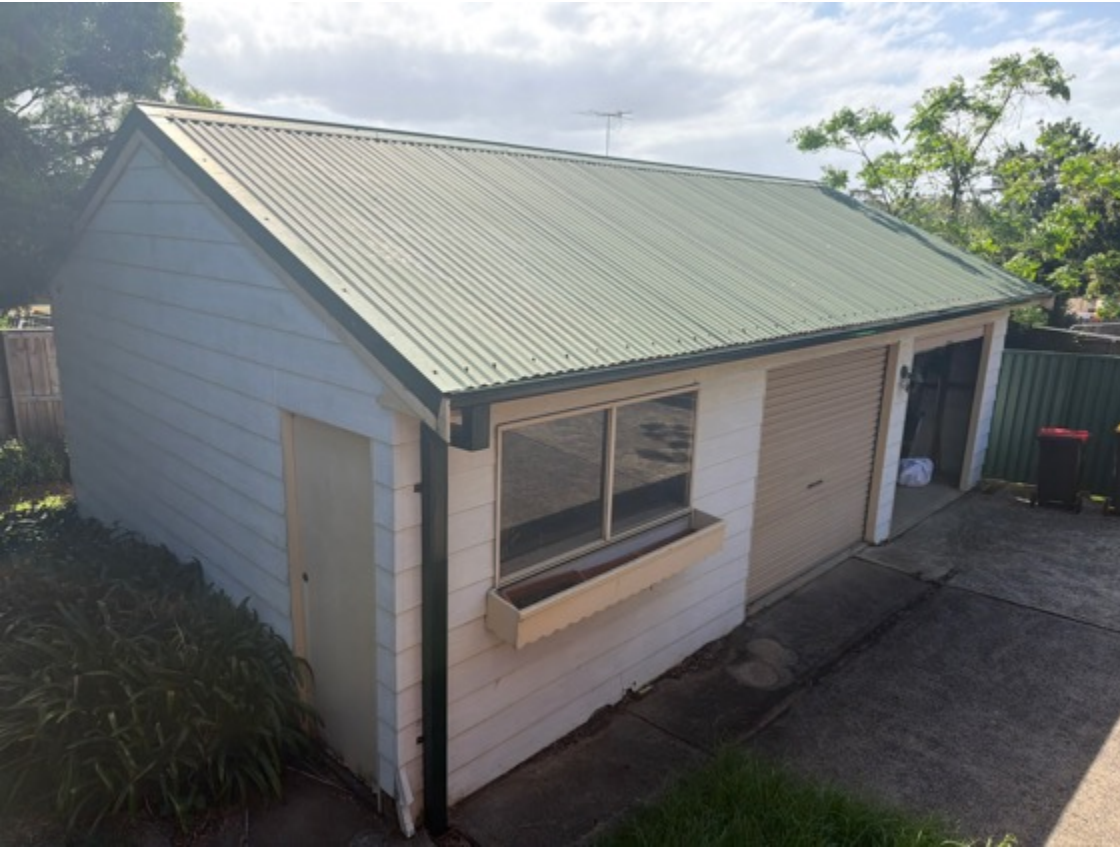
The shed is in serviceable condition for the age.

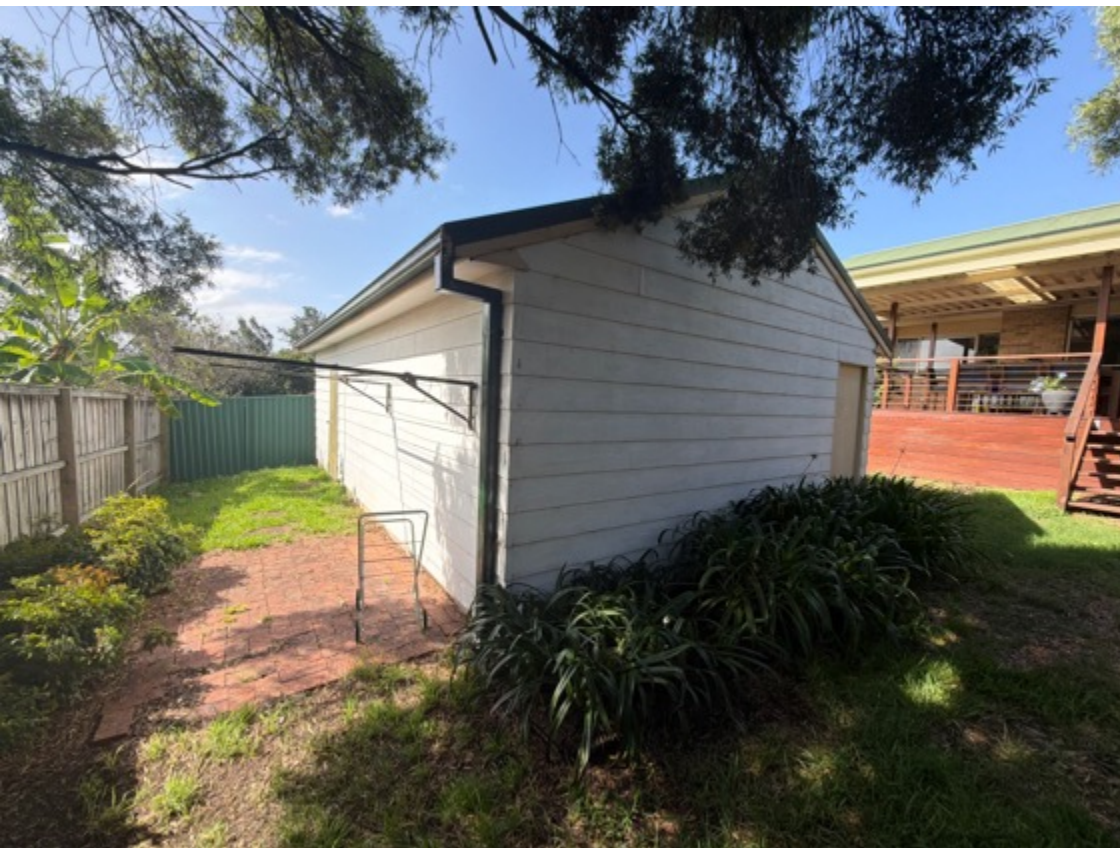
Surfaces are moderately paint blemished and timber is weathered, consistent with age.

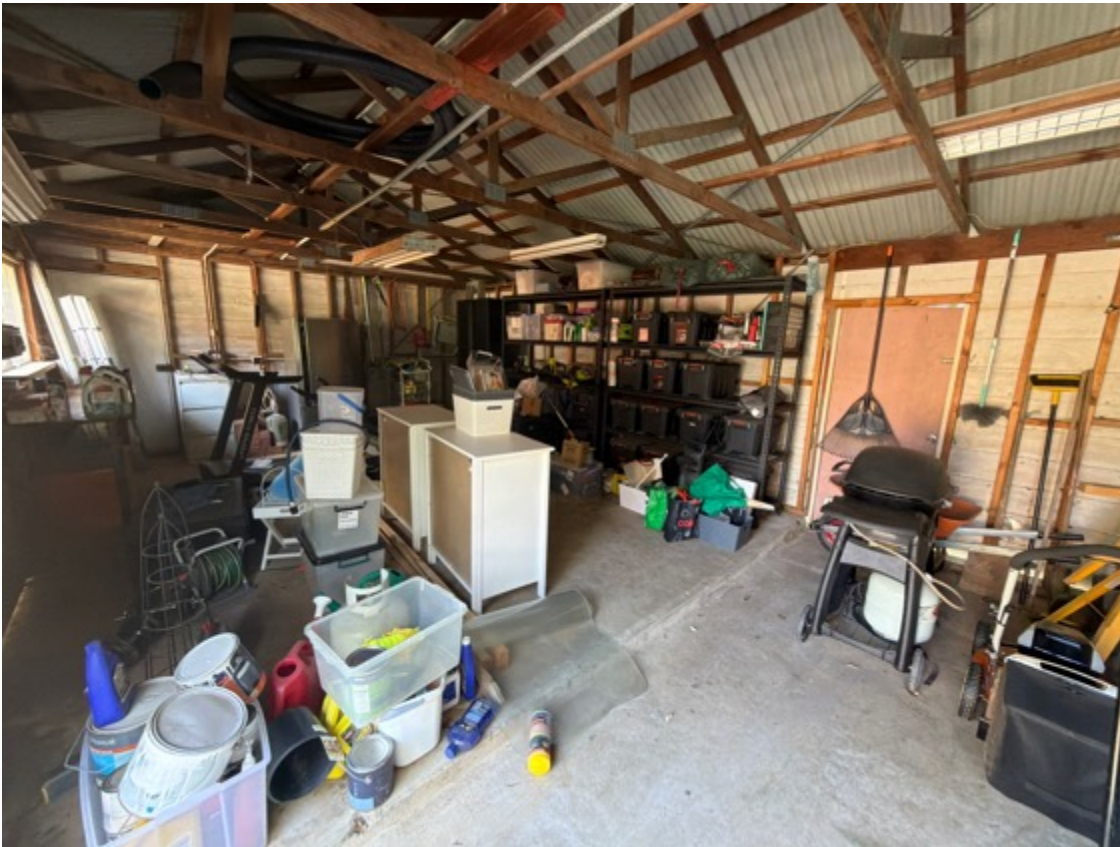
The shed interior is in serviceable condition.

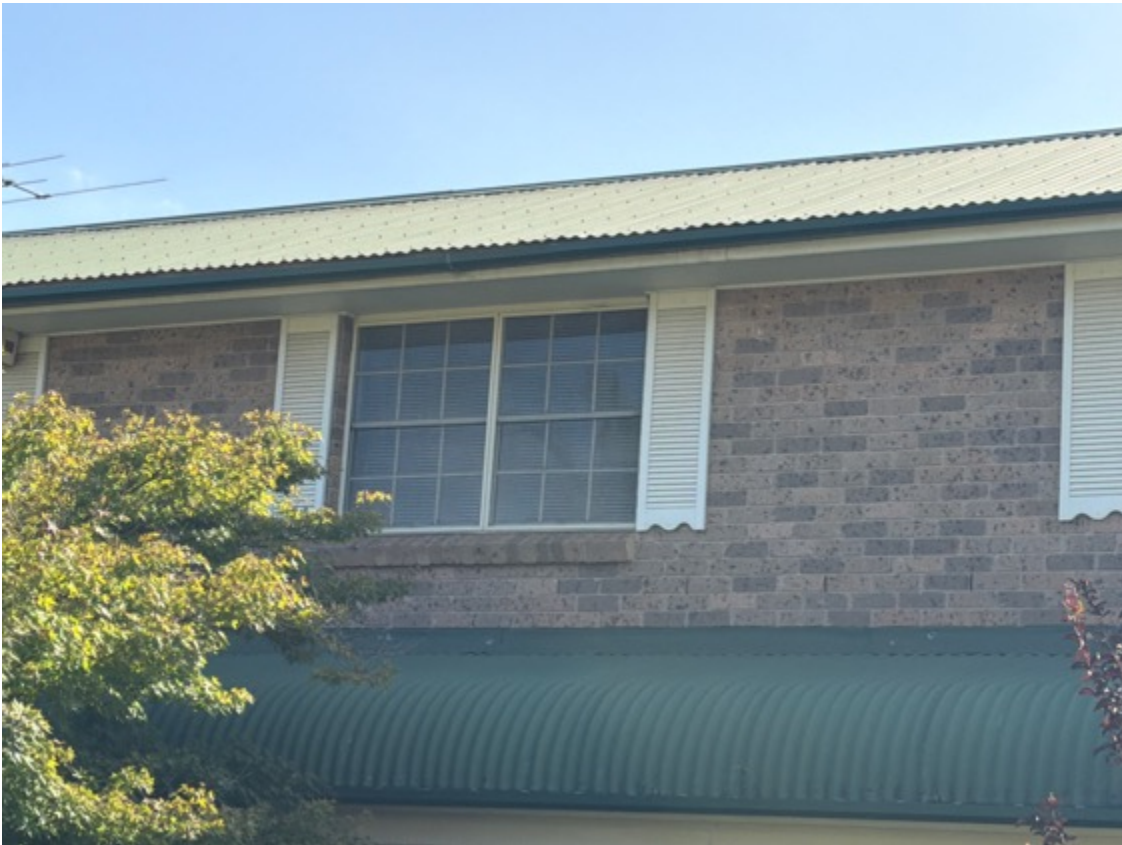
The roof exterior presents in satisfactory condition for the age.

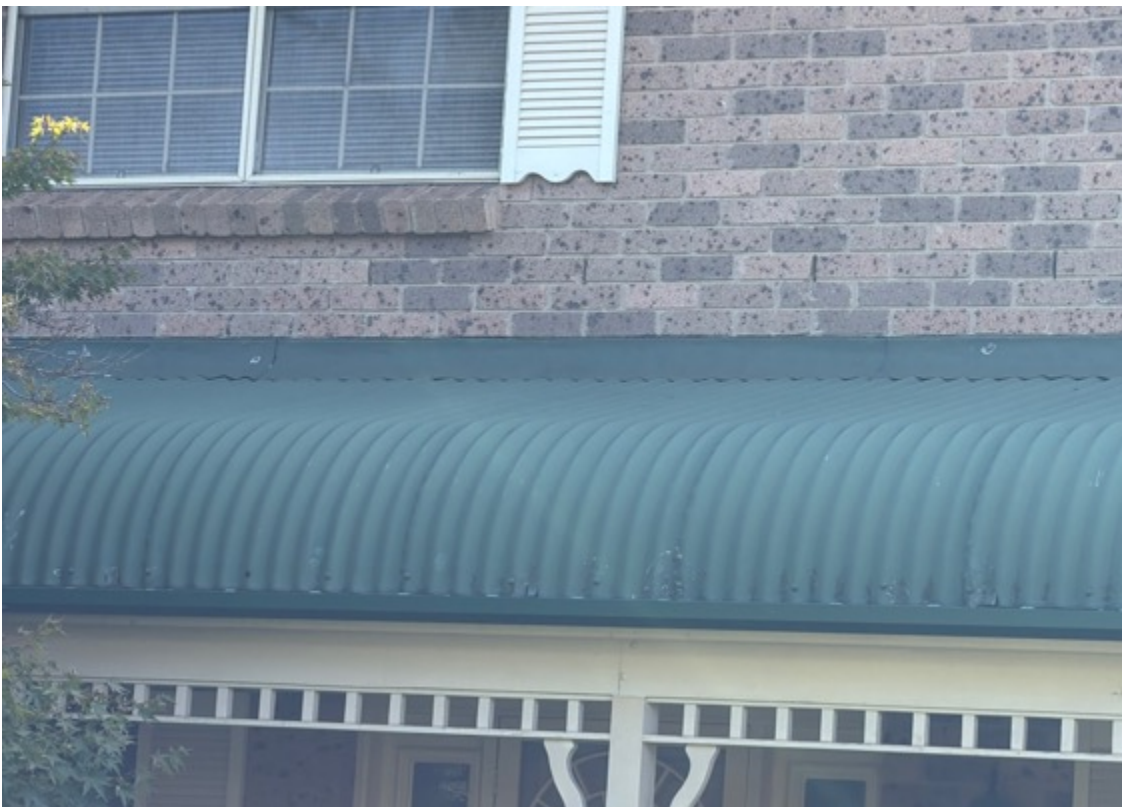
Lead flashing displays weathering, consistent with age.

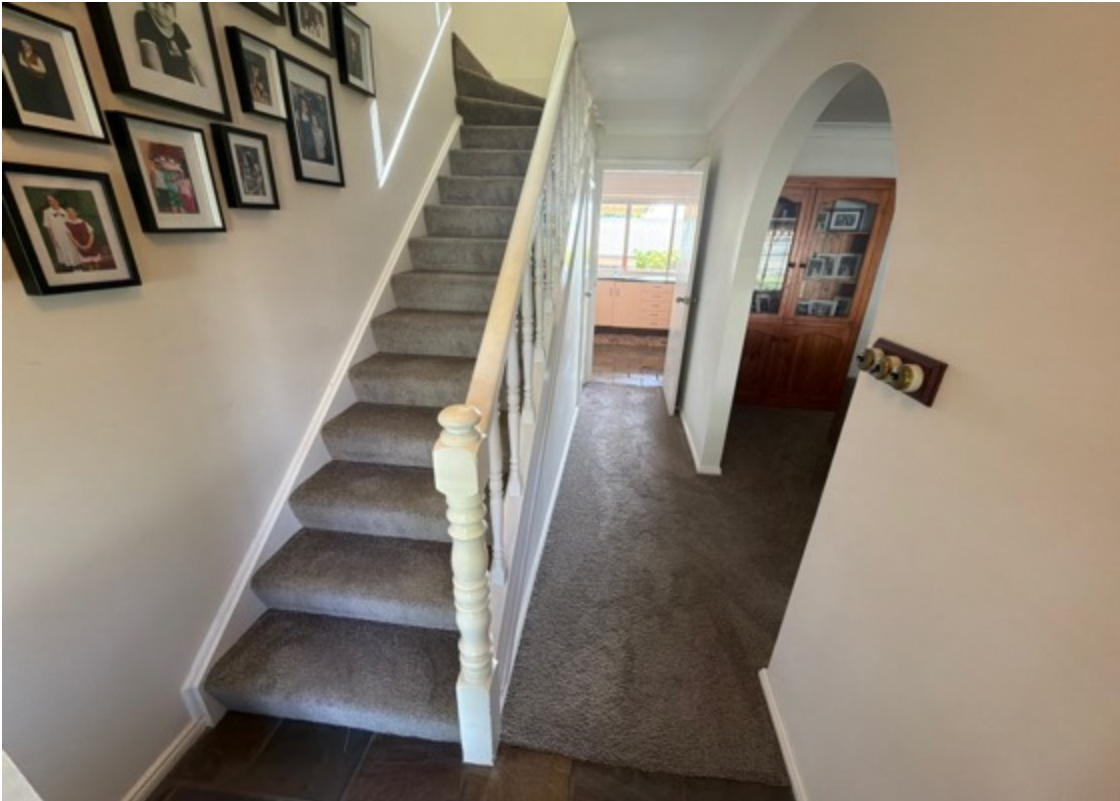
The interior of the house presents in satisfactory condition for the age.

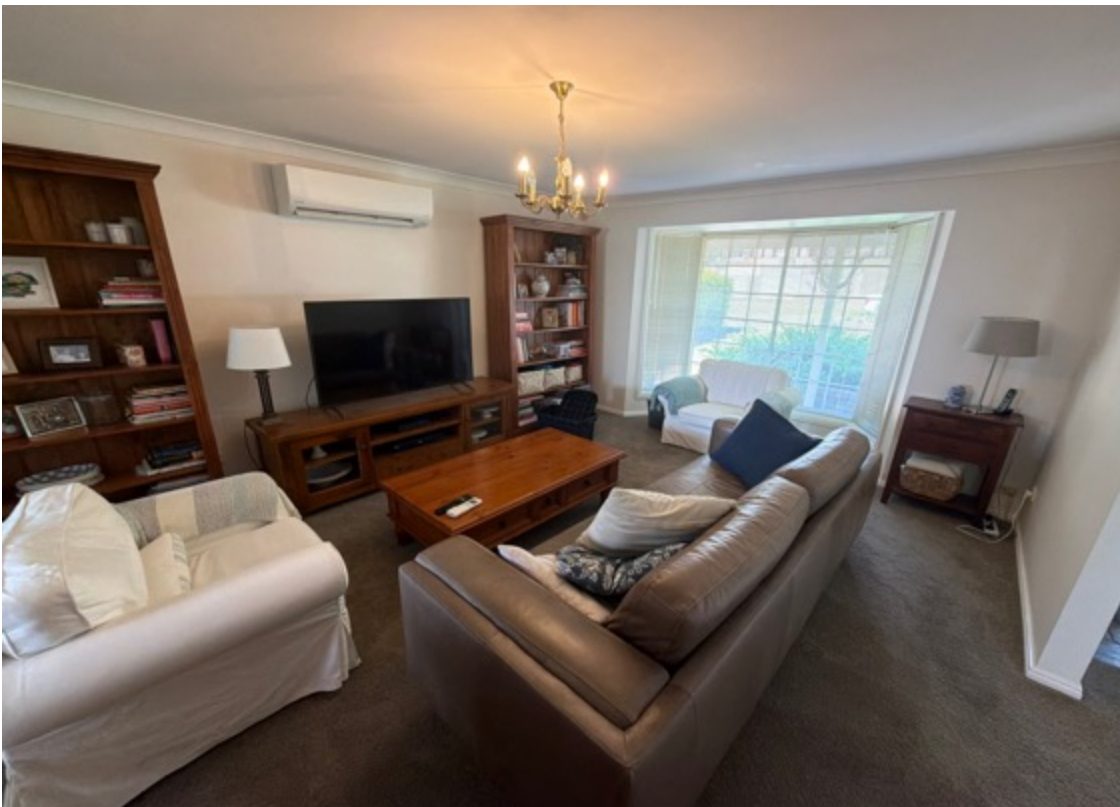
Interior living rooms present in satisfactory condition for the age.

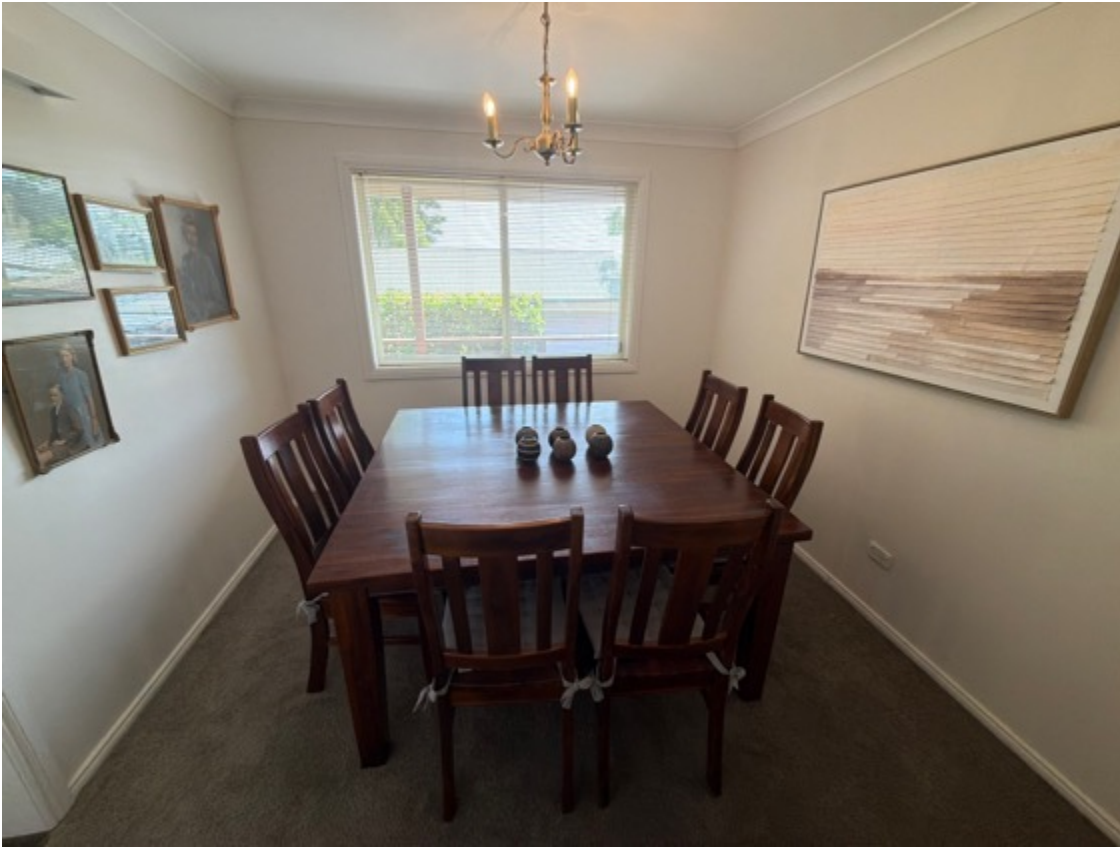
Example dining area above.

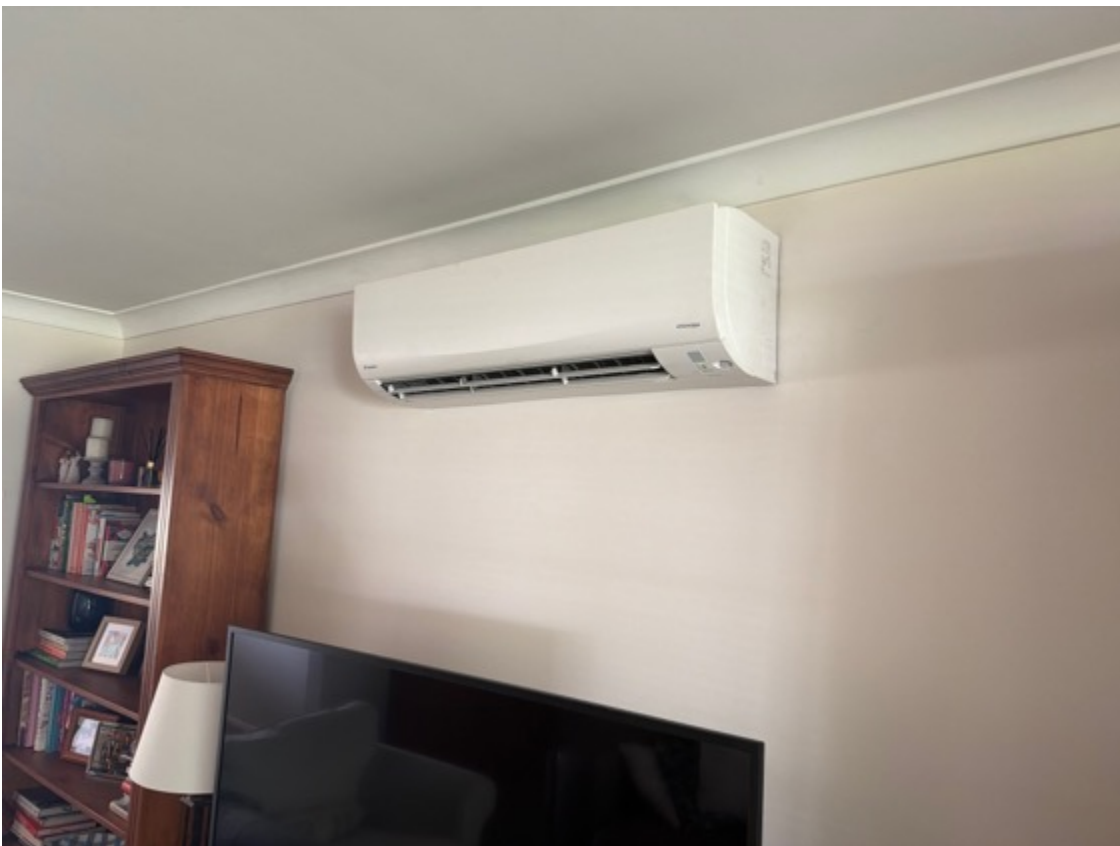
The wall mounted AC tested, functioned at the time of inspection.
