# **PRE-PURCHASE PROPERTY INSPECTION BUILDING REPORT**

**Visual Pre-Purchase Building Inspection Report.**

| <b>Inspection address:</b> | 14 Sherridon Crescent Quakers Hill. |
| <b>Inspection Date:</b> | <u>Date: 12.3.26 Arrival time: 2:00pm - Departure time: 3:30pm.</u> |

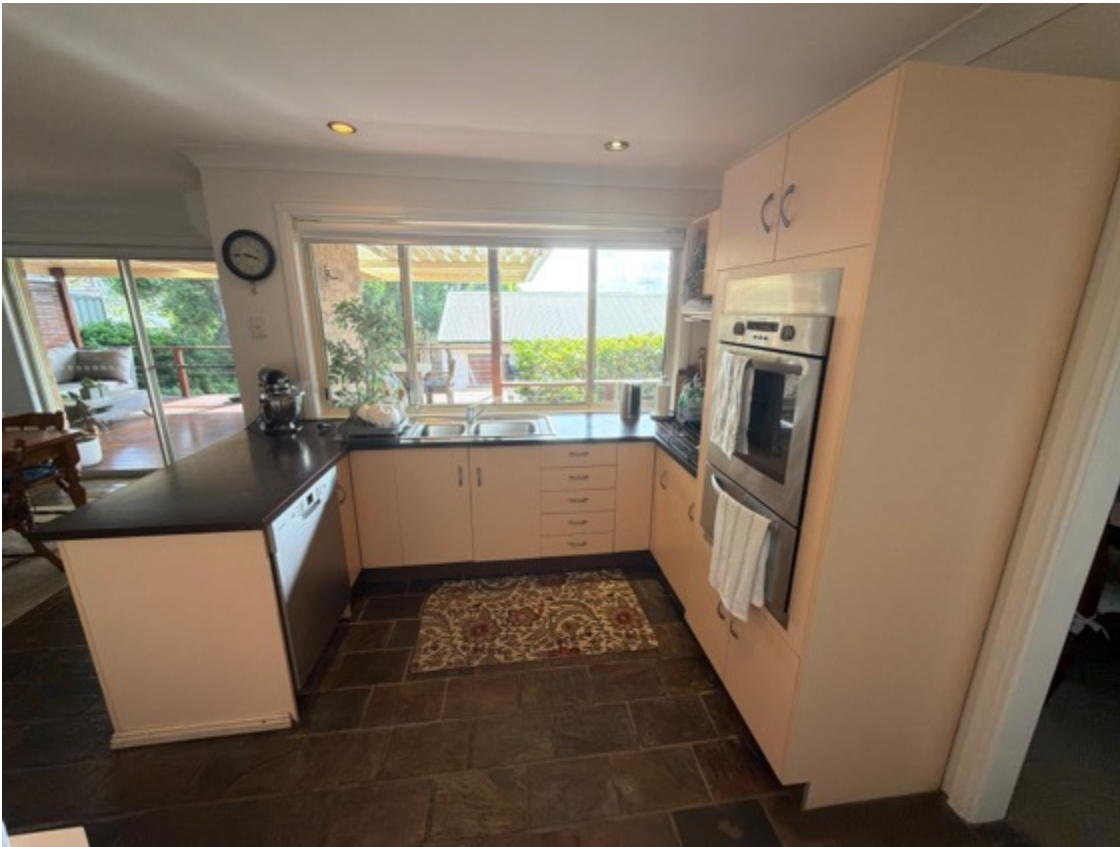
The kitchen area presents in serviceable condition for the age.

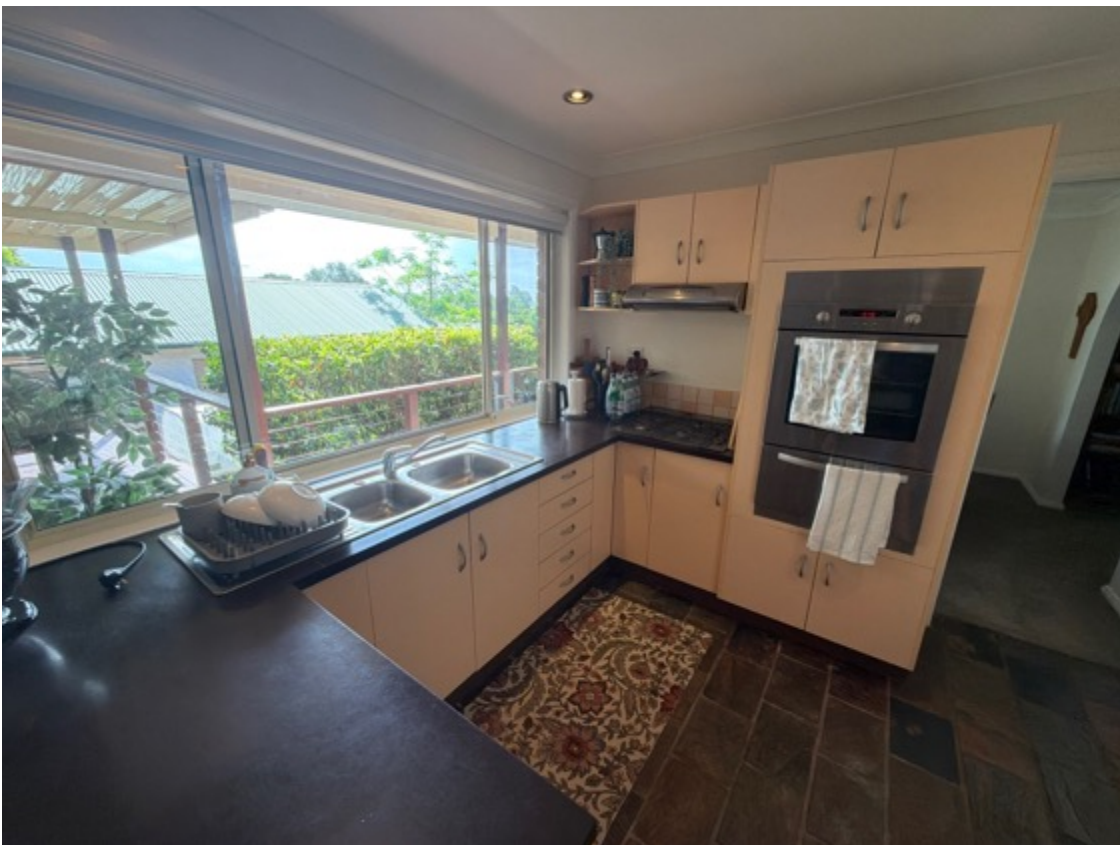
Appliances tested, functioned at the time of inspection.

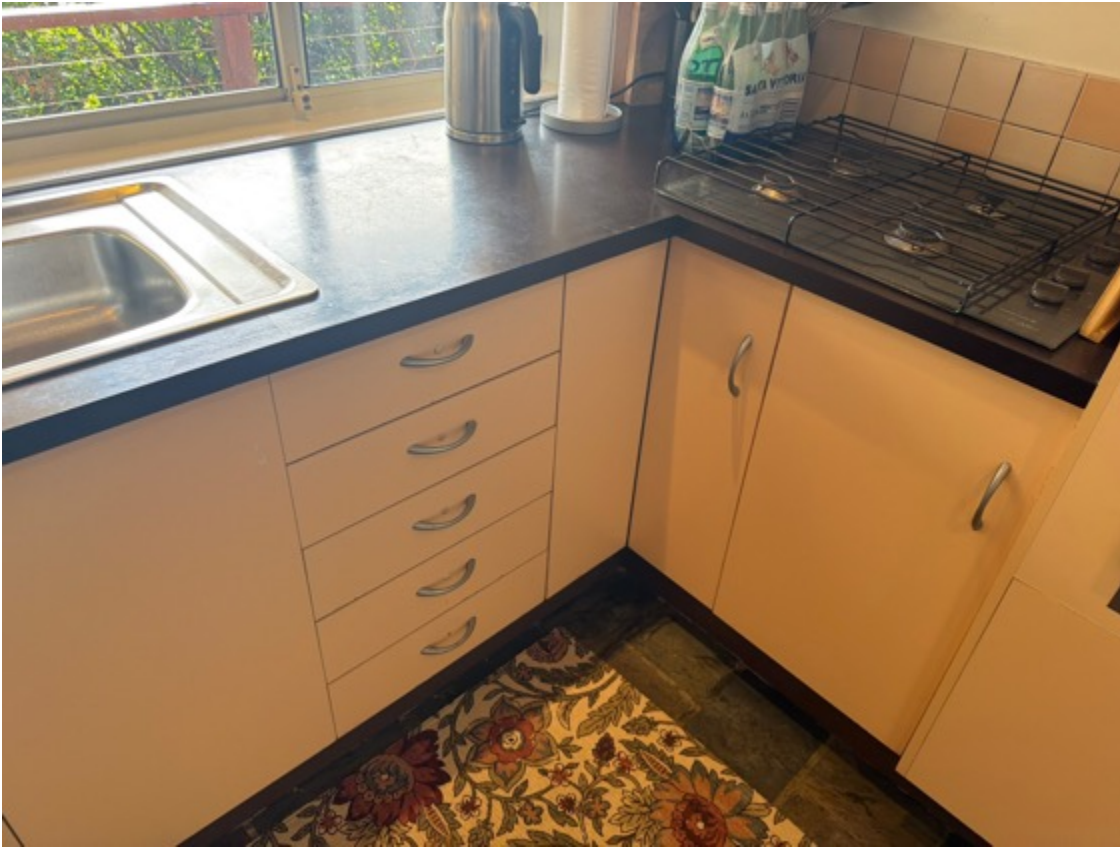
Cabinetry displays low level wear, consistent with age.

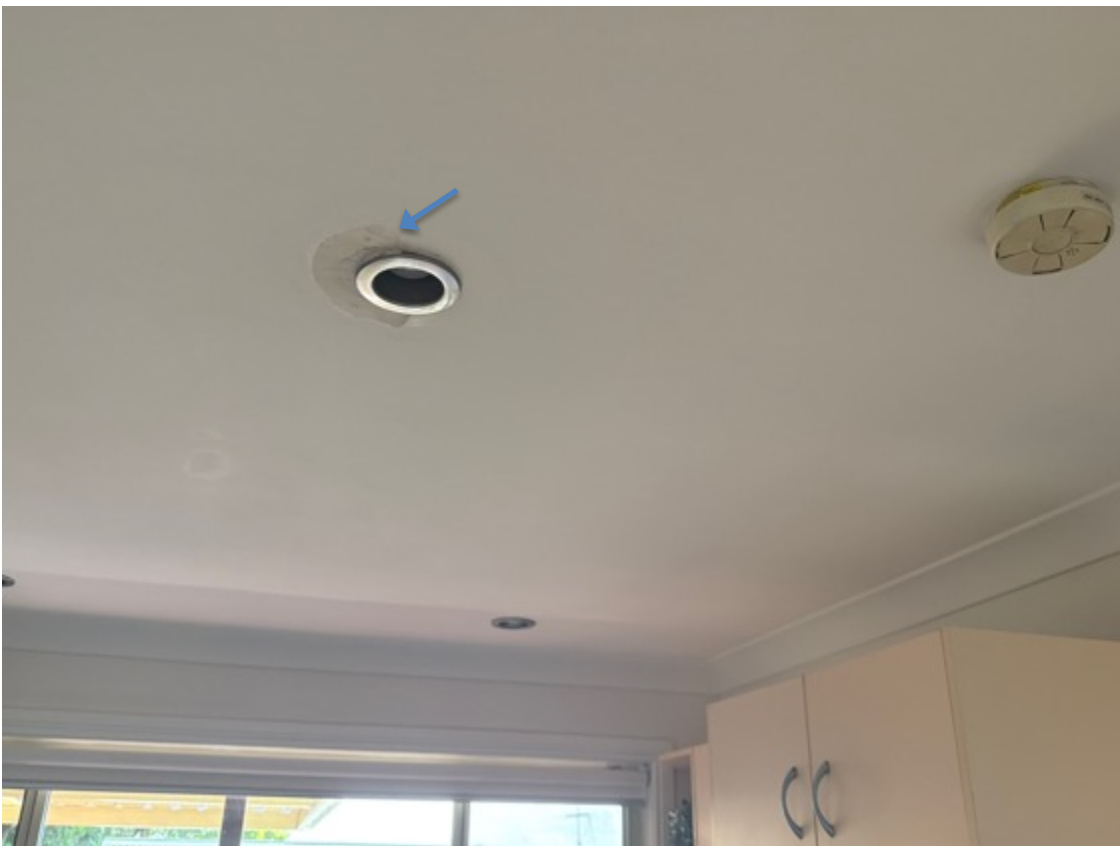
Patching around the ceiling light is incomplete.

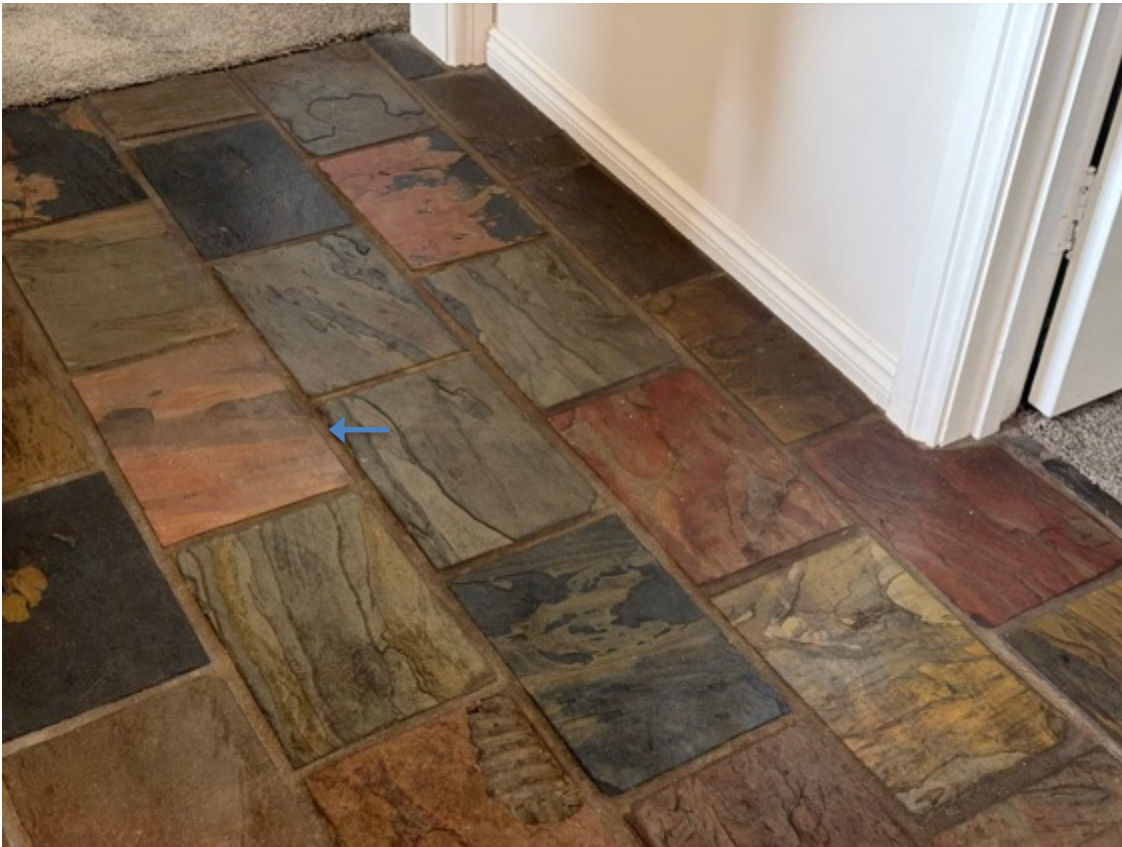
Isolated sections of internal tiles are chipped, consistent with age.

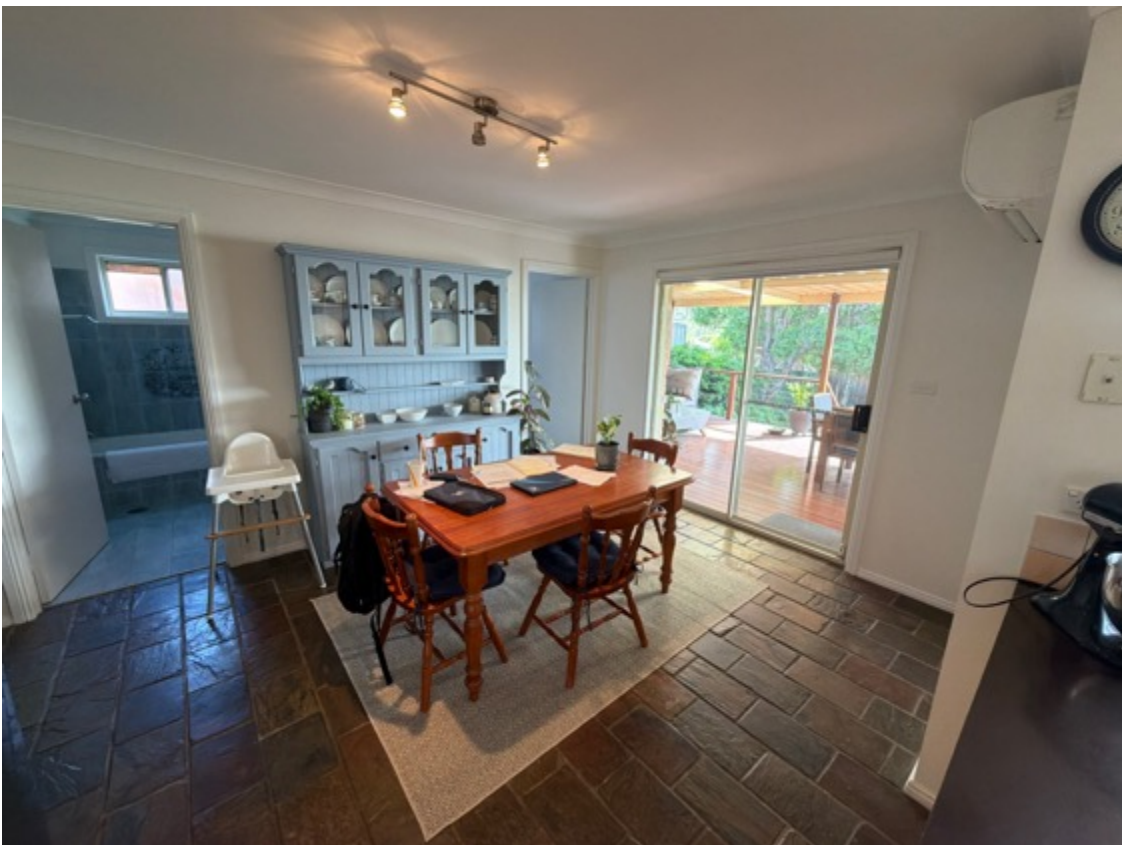
Lower level lights tested, functioned at the time of inspection.

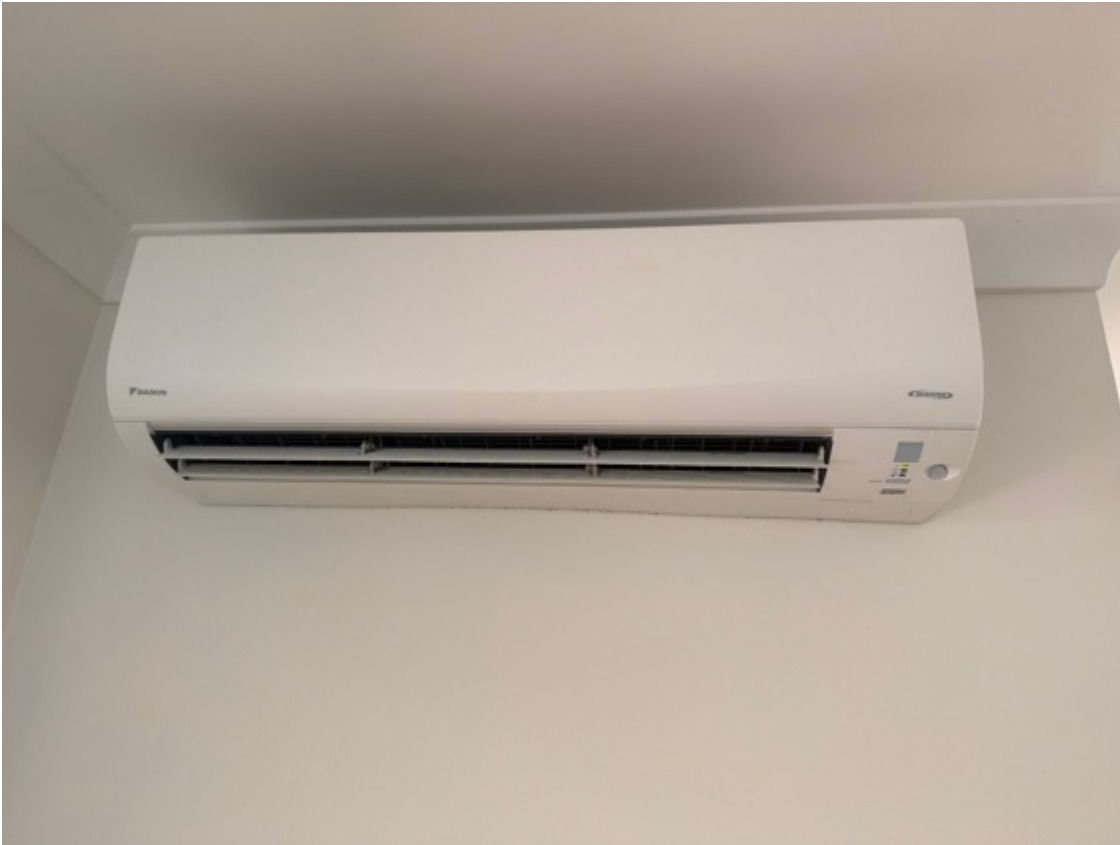
The wall mounted AC tested, functioned at the time of inspection.

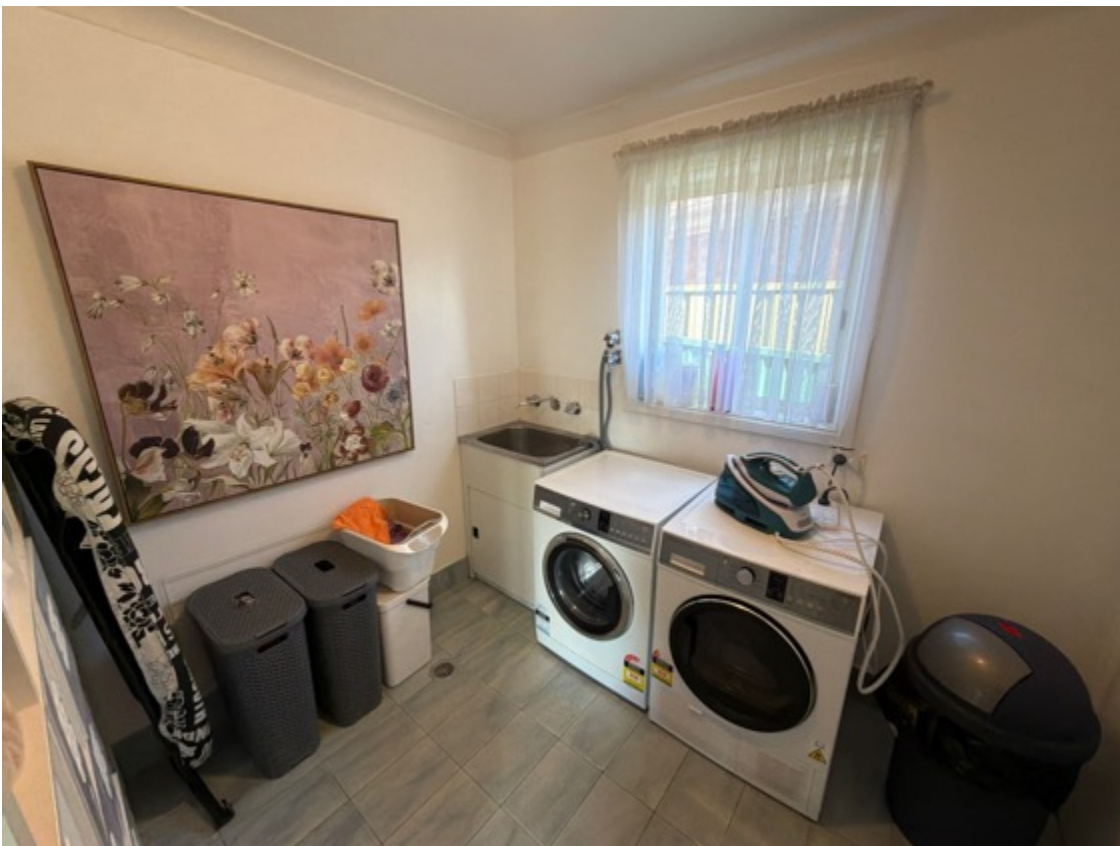
The laundry is in serviceable condition.

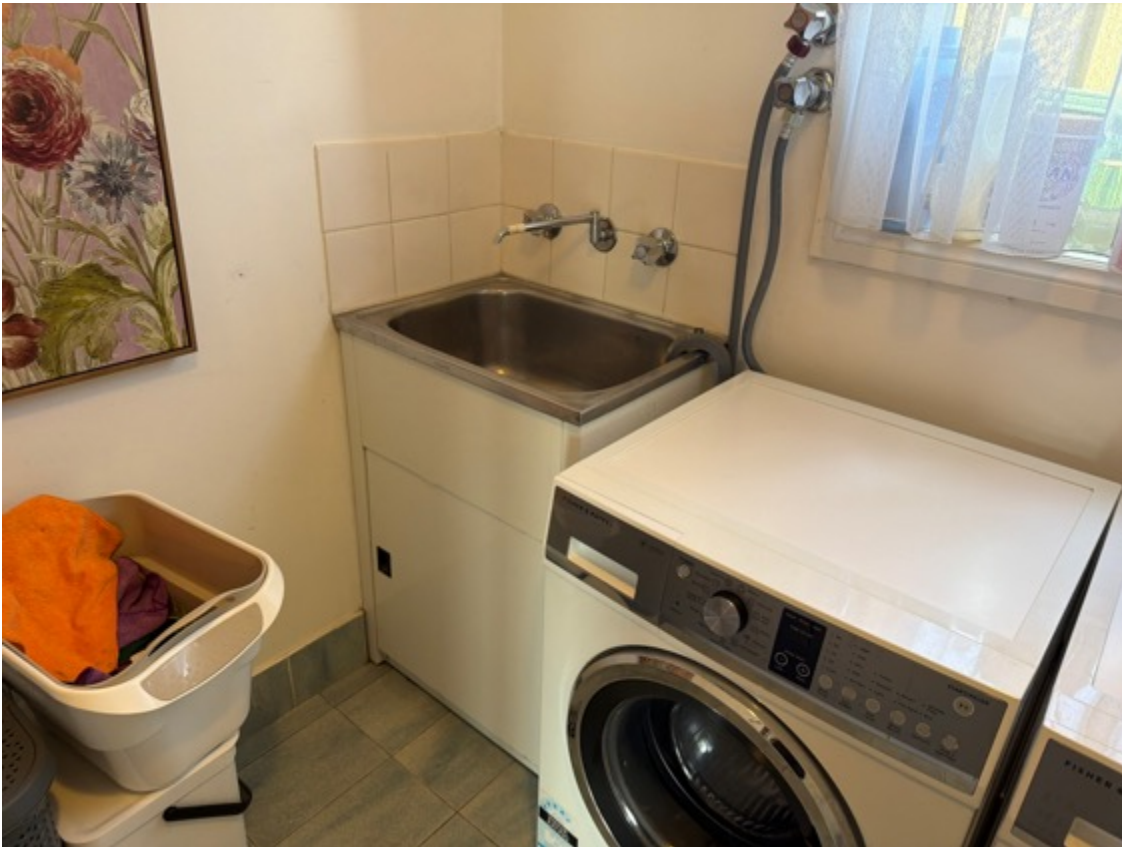
Water pressure tested, is sufficient.

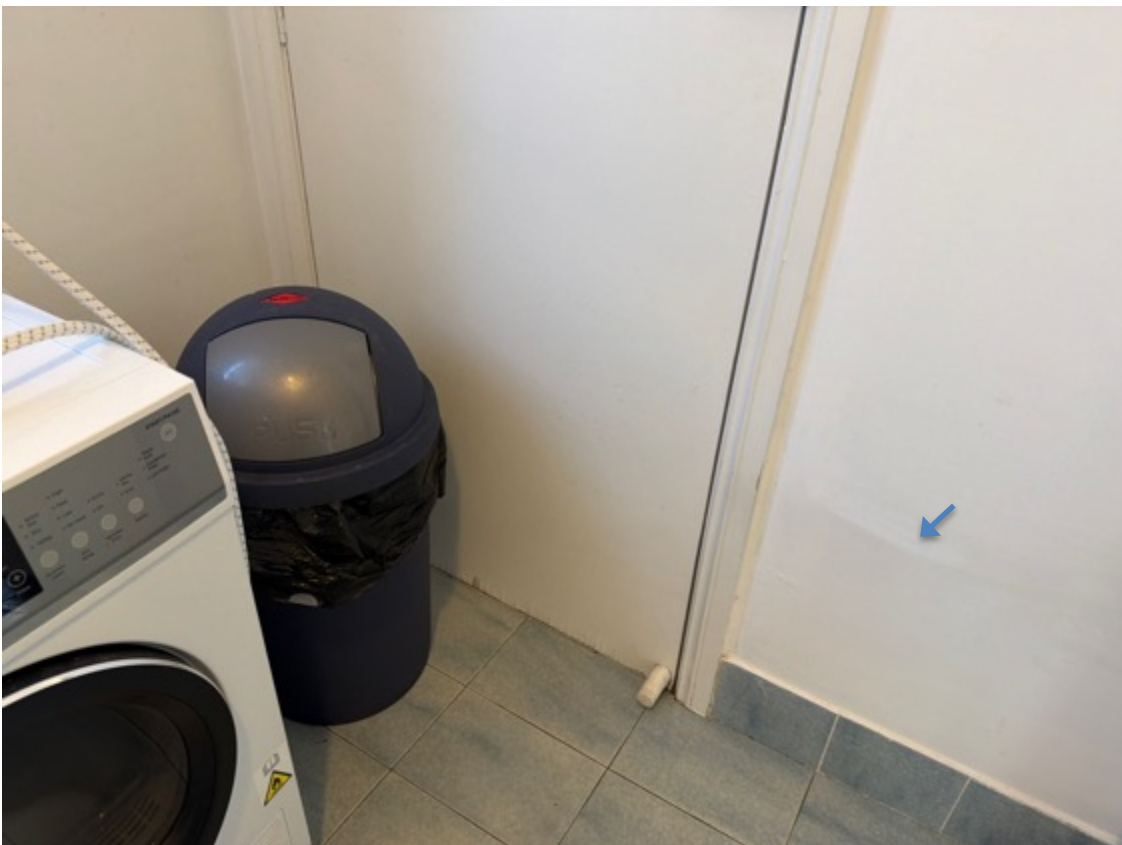
Internal surfaces display low level paint blemishes, consistent with age and the laundry door is weathered.

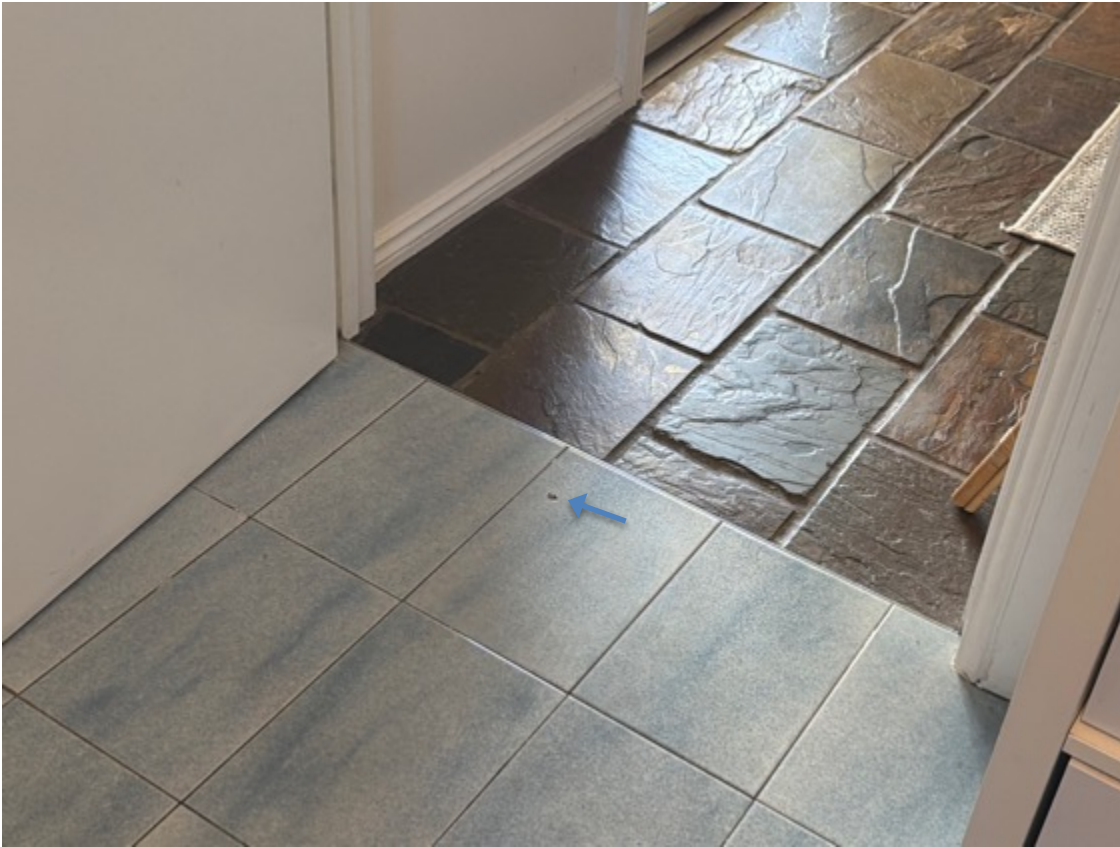
Isolated sections of tiles are chipped, consistent with age.

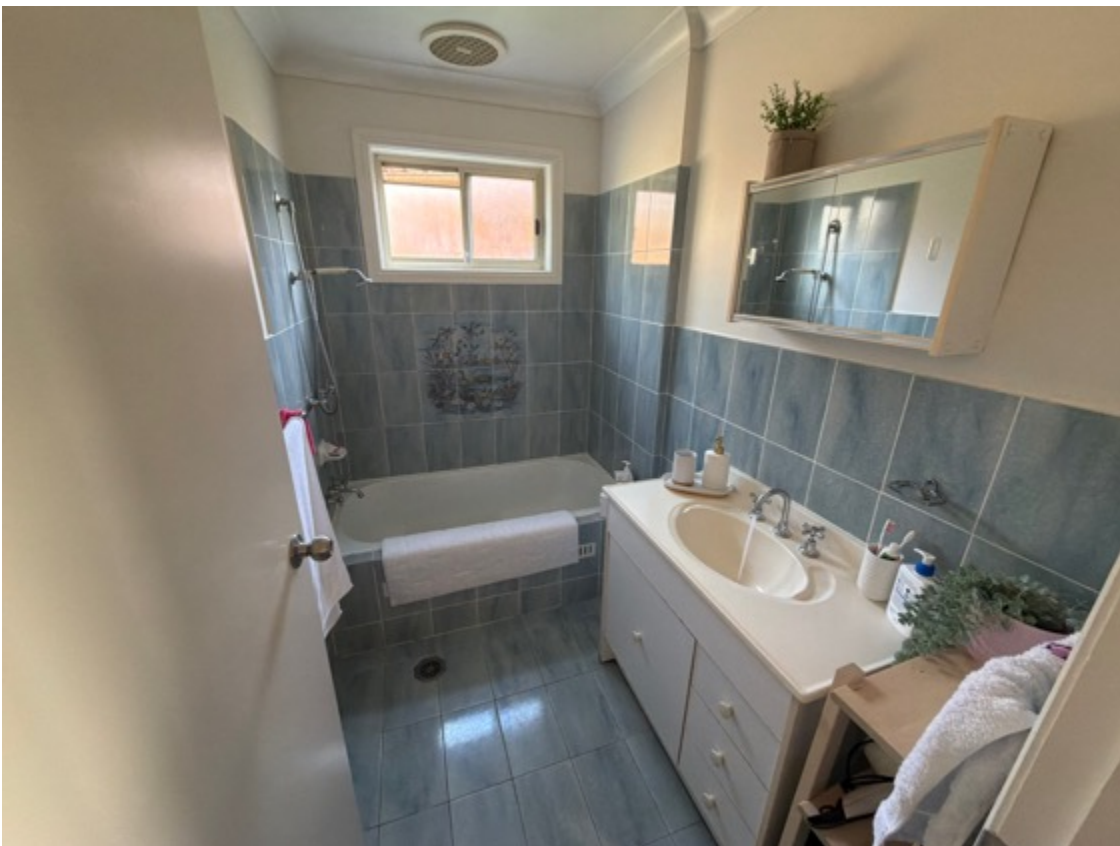
The ground floor common bathroom area tested for leaks, was issue free at the time of inspection.

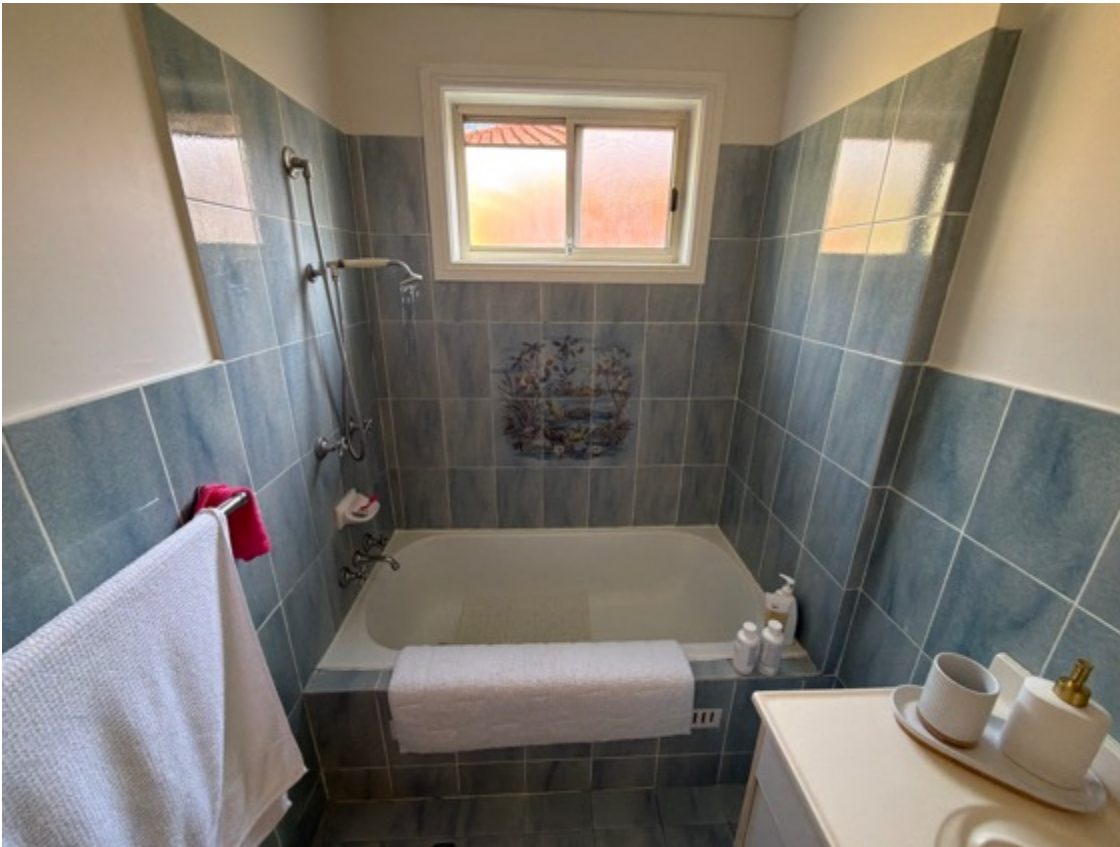
Hot and cold water services tested, functioned at the time of inspection.

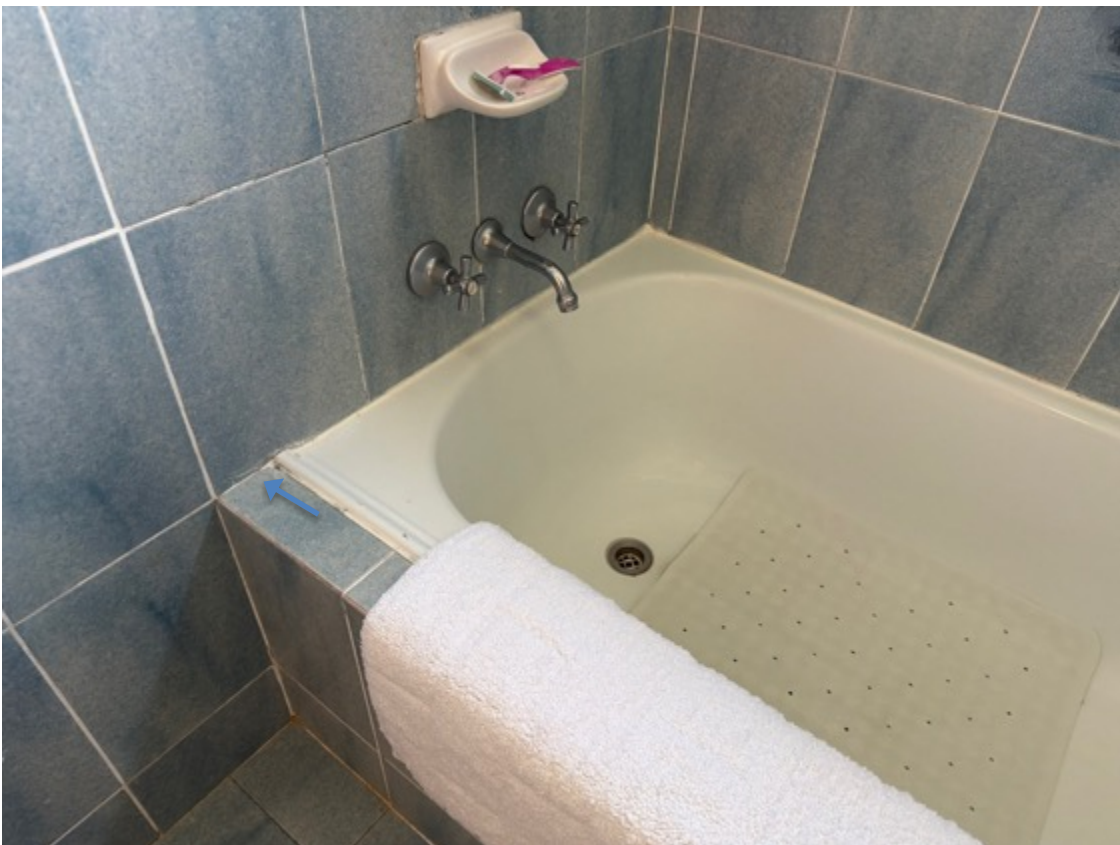
Wet areas tile grout and silicone is darkened, reapplication is recommended.

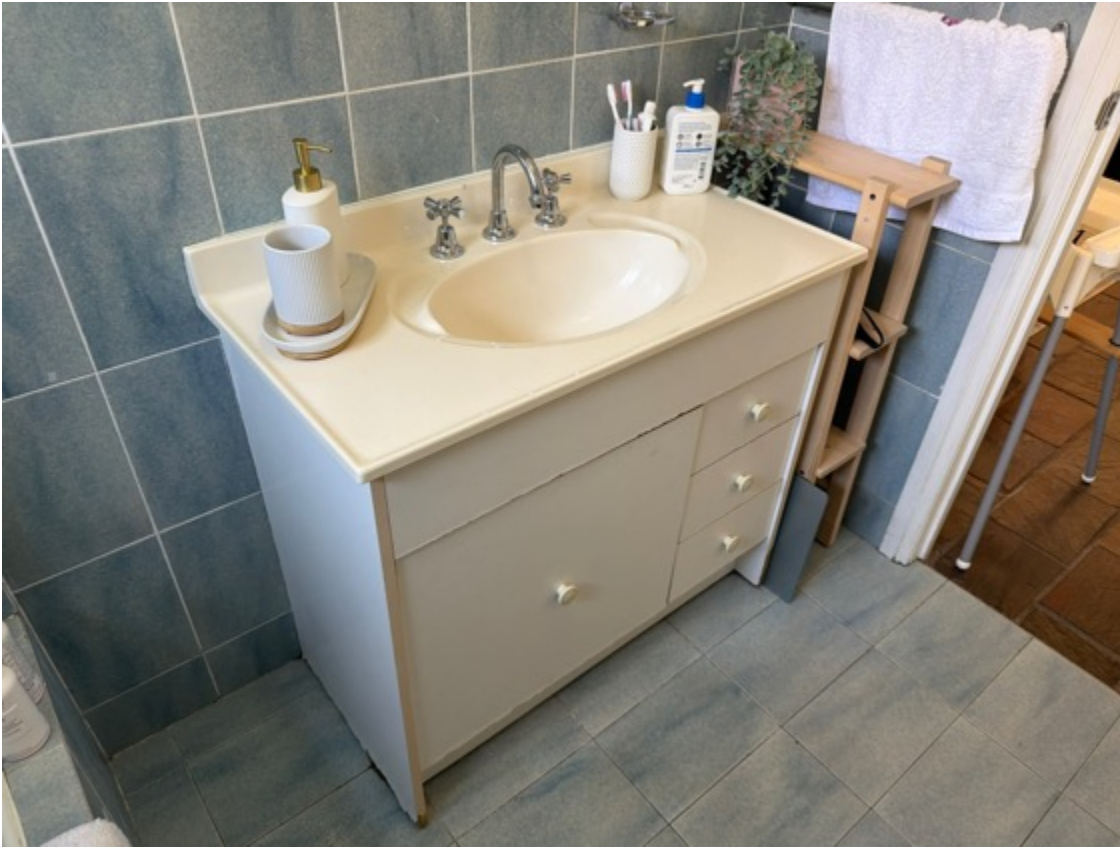
The vanity displays low to moderate level wear, consistent with age.

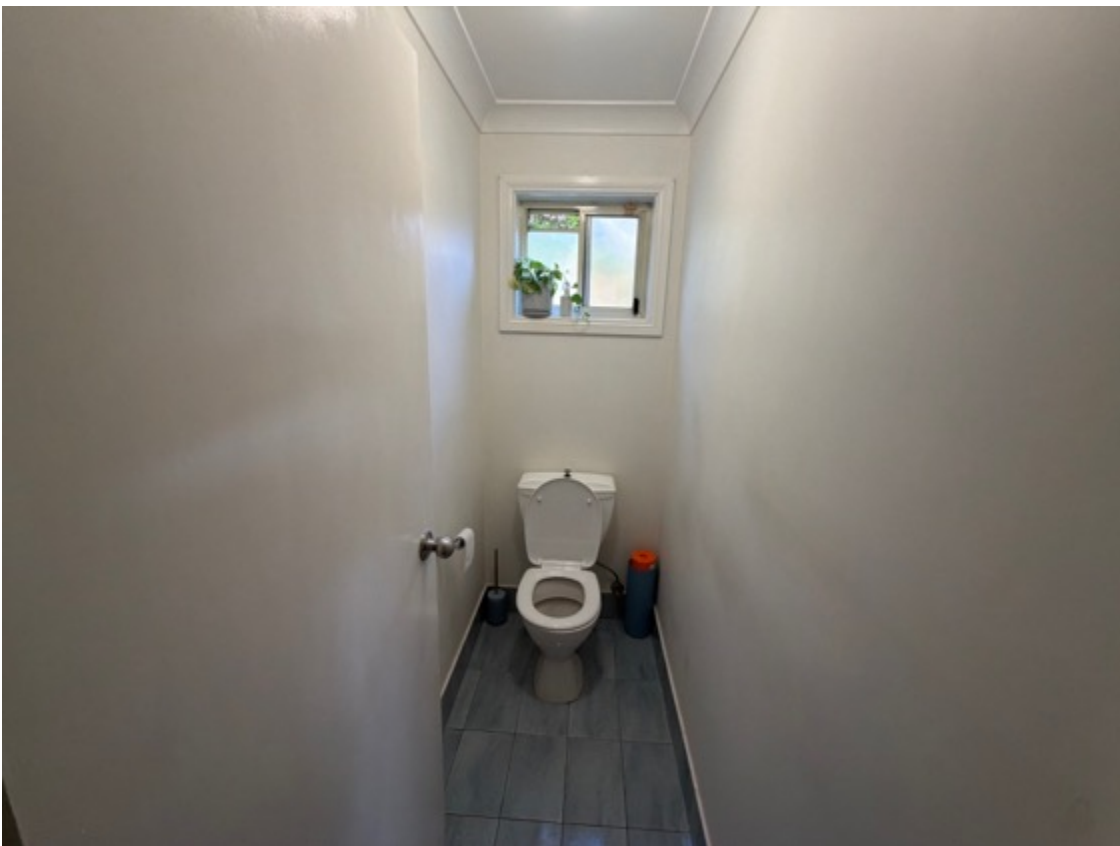
The common toilet tested, functioned at the time of inspection.

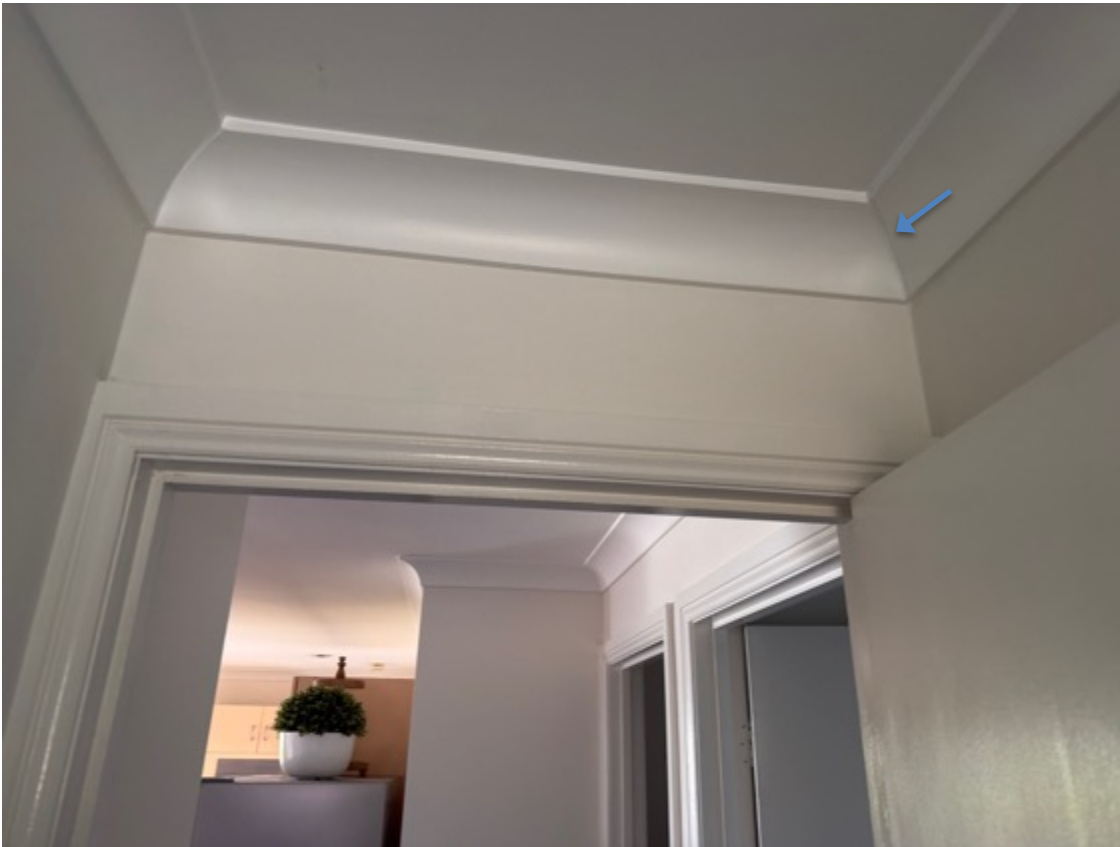
Isolated sections of plasterboard and cornices are cracking (common toilet example above.)

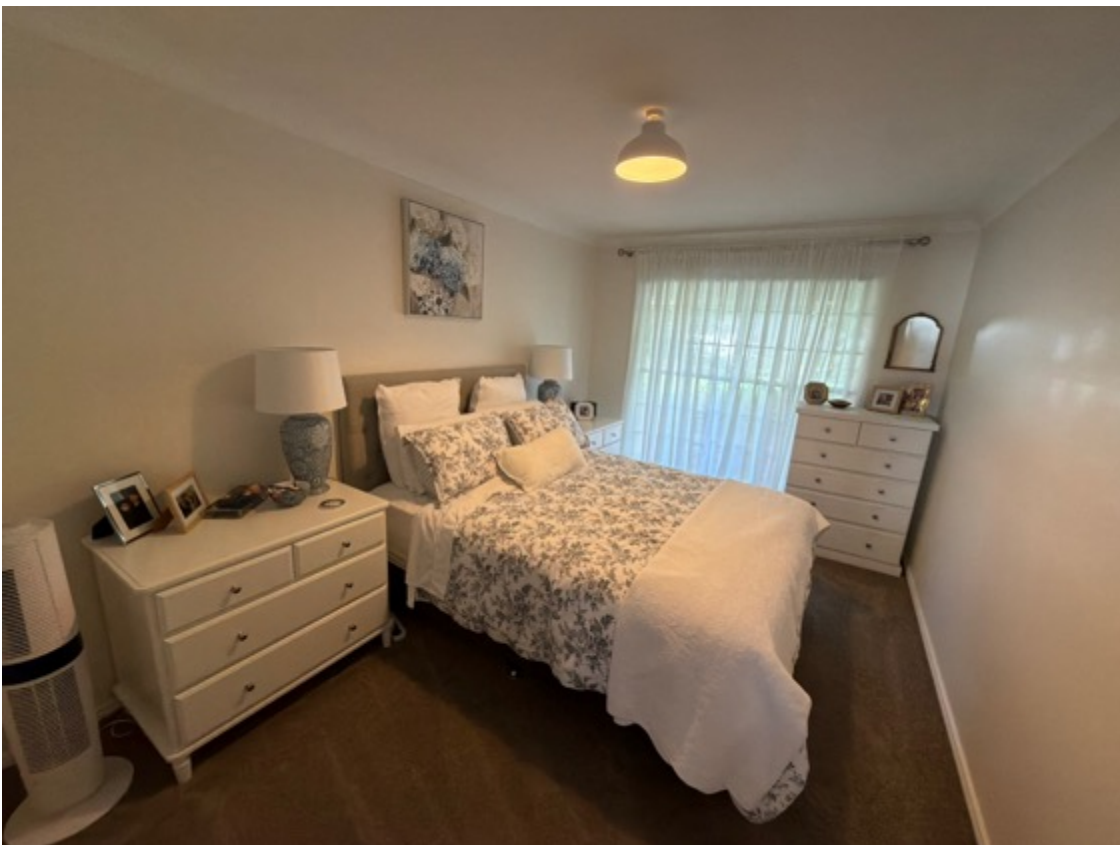
Interior bedroom areas present in serviceable condition for the age.

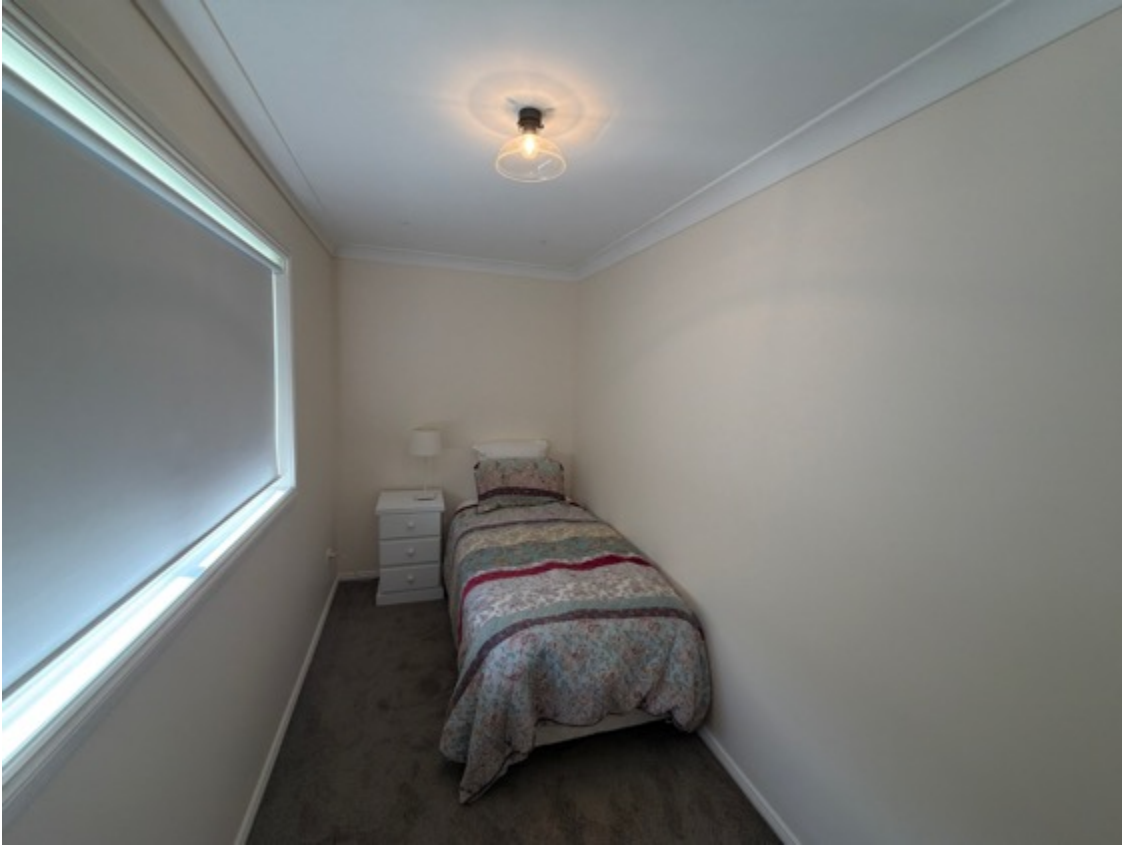
Example rear right side bedroom area above.

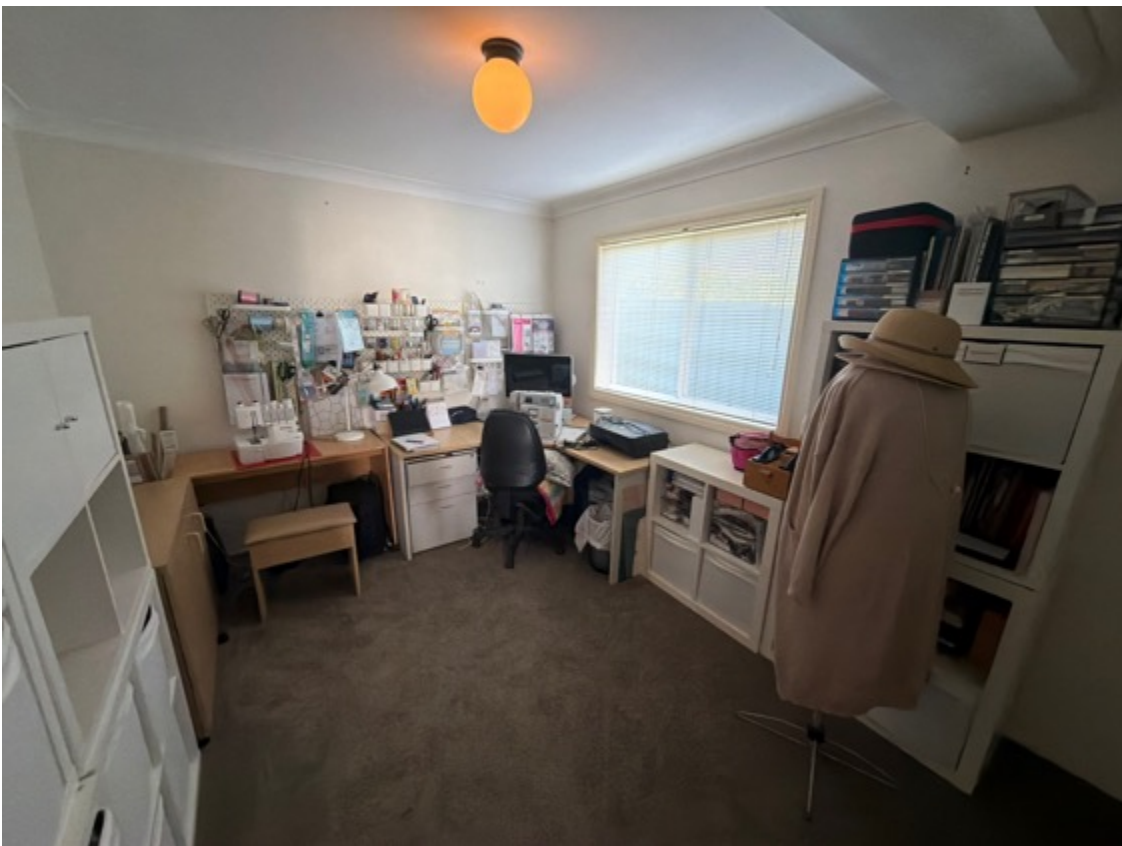
All interior lights tested, functioned as intended at the time of inspection.

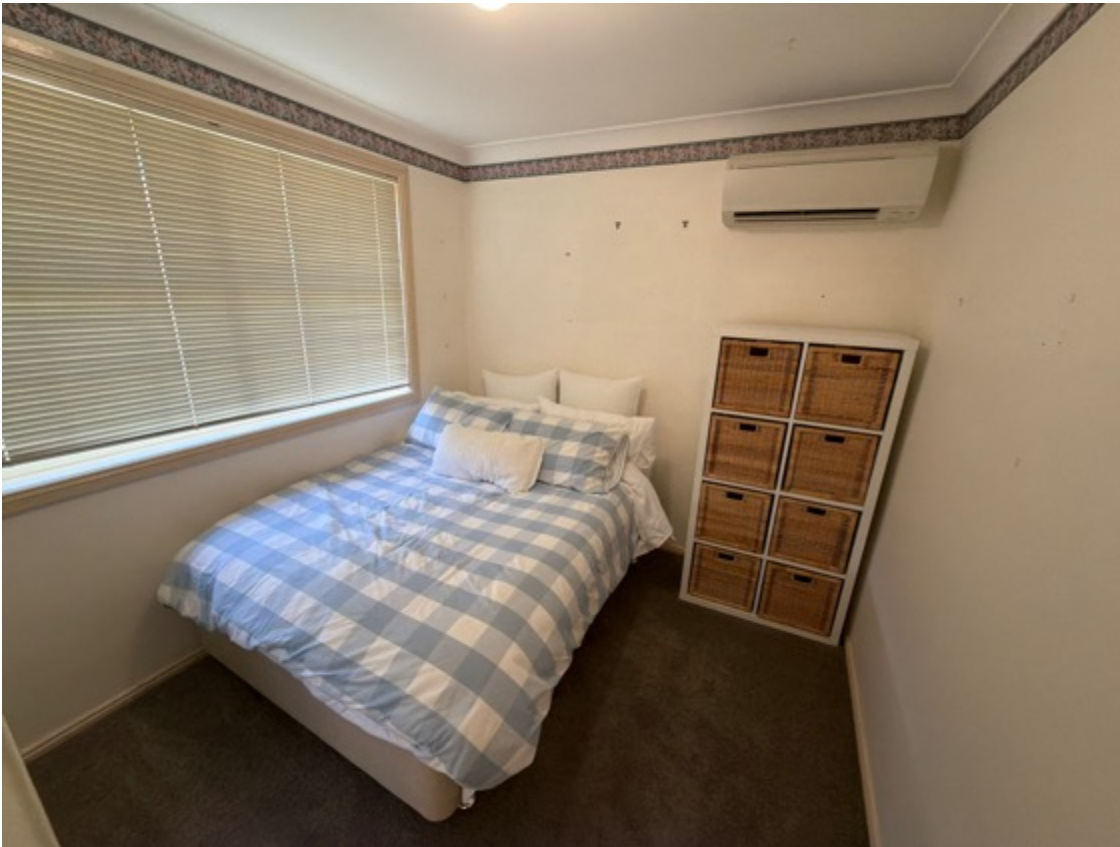
Example bedroom area above.

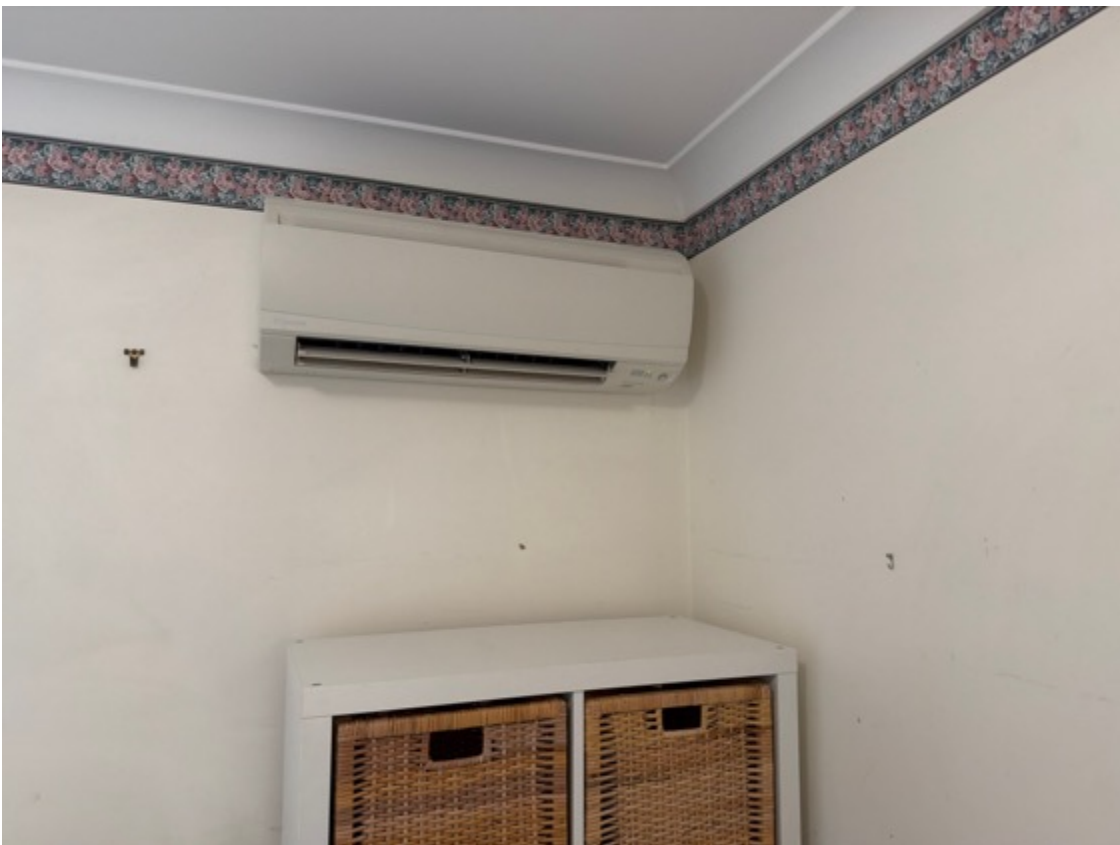
The wall mounted AC tested, functioned at the time of inspection.

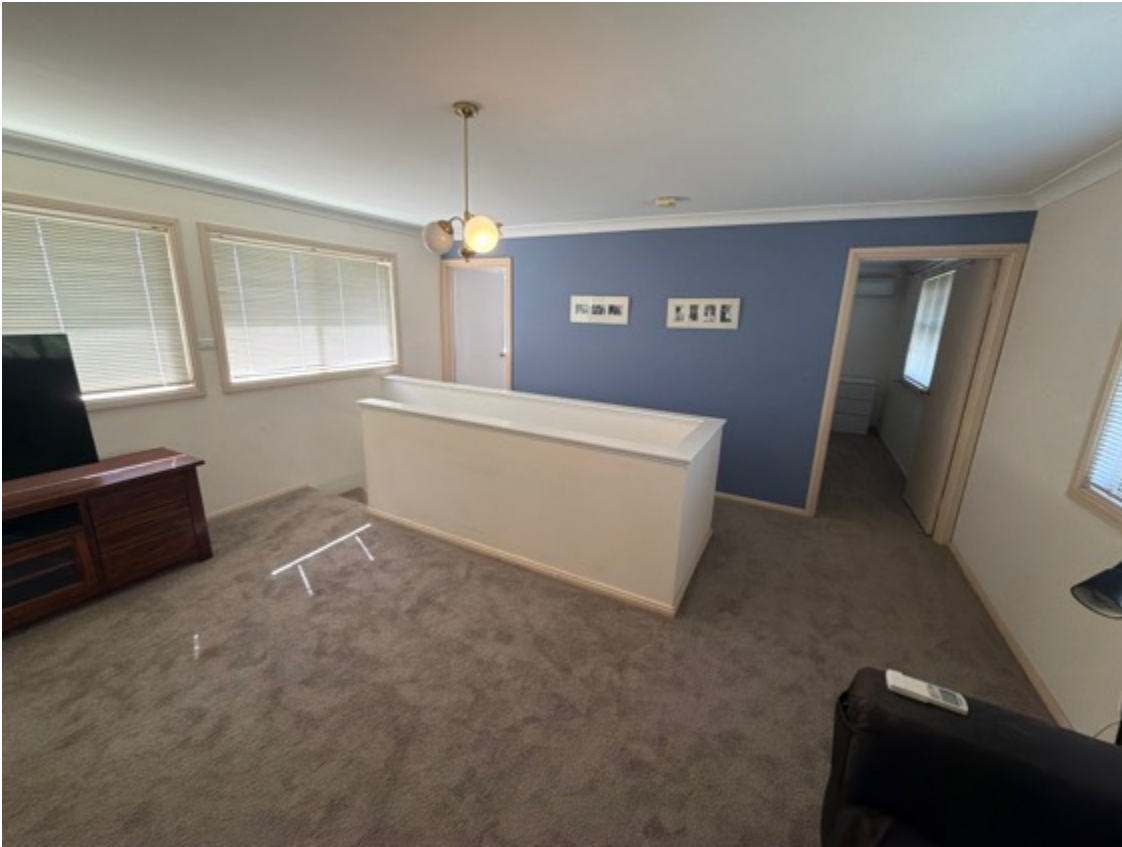
Interior railings checked are structurally sound.

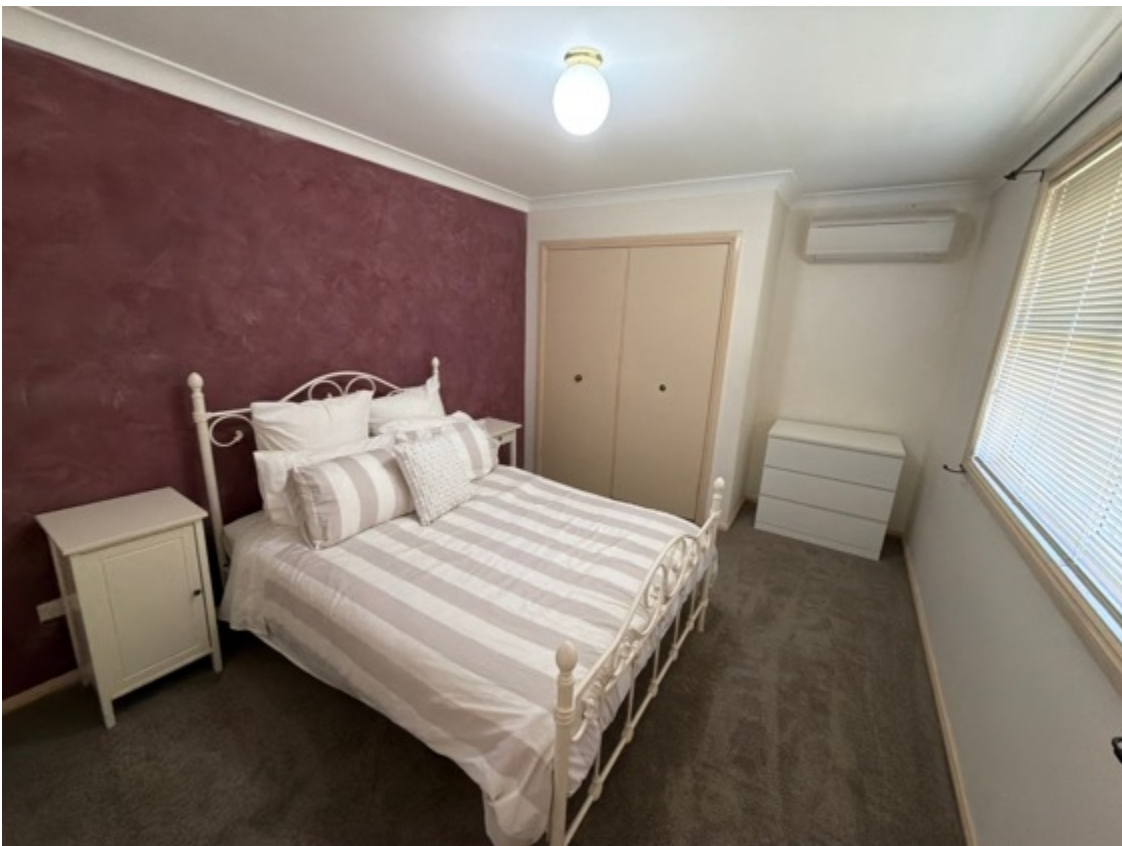
Internal carpet displays low to moderate level wear and sections squeak under foot, consistent with age.
