# **PRE-PURCHASE PROPERTY INSPECTION BUILDING REPORT**

**Visual Pre-Purchase Building Inspection Report.**

| <b>Inspection address:</b> | 14 Sherridon Crescent Quakers Hill. |
| <b>Inspection Date:</b> | <u>Date: 12.3.26 Arrival time: 2:00pm - Departure time: 3:30pm.</u> |

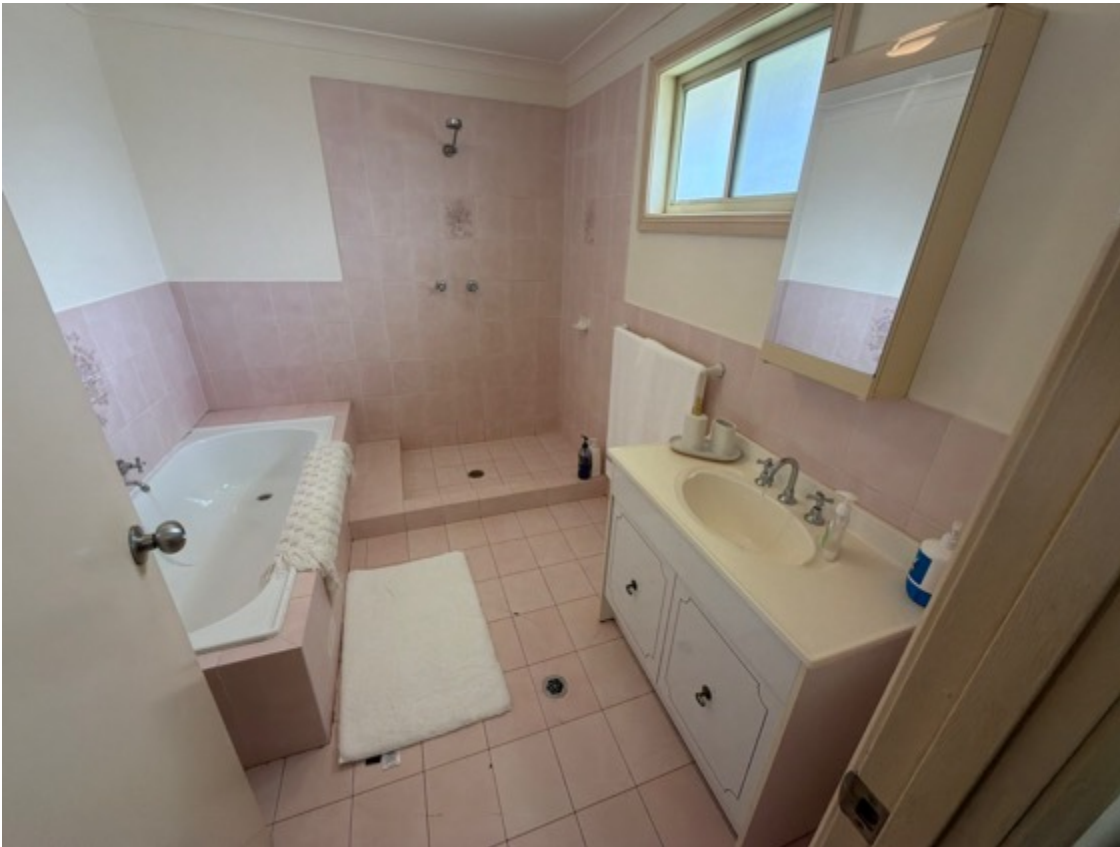
The first floor common bathroom area tested for leaks, fixings and stability was issue free at the time of inspection.

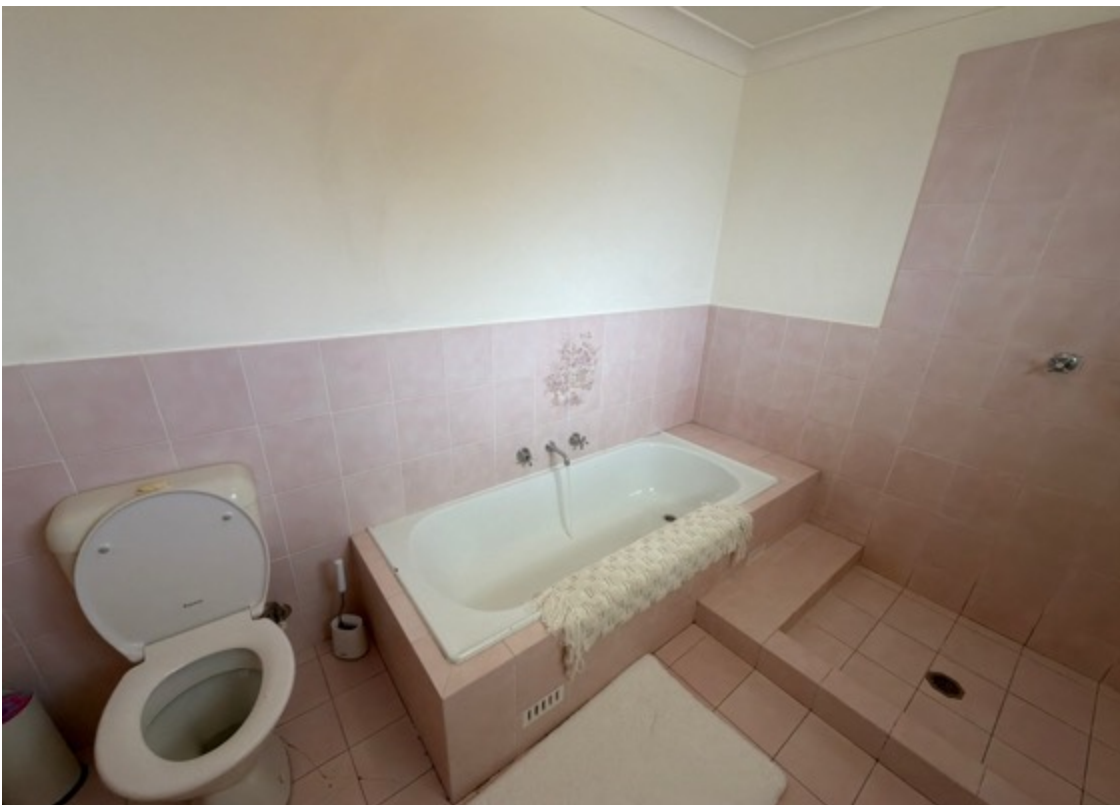
Hot and cold water services tested, functioned at the time of inspection.

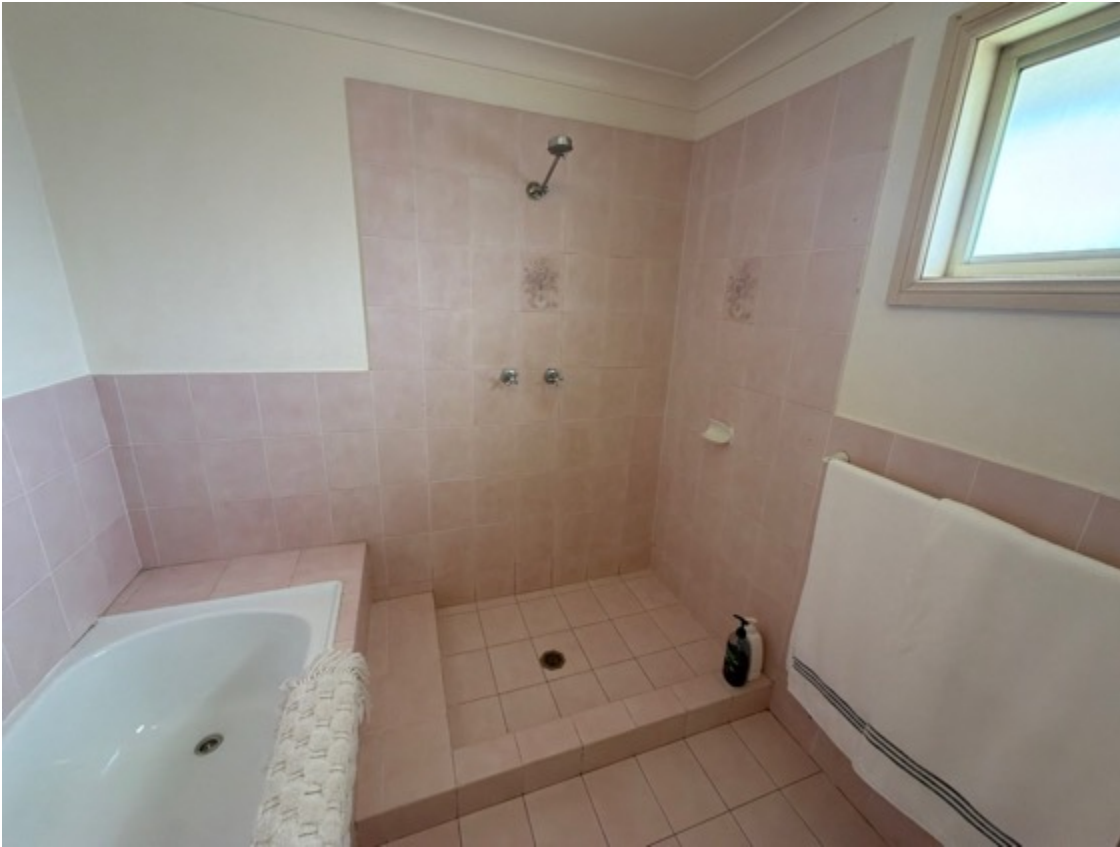
Water pressure tested, is sufficient.

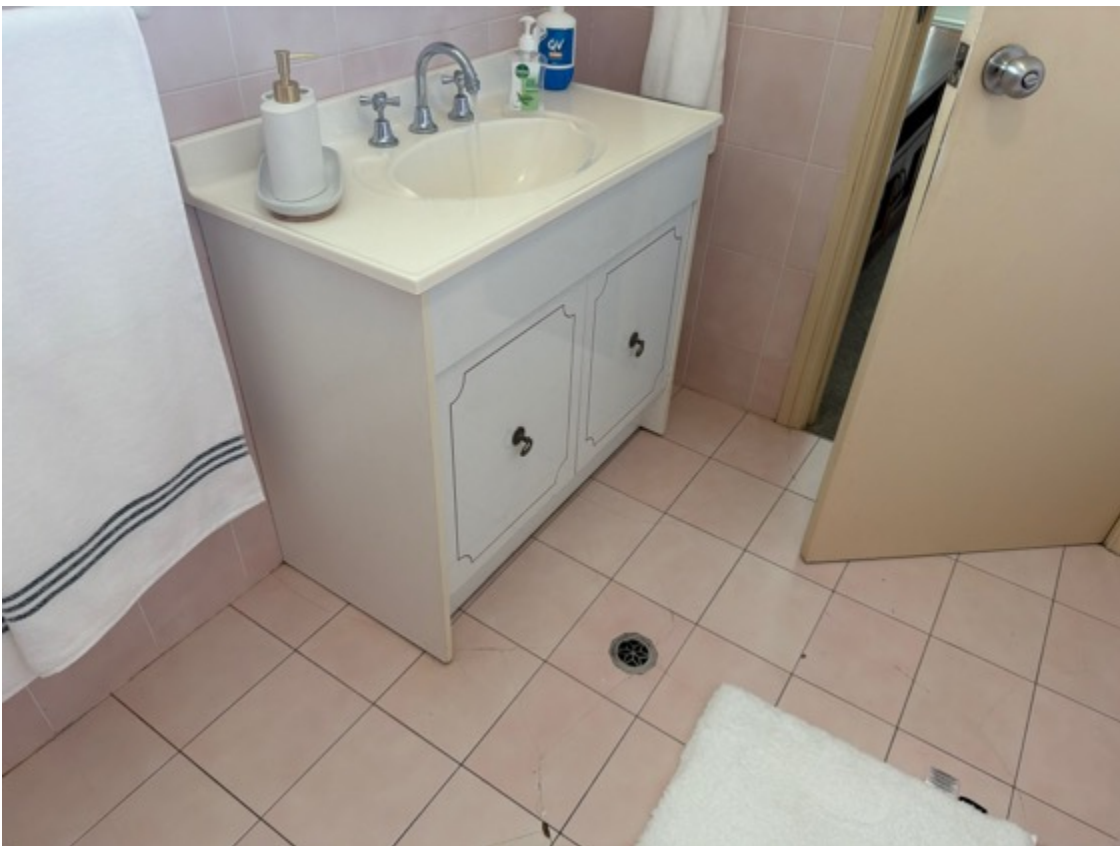
The vanity displays low level wear and sections of tiles are cracked, consistent with age.

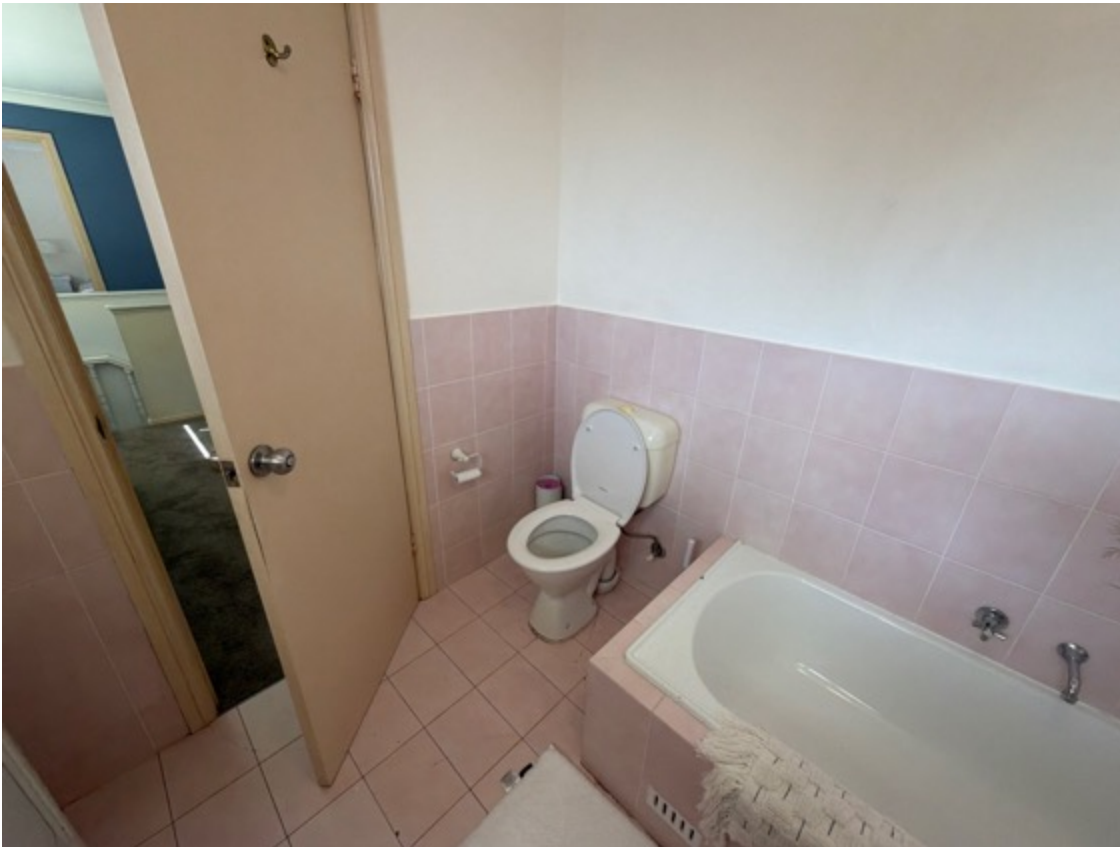
The common toilet tested, functioned at the time of inspection.

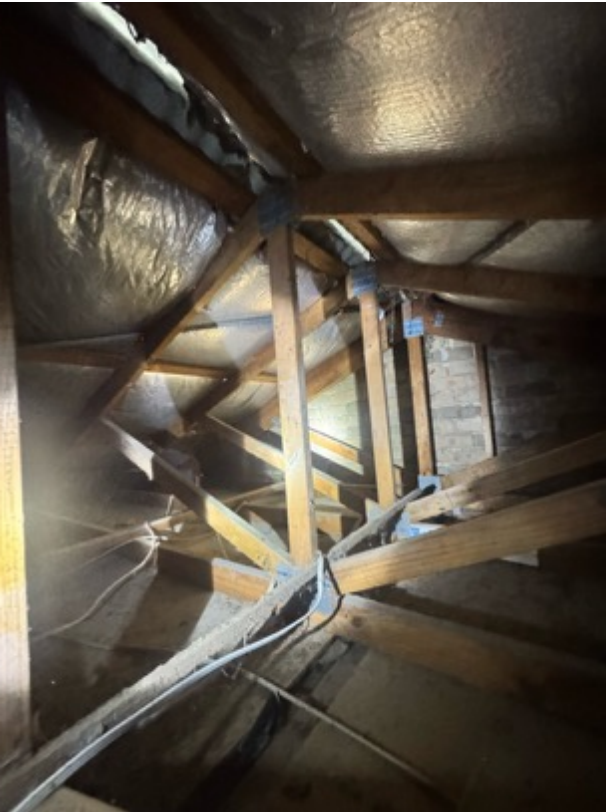
All areas within the roof space were dry at the time of inspection.
