# PROPERTY INSPECTION PEST REPORT

## Visual Timber Pest Inspection Report.

**14 SHERRIDON CRESCENT QUAKERS HILL.**

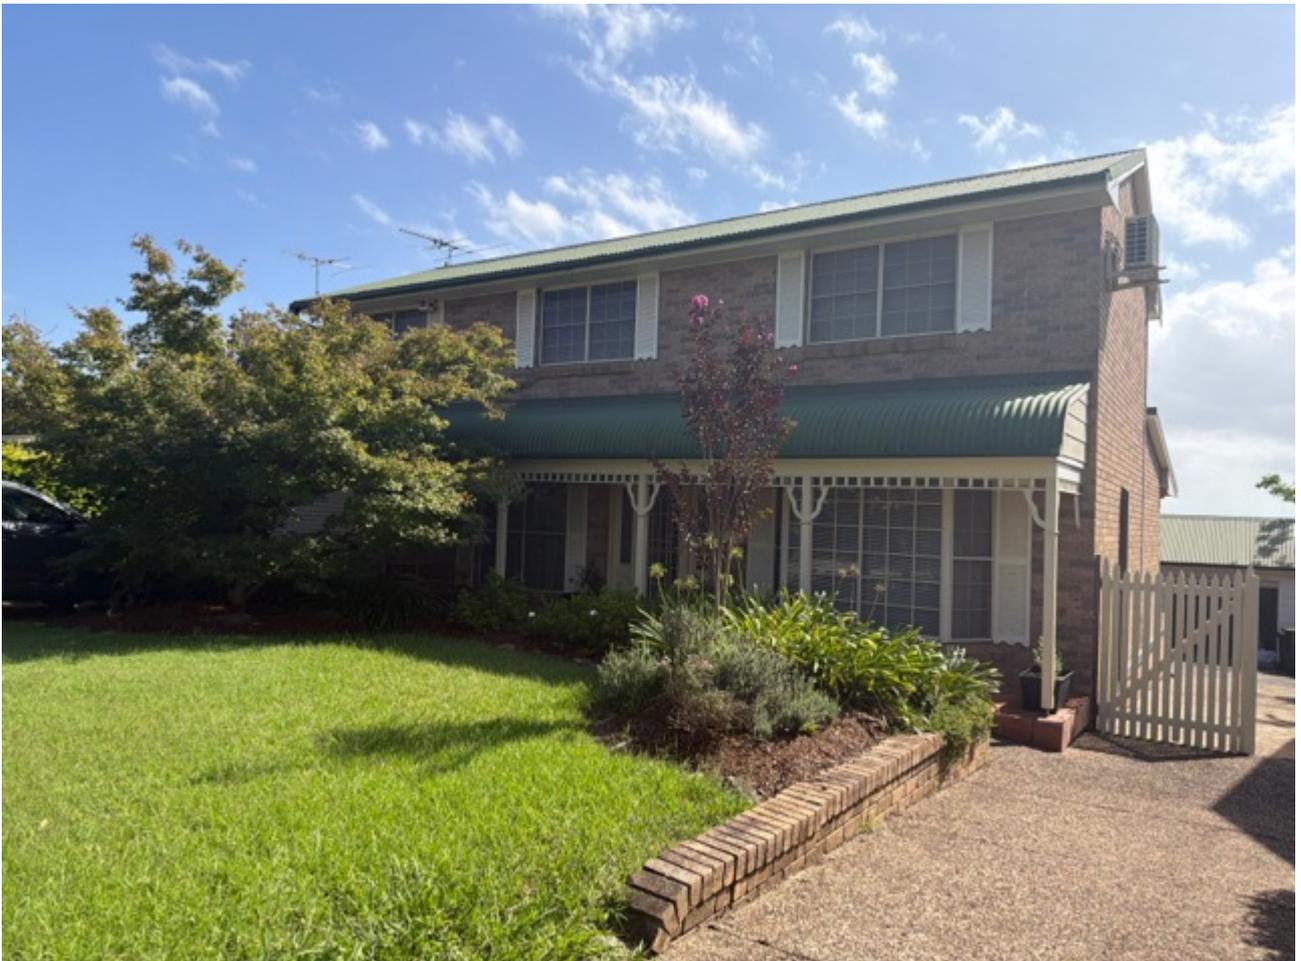
Front elevation of the Inspected property inspected.
