PRE-PURCHASE PROPERTY INSPECTION BUILDING REPORT

Visual Pre-Purchase Building Inspection Report.

| Inspection address: | 49 Sparman Crescent Kings Langley |
| Inspection Date: | Date: 12.3.26 Arrival time: 9:00am - Departure time: 10:00am. |

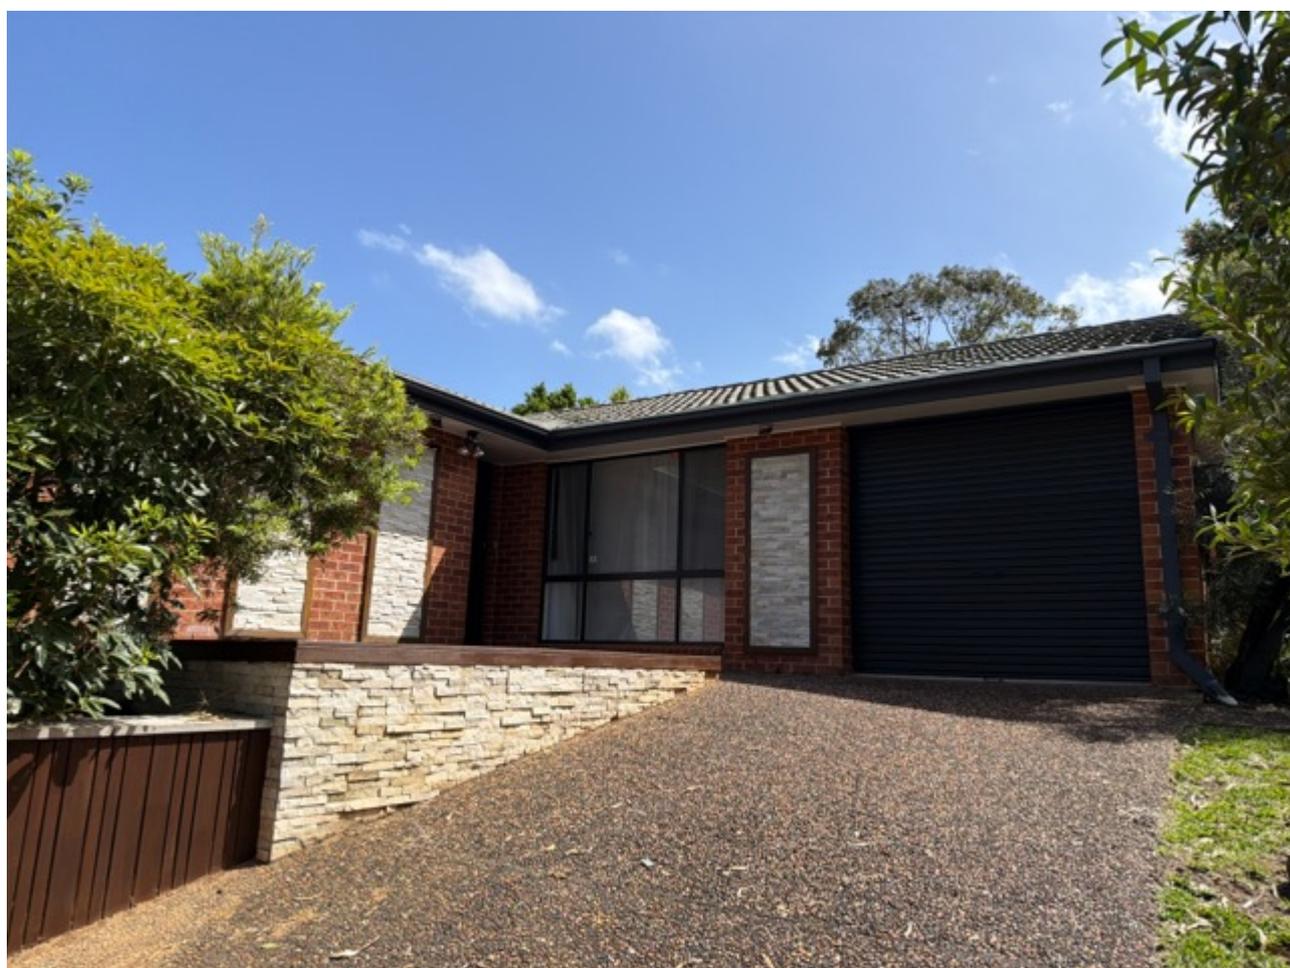
49 SPARMAN CRESCENT KINGS LANGLEY

Front elevation of the Inspected property inspected.

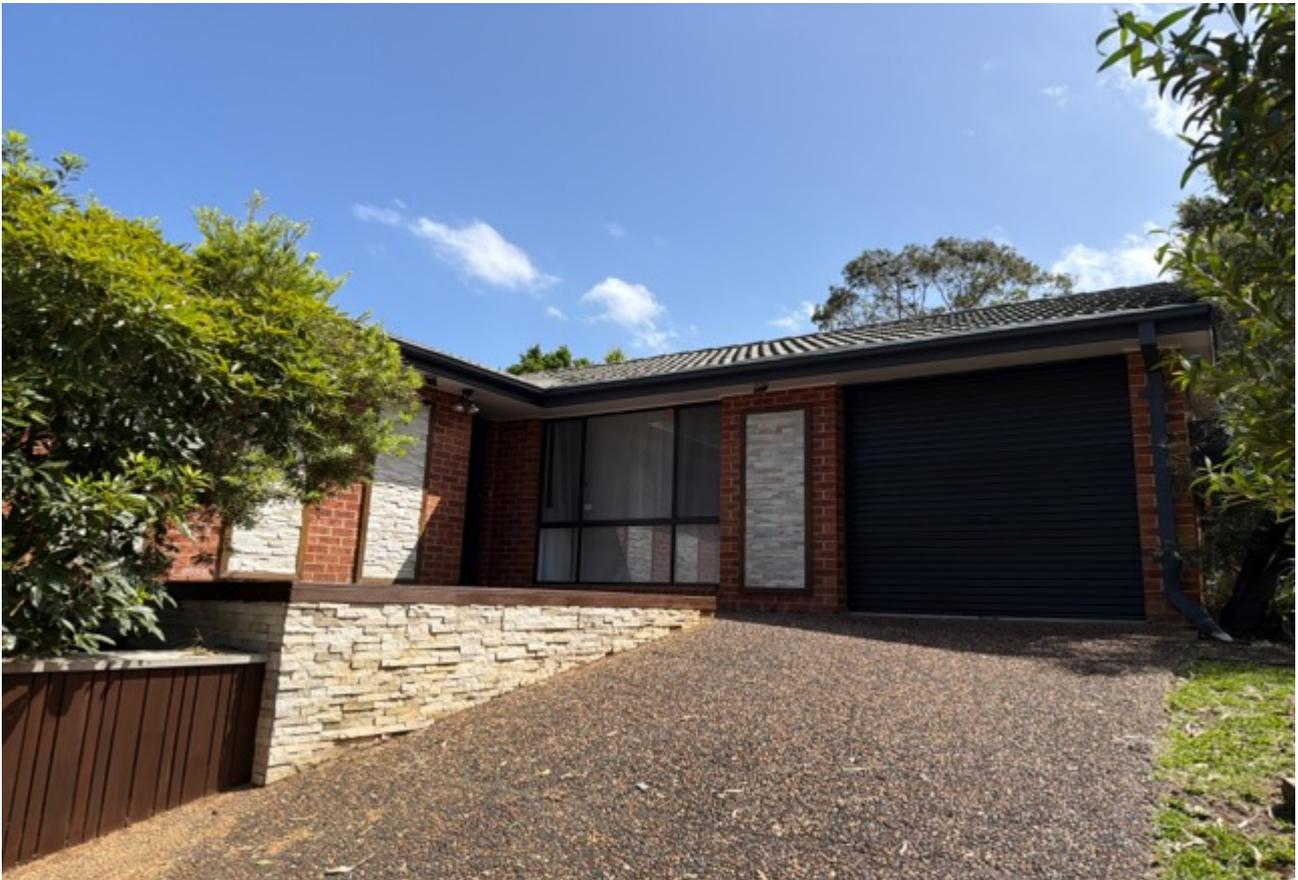
The exterior of the house presents in satisfactory condition for the age.

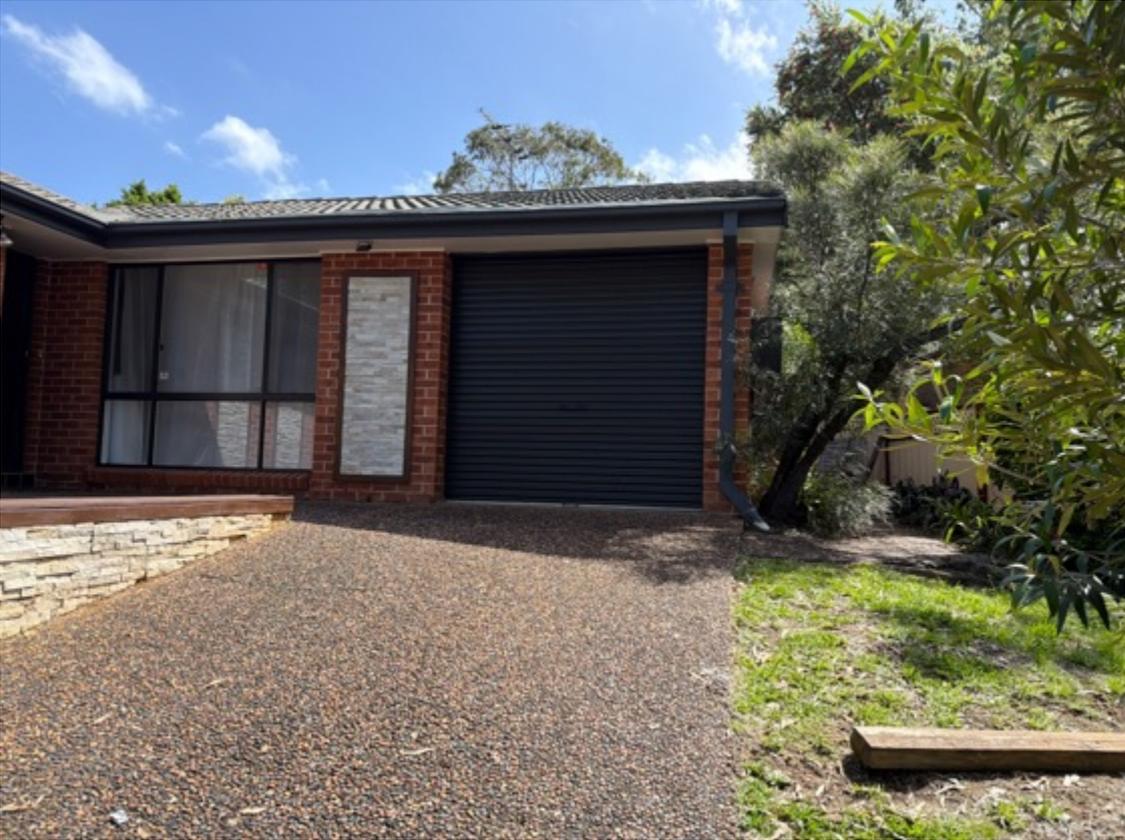
The garage roller door tested, functioned at the time of inspection - minor dents, consistent with age.

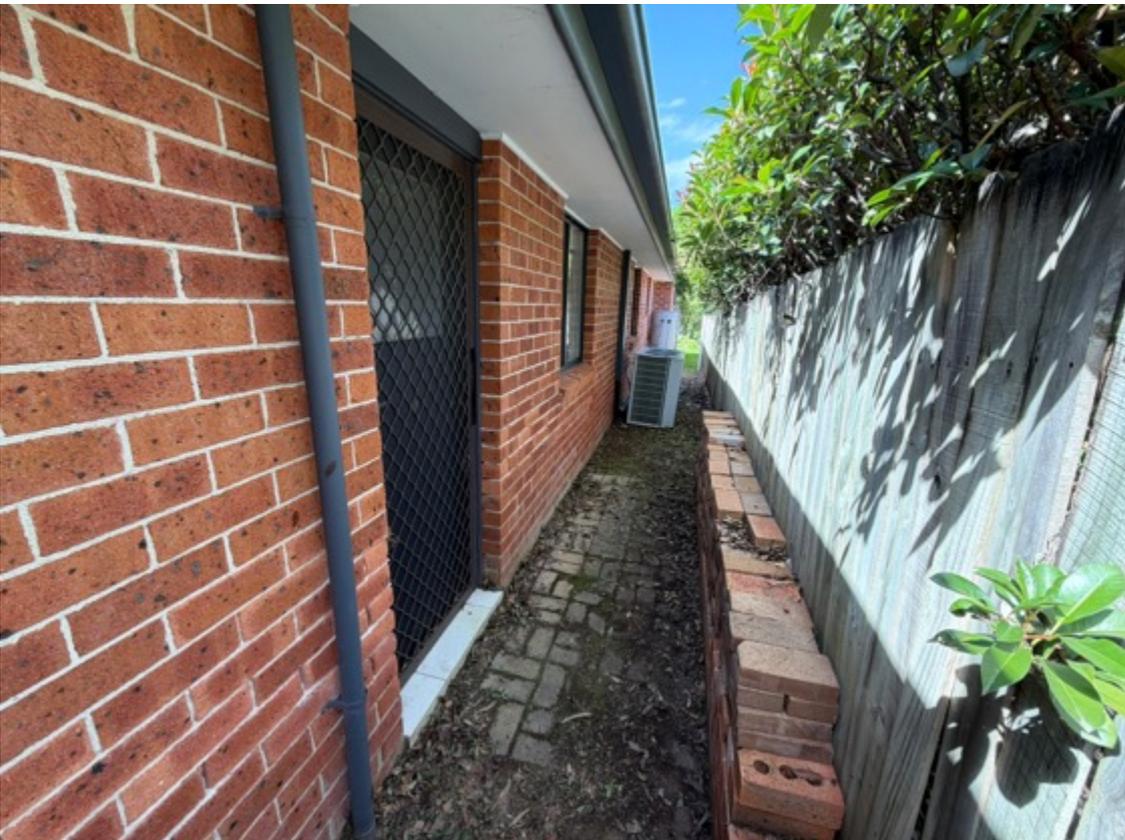
Exterior windows and doors present in satisfactory condition for the age.

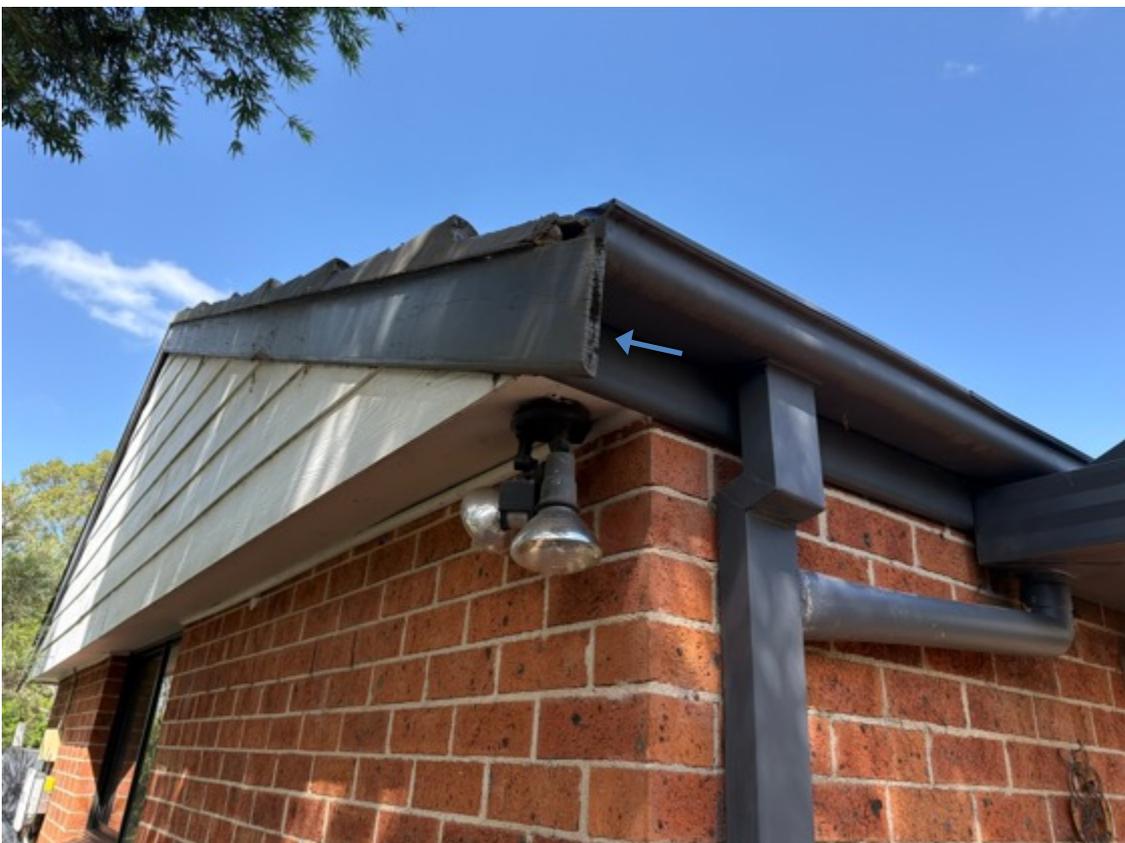
Exterior timber displays moderate level weathering - consistent with age.

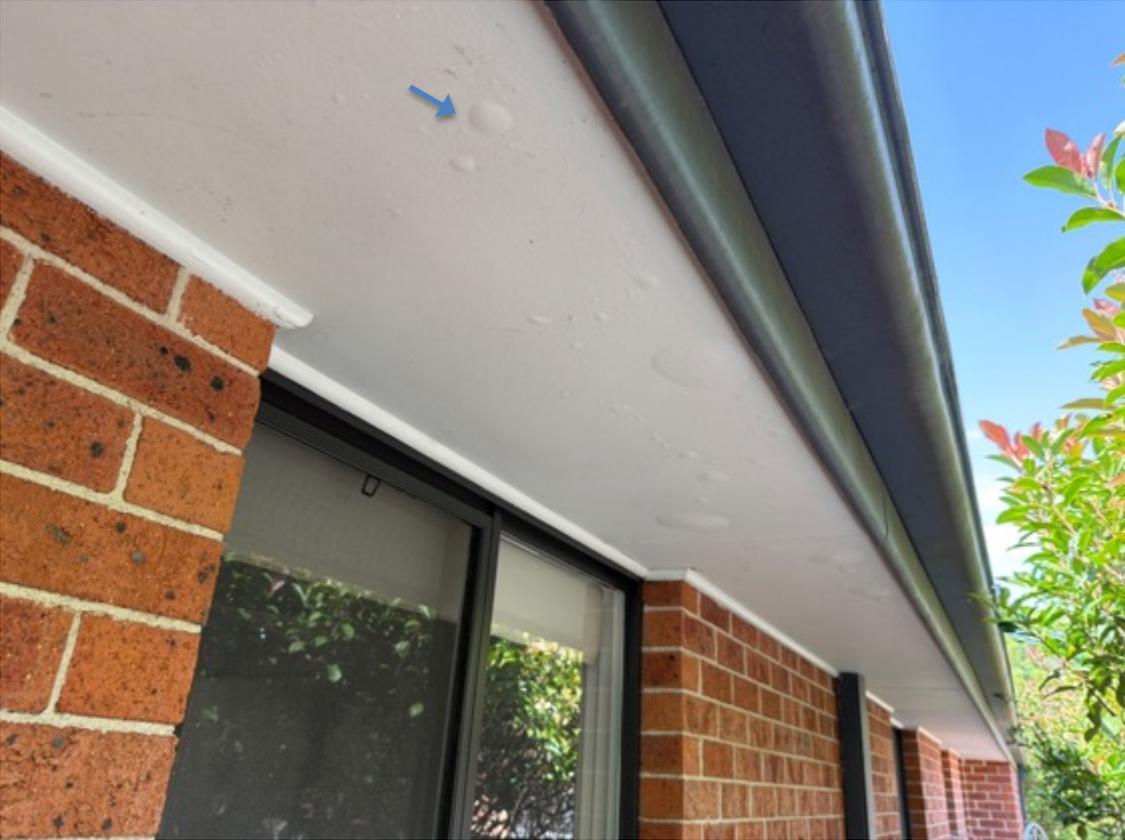
Left side elevation mid section eaves lining has bubbling paint - water ingress visible.

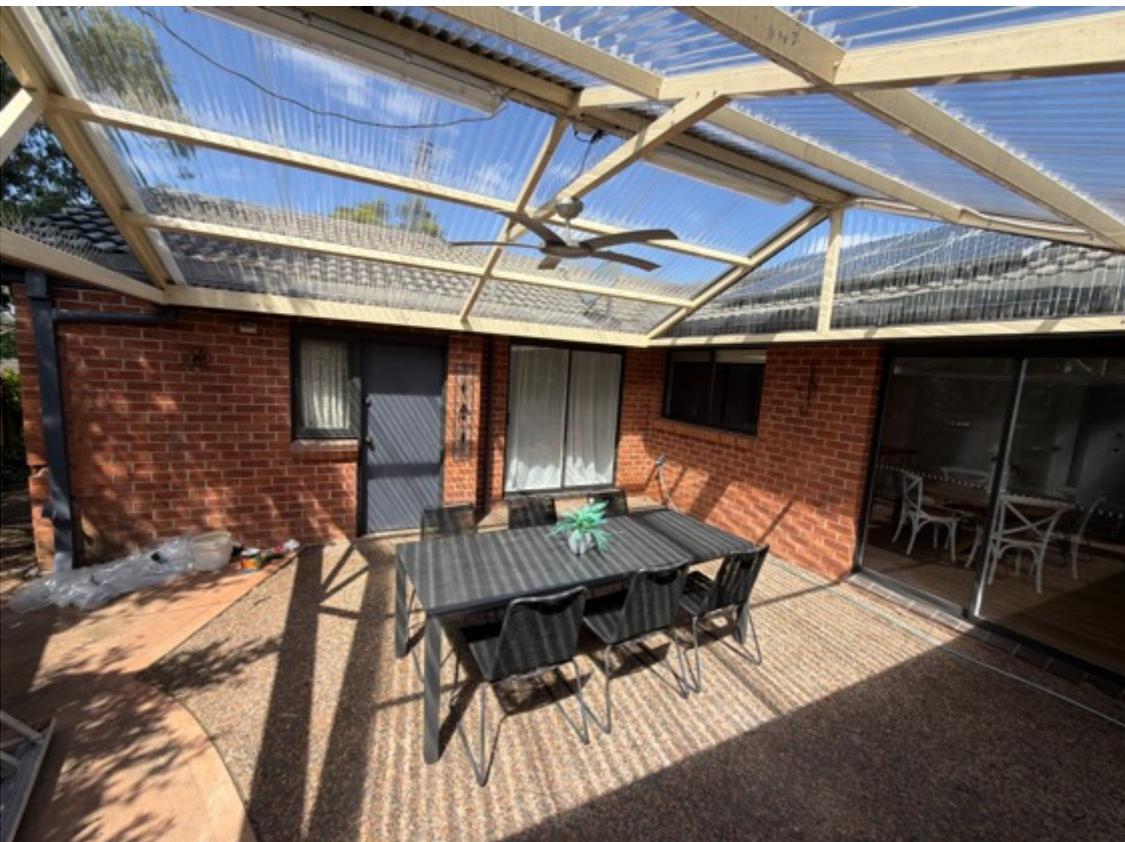
The rear pergola checked is structurally sound.

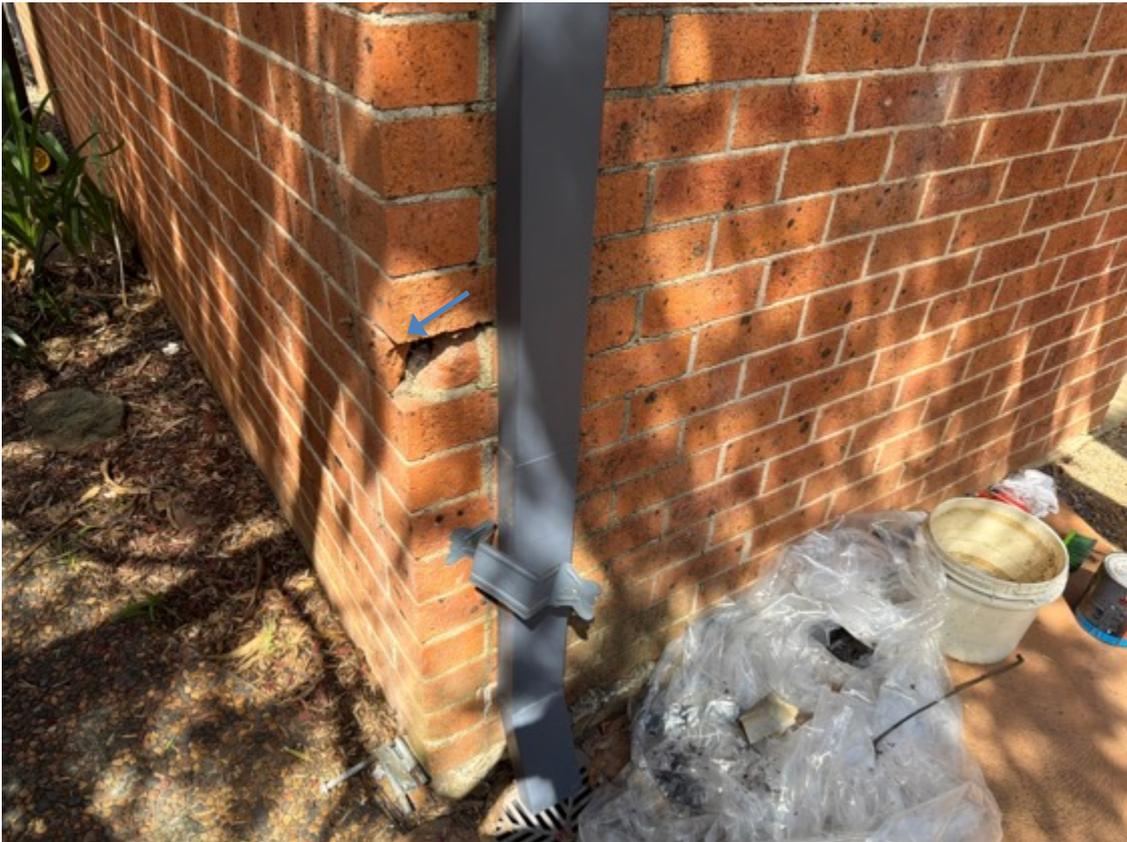
One rear right side elevation brick has damage here.

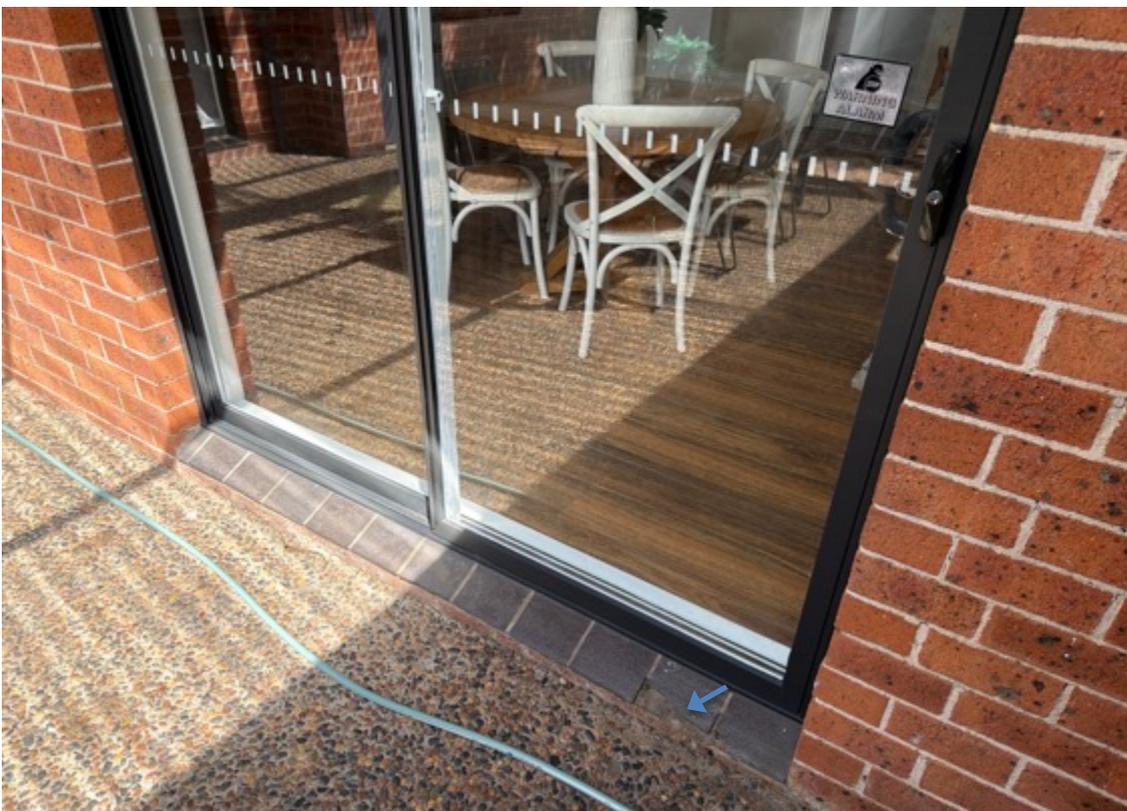
Isolated sections of external tiles are cracked, consistent with age (rear sliding door threshold example above.)

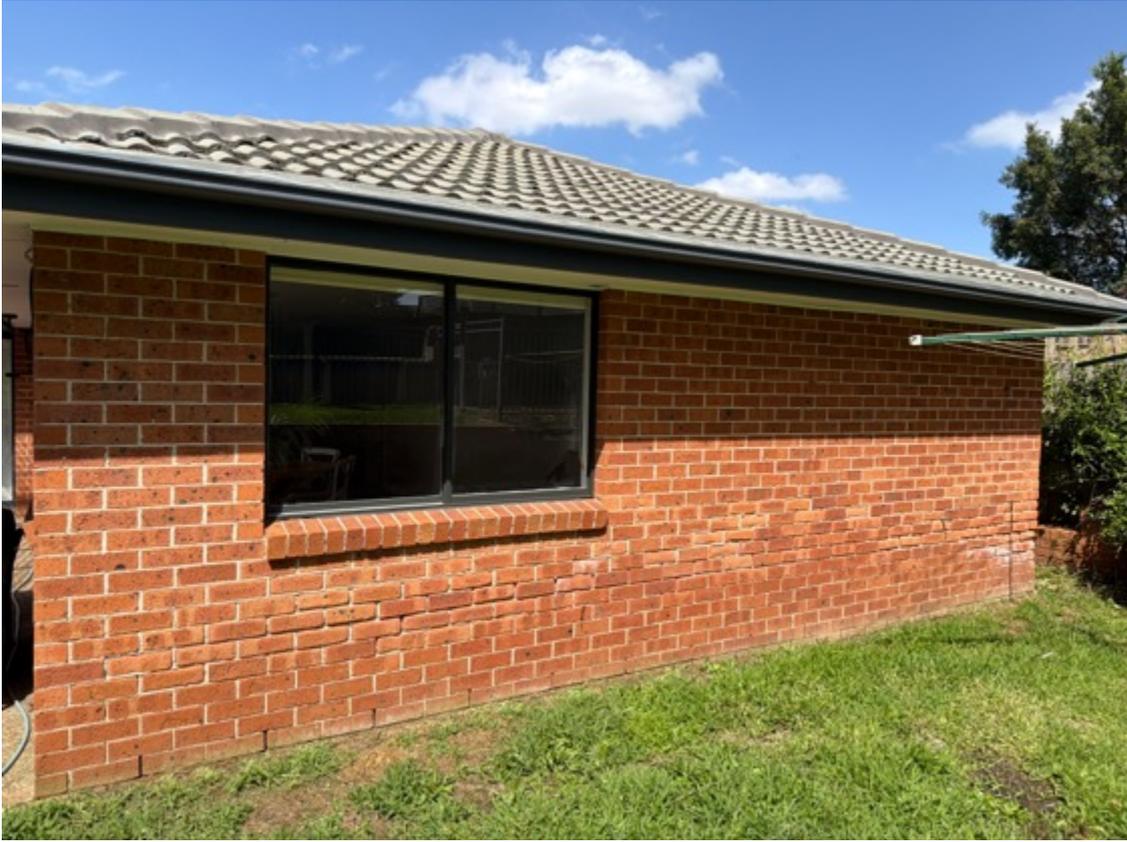
Sections of external brickwork has fretting - salt attack visible (remedial works required.)

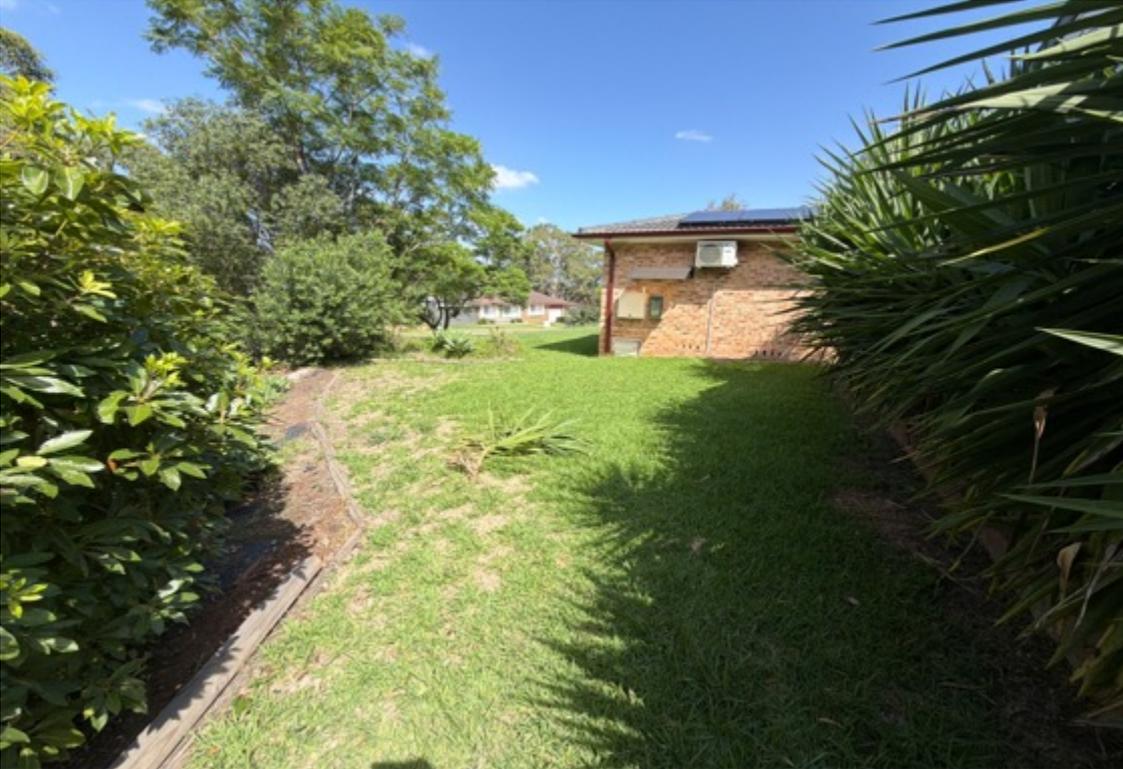
Site drainage / land overflow appears to function adequately with no signs of water laying at the time of inspection.

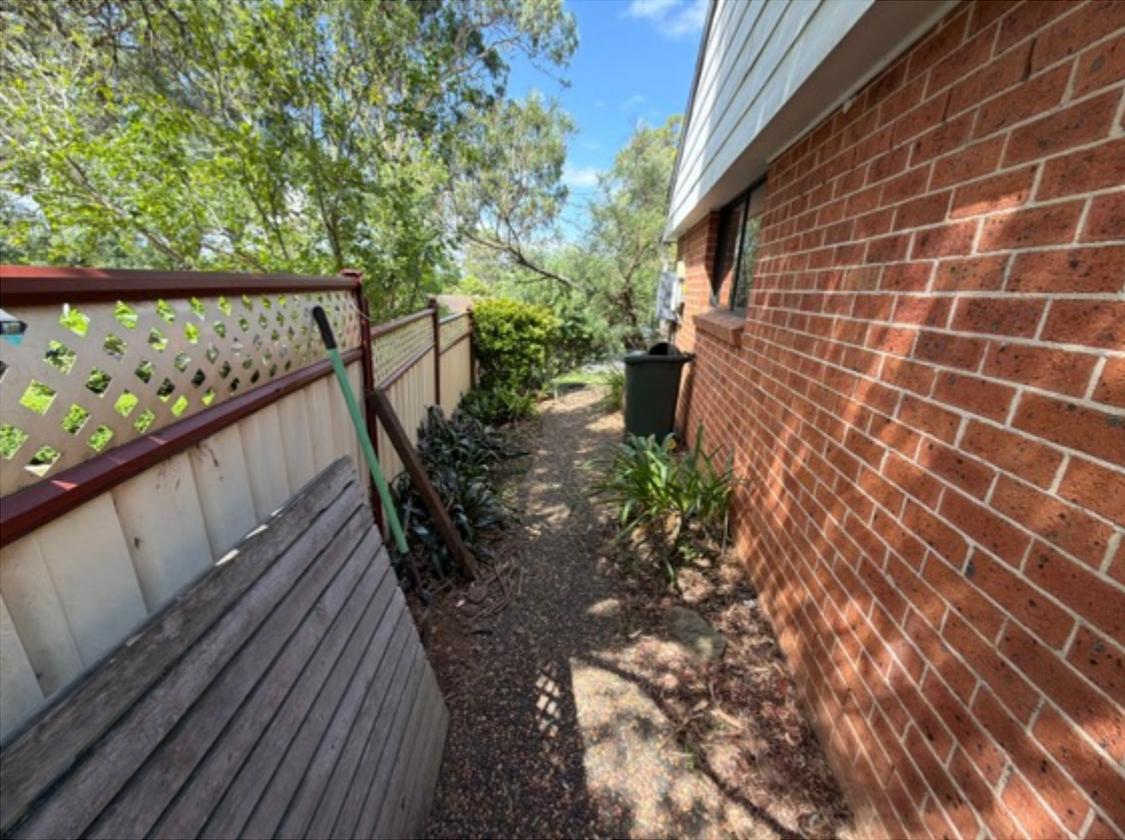
Site fences are in serviceable condition, isolated sections have minor dents (consistent with age.)

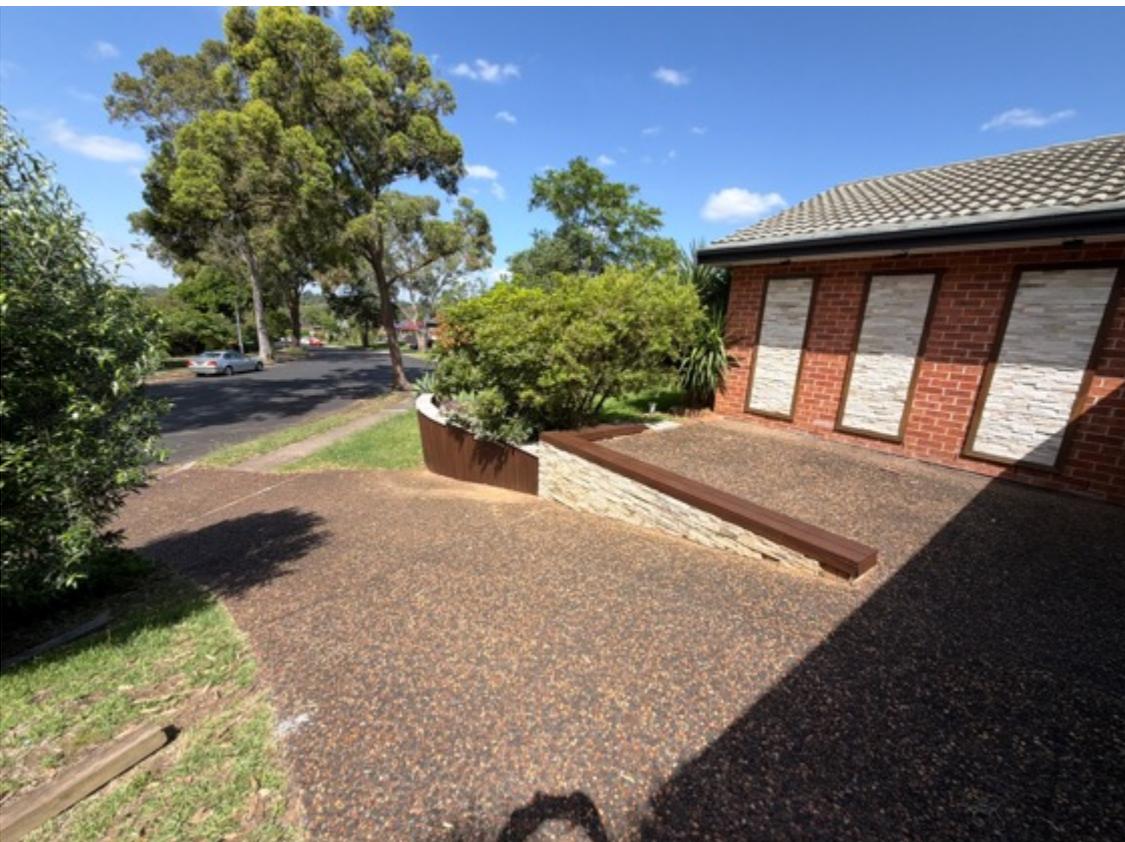
Isolated sections of exterior concrete displays typical shrinkage cracks and undulations - consistent with age.

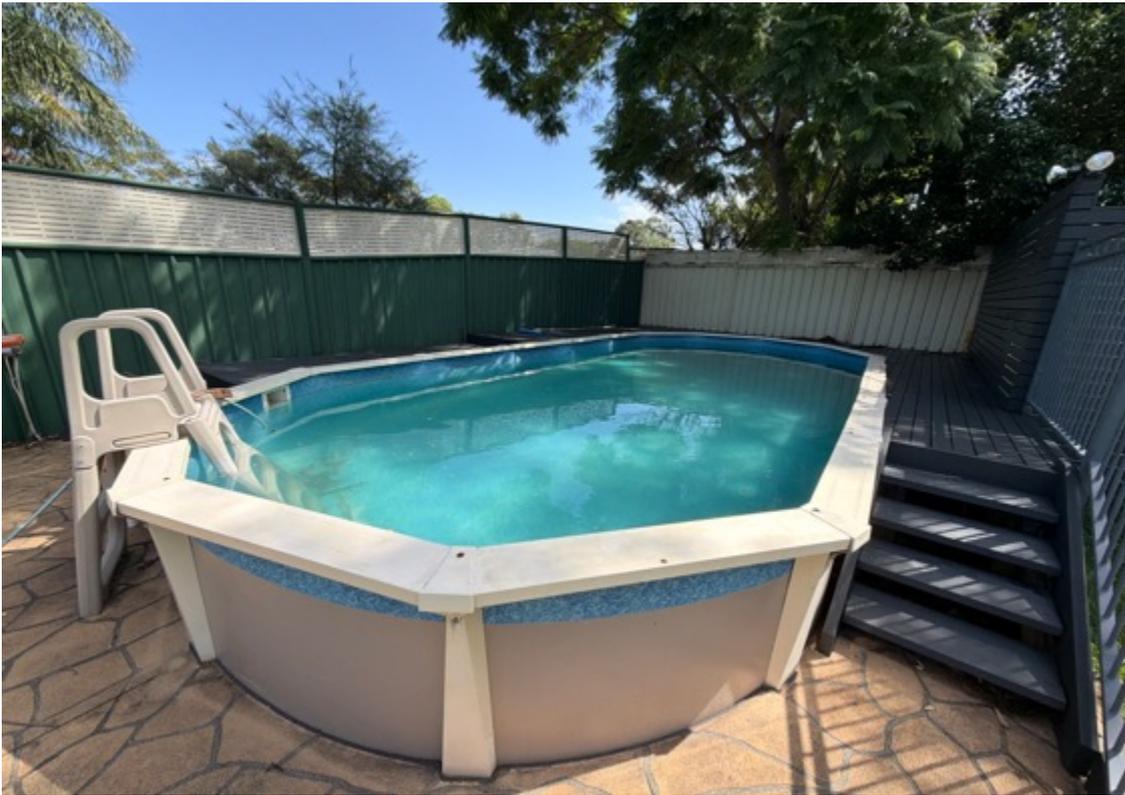
The pool area presents in satisfactory condition for the age.

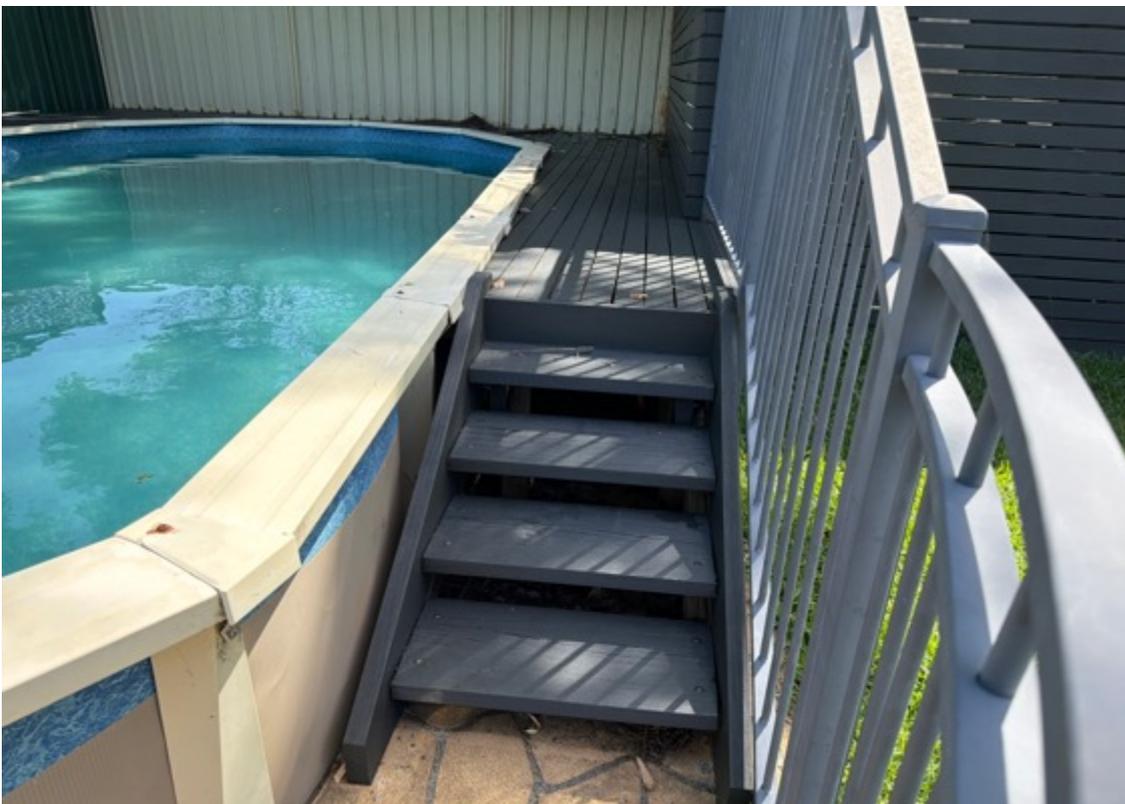
Decking boards display moderate level weathering, consistent with age.

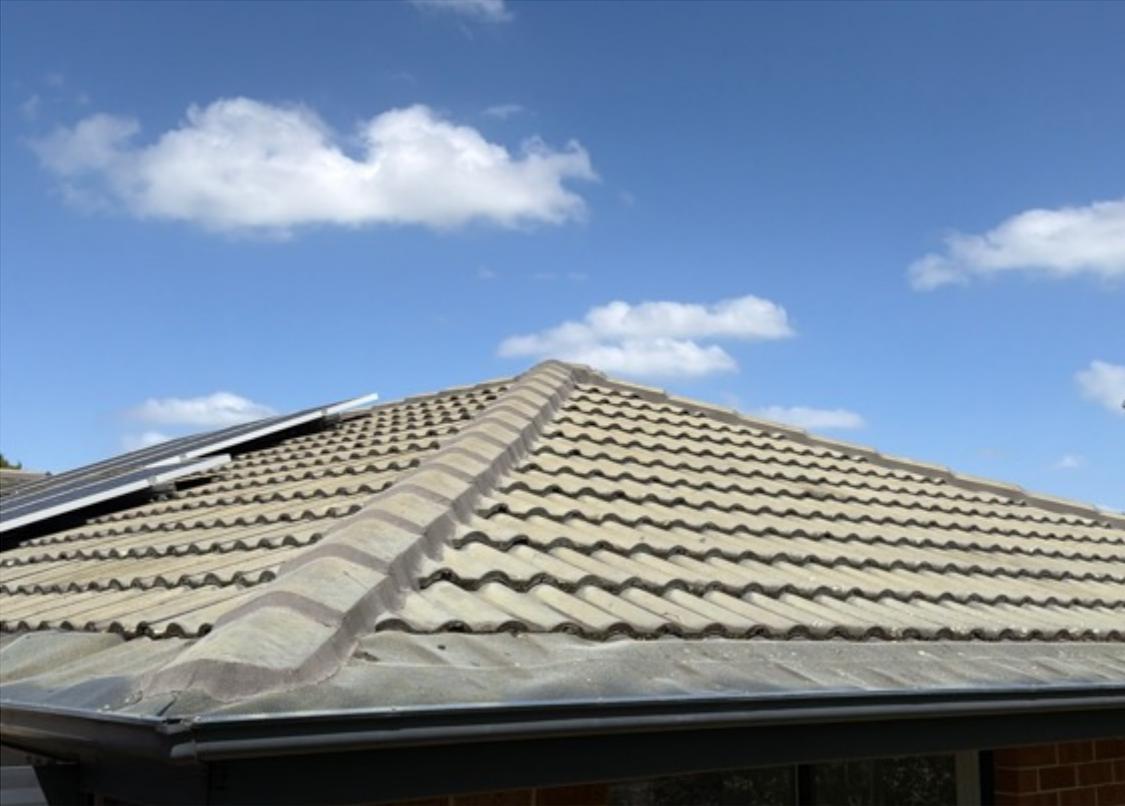
The roof exterior presents in satisfactory condition for the age.

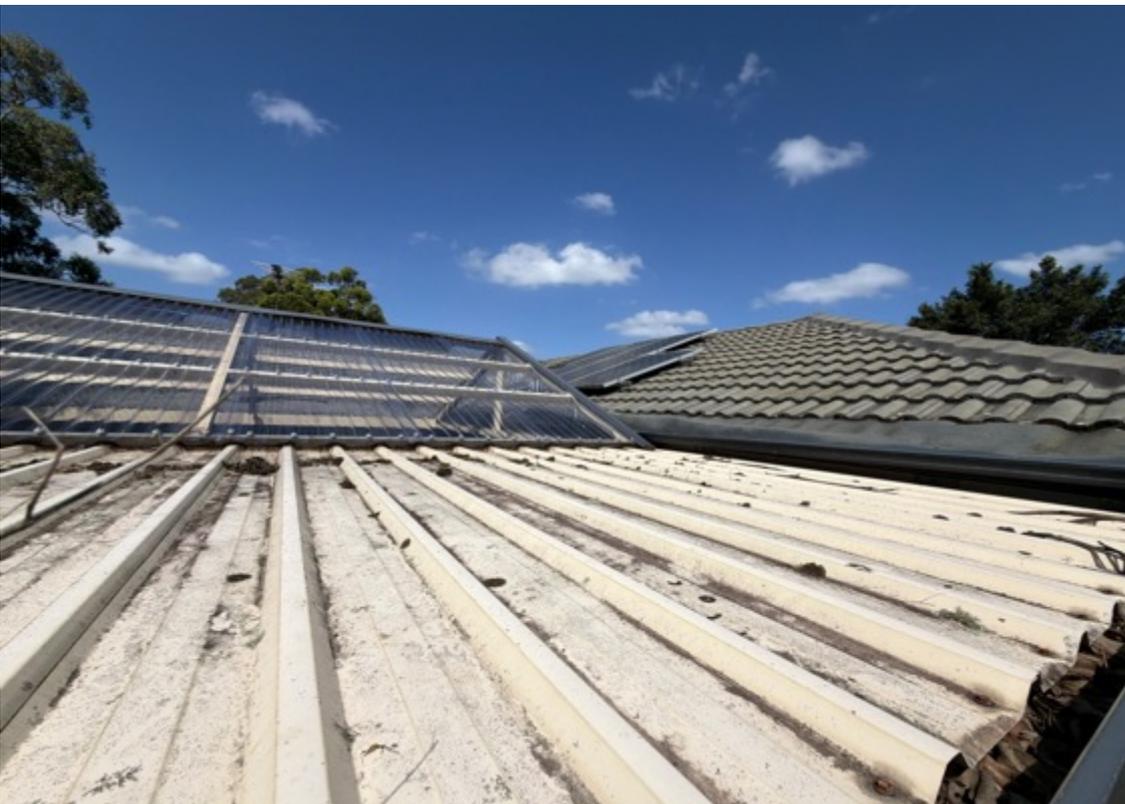
Rear sheet metal roof sheets present in satisfactory condition - isolated sections of roof tiles are chipped, consistent with age.

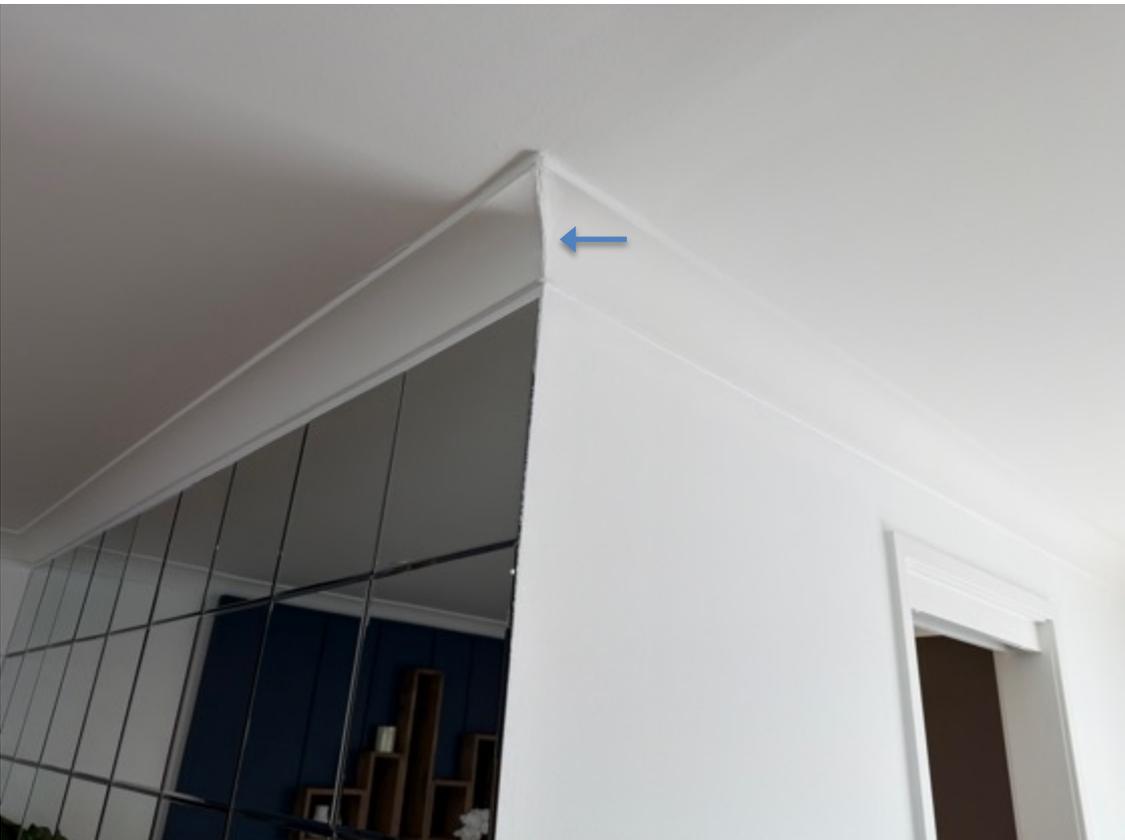
Isolated sections of plasterboard and cornices are cracking (dining room example above.)

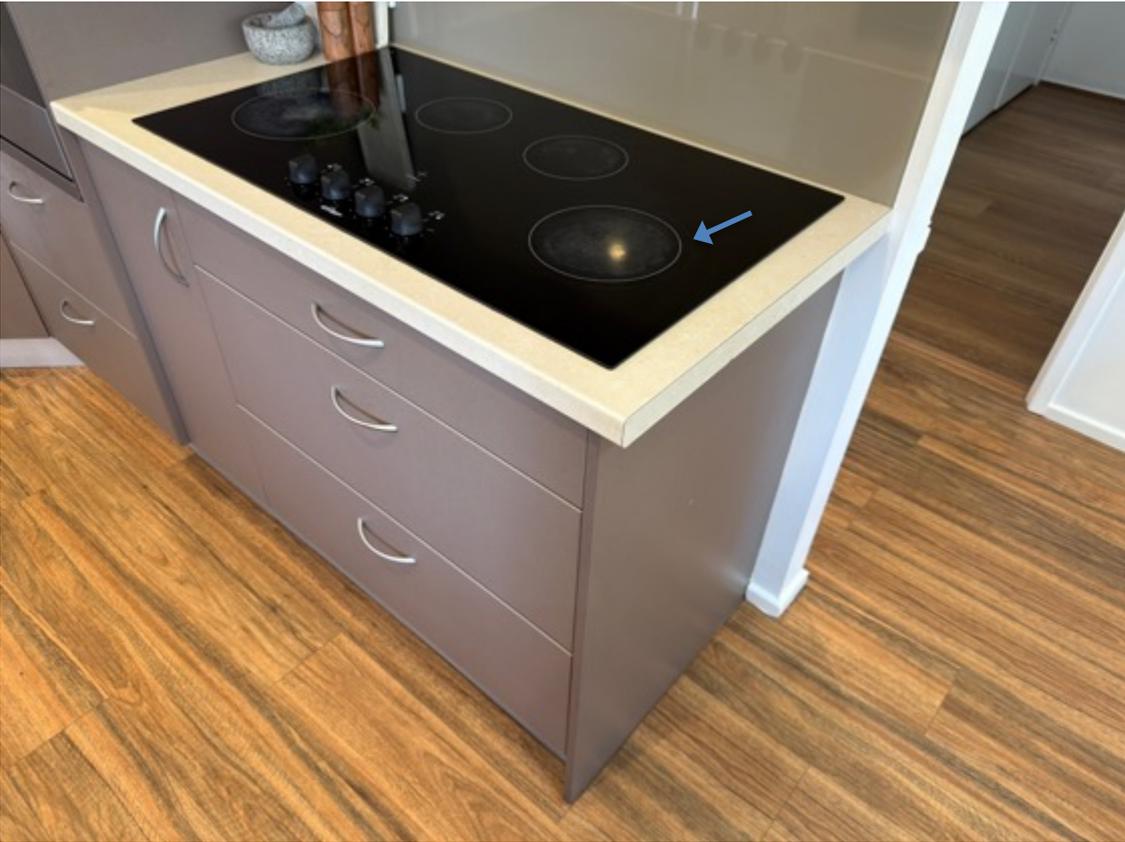
The glass cooktop surface and cabinetry display low level wear, consistent with age.

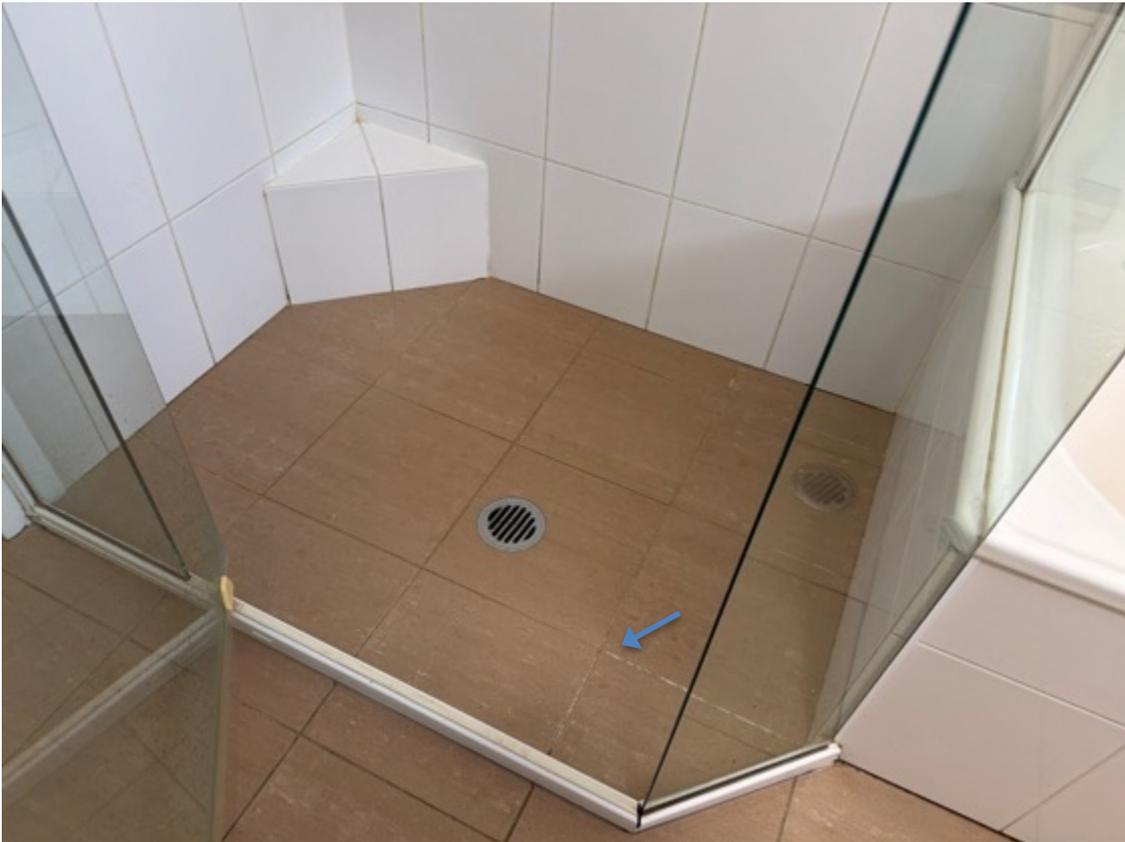
Tile grout and silicone is darkened, reapplication is recommended.

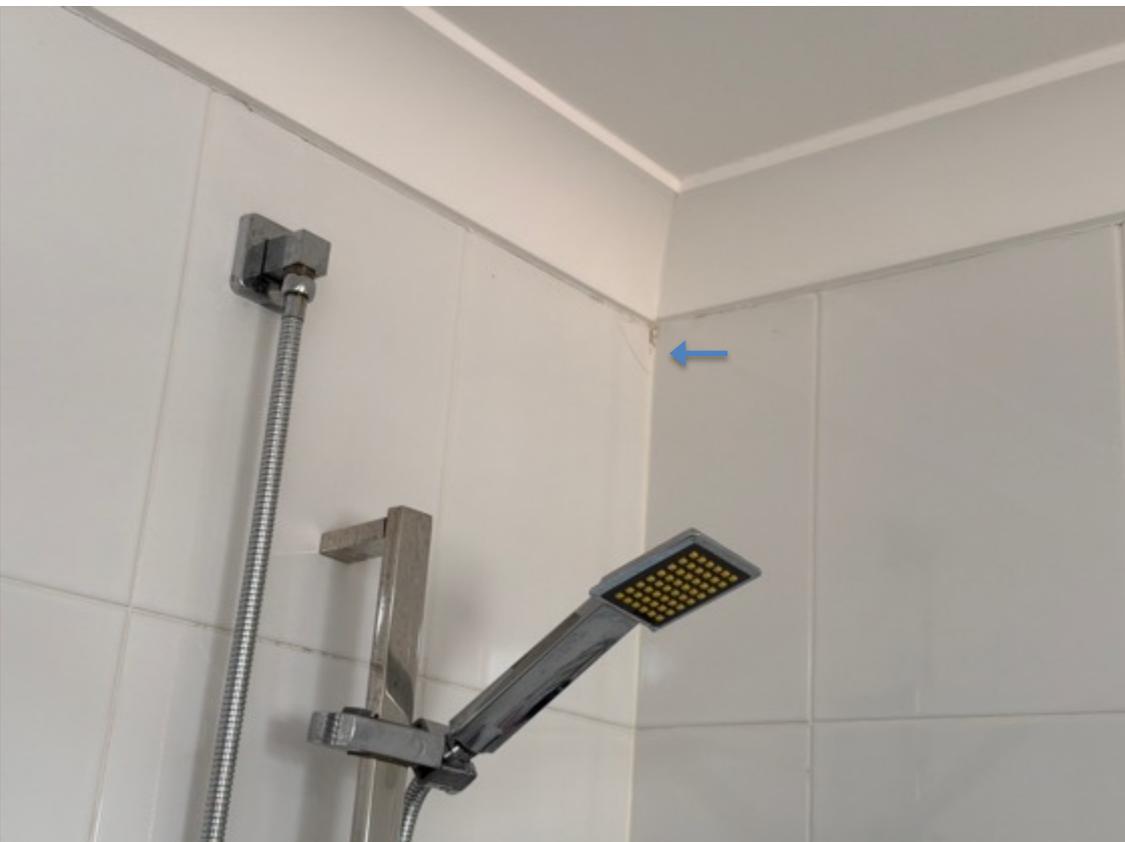
Isolated sections of tiles are cracked, consistent with age.

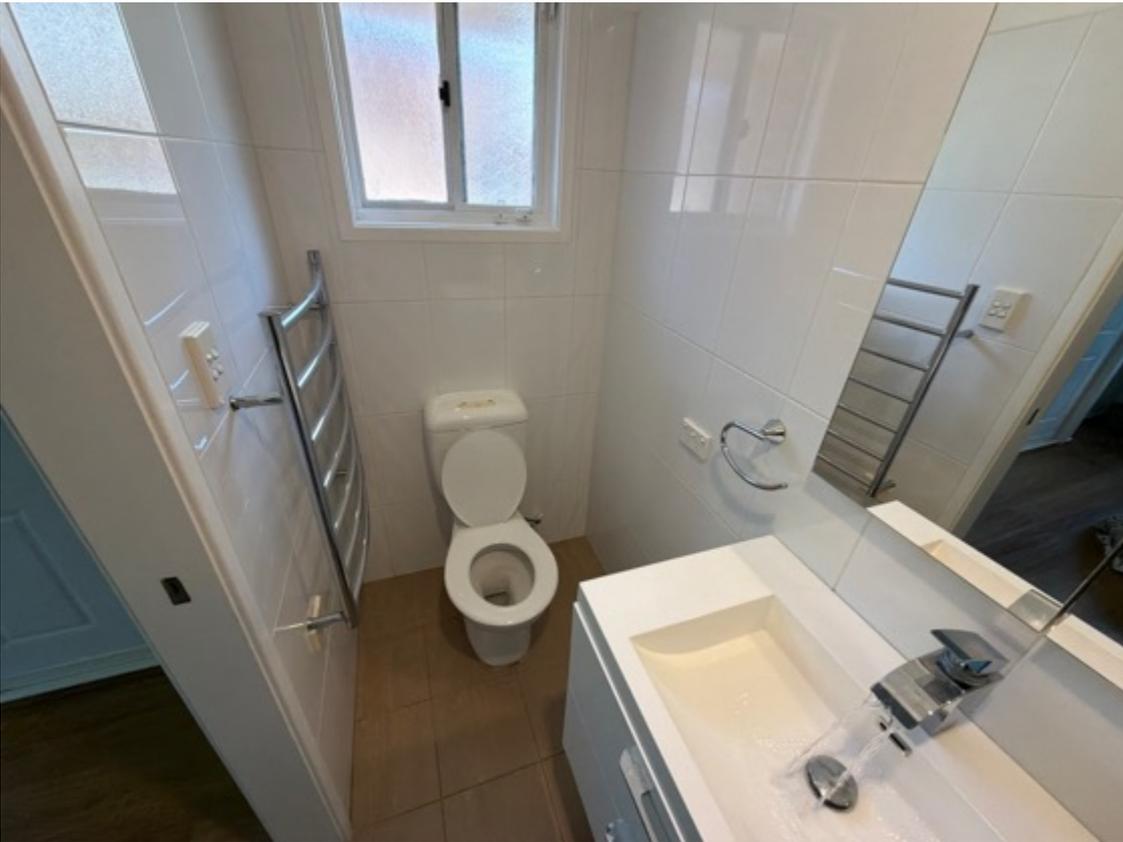
The ensuite bathroom area tested for leaks, fixings and stability was all clear at the time of inspection.

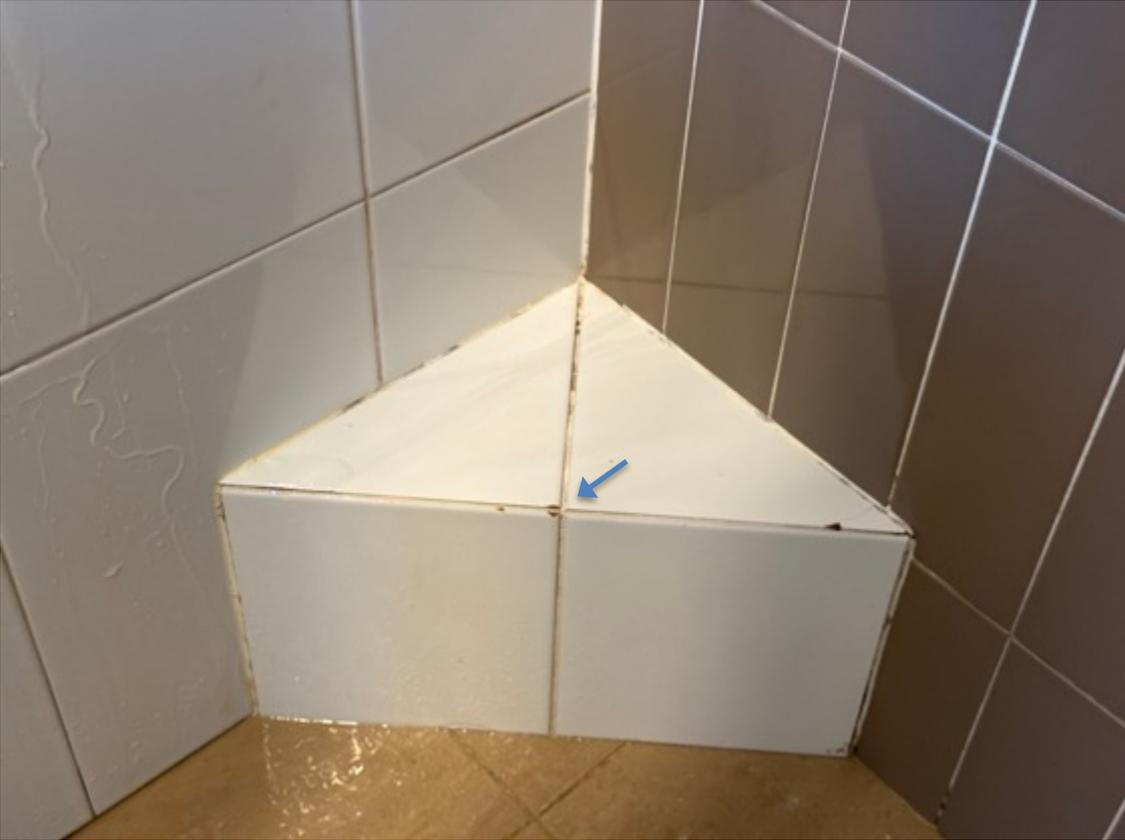
Isolated sections of tiles are cracked, consistent with age.
