PRE-PURCHASE PROPERTY INSPECTION BUILDING REPORT

Visual Pre-Purchase Building Inspection Report.

| Inspection address: | 49 Sparman Crescent Kings Langley |
| Inspection Date: | Date: 12.3.26 Arrival time: 9:00am - Departure time: 10:00am. |

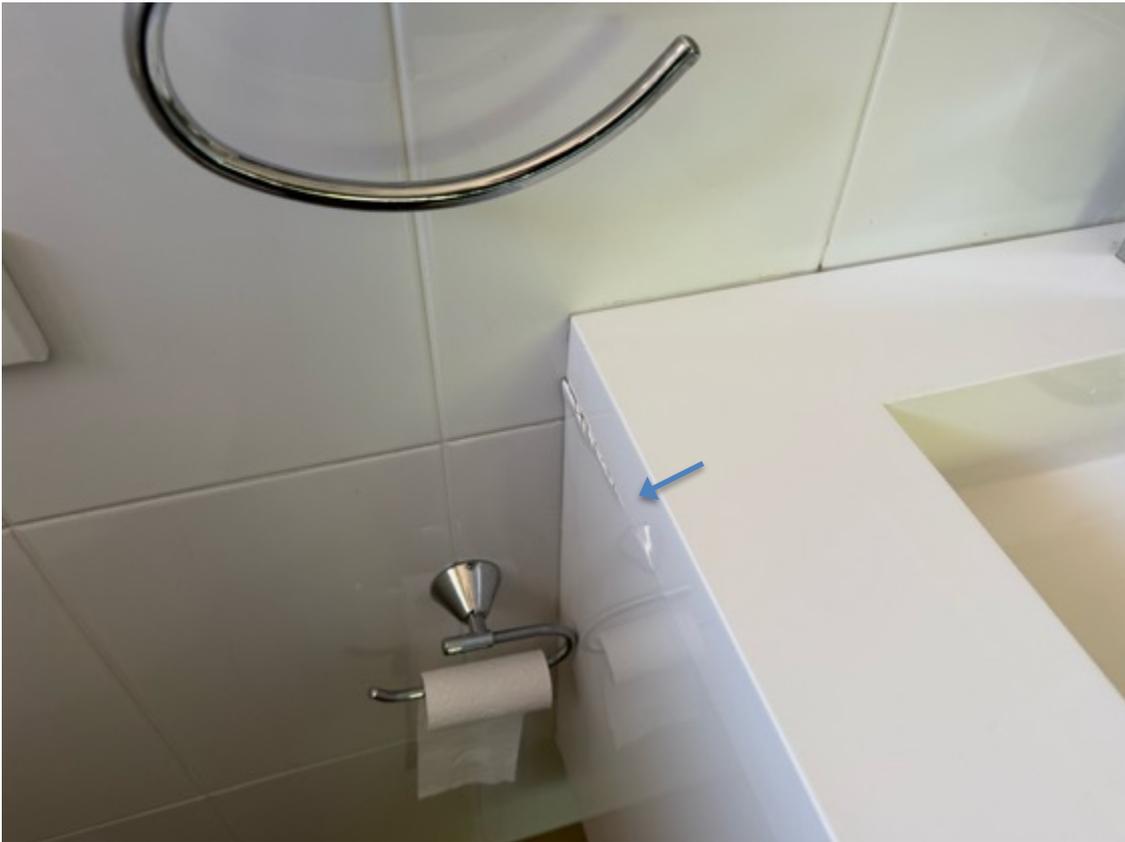
The vanity displays low level wear, consistent with age.

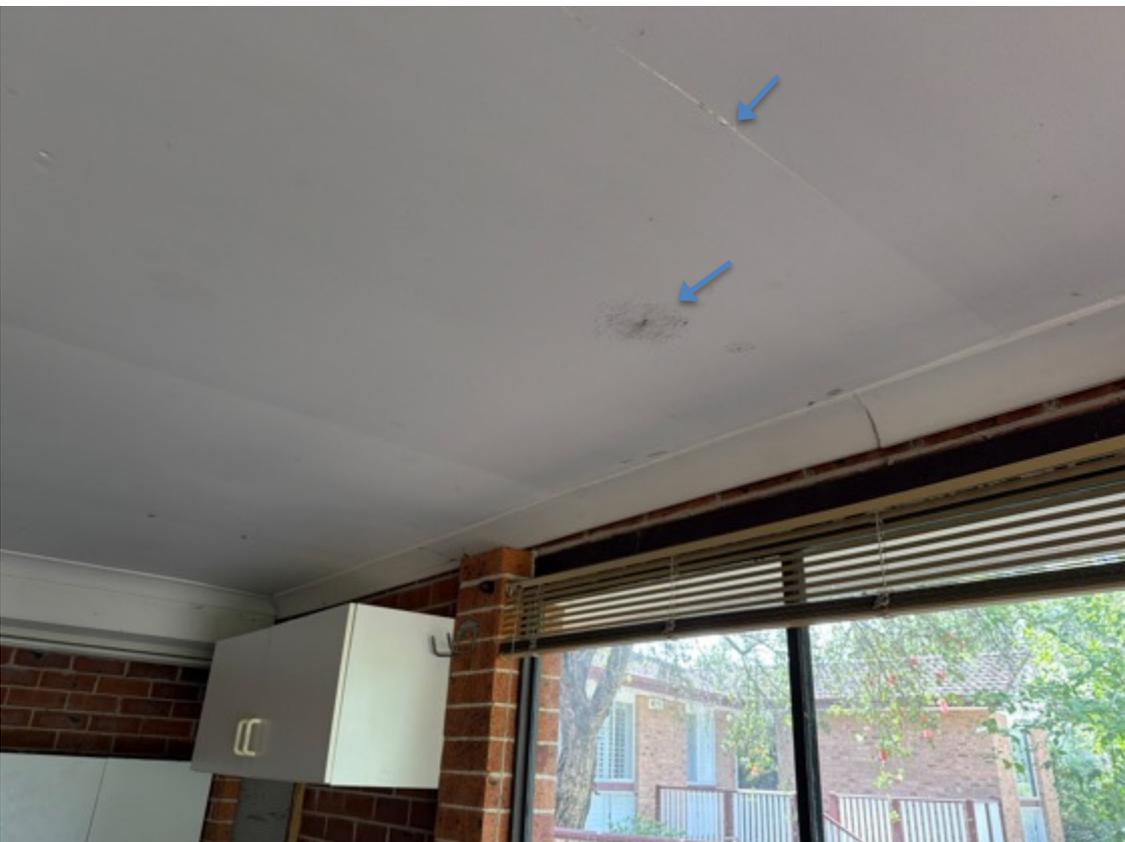
Plasterboard and cornices display imperfections, and cracking.

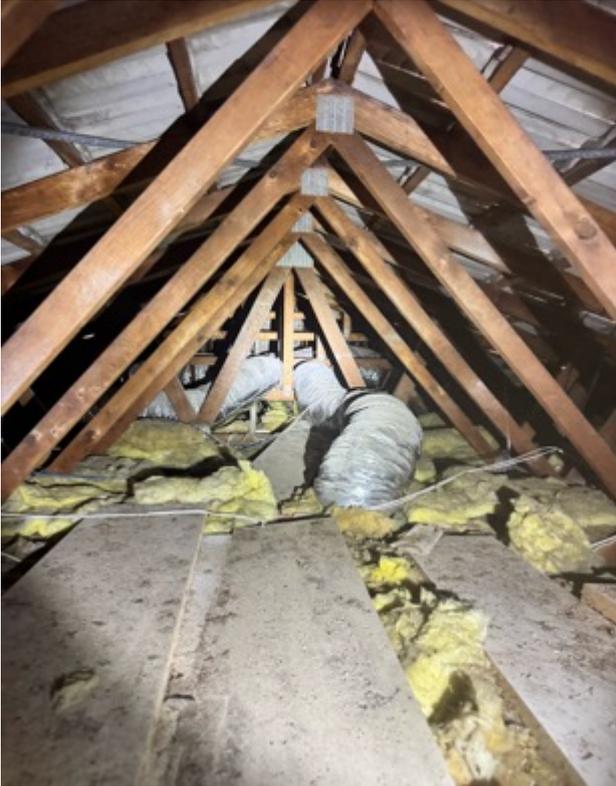
All areas within the roof space were dry at the time of inspection.
