Building and Timber Pest Inspection Report

Inspection Date: Tue, 27 May 2025

Property Address: 8 Clayton Pl, Girraween NSW 2145,
Australia

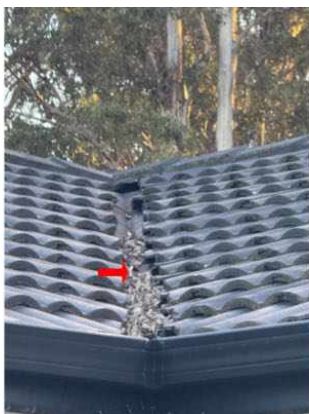
Finding 3.01

Blocked gutters are likely to lead to high levels of moisture in the affected areas. Such moisture will not only cause rust and decay of the associated building materials, but can also provide conditions that are conducive to termite and timber pest activity. Blockages in gutters should therefore be removed immediately to ensure dry conditions are maintained.

Consult a Licensed Plumber for further specific advice on remedial works that may be required. In the interim, it is highly advised that blocked gutters be removed by the homeowner or a general handyperson as a matter of urgency.

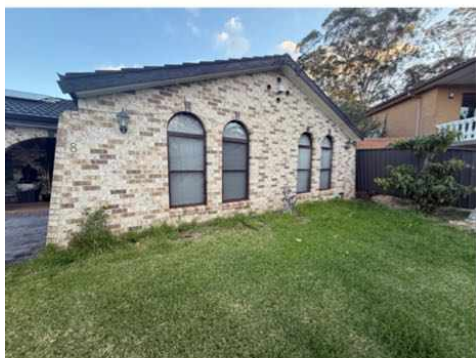
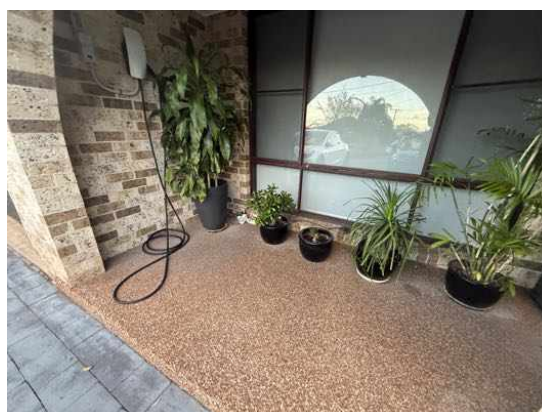
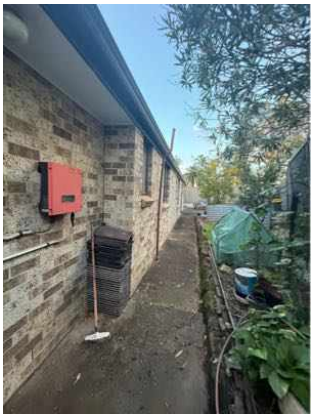
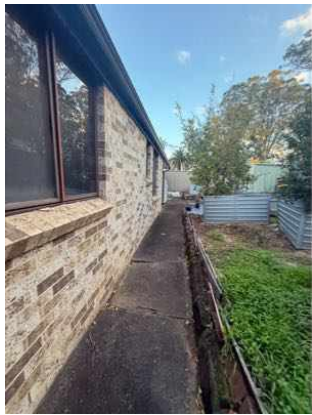
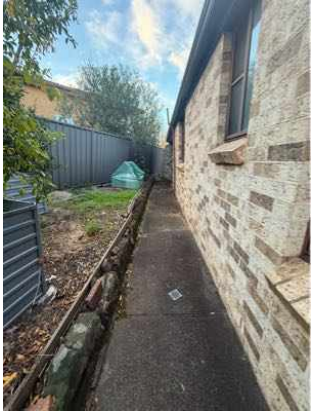
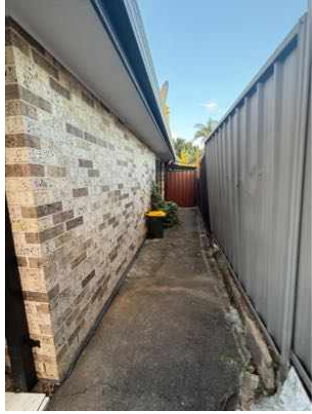
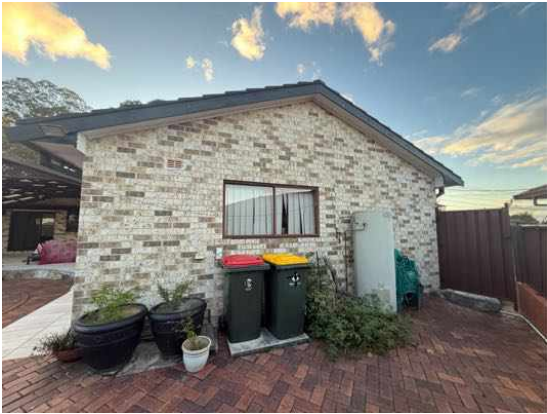
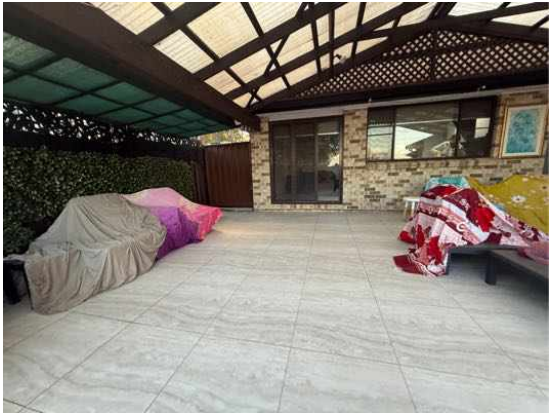
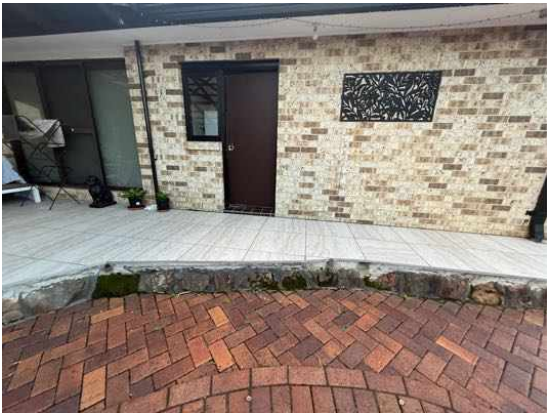
Building:	Main Building
Location:	External Walls
Finding:	Slab Edge Exposure - In accordance with the National Construction Code & Australian Standards
Information:	An inspection zone of at least 75mm in relation to the exposed slab edge, between the bottom brick and the perimeter pavement, is required. This inspection zone should be maintained in order to force termites into the open where they can be detected more readily during regular inspections. The slab edge should not be concealed by anything that may prevent inspection of the area, including render, landscaping, soil, turf, paving, concrete cladding or other structures.

As in this case It is common that termite barriers have been installed during the construction process. Where paths, paved areas and gardens have concealed slab edge and cannot be properly inspected. Therefore its recommended that termite inspections be carried out every 12 months as per they product warranty to aid protection of the property against termite infestation.

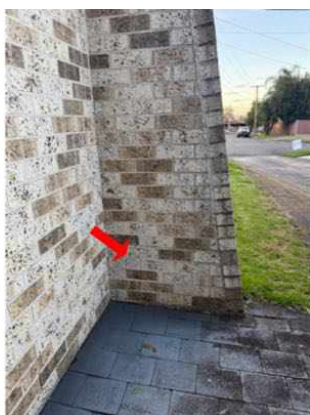
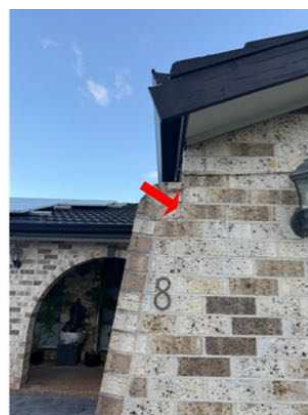
Finding 6.02

Building:	Main Building
Location:	External Walls
Finding:	Bridging or breaching of termite barriers - weep holes
Information:	Bridging is the spanning of a termite barrier or inspection zone so that subterranean termites are provided with passage over or around that barrier.

Weep holes in the exterior brickwork of the property are designed to allow condensation that may build up between the brickwork and subsequent timber framework to drain from within the wall hence preventing any deterioration of the timber building elements.

Additionally build-up of moisture is likely to occur if weep holes are covered further attracting termite activity to these areas.

It is highly recommended that weep holes are left exposed in all areas throughout the external property. Therefore if any termite activity leading into weep holes becomes easily detectable during frequent pest inspections.

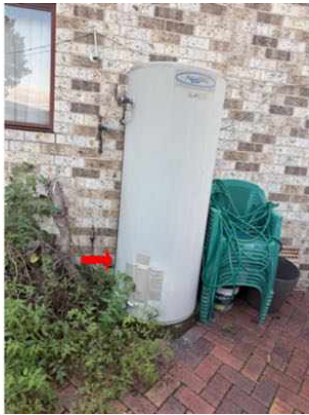
Finding 6.03

Building:	Main Building
Location:	Exterior walls - left side
Finding:	HWS Overflow
Information:	The Hot Water System (HWS) overflow was found to be creating excessive moisture in the surrounding area.

These damp conditions can lead to secondary defects such as rot, rust or corrosion of associated building elements, the formation of fungal decay, or even the creation of

potential slip hazards.

When coupled with poor site drainage, pooling of water may also attract termite activity to this area.

It is recommended that the HWS overflow be diverted into a stormwater drain point in order to prevent such an environment from being created.

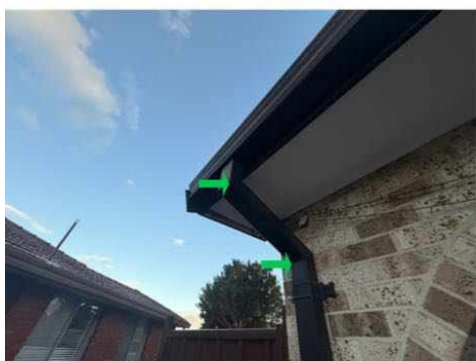
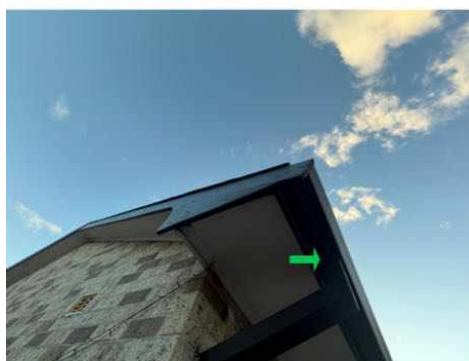
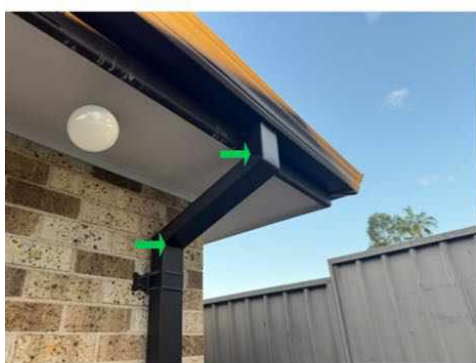
Building:	Main Building
Location:	Gutter and Downpipes
Finding:	Maintenance - Gutter & Downpipes
Information:	The joins in the downpipes and gutters are common areas where silt and debris accumulate, leading to corrosion over time. Regular maintenance, such as cleaning these areas to remove leaves, silt, and other debris, is crucial in preventing damage. It is recommended to engage a licensed building contractor to carry out these cleaning and maintenance tasks to ensure the work is done safely and effectively. Regular inspections can help identify any early signs of wear or corrosion and address them before more serious damage occurs.

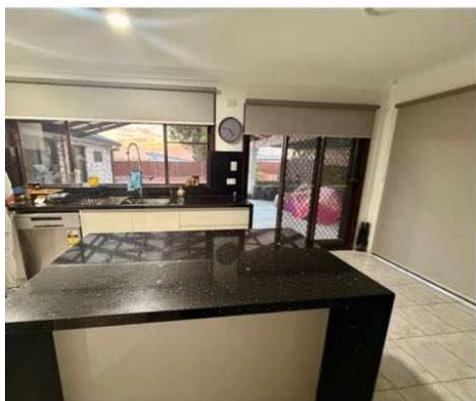
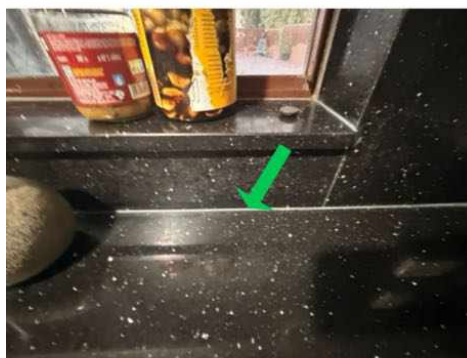
Building:	Main Building
Location:	Kitchen
Finding:	Maintenance - Tile Sealant Junction

Information: At the time of the inspection, the sealant at the junctions was found to be in good working order. However, ongoing maintenance of the silicone seal at the tile junctions is necessary to prevent moisture and mould growth behind the sealant. If any deterioration occurs, replacement of the silicone seal will be required.

It is important to note that if the sealants are not installed in accordance with the standards outlined in the Building Code of Australia (BCA), the National Construction Code (NCC), AS 3958.1, or the manufacturer's instructions, they are considered defective and may need to be replaced to ensure compliance and effectiveness.

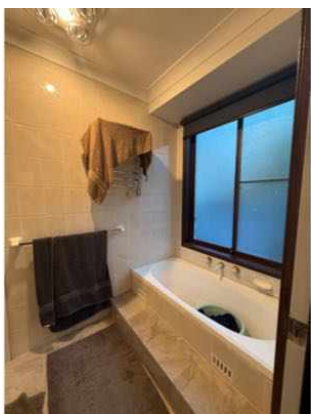
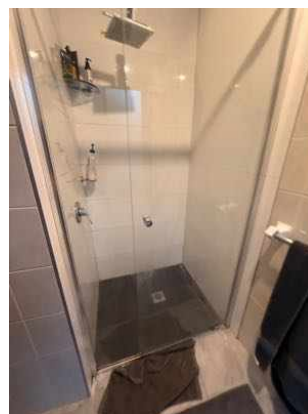
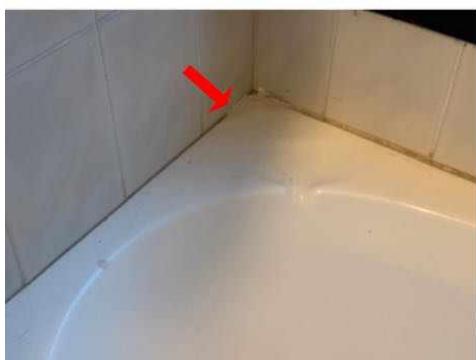
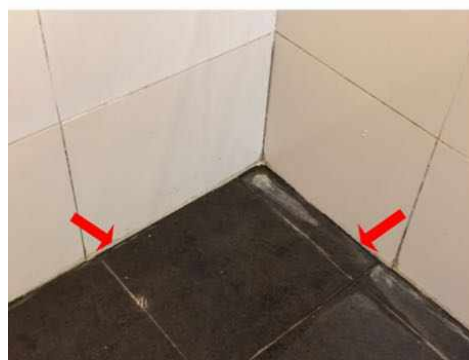
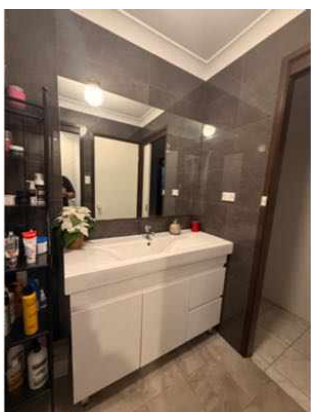
Information: At the time of the inspection, the sealant at the junctions was found to be in good working order. However, ongoing maintenance of the silicone seal at the tile junctions is necessary to prevent moisture and mould growth behind the sealant. If any deterioration occurs, replacement of the silicone seal will be required.

It is important to note that if the sealants are not installed in accordance with the standards outlined in the Building Code of Australia (BCA), the National Construction Code (NCC), AS 3958.1, or the manufacturer's instructions, they are considered defective and may need to be replaced to ensure compliance and effectiveness.

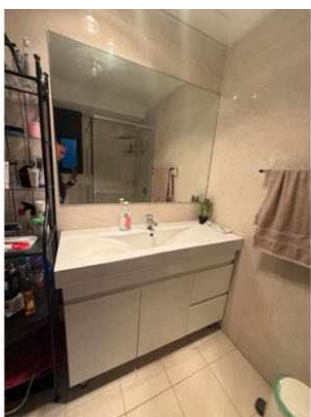
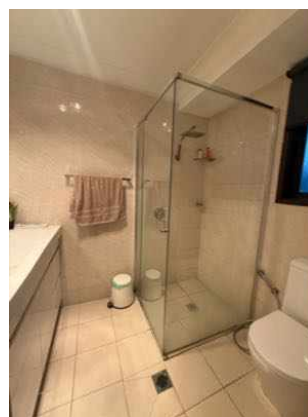
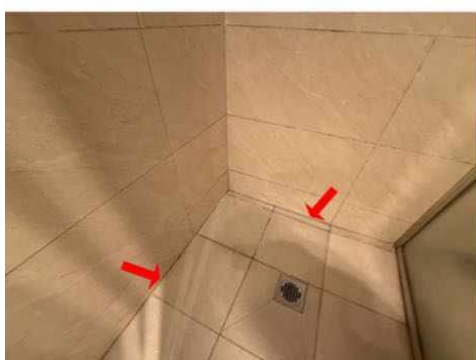
Building: Main Building
 Location: Bathroom 2
 Finding: Maintenance - Tile Sealant Junction
 Information: At the time of the inspection, the sealant at the junctions was found to be in good working order. However, ongoing maintenance of the silicone seal at the tile junctions is necessary to prevent moisture and mould growth behind the sealant. If any deterioration occurs, replacement of the silicone seal will be required.

It is important to note that if the sealants are not installed in accordance with the standards outlined in the Building Code of Australia (BCA), the National Construction Code (NCC), AS 3958.1, or the manufacturer's instructions, they are considered

defective and may need to be replaced to ensure compliance and effectiveness.

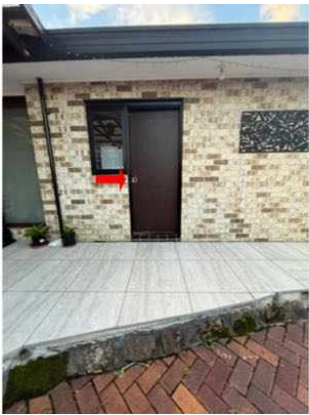
Building: Main Building
 Location: Laundry
 Finding: Door - Broken handle
 Information: The door handle in this area was found to be broken at the time of inspection. Breakage occurs generally when the building materials have aged and decayed, but may be indicative of impact damage (accidental or deliberate).

Repair and/or replacement of the broken door handle is advised to improve the operational state of the associated door.

A qualified carpenter or general handyman should be appointed to repair/replace the door handle at the client's discretion.

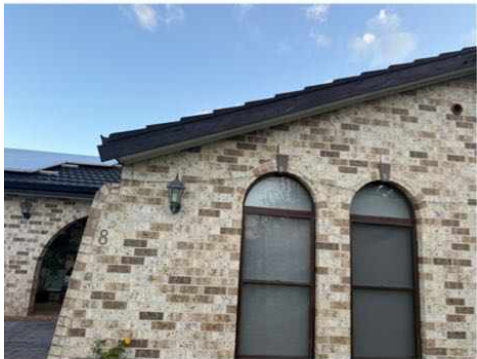
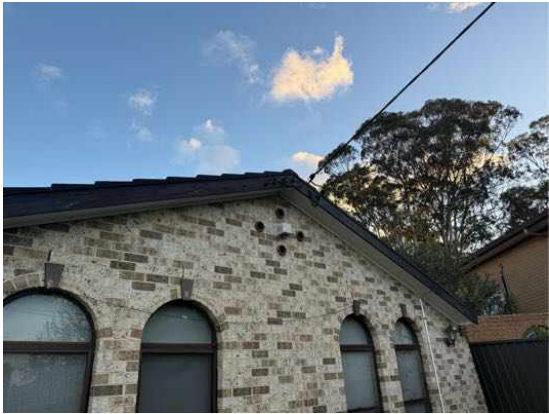
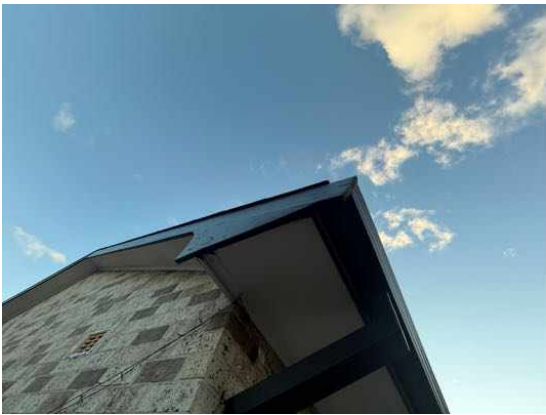
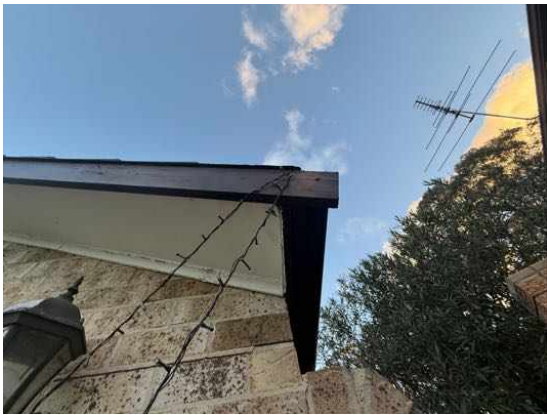
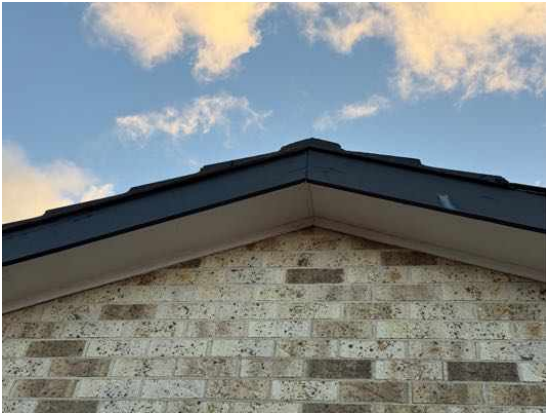
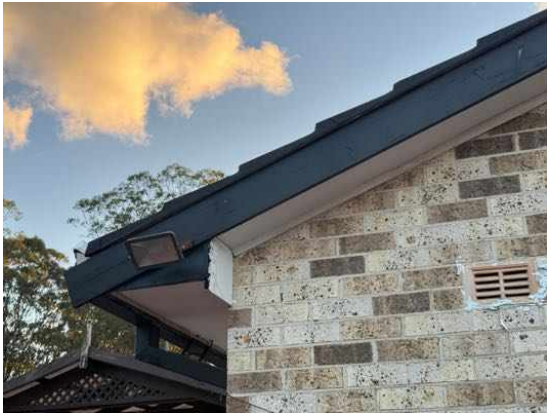
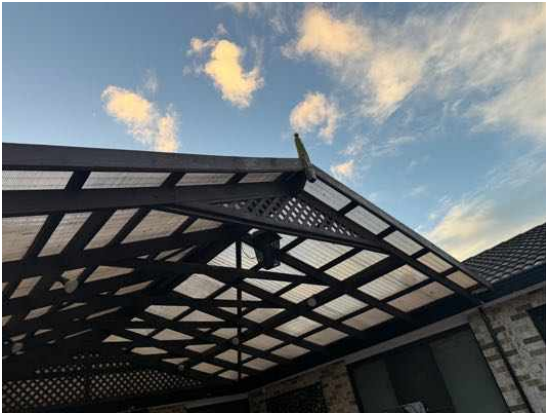
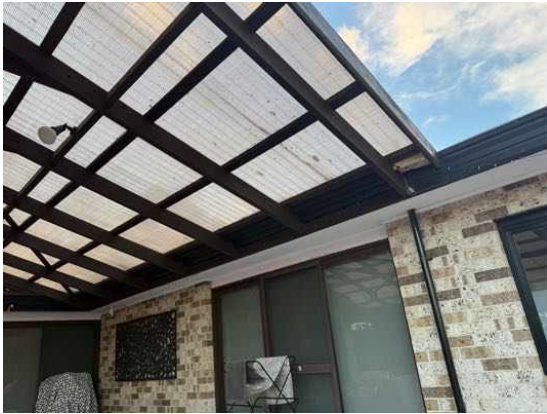
Building: Main Building
 Location: All External Timbers
 Finding: External Timber Maintenance - Exposed to weather
 Information: External timbers that are frequently exposed to harsh weather conditions require adequate protection in order to maintain their condition. Where timbers have not been maintained, painted or treated adequately, general deterioration is likely to occur at an accelerated rate.

Regular maintenance is required Applying adequate treatment, paint coating of these timbers is required which prolongs the life expectancy of the building elements reducing the need to replace rotting and weathered timbers.
