VISUAL BUILDING & PEST INSPECTION REPORT

Complies with Australian Standard 4349.1 & 4349.6

**Inspected Property:
3 Greenway Drive Pymble**

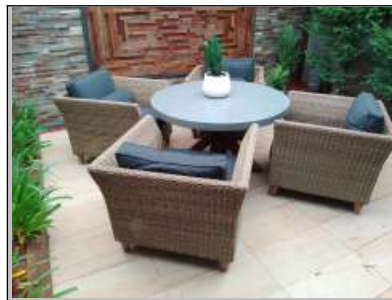
Front elevation.

Constructed from concrete or masonry. The condition of the structure is generally acceptable.

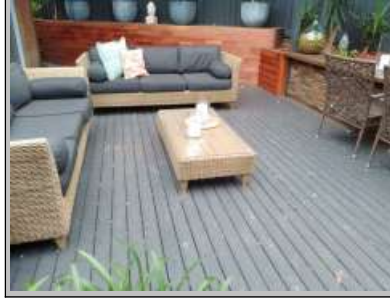
Front elevation.

The general condition of this structure is fair.

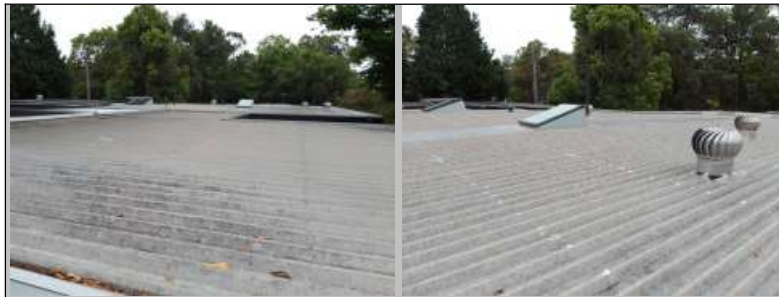
The overall condition of the roof coverings is fair. The metal roofing is rusted in areas and requires maintenance / treatment. General maintenance required to roof area.

Flashings appear to be in serviceable condition. Some maintenance required to areas.

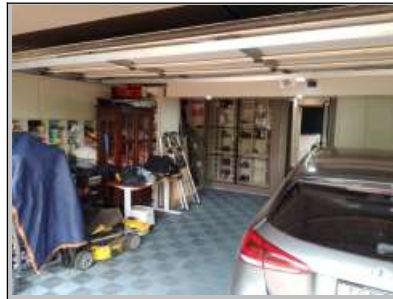
Garage.

The structure is generally in fair condition.

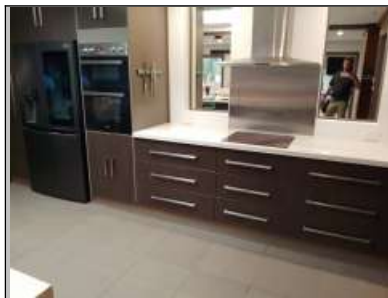
The condition of the fixtures is generally good.

Sink and taps appear in serviceable condition. Drain appears serviceable.

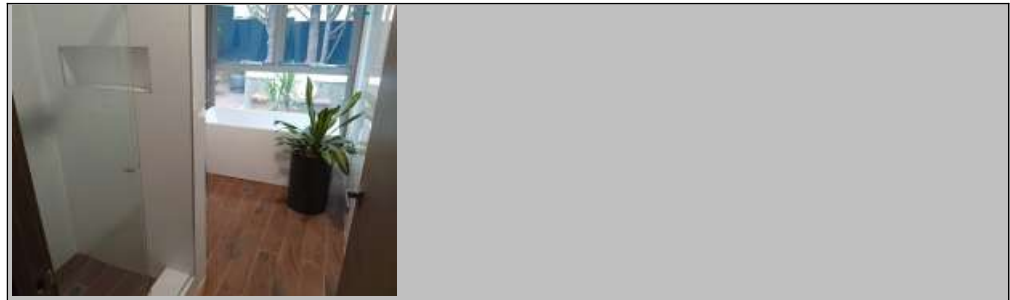
Rear.

The shower recess was tested and found to be leaking. Continued leaking may allow damage and decay to surrounding components. Rectification will be required and evaluation of extent of works should be requested from a Licensed Builder.

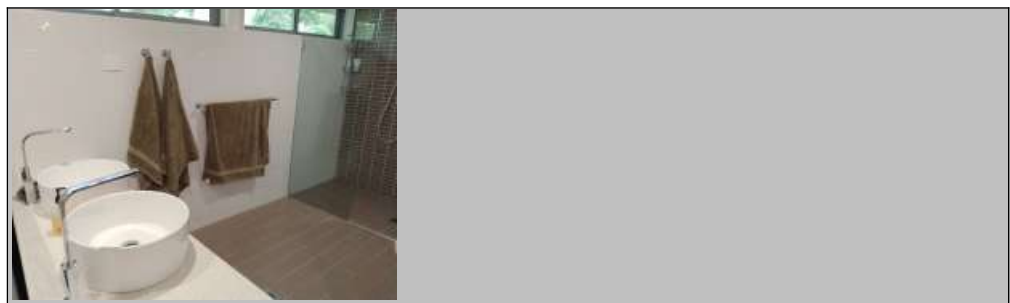
Front.

The shower recess was tested and there was no visible water penetration to surrounding areas. IMPORTANT NOTE: This test may not reveal water leaks until the shower is put into constant use and surrounding areas monitored over a period of time.

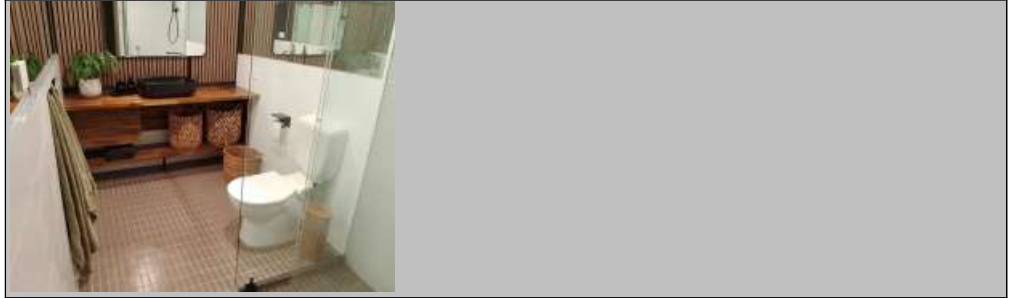
Rear.

The shower recess was tested and there was no visible water penetration to surrounding areas. IMPORTANT NOTE: This test may not reveal water leaks until the shower is put into constant use and surrounding areas monitored over a period of time.

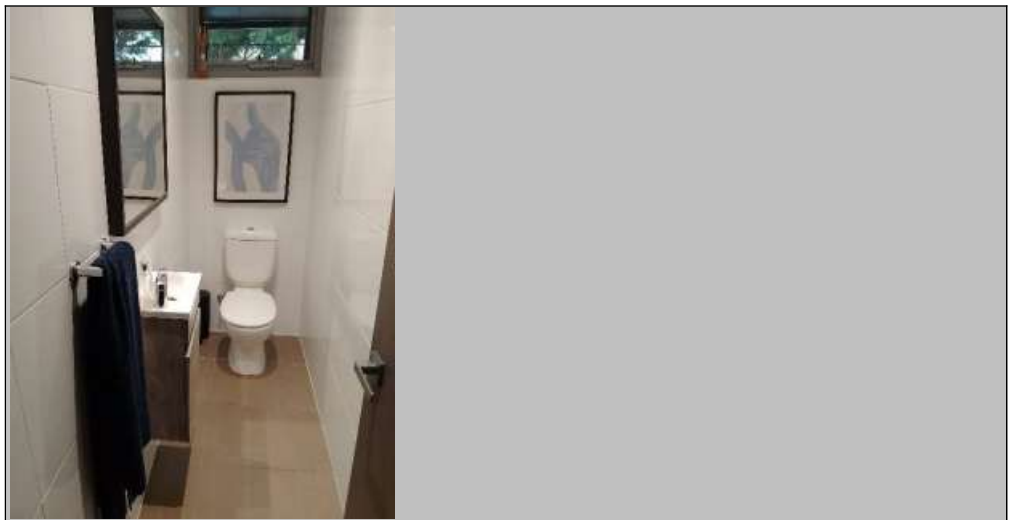
Rear.

The toilet appears to be in working order.

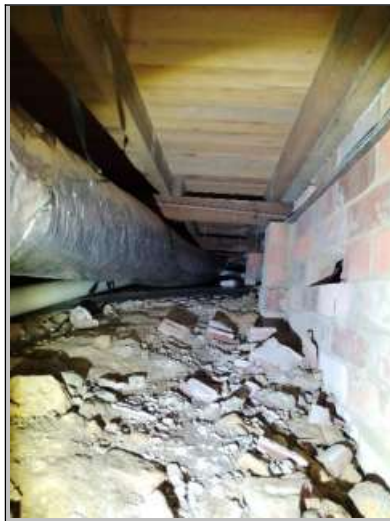
Some areas of the building are a concrete slab on ground construction and to these areas there is no accessible void for inspection. Crawl space was limited due to the method of construction resulting in a limited visual inspection from a distance being carried out. Inspection was restricted in or below the following locations and or areas: Bathroom. Bedroom three. Lounge room.

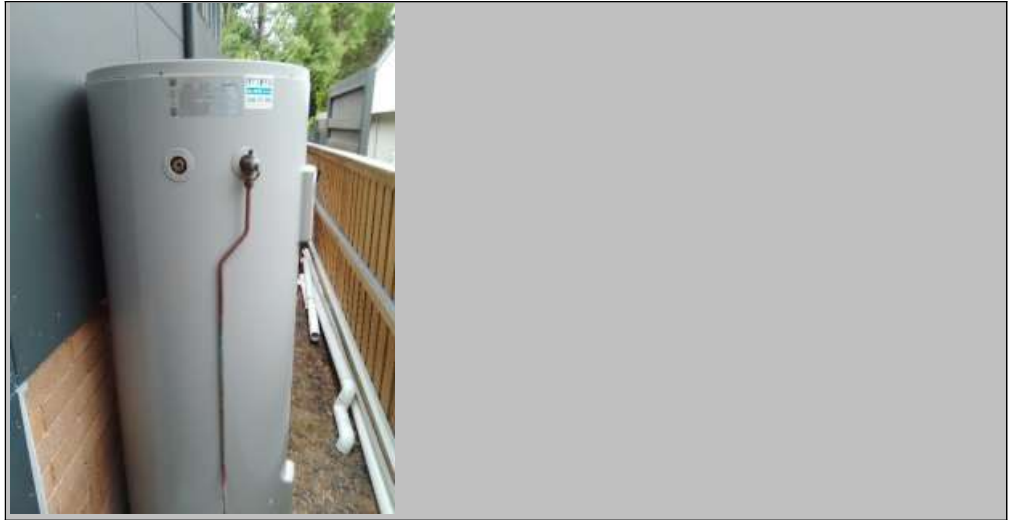
Mains electric hot water system: Mains pressure: Located externally: The hot water system appears to be in working condition. No specific tests other than running the hot water tap were carried out. No determination has been made as to the suitability or adequacy of the hot water system in relation to capacity or otherwise.

The unit was manufactured in 2022.

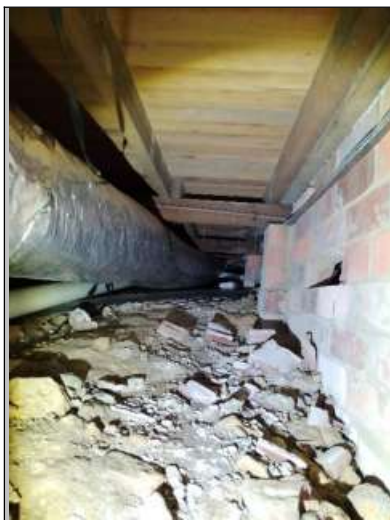
Cavity Present/Not Accessible

Some areas of the building are a concrete slab on ground construction and to these areas there is no accessible void for inspection. Crawl space was limited due to the method of construction resulting in a limited visual inspection from a distance being carried out. Inspection was restricted in or below the following locations and or areas: Bathroom. Bedroom three. Lounge room.
