**VISUAL BUILDING & PEST INSPECTION REPORT**

Inspected Property:  
20 Pymble Avenue Pymble

26.8.24.

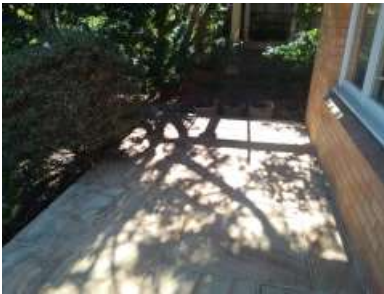
Front elevation.

Constructed from concrete or masonry. The condition of the structure is generally acceptable.

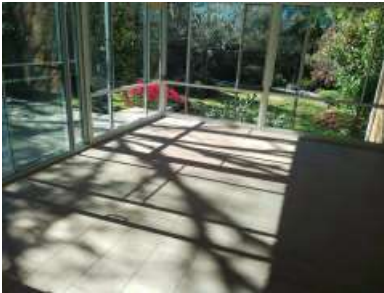
Rear elevation.

Constructed from concrete or masonry. The condition of the structure is generally acceptable.

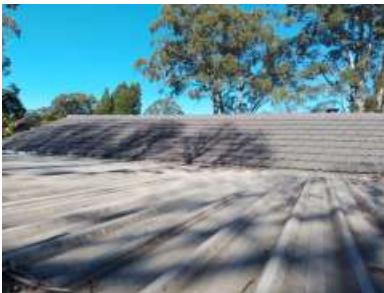
The roof is of skillion style construction.

The overall condition of the roof coverings is fair.

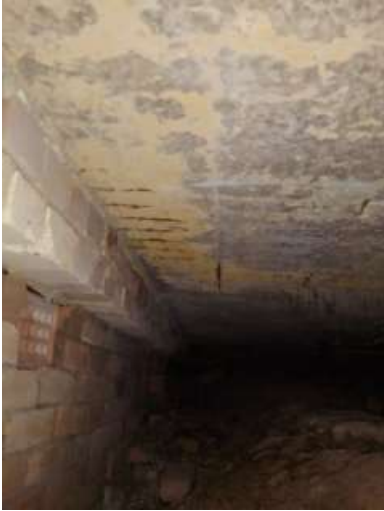
Concrete spalling and is present to this area and this damage to the concrete should be repaired.

Active leak noted to the floor area. This could be due to a waterproofing or flashing defect. This should be further investigated to determine cause. Rectification may be required and this could involve removal of floor finishes and installation of a new water proof membrane.

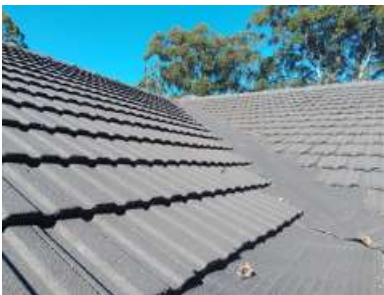
The roof is of pitched construction.

No access was possible to part of the external roof area due to the roof not being accessible from a 3.6 meter ladder.

The overall condition of the roof coverings is fair.

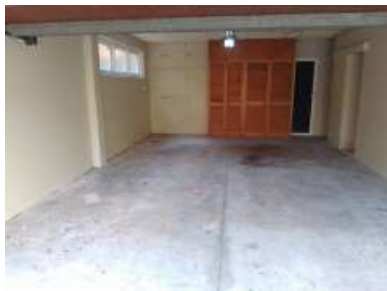
Garage.

The structure is generally in fair condition.

The condition of the walls is generally fair. Base of some walls are below the external soil levels and are subject to lateral dampness.

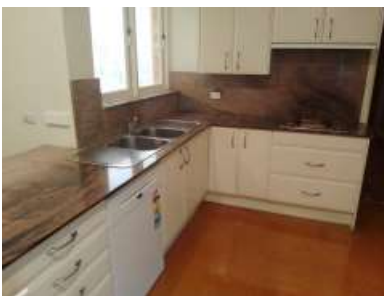
The condition of the fixtures is generally fair. A stone splashback is located over the benchtop area. Stone appears to be in serviceable condition.

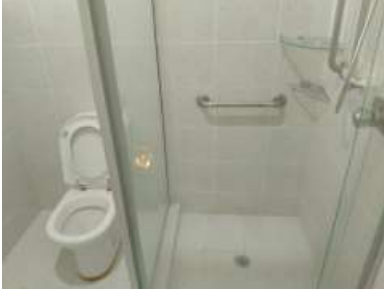
Adjacent to hall.

The shower recess was tested and there was no visible water penetration to surrounding areas. **IMPORTANT NOTE:** This test may not reveal water leaks until the shower is put into constant use and surrounding areas monitored over a period of time.

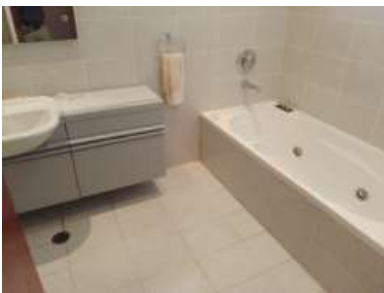
Adjacent to hall.

The shower recess was tested and there was no visible water penetration to surrounding areas. **IMPORTANT NOTE:** This test may not reveal water leaks until the shower is put into constant use and surrounding areas monitored over a period of time. A spa bath is present however, due to the requirement to fill the unit above jet level for testing the spa was not tested for adequacy or reliability. Defects may be present and not detected.

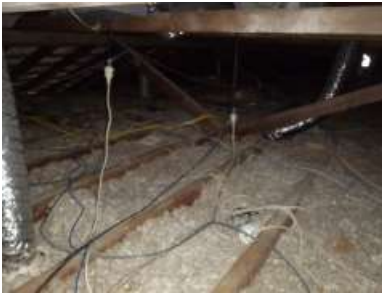
Insulation is present in the roof cavity. This restricted inspection to some roofing timbers. Removal of insulation is not within the scope of a standard visual inspection report, however as in accordance with "industry best standard" the inspector will lift insulation in 3 areas in roof void.

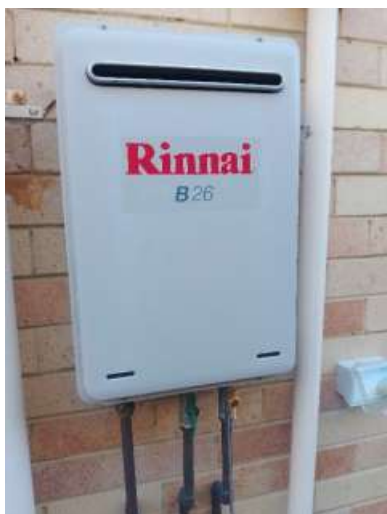
Gas hot water system: Mains pressure: Instantaneous: Located externally: The hot water system appears to be in working condition. No specific tests other than running the hot water tap were carried out. No determination has been made as to the suitability or adequacy of the hot water system in relation to capacity or otherwise.

The hot water service has no date but appears to be new.

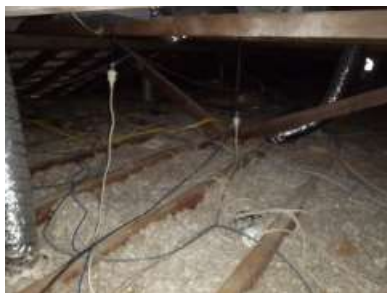
Insulation is present in the roof cavity. This restricted inspection to some roofing timbers. Removal of insulation is not within the scope of a standard visual inspection report, however as in accordance with "industry best standard" the inspector will lift insulation in 3 areas in roof void.
