Loose-Fill Asbestos Insulation Ceiling Cavity Inspection Report

20 Pymble Avenue, PYMBLE

Report Number: 96574/2016/LAN_0485/100/1_20_Pymble_Avenue_PYMBLE
Issue Date: 22 May, 2017

Report Number:	96574/2016/LAN_0485/100/1_20_Pymble_Avenue_PYMBLE
Issue Date:	22 May, 2017
Company Name:	Clearsafe Environmental Solutions Pty Ltd
Our Reference:	55-9491

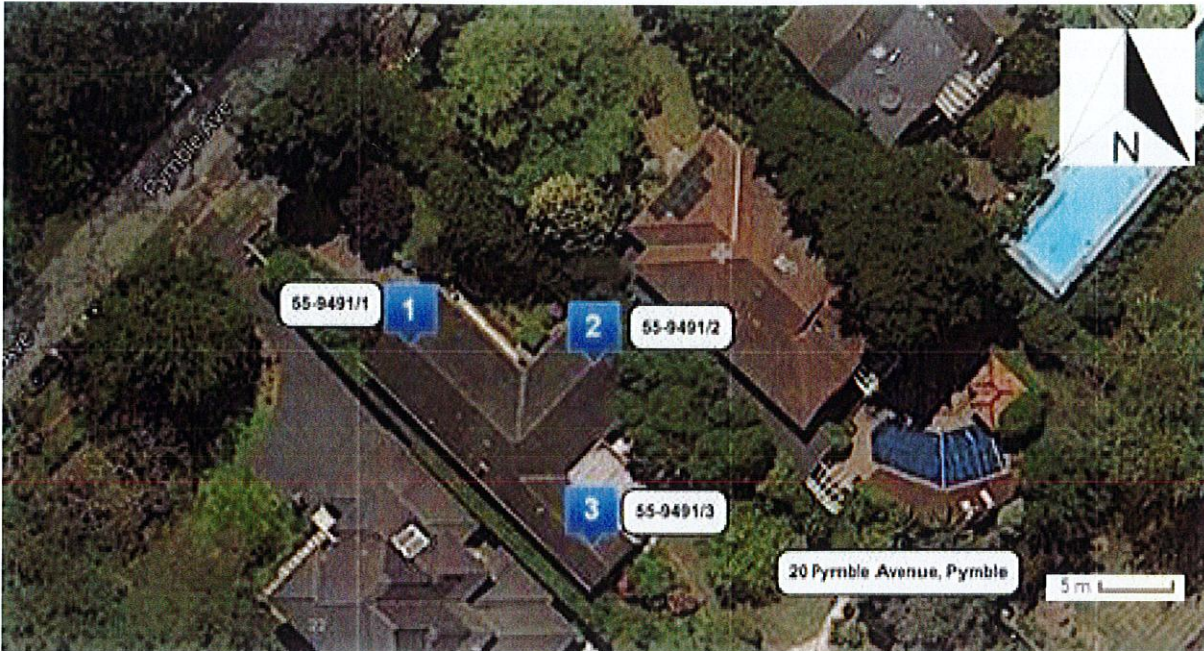
Figure 1: Diagram showing approximate sampling locations

Sample Number	Sample Location	Description	Result
55-9491/1	Ceiling space north-western section	Fibrous Clump, Glassy Rod-Like Fibres. Sample Size: 50x50x5mm	No Asbestos Detected
55-9491/2	Ceiling space north-eastern section	Fibrous Clump, Glassy Rod-Like Fibres. Sample Size: 50x50x5mm	No Asbestos Detected
55-9491/3	Ceiling space south-eastern section	Fibrous Clump, Glassy Rod-Like Fibres. Sample Size: 50x50x5mm	No Asbestos Detected

Within the scope and limitations of the assessment, LFAI was not identified by the inspecting consultant within the area(s) inspected at the time of inspection.

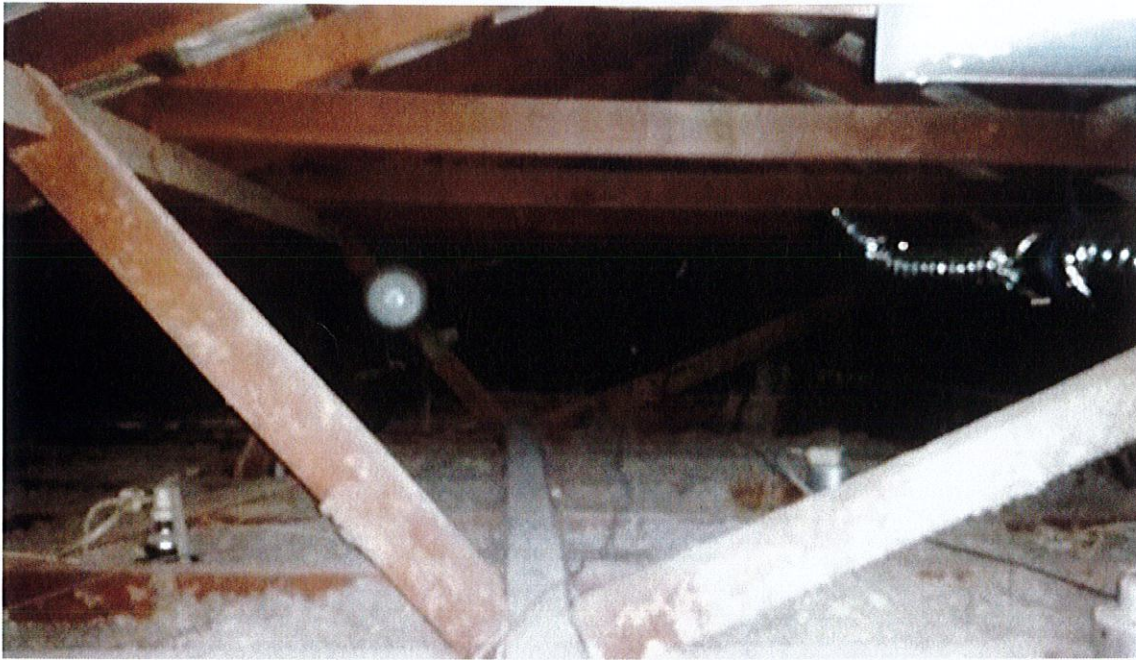
Construction Date:	1950
Extensions or Renovations:	Nil
Building Description:	Free standing house, single storey, brick, tiled roof
What evidence, if any, is there that LFAI was sprayed in the ceiling cavity?	None observed

Photograph 1: Representative photograph of ceiling space
