VISUAL BUILDING & PEST INSPECTION REPORT

Complies with Australian Standard 4349.1 & 4349.6

**Inspected Property:
33 Avon Road Pymble**

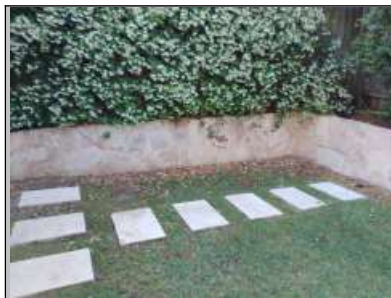
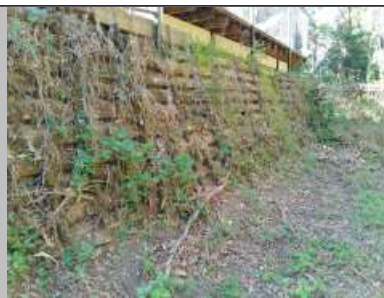
The masonry retaining walls appear in acceptable condition.

The timber retaining walls appear in acceptable condition.

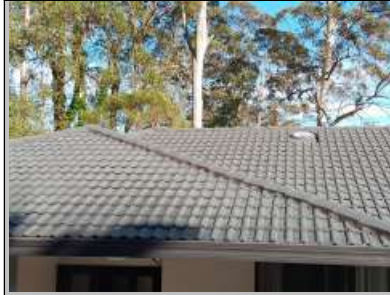
The roof is of pitched construction.

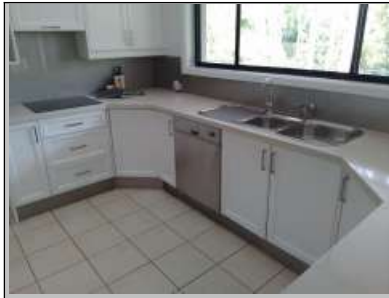
The condition of the fixtures is generally good.

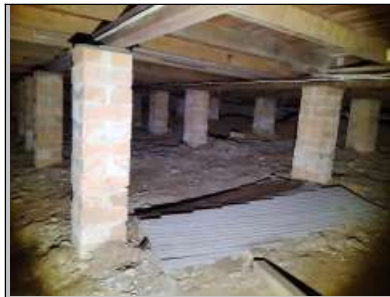
The building is constructed on a combination of strip footings and piers. The footings appear to be generally sound.

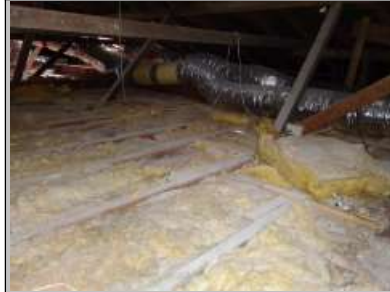
Insulation is present in the roof cavity. This restricted inspection to some roofing timbers. Removal of insulation is not within the scope of a standard visual inspection report, however as in accordance with "industry best standard" the inspector will lift insulation in 3 areas in roof void.

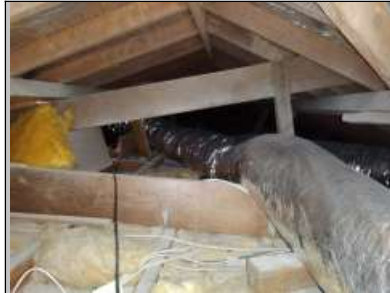
Inspection within the roof cavity was significantly restricted due to the method of construction. This allowed only a very limited visual inspection to be carried out. Roofing timbers above the area(s) listed below were not fully accessed. Inspection was restricted above the following locations and or areas: Garage.

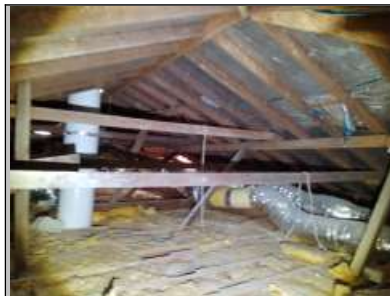
The cut and pitched roof timbers appear to provide adequate support.

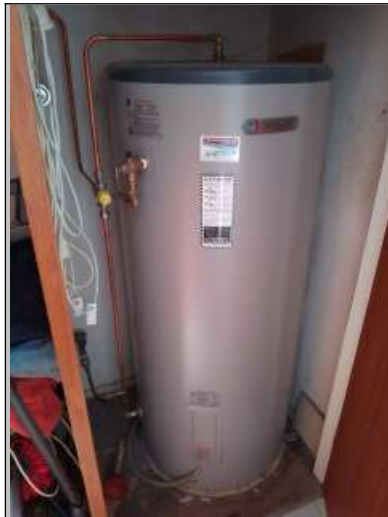
Mains electric hot water system: Mains pressure: Located in the laundry: The hot water system appears to be in working condition. No specific tests other than running the hot water tap were carried out. No determination has been made as to the suitability or adequacy of the hot water system in relation to capacity or otherwise. A safety tray was not installed. Where water tanks are installed internally, a safety tray should be installed to prevent damage to surrounding areas in case of a water leak to the tank.

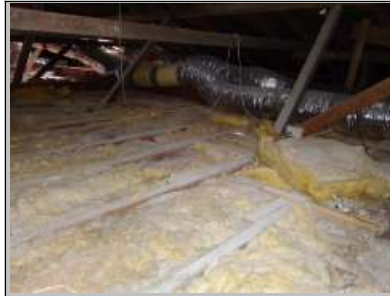
Insulation is present in the roof cavity. This restricted inspection to some roofing timbers. Removal of insulation is not within the scope of a standard visual inspection report, however as in accordance with "industry best standard" the inspector will lift insulation in 3 areas in roof void.

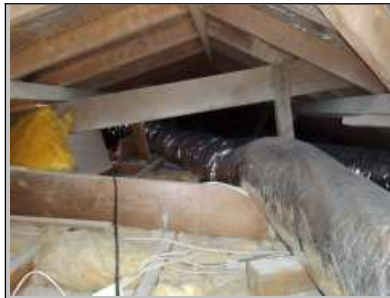
Inspection within the roof cavity was significantly restricted due to the method of construction. This allowed only a very limited visual inspection to be carried out. Roofing timbers above the area(s) listed below were not fully accessed. Inspection was restricted above the following locations and or areas: Garage.

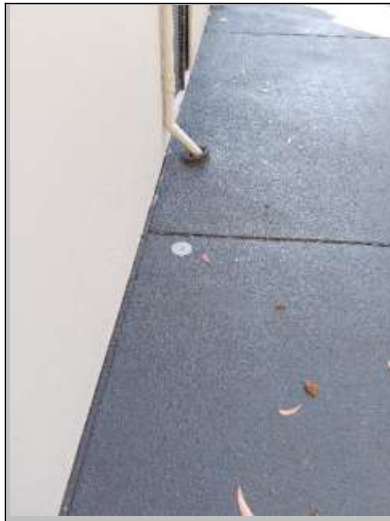
Yes - We found evidence that a termite treatment may have been carried out to this property. The following evidence was found during our inspection; We found evidence of a termite baiting system present at the property.
