VISUAL BUILDING & PEST INSPECTION REPORT

Complies with Australian Standard 4349.1 & 4349.6

Inspected Property:
122 Livingstone Avenue, Pymble

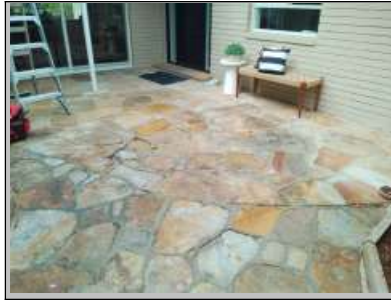
The paths/paved areas are in fair condition. The paved paths/paved areas have subsided in areas and will require repair and or relaying.

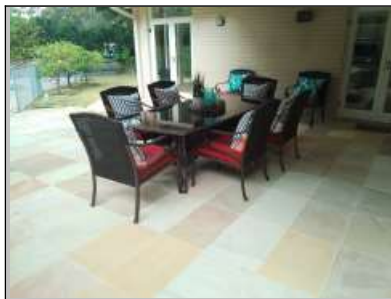
Rear elevation.

Constructed from concrete or masonry. The condition of the structure is generally acceptable.

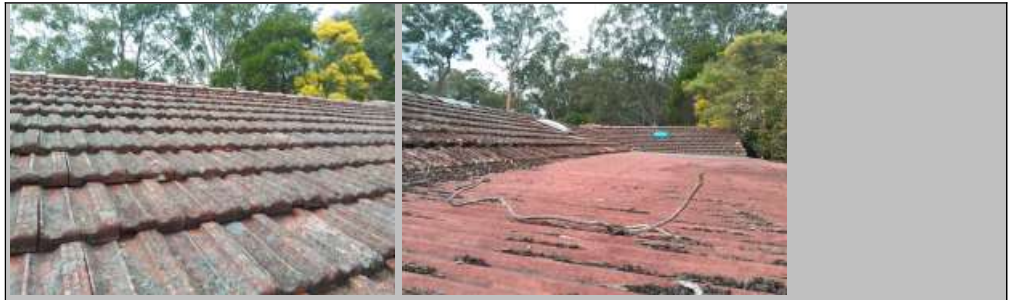
The overall condition of the roof coverings is fair. Areas of repairs are required. Mortar beds to the hip and ridge capping are cracked and require maintenance or re bedding and pointing in areas.

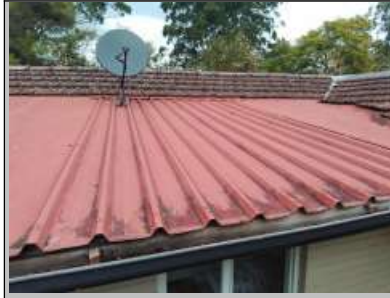
Front elevation.

The overall condition of the roof coverings is fair.

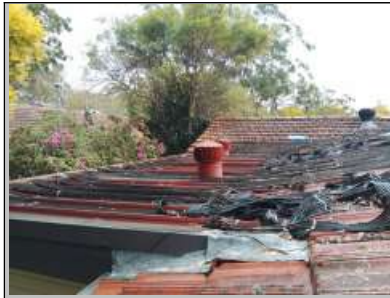
Rear elevation.

The overall condition of the roof coverings is fair.

Flashing material is of sheet metal. Flashings appear to be in serviceable condition.

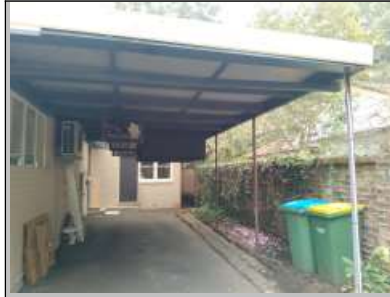
Carport.

The structure is generally in fair condition.

The steel support posts are rusting and require maintenance and or repair to prevent further deterioration.

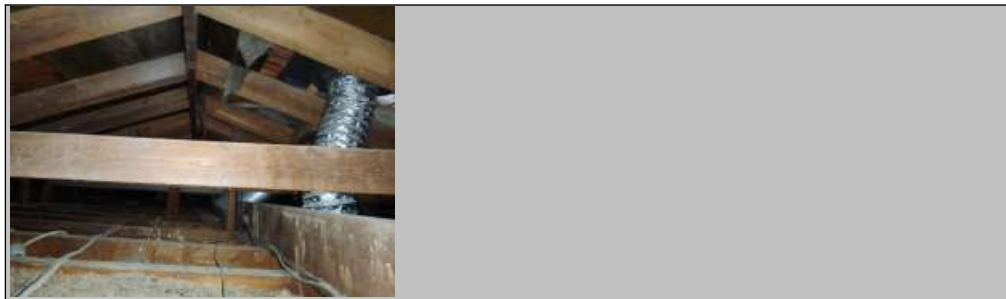
Clearance within the roof void was too low to allow body access. This allows only a limited visual inspection from a distance to be carried out.

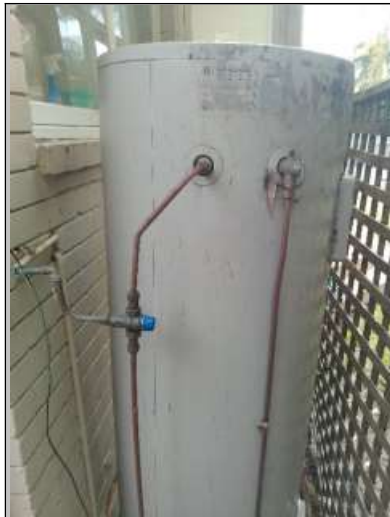
Mains electric hot water system: Mains pressure: Located externally: The hot water system appears to be in working condition. No specific tests other than running the hot water tap were carried out. No determination has been made as to the suitability or adequacy of the hot water system in relation to capacity or otherwise.

The unit was manufactured in 2017.

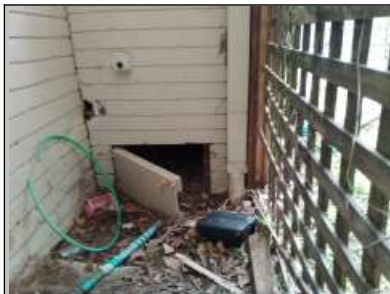
The entry point is too small to allow body access and accordingly no report on this area is submitted.

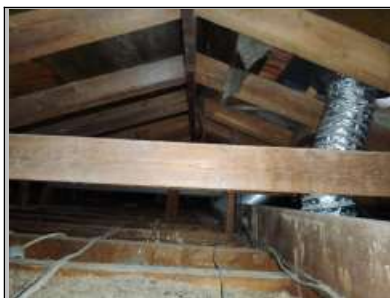
Clearance within the roof void was too low to allow body access. This allows only a limited visual inspection from a distance to be carried out.
