VISUAL BUILDING & PEST INSPECTION REPORT

Complies with Australian Standard 4349.1 & 4349.6

**Inspected Property:
5 The Chase Turramurra**

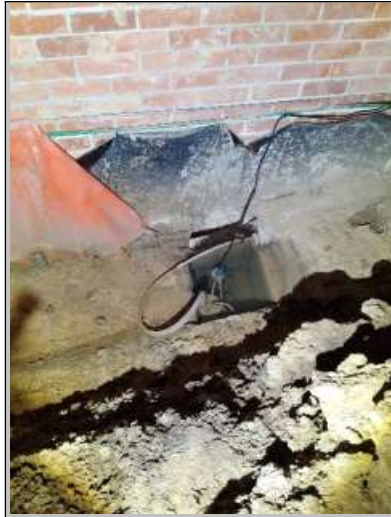
Site drainage appears to be acceptable. However, the site should be monitored during heavy rain to determine whether the existing drains can cope and function. Submersible pump will require periodic maintenance.

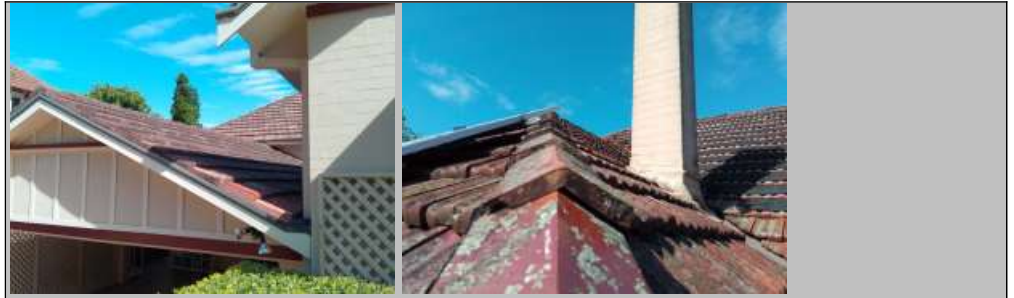
No access was possible to part of the external roof area due to the roof not being accessible from a 3.6 meter ladder.

The overall condition of the roof coverings is fair.

The overall condition of the valley metal is fair.

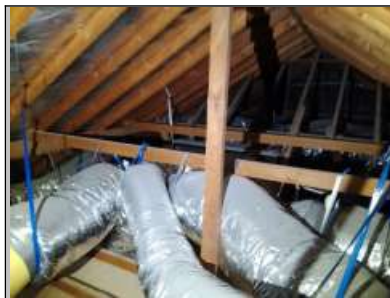
Sarking membrane covered tile battens restricting inspection. Ducting associated with air-conditioning or heating restricted inspection. Inspection was restricted above the following locations and or areas: Lounge room.

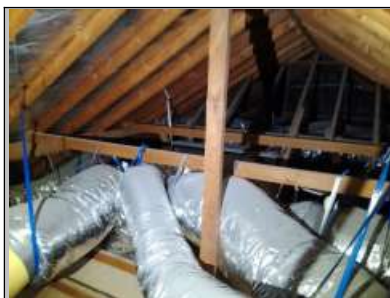
Sarking membrane covered tile battens restricting inspection. Ducting associated with air-conditioning or heating restricted inspection. Inspection was restricted above the following locations and or areas: Lounge room.
