## **VISUAL BUILDING & PEST INSPECTION REPORT**

Complies with Australian Standard 4349.1 & 4349.6

**122 Bobbin Head Road Turrumurra**

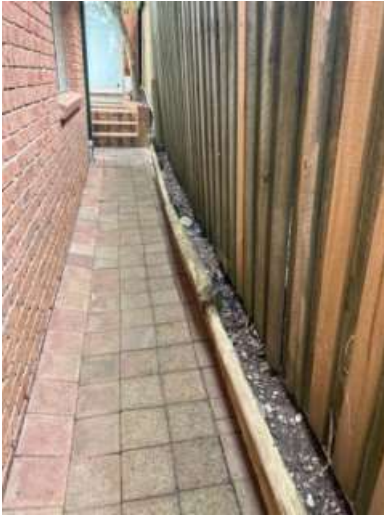
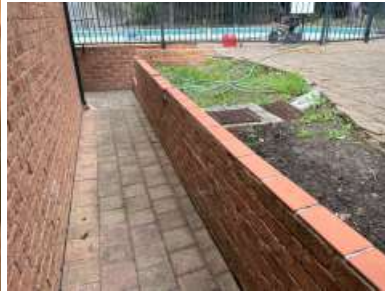
The timber retaining walls show deterioration and should be monitored for additional movement. Some repairs will be required.

The masonry retaining walls show deterioration, cracks etc, and should be monitored for additional movement. Some maintenance / repairs may be required.

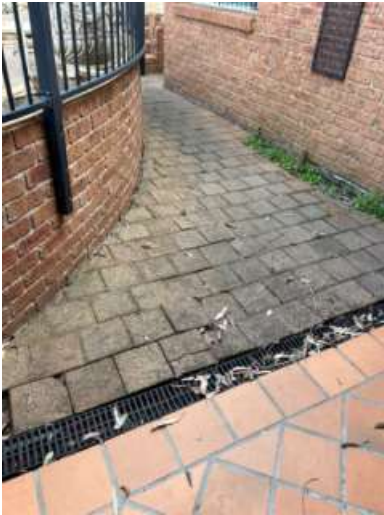
The paths/paved areas are in fair condition. The paved paths/paved areas have subsided in areas and will require repair and or relaying.

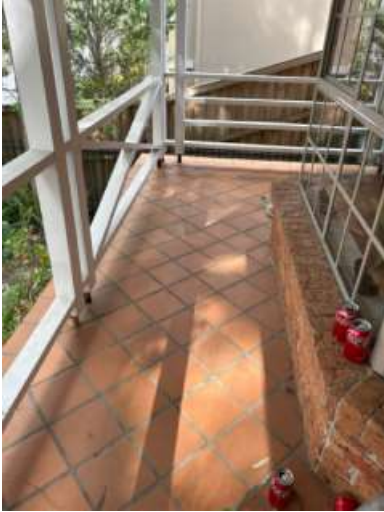
Front elevation.

Constructed from concrete or masonry. The general condition of this structure is fair.

Some support posts are rusted and require replacement.

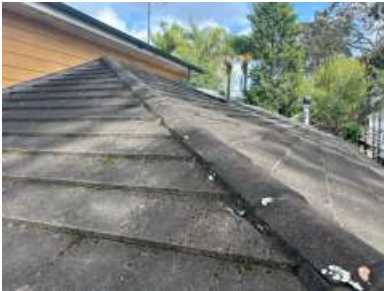
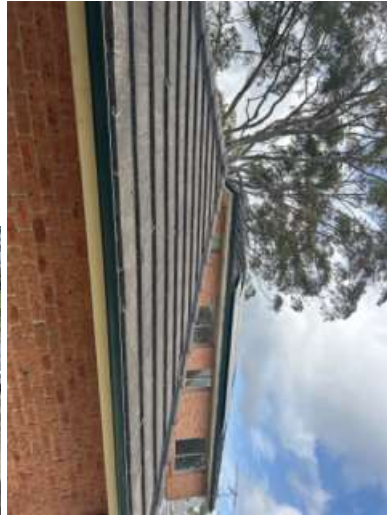
The overall condition of the roof coverings is fair. Mortar beds to the hip and ridge capping are cracked and require maintenance or re bedding and pointing in areas.

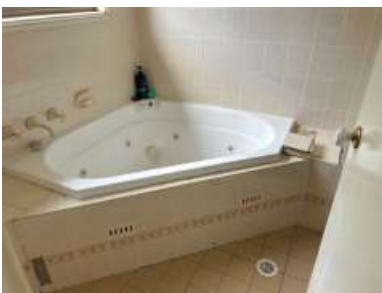
Level one.

The condition of the tiles is generally poor.

The condition of the vanity unit is generally poor.

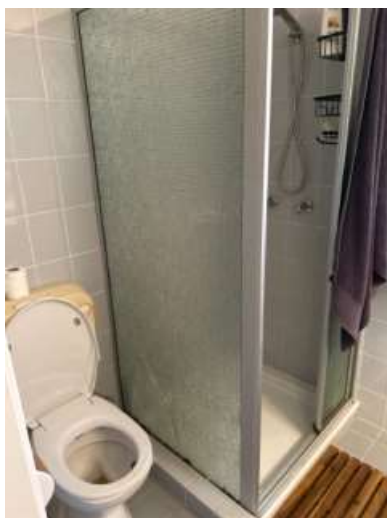
Level one.

The condition of the tiles is generally poor.
