VISUAL BUILDING AND PEST INSPECTION REPORT

Complies with Australian Standard 4349.1 & 4349.3

16 Macquarie road, Pymble

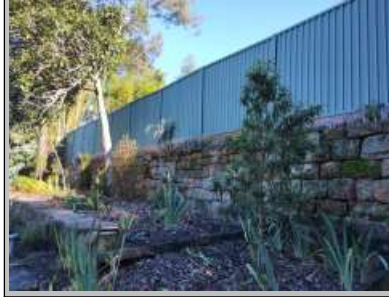
The masonry retaining walls appear in acceptable condition.

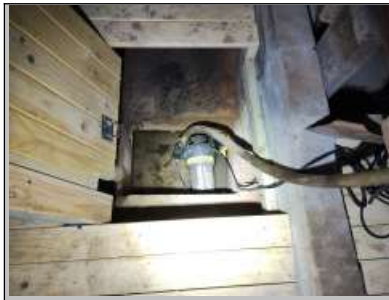
Site drainage appears to be acceptable. However, the site should be monitored during heavy rain to determine whether the existing drains can cope and function. Submersible pump will require periodic maintenance.

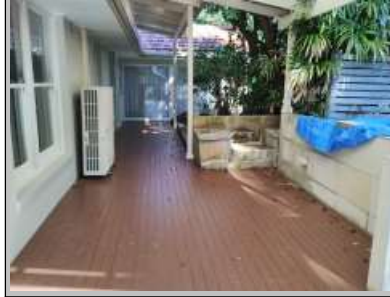
Rear elevation.

The general condition of this structure is fair.

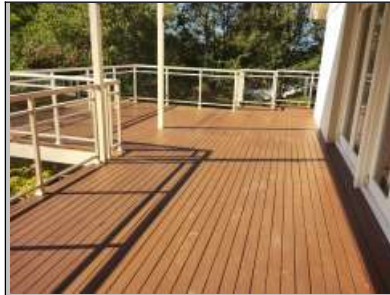
Northern elevation.

Where an external structure is constructed from timber or has significant timber components, and exposed to the elements, a suitably qualified engineer should inspect the structure to determine if it is structurally sound. We cannot determine or advise what weight the structure can hold, The general condition of this structure is fair.

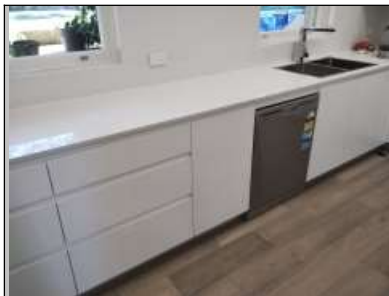
The condition of the fixtures is generally good, A stone splashback is located over the benchtop area. Stone appears to be in serviceable condition.

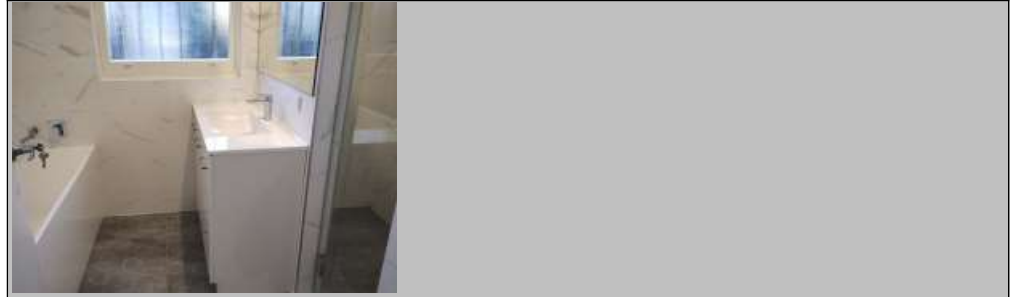
Level one.

The shower recess was tested and there was no visible water penetration to surrounding areas. IMPORTANT NOTE: This test may not reveal water leaks until the shower is put into constant use and surrounding areas monitored over a period of time.

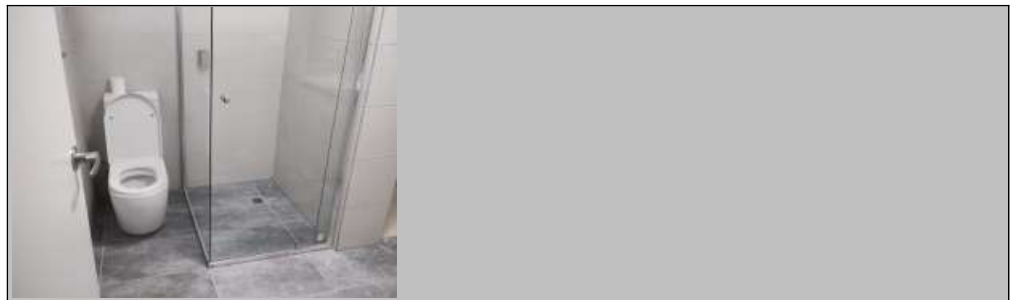
Ground floor.

The shower recess was tested and there was no visible water penetration to surrounding areas. IMPORTANT NOTE: This test may not reveal water leaks until the shower is put into constant use and surrounding areas monitored over a period of time.

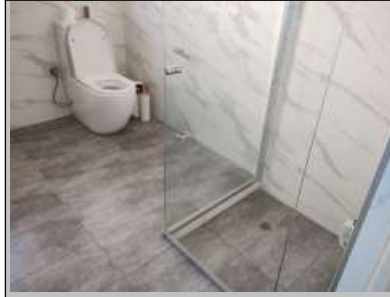
Level one.

The shower recess was tested and there was no visible water penetration to surrounding areas. IMPORTANT NOTE: This test may not reveal water leaks until the shower is put into constant use and surrounding areas monitored over a period of time.

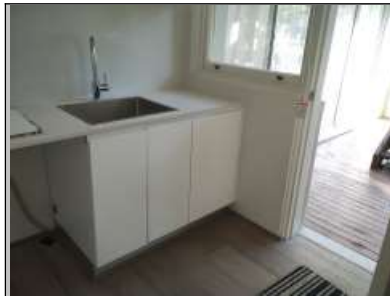
Adjacent to the kitchen.

The tub and taps appear serviceable. Drain appears serviceable.

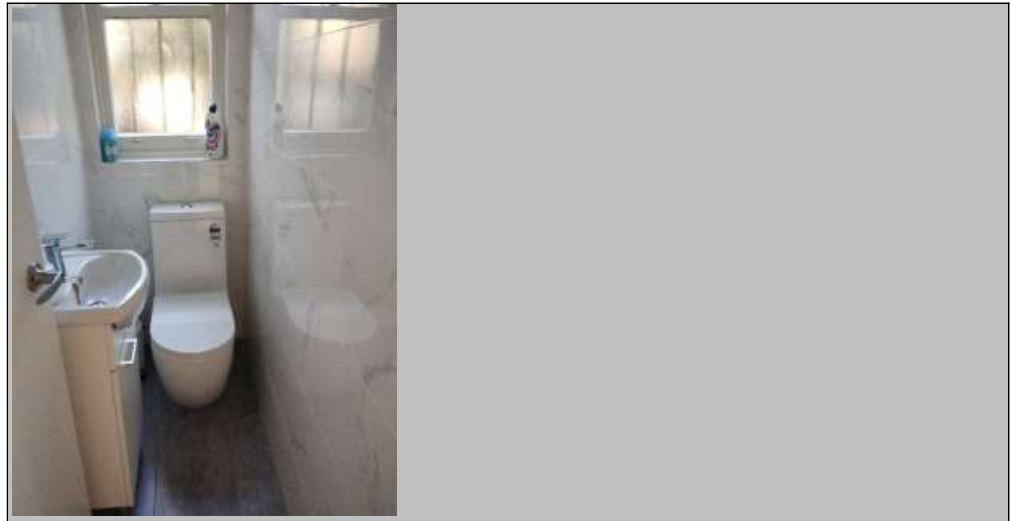
Rear.

The toilet appears to be in working order.

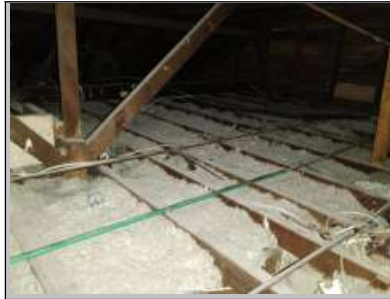
Insulation is present in the roof cavity. This restricted inspection to some roofing timbers. Removal of insulation is not within the scope of a standard visual inspection report, however as in accordance with "industry best standard" the inspector will lift insulation in 3 areas in roof void.

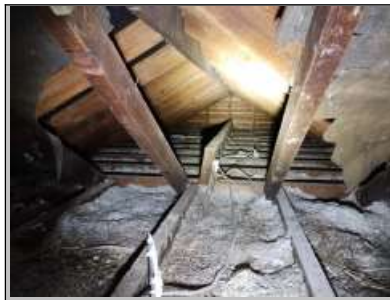
Inspection within the roof cavity was significantly restricted due to the method of construction. This allowed only a very limited visual inspection to be carried out. Roofing timbers above the area(s) listed below were not fully accessed.

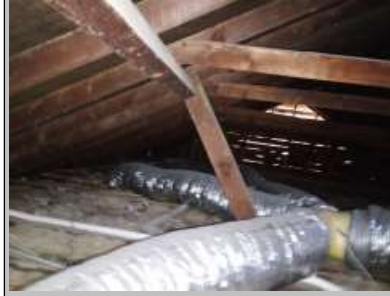
The cut and pitched roof timbers appear to provide adequate support.

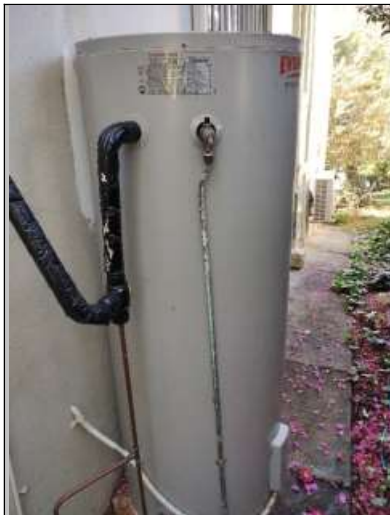
Mains electric hot water system: Mains pressure: Located externally: The hot water system appears to be in working condition. No specific tests other than running the hot water tap were carried out. No determination has been made as to the suitability or adequacy of the hot water system in relation to capacity or otherwise.

The unit was manufactured in 2023.

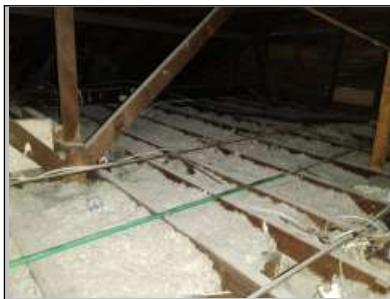
Insulation is present in the roof cavity. This restricted inspection to some roofing timbers. Removal of insulation is not within the scope of a standard visual inspection report, however as in accordance with "industry best standard" the inspector will lift insulation in 3 areas in roof void.

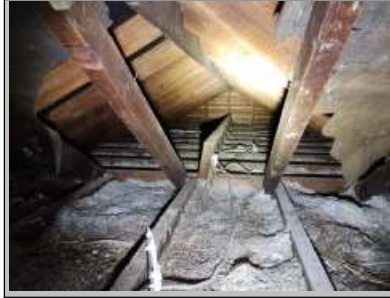
Inspection within the roof cavity was significantly restricted due to the method of construction. This allowed only a very limited visual inspection to be carried out. Roofing timbers above the area(s) listed below were not fully accessed.
