Inspection Report

Inspection Address

398A Bobbin Head Road, North Turramurra, New South Wales, 2074

Inspection Date: 29 Feb 2024

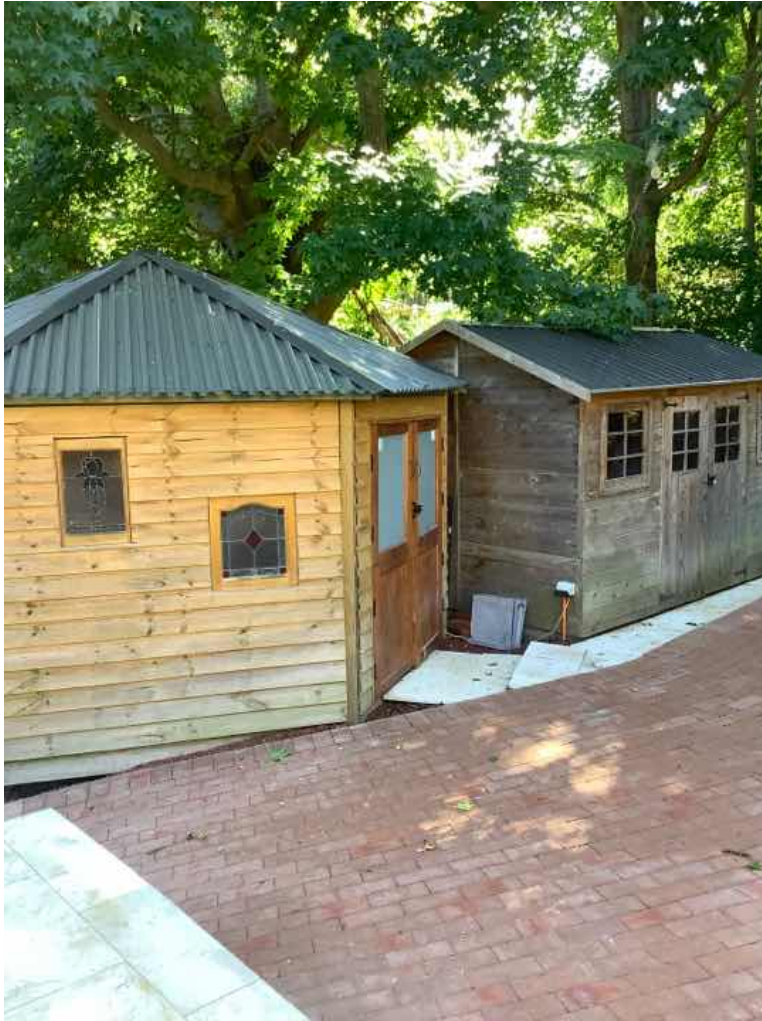
Shed Condition

The shed is in fair usable condition.

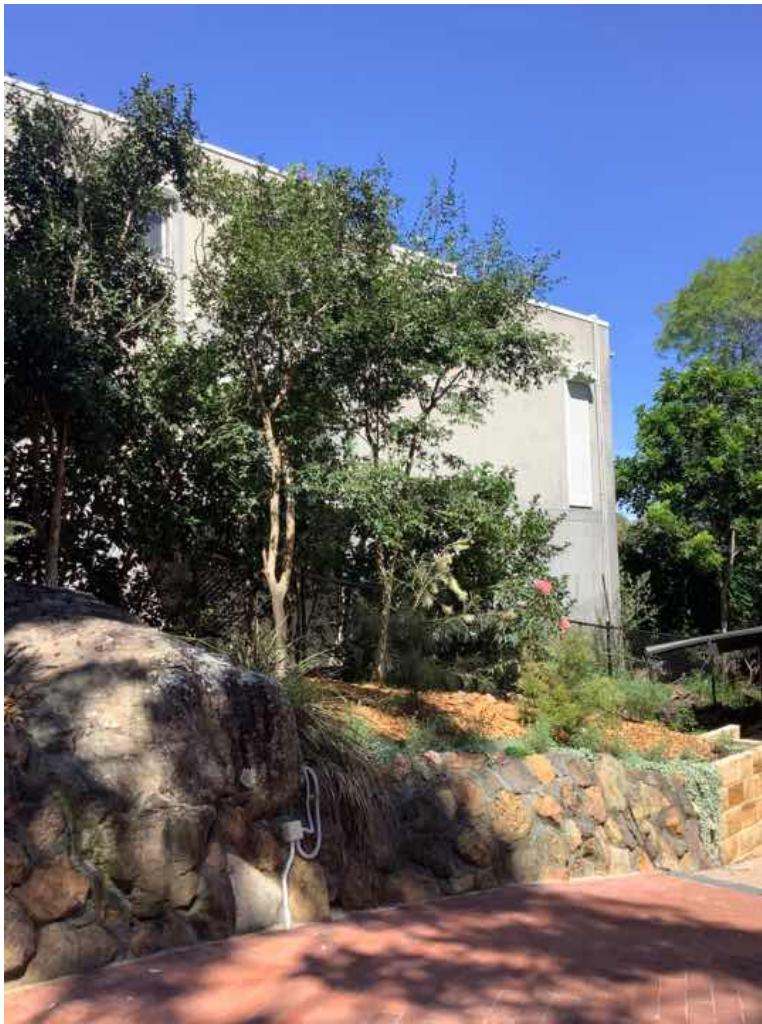
Tree Findings

Trees are overhanging roof areas. Recommendations: These should be cut back away from the roof line and gutters.

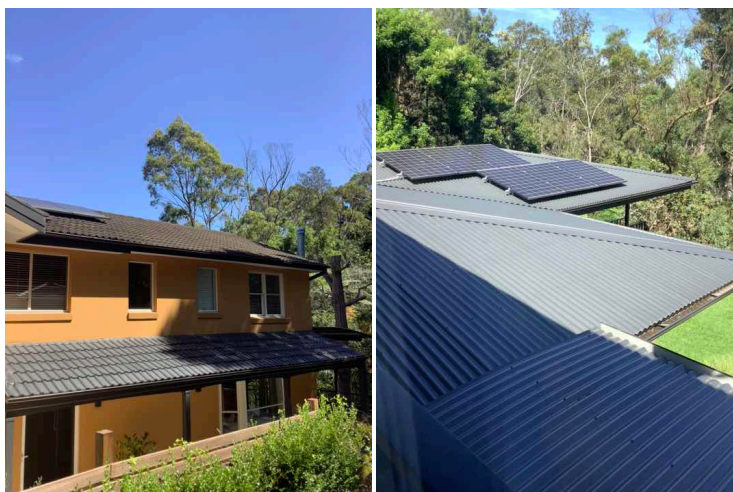
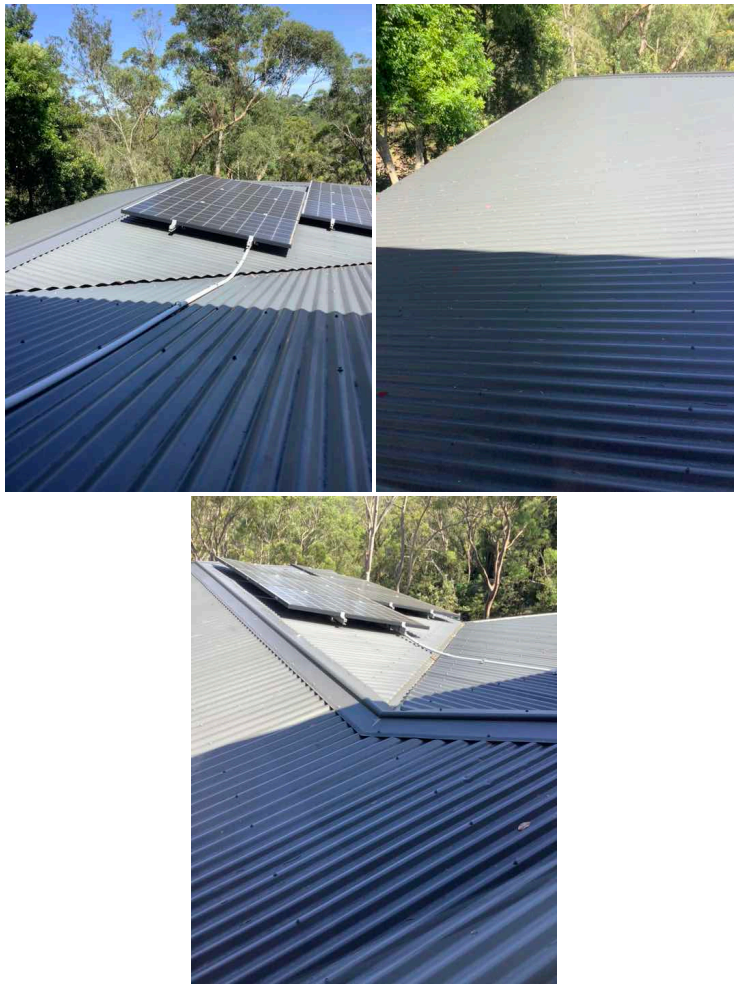
Roof Covering Condition

Visible section of The roof cladding appeared in a serviceable condition for the age of this dwelling. Annual maintenance inspection recommended.

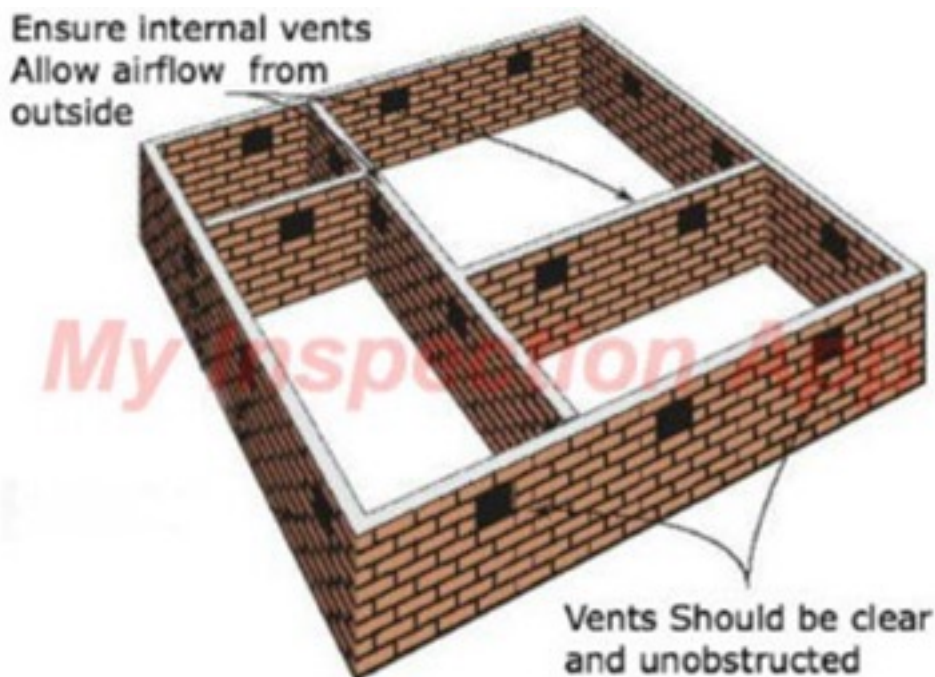
Findings

The vents are unobstructed.

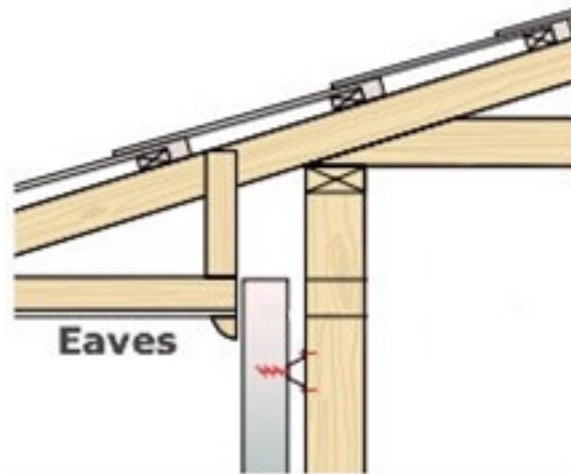
Eave Condition

The eaves are in a serviceable condition with no notable defects.

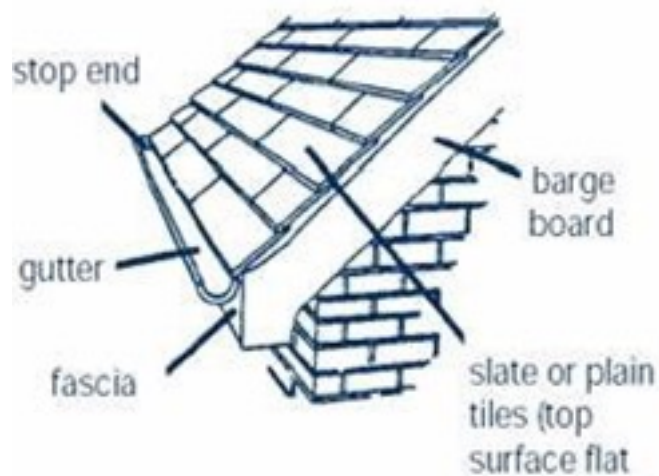
Fascia and Barge Boards

On visual inspection, the general condition of the fascia/barge boards is serviceable.

These timbers due to their position are prone to decay and should be kept well painted to prevent such deterioration.

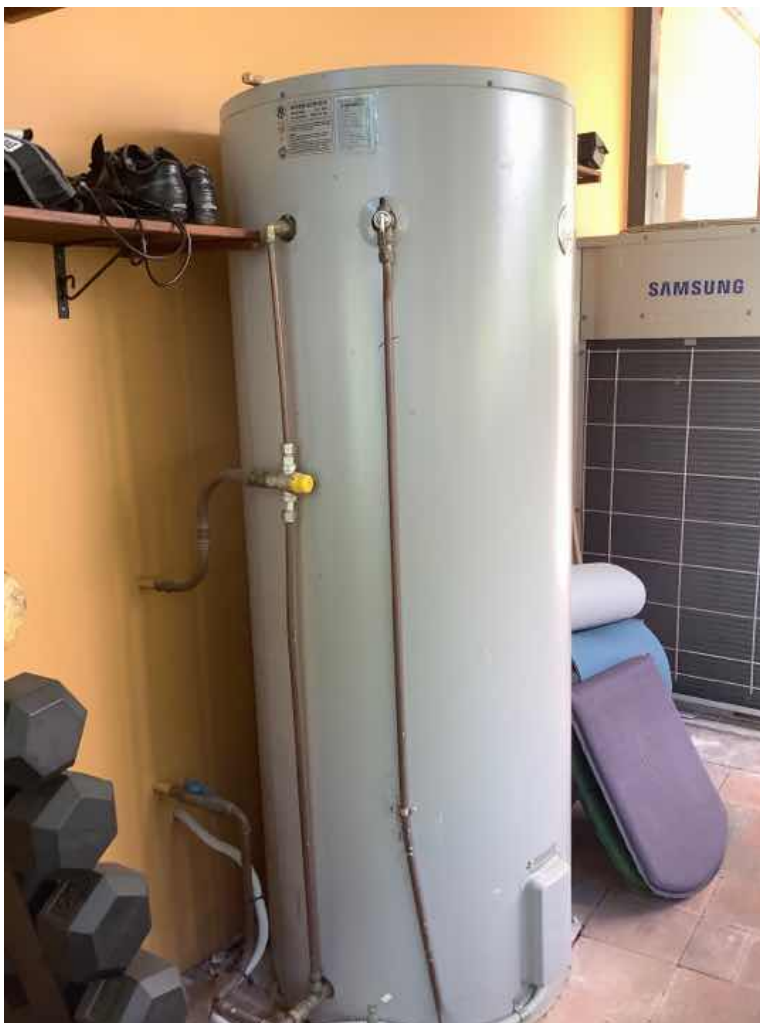
Hot Water Unit Findings

The hot water system appears to be in a serviceable condition. No specific tests other than running the hot water from a tap was carried out. No determination has been made as to the suitability or adequacy of the hot water system in relation to capacity or otherwise.

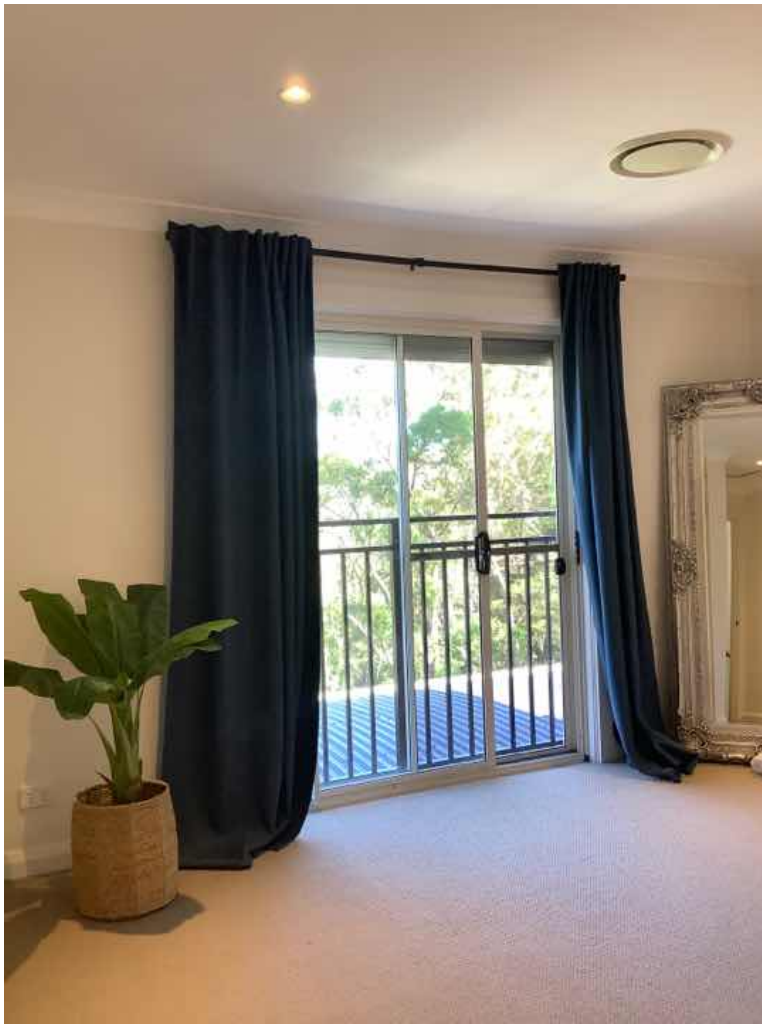
Flooring

Squeaky and uneven floor boards noted. Re-fixing the floor boards may fix this issue. Contact a licensed carpenter for advice and recommendations.

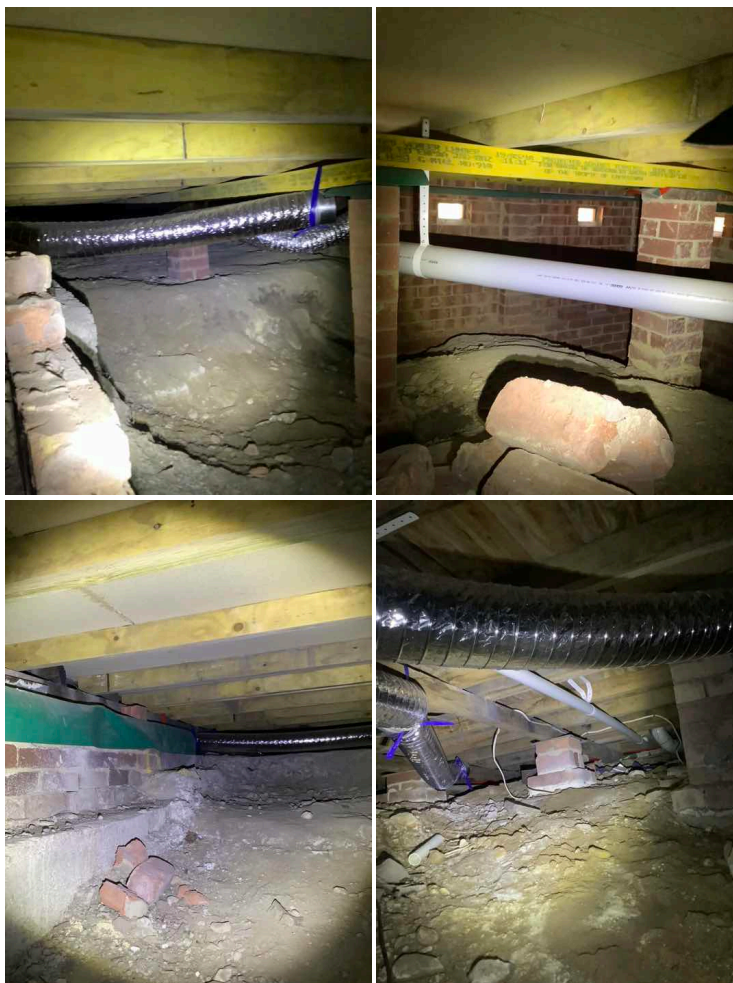
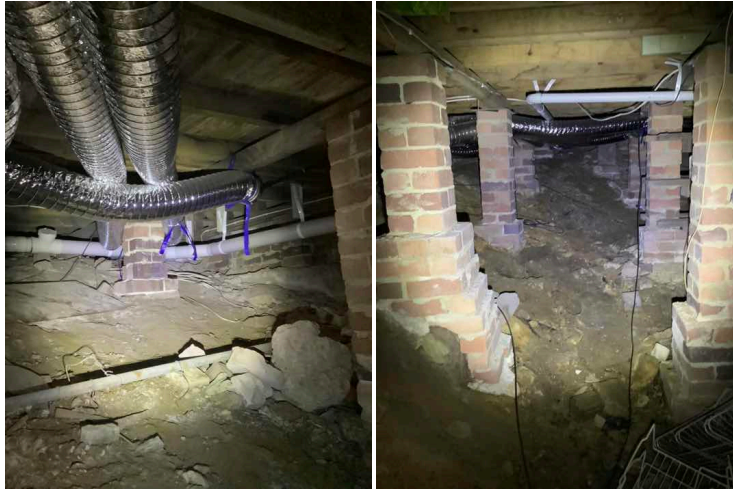
General Condition

Of areas accessible and visible, the subfloor and components appeared to be in a serviceable condition.

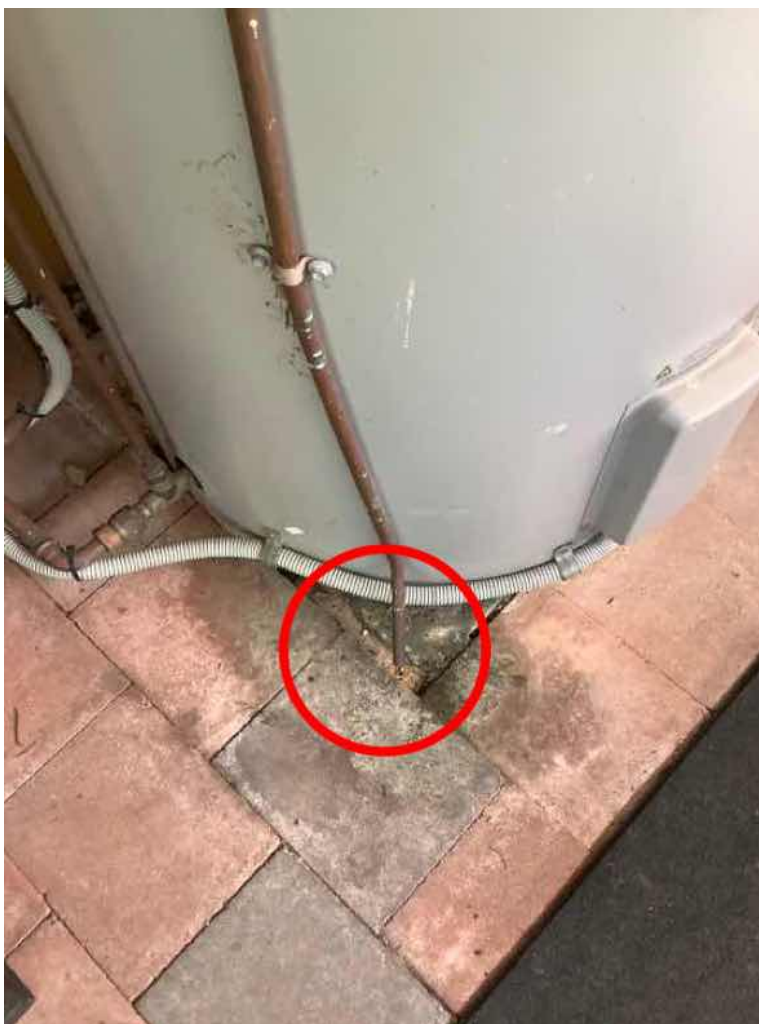
Was the overflow sufficiently drained

No - Divert hot water overflow away from the building perimeter
