# **PRE SALE PROPERTY INSPECTION**

28 Clarke Street, Hendra.

# Visual Pre Purchase Building & Timber Pest Inspection Report

To comply with Australian Standard AS4349.1-2007 and AS4349.3-2010

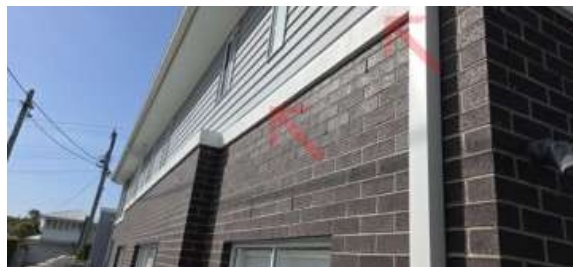
Minor maintenance and or repair required prior to next repainting.

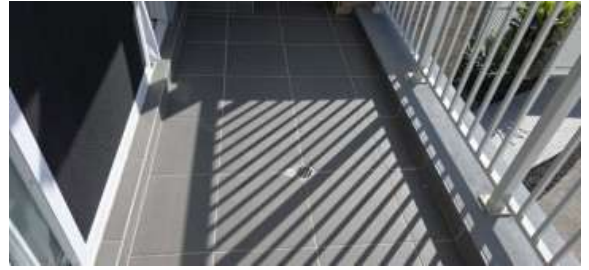
Scumming noted to tiles.

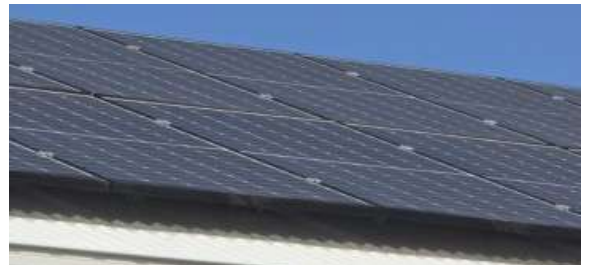
No access was possible to the external roof area due to the roof not being accessible from 3.6 metre ladder. Due to work cover constraints, aging, unsafe materials, safety rail, perimeter scaffold, and/or harness requirements it should be clearly understood that no human access, or attempts to walk on or traffic the roof external surface was made by the inspector at any point of this inspection. If a detailed assessment of the roof fabric beyond this report is sort, a licensed roofing experts opinion should be commissioned. Solar panels have been installed to the external roof surface restricting inspection of the roofing material. Defects and or roofing material damages that can lead to water entry may be in areas not accessible.

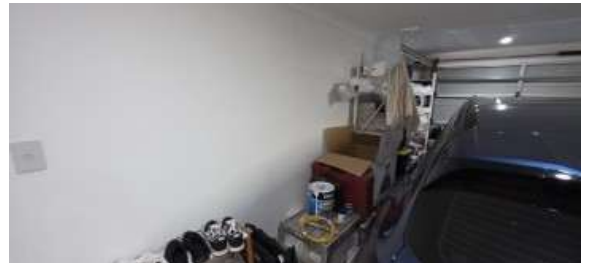
Stored items restricted inspection to the interior. These goods must be removed to enable a more complete report to be submitted.

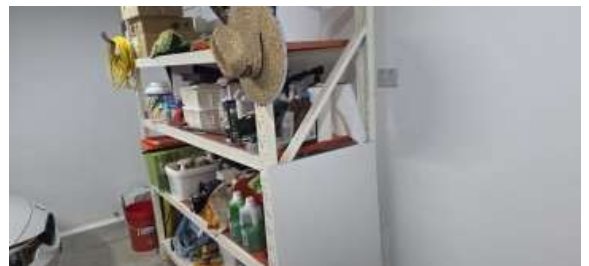
Stored items restricted inspection to the interior. These goods must be removed to enable a more complete report to be submitted.

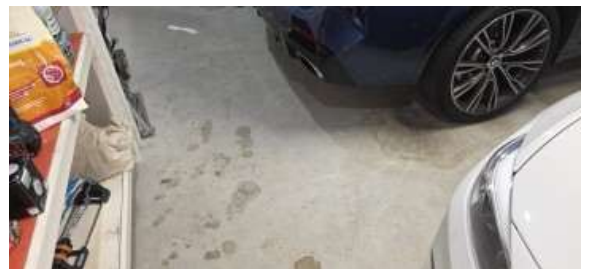
The concrete floor shows signs of minor cracking. Please refer to section of this report - CRACKING OF BUILDING ELEMENTS for additional details.

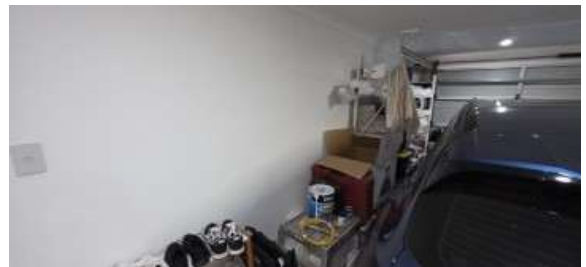
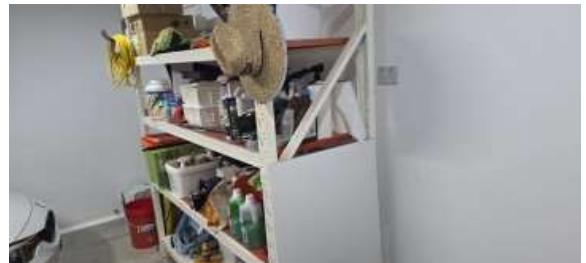
Stored items restricted inspection to the interior. These goods must be removed to enable a more complete report to be submitted.
