RESIDENTIAL BUILDING INSPECTION REPORT

Client: Jake MOEN & Emily BRIGHT-BRADY
Mobile: 0413 580 102
E-mail: moenj02@gmail.com
Property Inspected: 2/59 College Street, Hamilton, QLD 4007
Date of Inspection: Thursday 19 February 2026

Client initiated Building Inspection, in conjunction with a Timber Pest Inspection, as part of Pre-sale considerations.

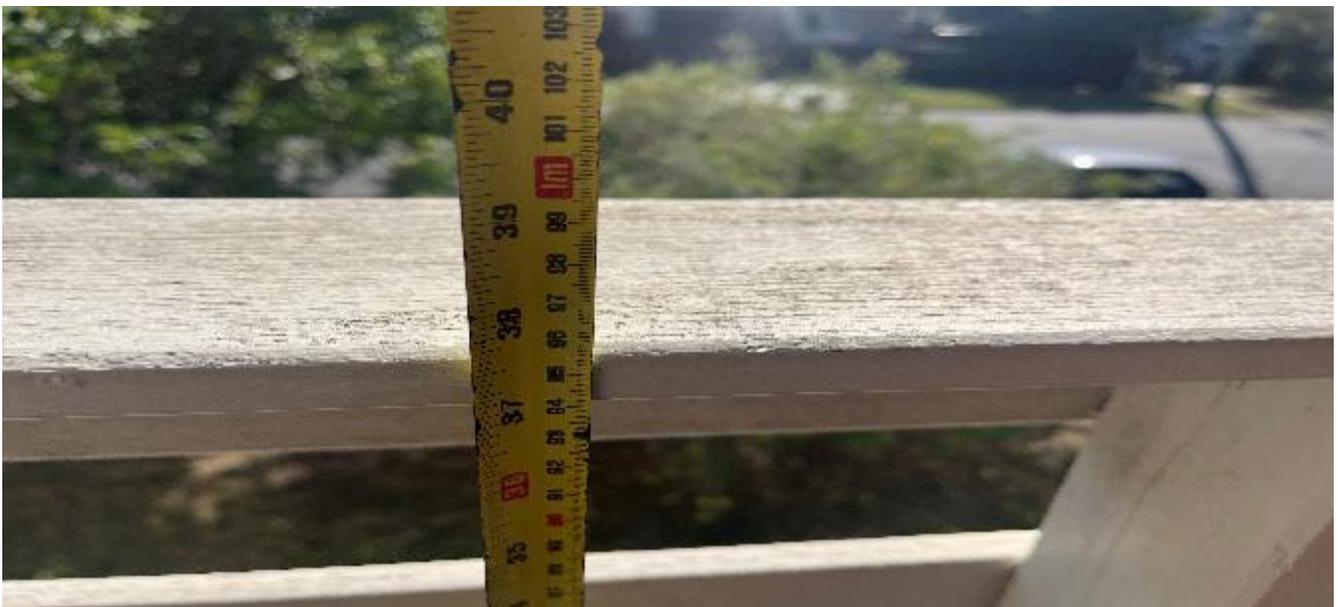
It was noted that there are some components of the balustrades in service, which are not in compliance with the requirements of today’s stipulations within the National Construction Code. This is of course completely understandable, as the balustrades were built well before the current requirements were cemented in place around 1998, with an amendment being added to the Building Code of Australia (now National Construction Code, section 3.9.2.3 – Volume 2.)

The reason(s) for the balustrades not being compliant, were the following:

- The height of the balustrade is less than one metre.

Important Recommendation for Balustrade Non-Compliance at subject residence

Whilst not currently required under any statute law (as of May 2019), we have a legal obligation under our Duty of Care to recommend, that for any non-compliance issues listed above, that you consider taking immediate action to ensure rectifications are carried out, where necessary, to make the balustrades, and all components of the balustrades, compliant with the present day’s requirements within the NCC.

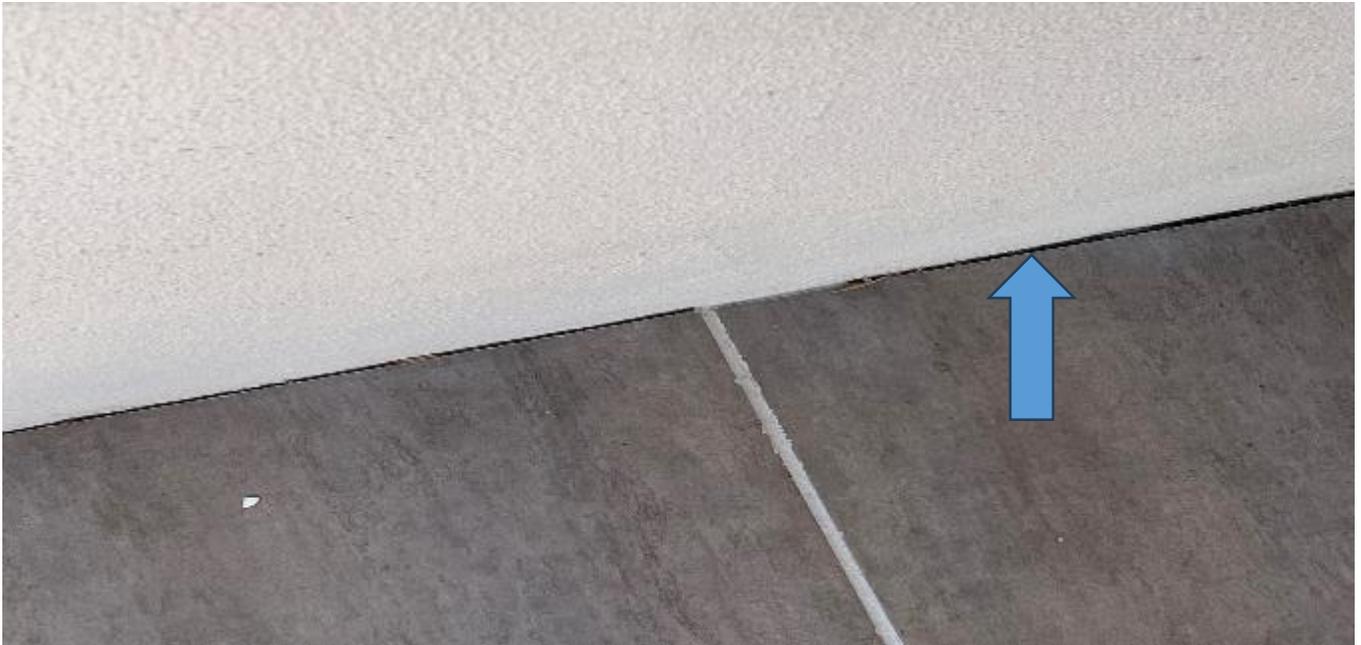
Grout/silicone or other waterproof material coming away.

It was noted that there were some areas where the silicon or grout has come out and is no longer present. This often can relate to intersecting materials and tile joints and these must be free from such defect at all times in order to ensure the best quality waterproofing is in place.

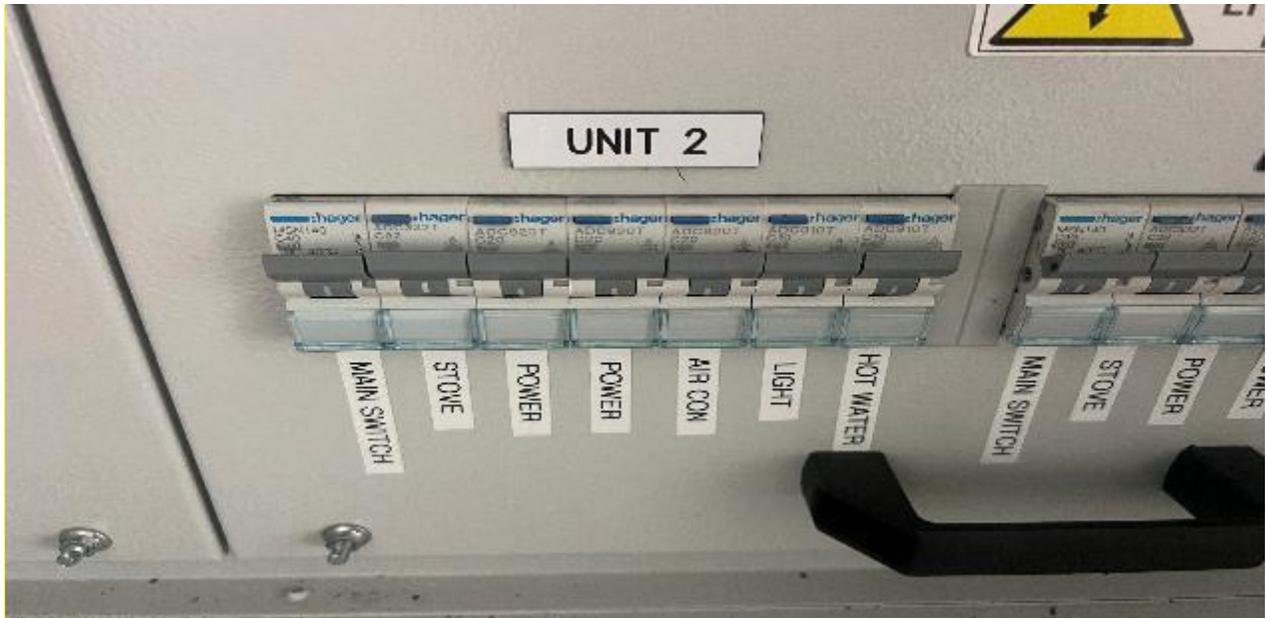
There are circuit breakers fitted within the meter box.

Circuit breakers came in around the late 1980s to supersede wire fuses and therefore eliminate need to replace fuse wire in the event a circuit would 'blow' if there is too much load on the particular circuit. In the case of circuit breaker fuse boxes being in place, the switch will simply flick off if there is an overload or problem with the circuit and there is no need for new wire to be added.
