# Pre-Sale Building & Timber Pest Inspection Report

37 Webster Ave, Hendra QLD, Australia

09 Jan 2026

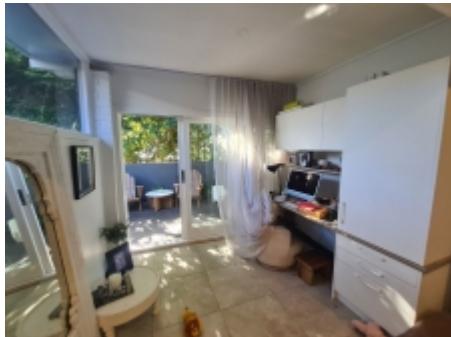
This room appears to be an extension to the main building.  
Recommend to contact the local council to ensure the extension has been recorded by council and is compliant

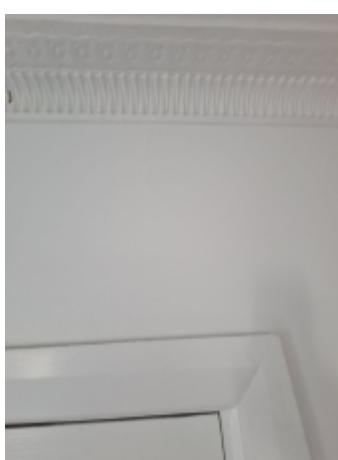
Evidence of repairs to a crack in the wall.

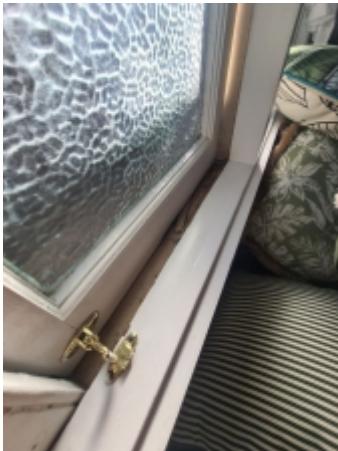
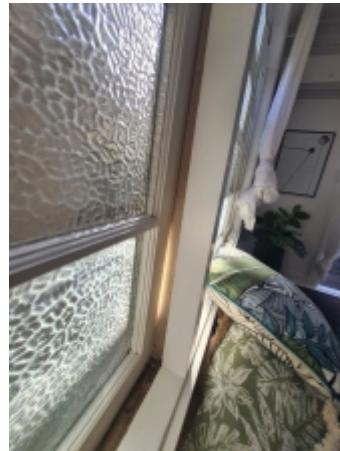
Window sash is not sitting correctly in frame. Recommend to have all window sashes throughout the building checked and adjusted and replace broken hinges

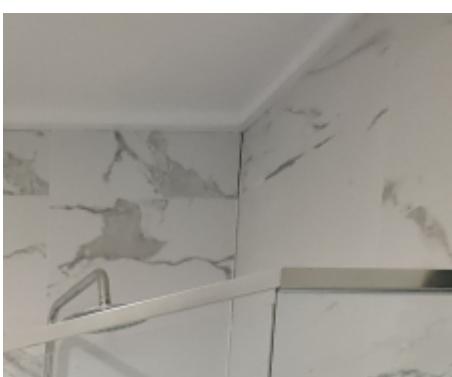
Sealant is missing to wall joins in shower

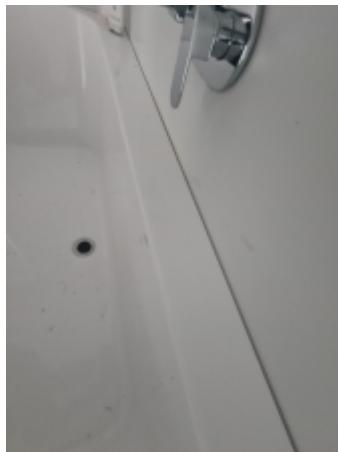
Seal back edge of bath to wall tiles

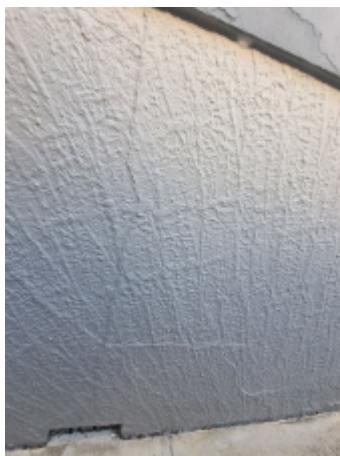
Minor cracking to masonry rendered wall

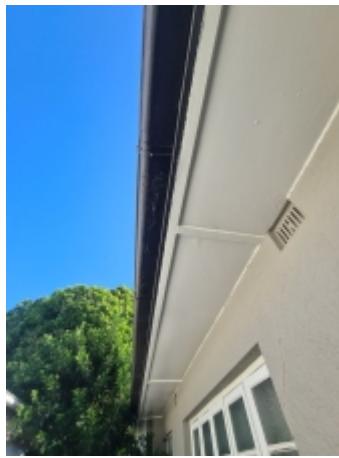
Paint peel to gutter with rusting

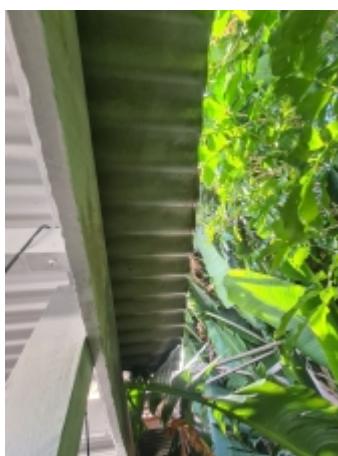
There is no gutter and downpipe installed to roof

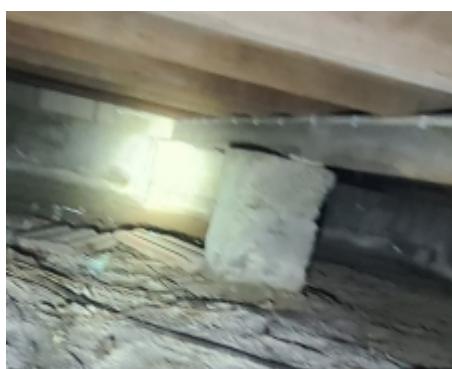
There is no antcapping

Recommend Further Inspection By:

Licensed Builder

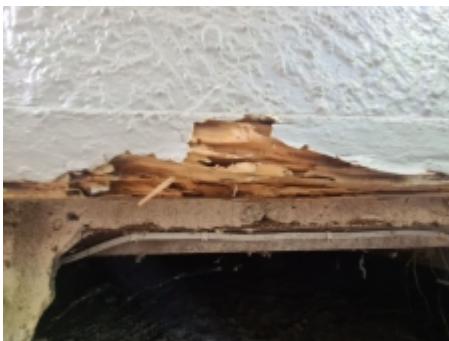
Termite damage to access hatch frame.

The full extent of timber replacement and/or repair can not necessarily be determined during this visual inspection and as damage or activity may exist in concealed or inaccessible areas.

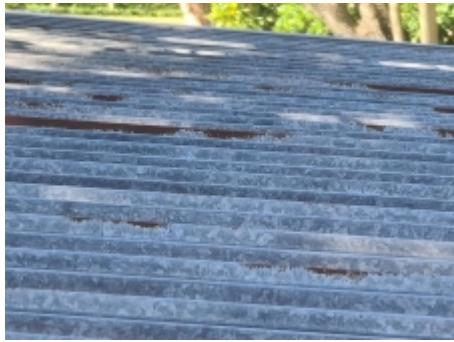
Rusting to metal roofing

Due height restrictions and the steep pitch of the roof a full inspection could not be conducted  
Recommend to have roof looked over by a licensed roofer

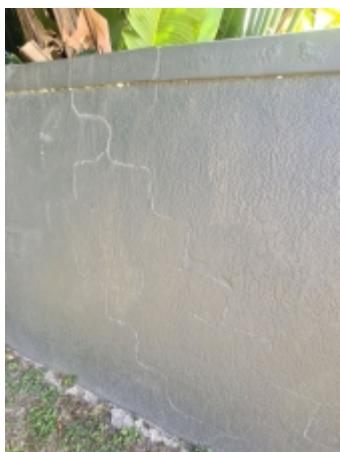
Defect Severity	<span style="background-color: green; width: 10px; height: 10px; display: inline-block;"></span> Minor Defect
Comment	Cracking to masonry block fence. Front

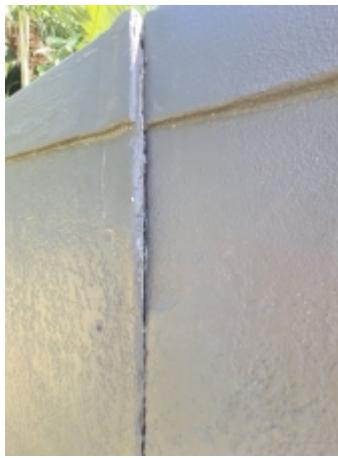
Defect Severity	<span style="background-color: green; width: 10px; height: 10px; display: inline-block;"></span> Minor Defect
Comment	Dislodged render from movement at control join. Front

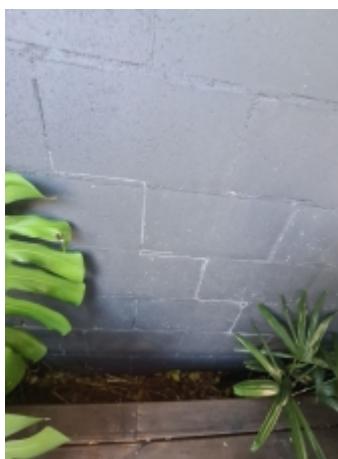
Cracking to masonry block fence. Right side

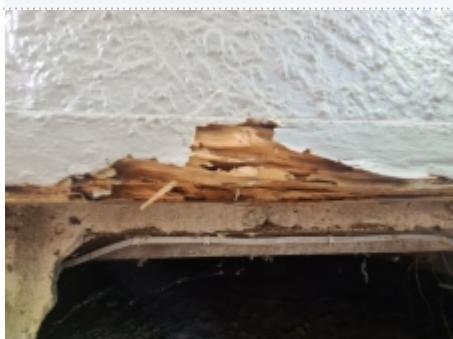
Gate frame to subfloor access hatch. Rear

It is strongly recommended that the full extent of any such activity and damage be fully understood through the engagement of a Licenced Builder, Structural Engineer or appropriately qualified expert.

Recommend that a Termite Management Program be installed
