Pre-Sale Building & Timber Pest Inspection Report

4 Golden Square Hendra 4011 Queensland Australia

10 Nov 2025

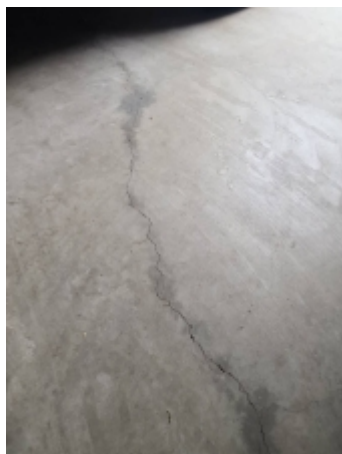
Garage

Concrete floor has some cracking. This is common with concrete floors and considered cosmetic

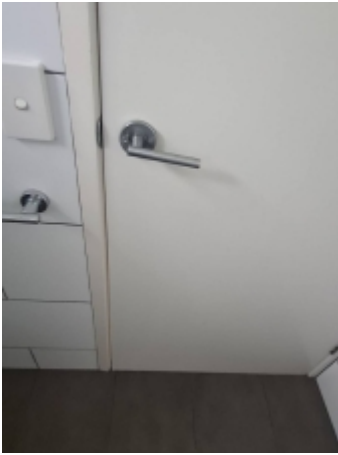
Ensuite 3

Door not latching to door frame

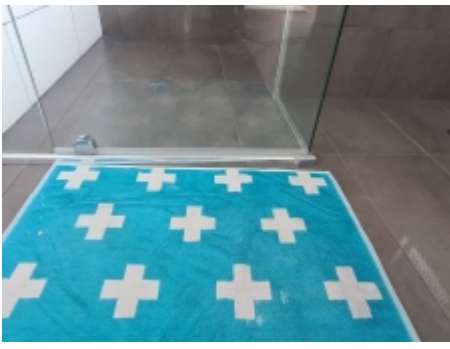
Ensuite

Adjustments to shower screen door recommended

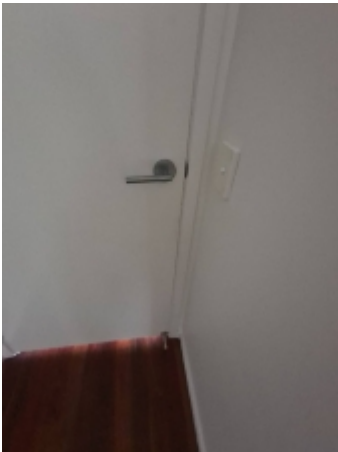
Bedroom 1

Door not latching to door frame

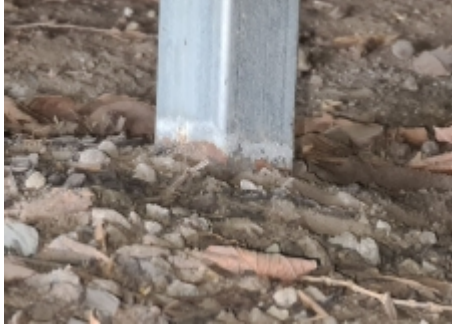
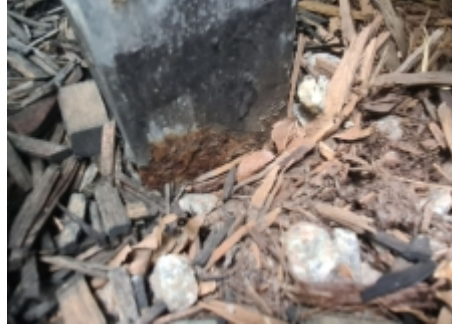
Comment	Rusting to base of steel posts. Maintenance recommended
---------	---

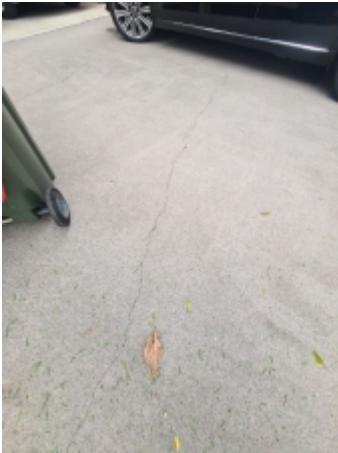
Driveways

Defect Severity	Minor Defect
Comment	The concrete driveway has some visible cracking, this type of cracking is common with concrete driveways and considered cosmetic
