Pre-Sale Building & Timber Pest Inspection Report

5/17 Magdala Street Ascot 4007 Queensland Australia

02 Mar 2026

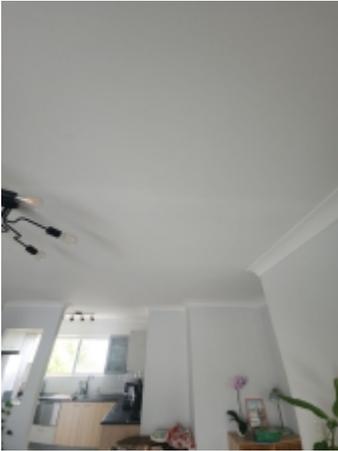
Living Room

Cosmetic cracking was noted to ceiling linings

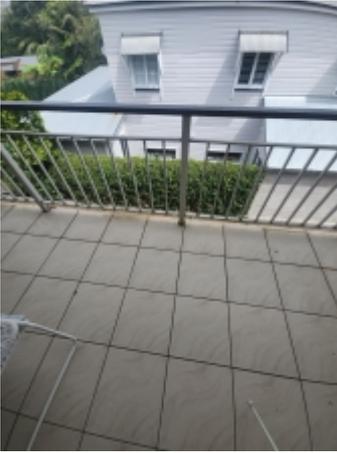
Balcony

Some drummy and cracked tiles were noted to the floor area

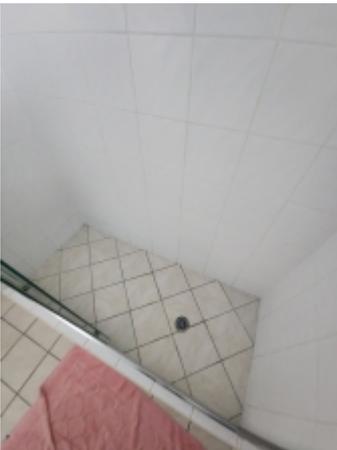
Bathroom

Drummy tiles were noted to the floor

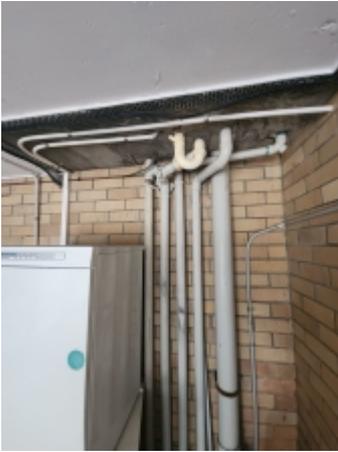
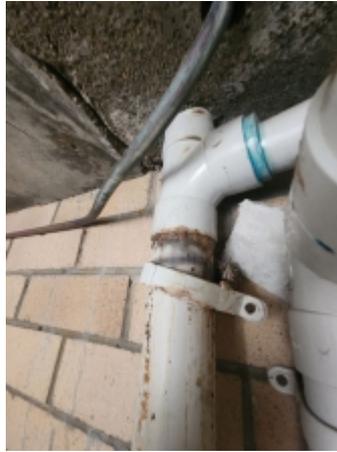
Garage + Laundry

The plumbing pipe is leaking; repairs are required

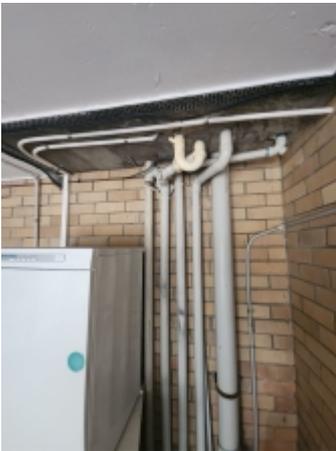
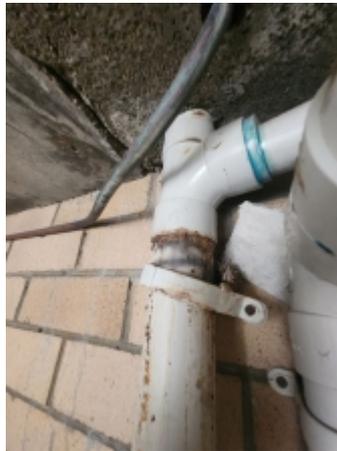
Were water leaks found at the time of inspection? **Yes**

Details & Recommendations: Garage plumbing waste pipe.

If leaks are detected, it is recommended that a suitably qualified plumber or builder is engaged to rectify as soon as possible.
