Pre-Sale Building & Timber Pest Inspection Report

34 Hilda Street Hamilton 4007 Queensland Australia

26 Mar 2026

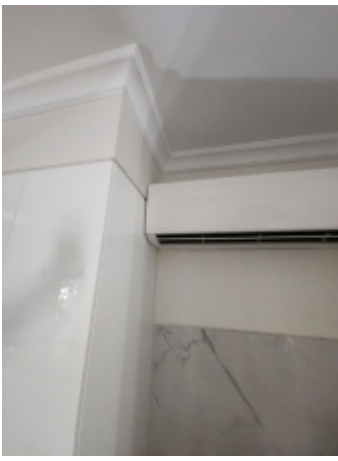
Kitchen

Minor (appearance) cracking was noted to wall linings

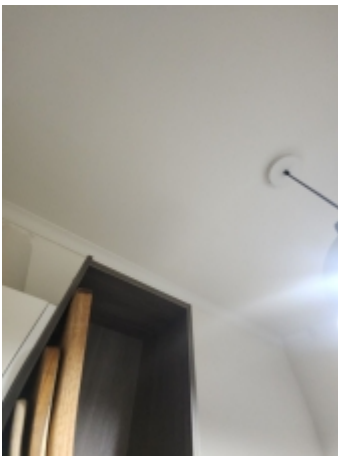
Laundry

Minor (appearance) cracking was noted to ceiling linings

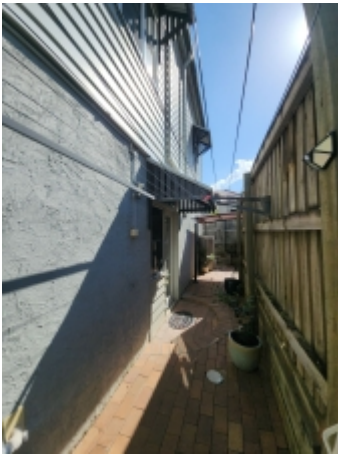
Rear Elevation

The external render is cracking in places

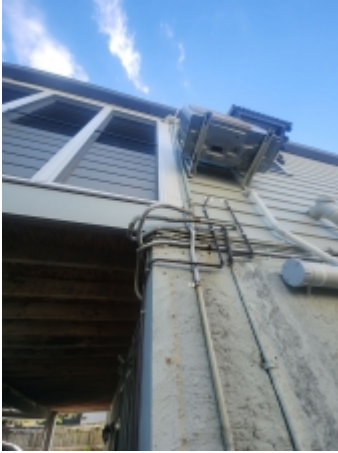
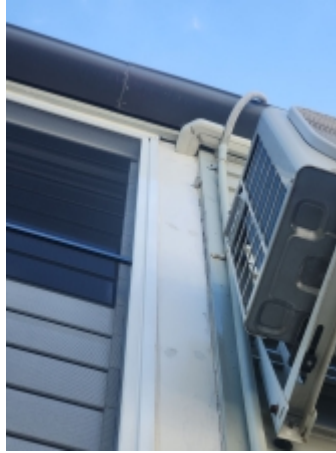
Right Side Elevation

The aircon overflow pipe is dripping down the wall it is recommended this be piped to a drain

Visible leaks were located in the following areas: **Air conditioning overflow**

If leaks are detected, it is recommended that a suitably qualified plumber or builder is engaged to rectify as soon as possible.

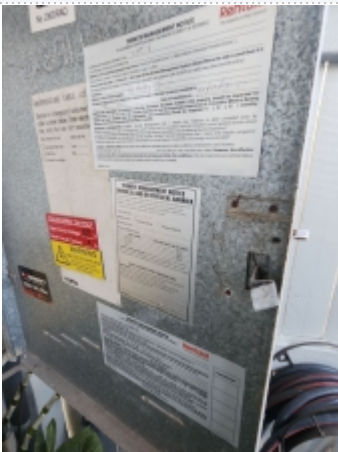
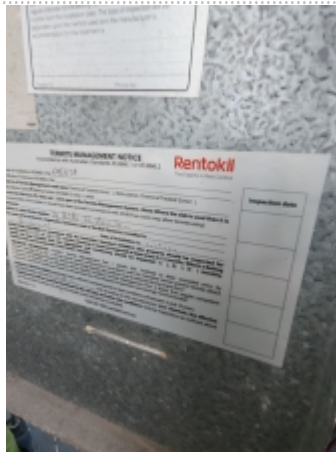
Description of the evidence found: Treatment sticker in meter box

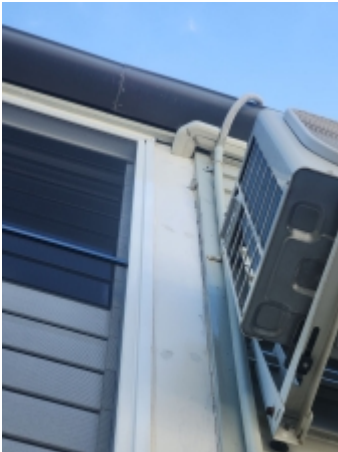
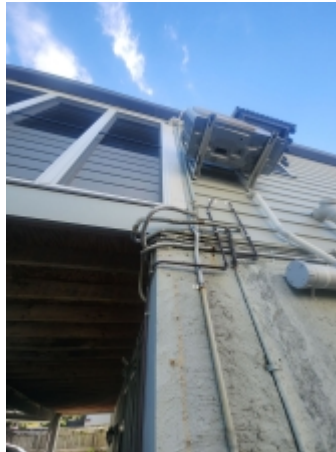
Were water leaks found at the time of inspection? **Yes**
