# Pre-Sale Building & Timber Pest Inspection Report

29 Hatfield Street Banyo 4014 Queensland Australia

## Pre-Sale Building and Timber Pest Inspection - ASBIR Pre-Sale Building & Timber Pest Inspection Report

09 Jul 2026

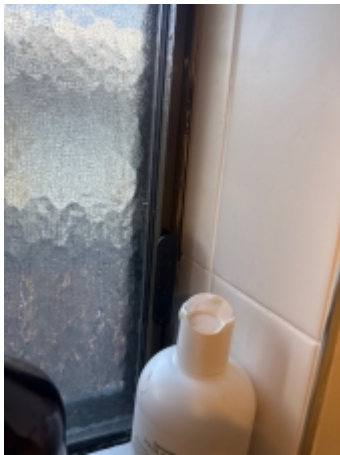
| Defect Severity | Minor Defect |
| Comment | Silicone missing rear of window tiles |

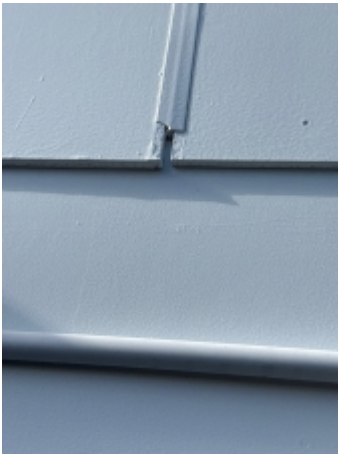
| Defect Severity | Minor Defect |
| Comment | Cover strip broken above overlap - repair to prevent water ingress |

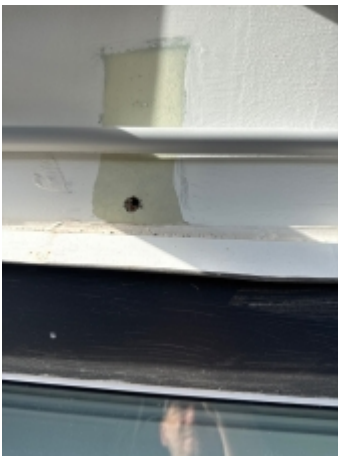
| Defect Severity | Minor Defect |
| Comment | Hole in cladding - repair |

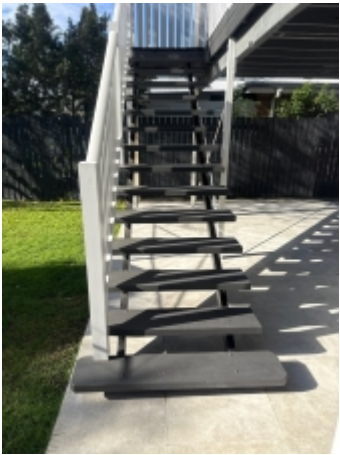
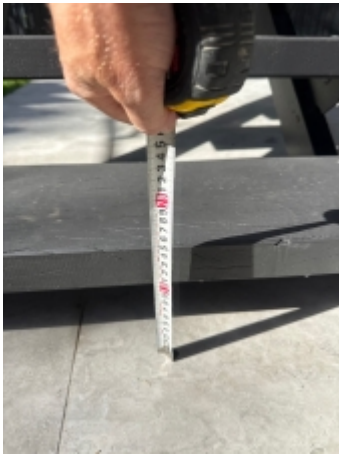
| Defect Severity | Minor Defect |
| Comment | Rear stair case. Lowest stair tread is out of tolerance.<br>This is included in this report as this presents a potential trip hazard.<br>In accordance with the National Construction Code (NCC), stair risers in residential buildings must be between 115 mm and 190 mm in height, with a maximum variation of 5 mm within the same flight |

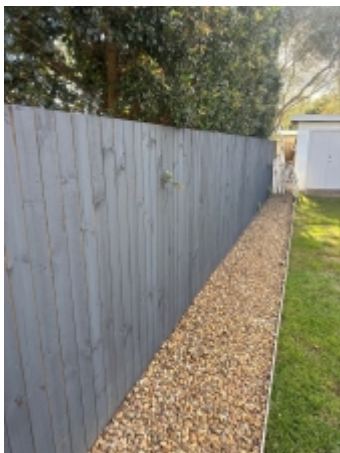
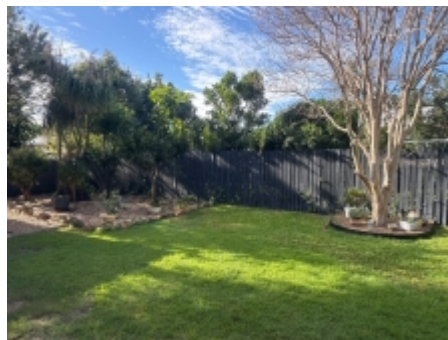
| Area Comments | Fence on right side elevation has some loose pailings |

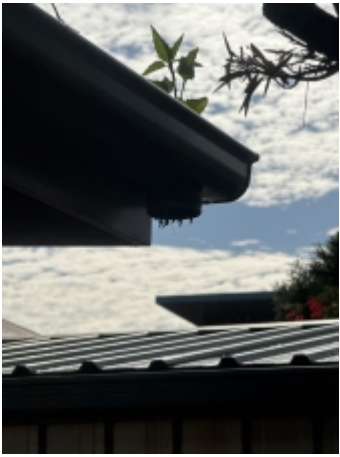
| Defect Severity | Minor Defect |
| Comment | Plant growing in gutter |

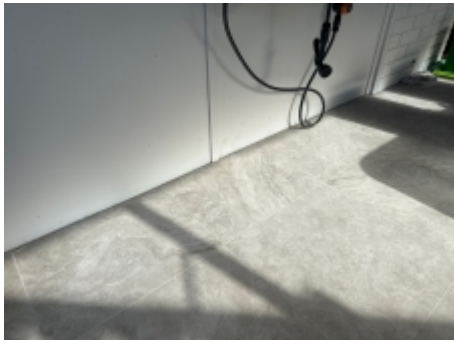
Does the slab edge inspection zone fully comply? No

Details & Recommendations: At rear of home Where tiles butt to the cladding - slab edge is not visible for timber pest inspection.

The concrete edge should not be concealed but rather, a visible inspection zone of at least 75 mm should be maintained to allow visible detection of possible termite activity with regular Inspections undertaken in accordance with AS 3660.3.
