Pre-Sale Building & Timber Pest Inspection Report

34 Blaikie Street Hendra 4011 Queensland Australia

16 Mar 2026

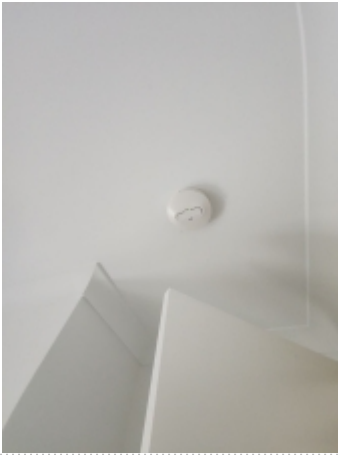
Smoke Alarms

Smoke alarms are installed; however, their functionality has not been tested as part of this inspection

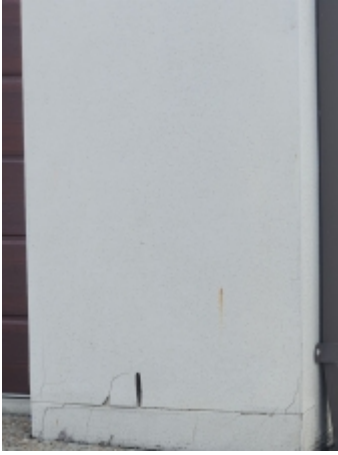
Defect Severity	Minor Defect
-----------------	--------------

Comment	The external render is cracking in places; this is appearance cracking
---------	--

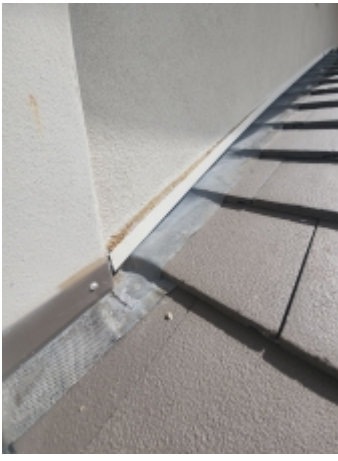
Defect Severity	Minor Defect
-----------------	--------------

Comment	The cladding trim strip is loose,
---------	-----------------------------------

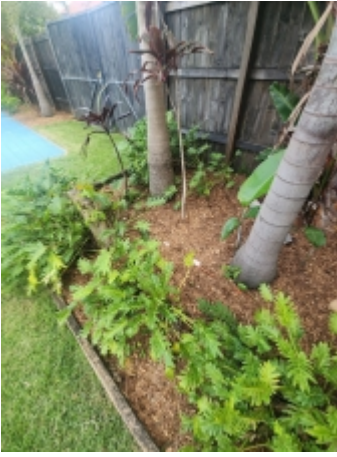
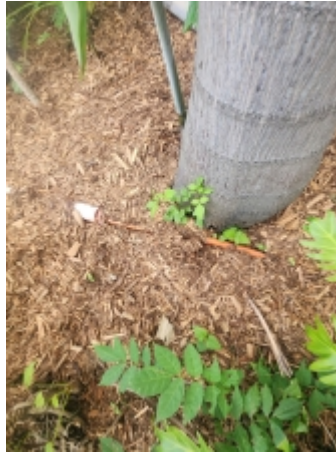
Safety Hazard

There appears to be a electrical cable in the garden, the cable is missing from conduit. A Licensed electrician should be called to make a further evaluation and repairs or rectification as needed.

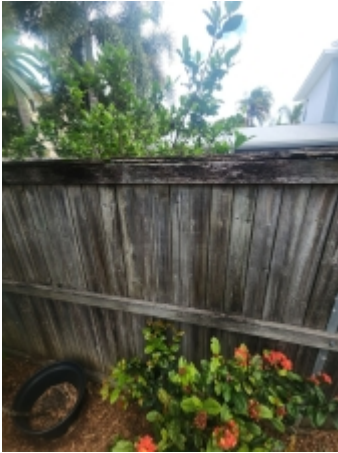
Defect Severity	Minor Defect
Comment	Wet rot decay was present to some fencing timbers,
