Pre-Sale Building & Timber Pest Inspection Report

75 Nellie Street Nundah 4012 Queensland Australia

06 Mar 2026

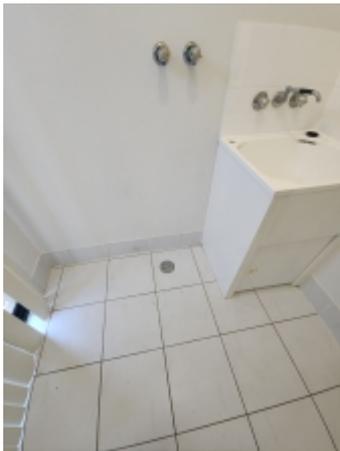
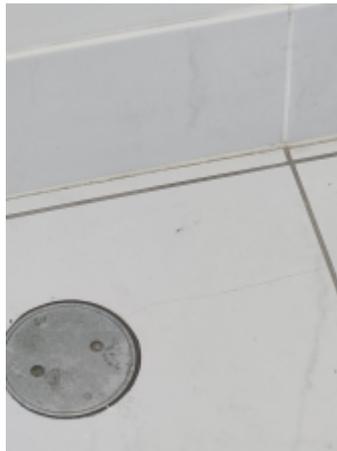
Laundry

Minor Defect

Some cracked tiles were noted to the floor area; this is considered a cosmetic issue

Recommend Further Inspection By:

Licensed Tiler / Water-proofer

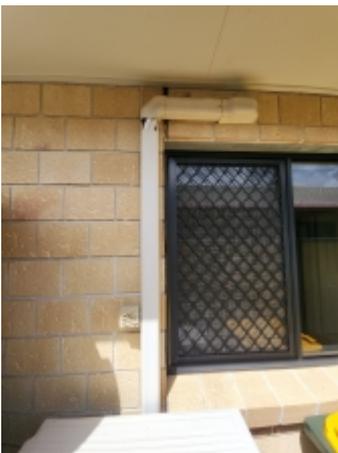
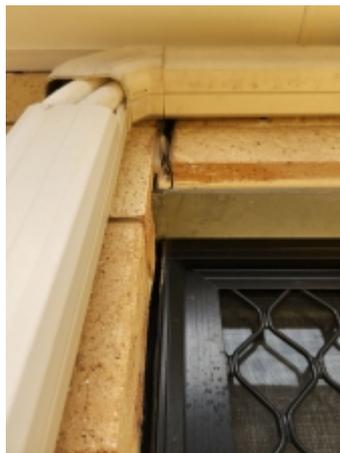
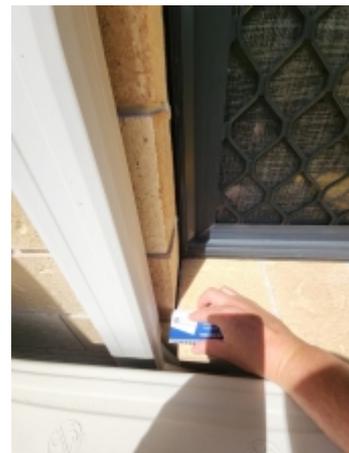
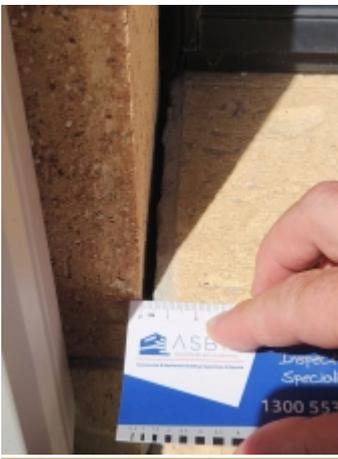
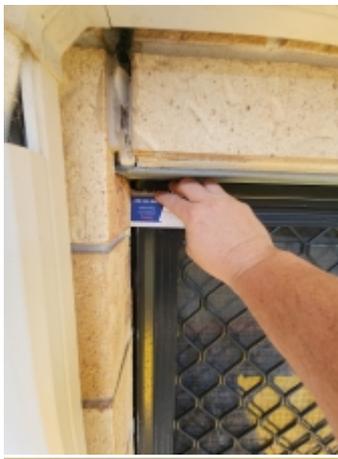
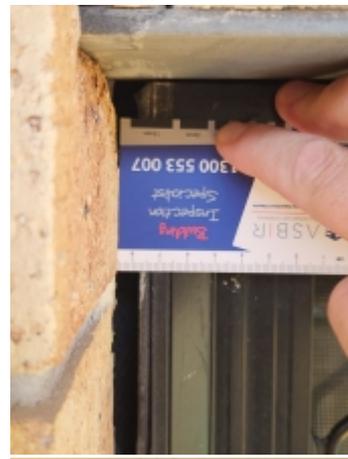
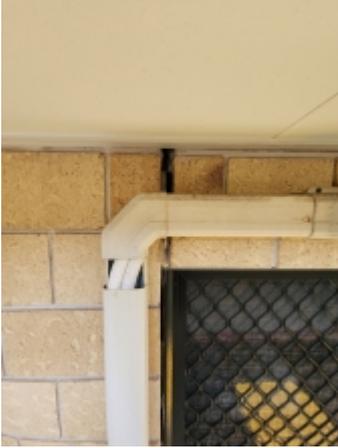
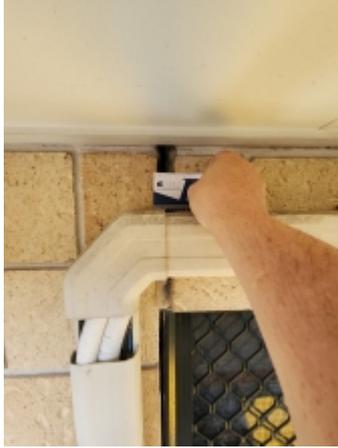
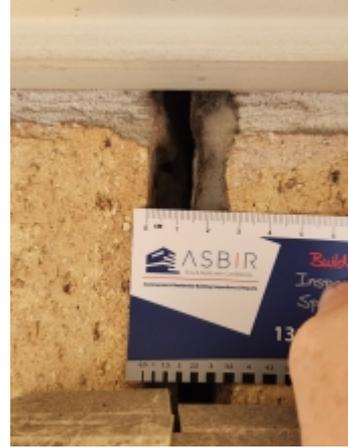
Right Side Elevation

Major Defect

There is a large gap to the brick articulation joint and a gap large between the window and brickwork. A Licensed builder should be called to make a further evaluation and repairs or rectification as needed

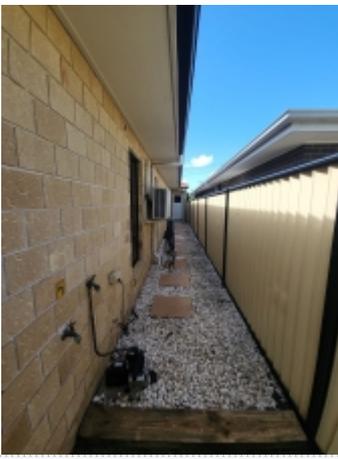
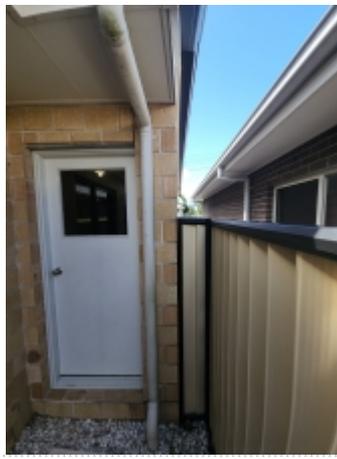
Left Side Elevation

Full access to the left elevation was not gained due to zero boundary.

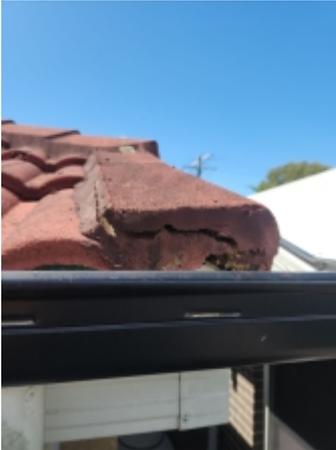
Roof Exterior

Minor Defect

Cracking was noted to the roof tile mortar

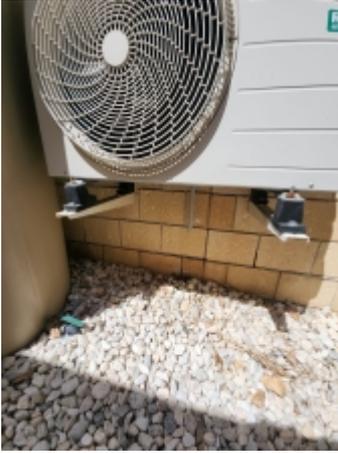
The air-conditioner overflow is directed around the foundations of the house, we recommend this is directed to a drain.
