# Pre-Sale Building & Timber Pest Inspection Report

41 Oxford Street Hamilton 4007 Queensland Australia

## Pre-Sale Building and Timber Pest Inspection - ASBIR Pre-Sale Building & Timber Pest Inspection Report

21 May 2026

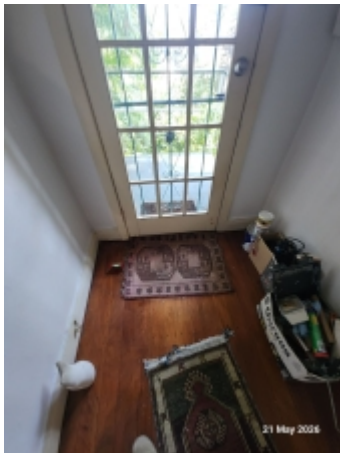
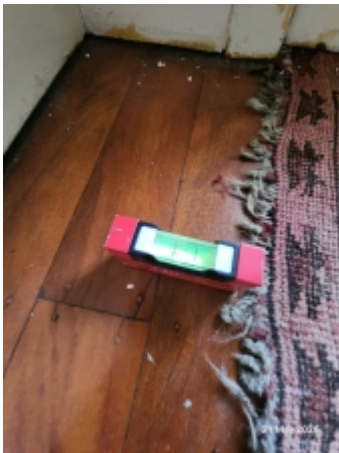
| Comment | Some areas throughout the house the floor appears to be out of level. |

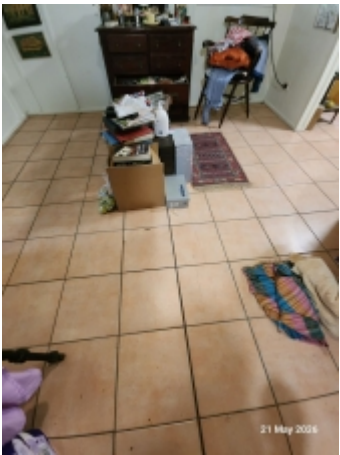
| Comment | Some cracked and drummy tiles were noted to the floor area. |

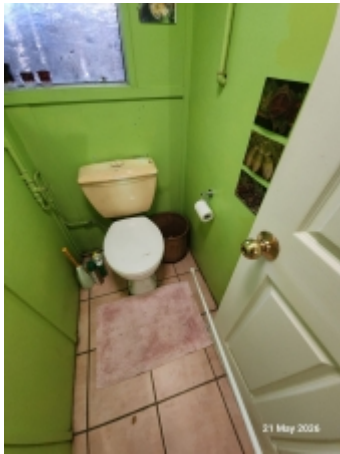
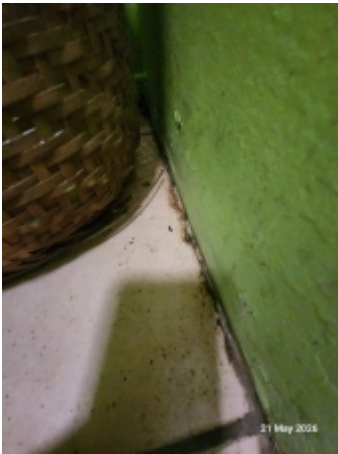
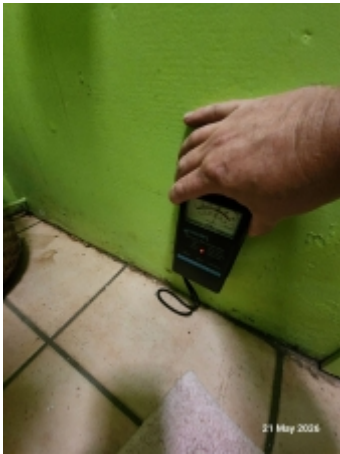
A high moisture reading and what appears to be water staining was present to the base of the wall backing onto the shower. This is an indicator that a water leak or other free moisture source is present and should be further investigated. A Licensed plumber should be called to make a further evaluation and repairs or rectification as needed.

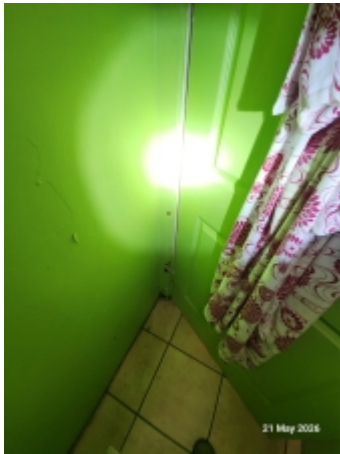
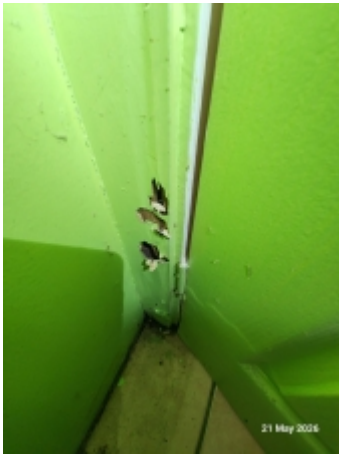
Evidence of what appears to be a termite attack was noted to the architraves. Replacement of the damaged timber is required. The full extent of timber replacement and/or repair can not necessarily be determined during this visual inspection as damage or activity may exist in concealed or inaccessible areas

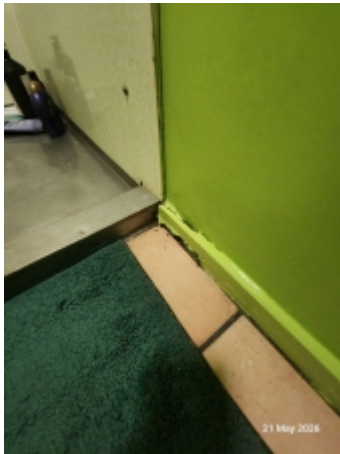
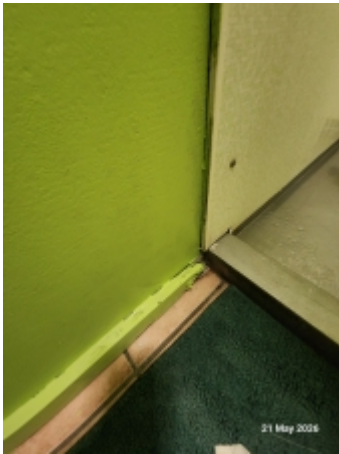
| Comment | Wet rot decay present to the timber skirtings |

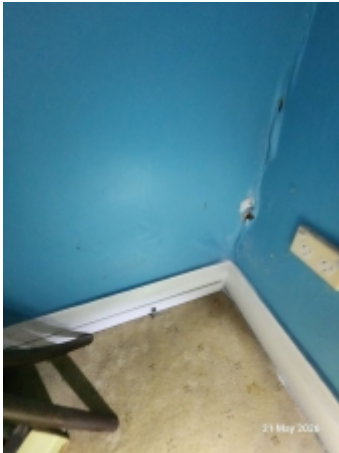
The wall sheeting appears warped and damaged. Repairs are required. Further investigation is recommended to determine the cause and extent of the issue

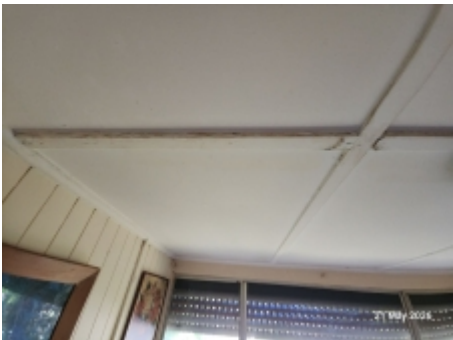
| Comment | Evidence is noted of past water penetration through the ceiling. The cause of this should be further investigated and rectified. |

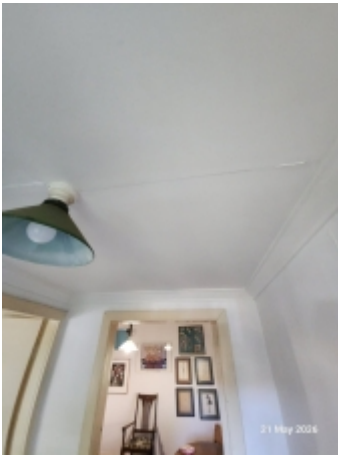
| Comment | Cracking was noted to ceiling linings. These are typical of this type of material |

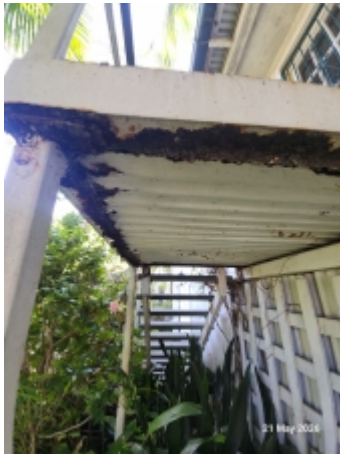
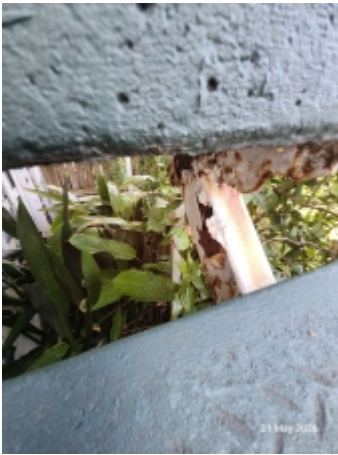
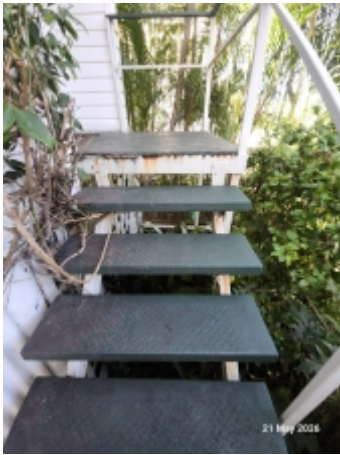
Rust was observed to the external stair landing and stringers. Repairs are required. A Licensed builder should be called to make a further evaluation and repairs or rectification as needed.

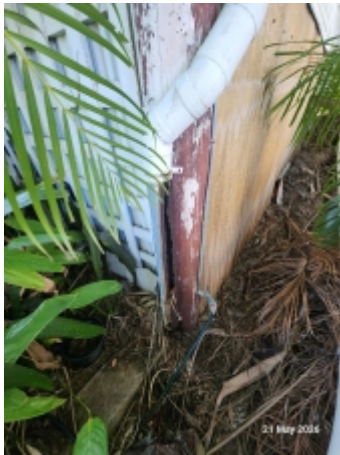
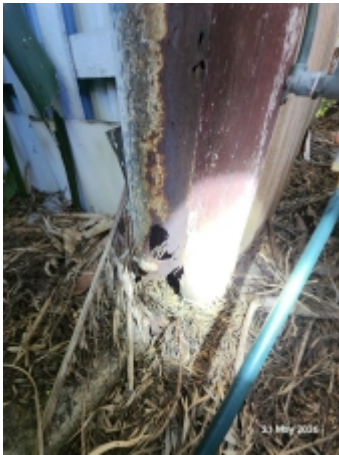
Downpipe is not connected to the stormwater dispersal system; This should be rectified. If there is no stormwater system present the downpipes should be diverted away from all foundations. Downpipes are rusted and should be repaired or replaced as necessary.

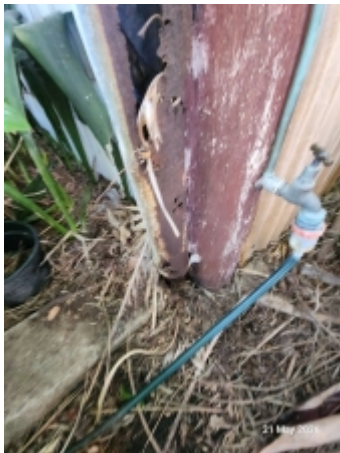
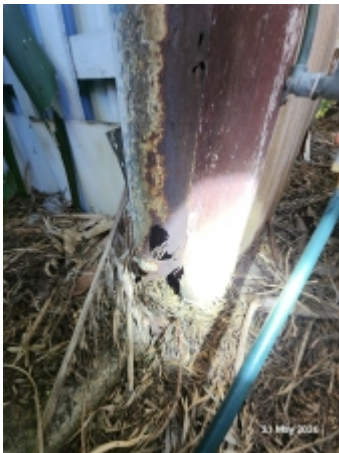
Wet rot decay was observed in the timber house stump. Repair or replacement is required. A licensed builder should be called to make a further evaluation and repairs or rectification as needed.

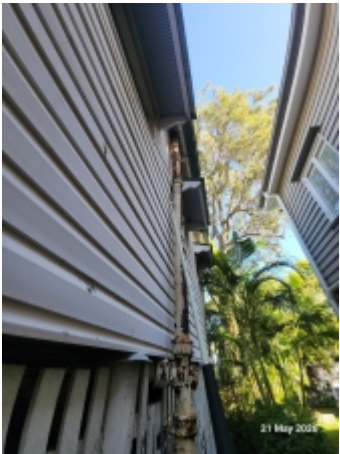
A hole is present in the external cladding. Repairs are recommended. Cladding appears bowed in sections. The cause of this should be further investigated and rectified.

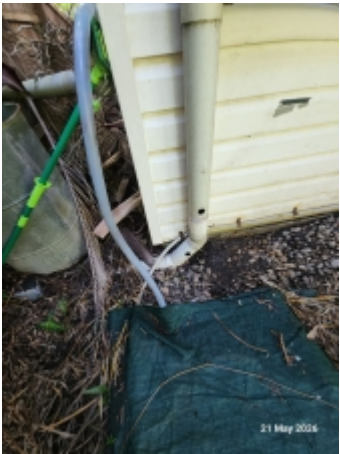
| Comment | Holes present to the downpipe. Repairs are required |

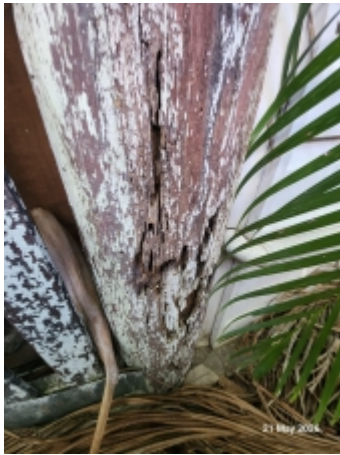
Wet rot decay was observed in the timber house stump. Repair or replacement is required. A licensed builder should be called to make a further evaluation and repairs or rectification as needed.

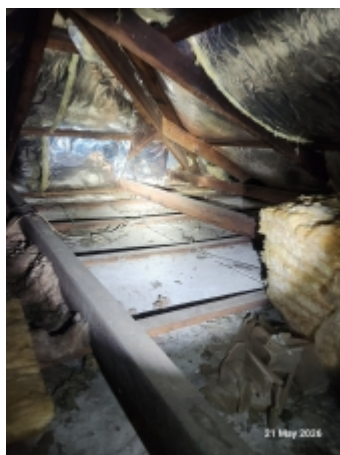
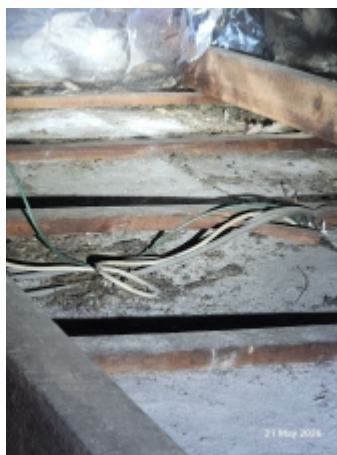
The ceiling is sagging in sections, repairs are required. A Licensed builder should be called to make a further evaluation and repairs or rectification as needed

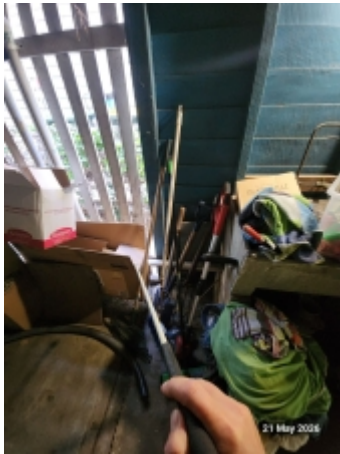
The plumbing to the sink is leaking and the discharge pipe to the sewer is no longer connected. This is considered a major defect. A Licensed plumber should be called to make a further evaluation and repairs or rectification as needed.

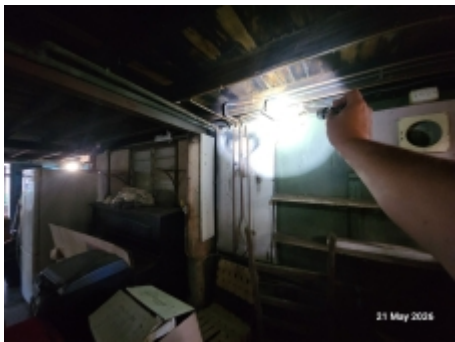
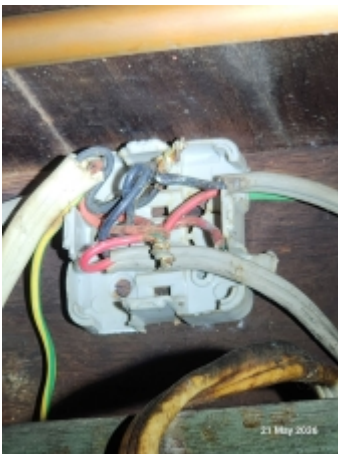
Exposed wires were noted. A Licensed electrician should be called to make a further evaluation and repairs or rectification as needed.

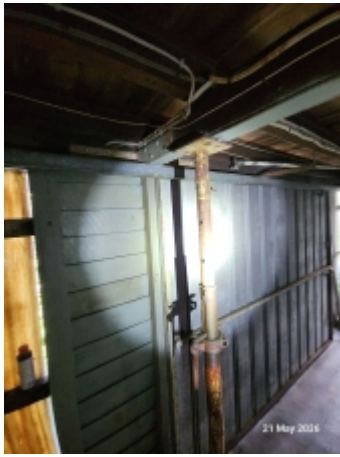
A temporary support has been installed across the property to support a bearer. Further investigation is recommended to determine the reason for the temporary works and to ensure the adequacy and safety of the supporting structure. A Licensed builder should be called to make a further evaluation and repairs or rectification as needed.

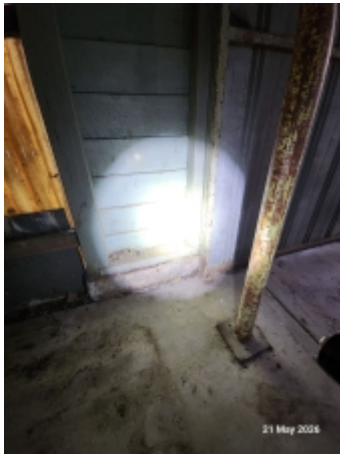
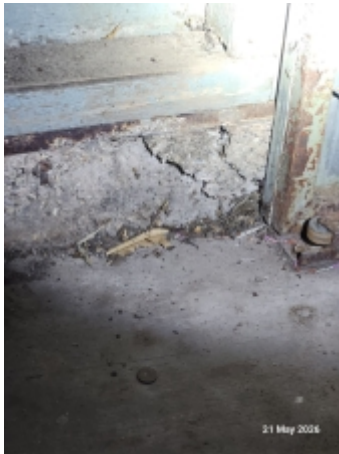
| Comment | Cracking has been observed in the concrete support wall that is supporting load-bearing walls, which is considered a major defect. A Licensed builder should be called to make a further evaluation and repairs or rectification as needed. |

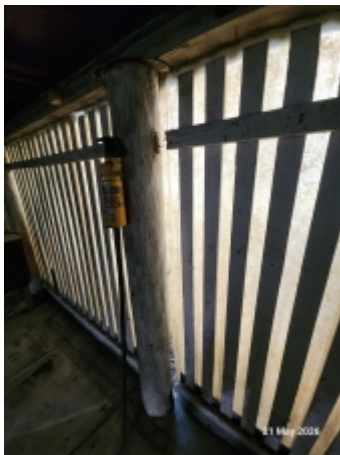
| Comment | The lattice work framing is loose. |

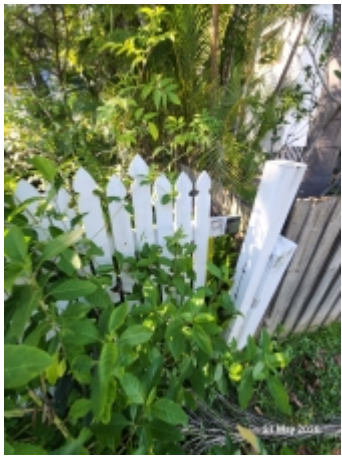
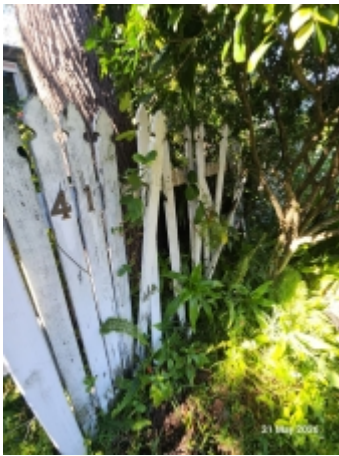
| Comment | Sections of fence require repairs. |

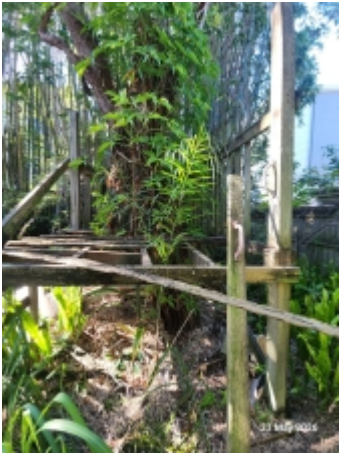
| Comment | The old cubby house is in poor condition and could be a safety hazard. Removal is recommended |

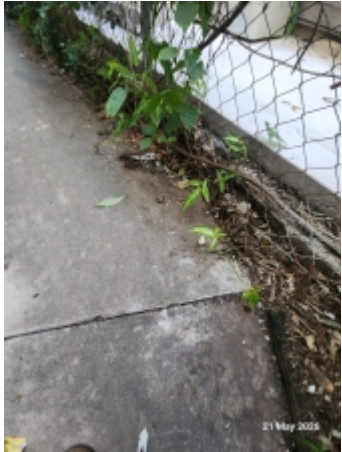
| Comment | The paths have some visible cracking, which may pose a tripping hazard; Rectification is recommended. |

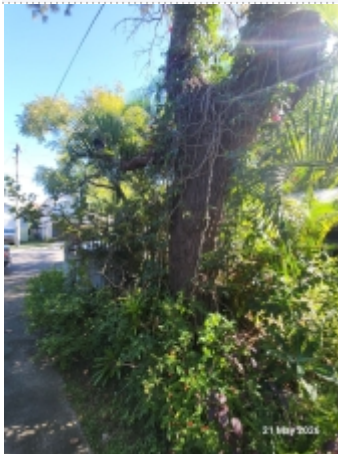
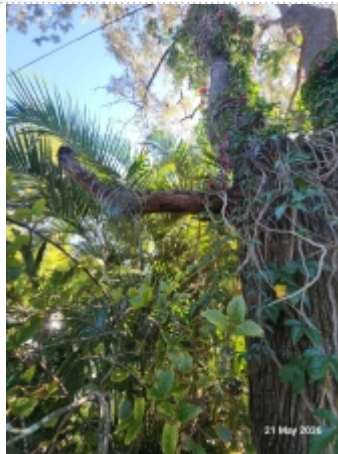
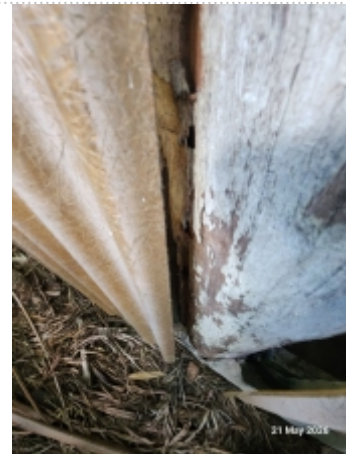
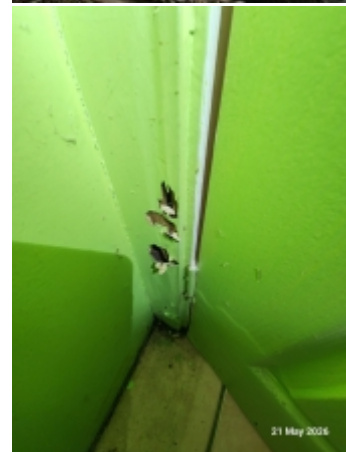
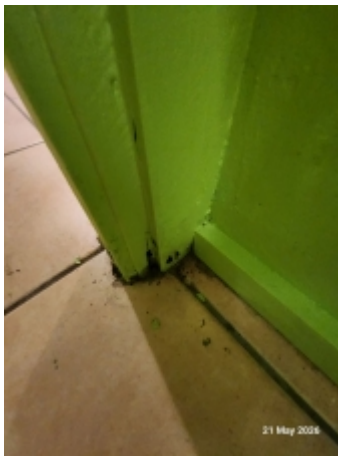
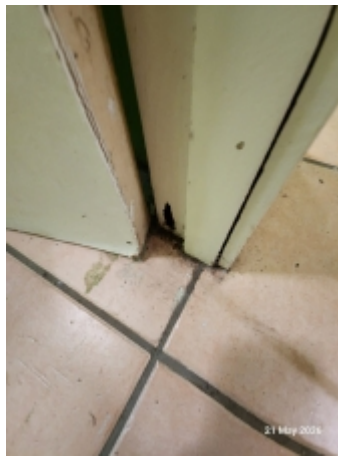
Tree to front elevation.  
Right elevation house stumps.  
Ground floor toilet architraves and door jamb.  
Bathroom 2 architraves and door jamb.

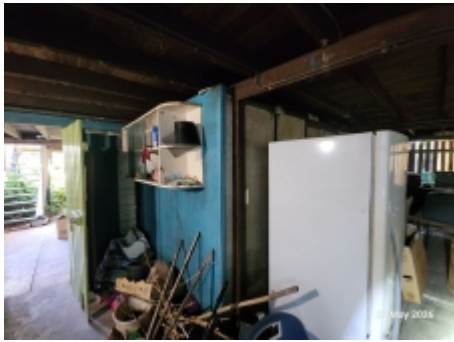
Details & Recommendations: **Not all areas have ant caps fitted. If it is not possible or practicable to fit antcapping, this area should be regularly inspected by a Licensed Pest Inspector.**

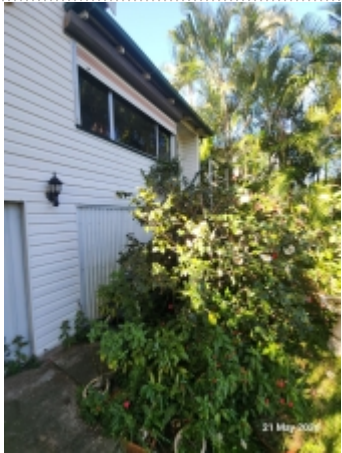
| Photo Comments | Trees and shrubs are close to the external walls. These should be removed as they can allow concealed termite entry. |

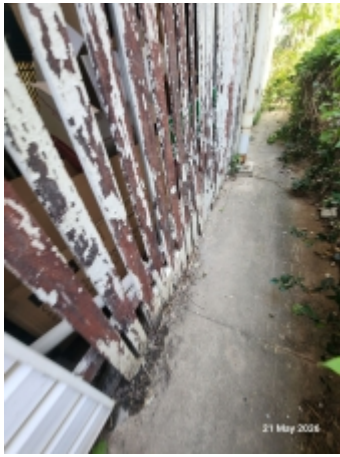
| Photo Comments | Timbers in contact with the ground can attract termites, clearance is recommended. |
