Pre-Sale Building & Timber Pest Inspection Report

43 Clarke Street Hendra 4011 Queensland Australia

04 Jul 2025

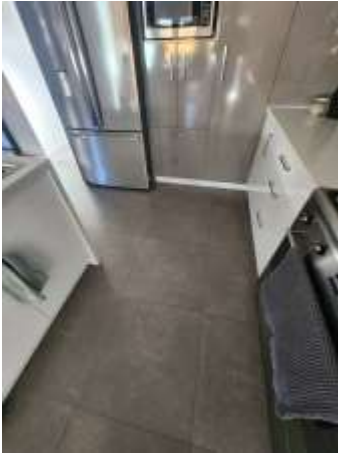
Kitchen

Some drummy tiles were noted to the floor area.

A drummy tile is one that has not adhered properly to the adhesive between tile and floor at time of installation, or that has come loose from the adhesive after installation. The grout between tiles may or may not necessarily be affected by this. Drummy tiles are not generally visually apparent and are usually only detected during inspection by an inspector using a special tapping tool, giving a drummy or hollow sound when tapped. Drummy tiles do not generally affect the serviceability of the tile; however, these may have a tendency to come loose over time and will need to be re-fixed. A drummy tile may also crack more easily than a tile that is solidly fixed in the adhesive, if something heavy was to be dropped on it.

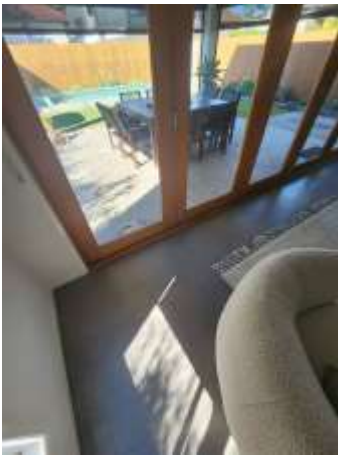
Living Room

Some drummy tiles were noted to the floor area.

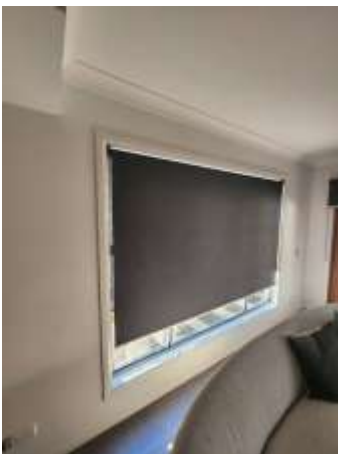
Minor / appearance cracking was noted to wall linings,

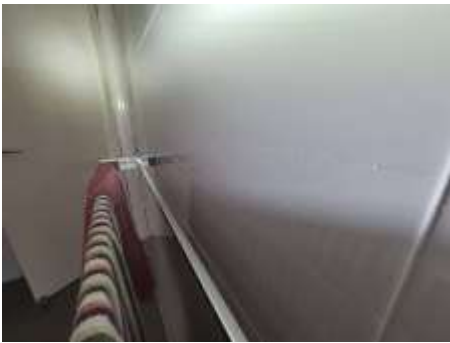
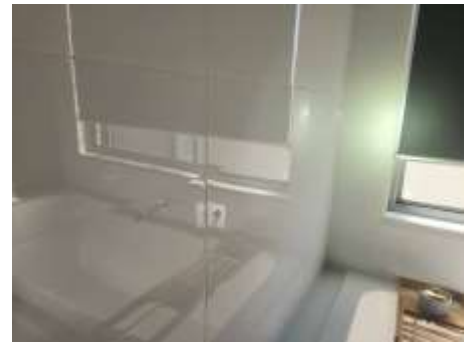
Bathroom

Cracked tiles were noted in a horizontal line across the entire wall. From our visual inspection we could not determine if the waterproofing has been compromised. The cause of this should be further investigated and rectified if necessary

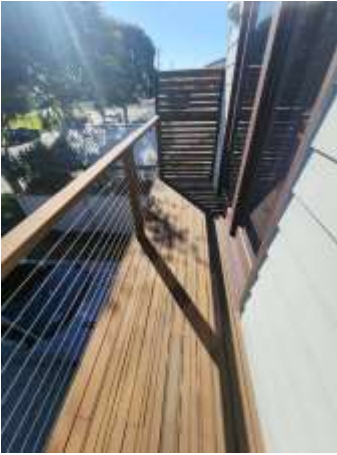
Balcony

Loose decking board noted; maintenance recommended

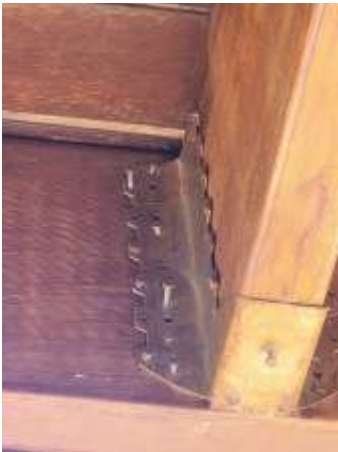
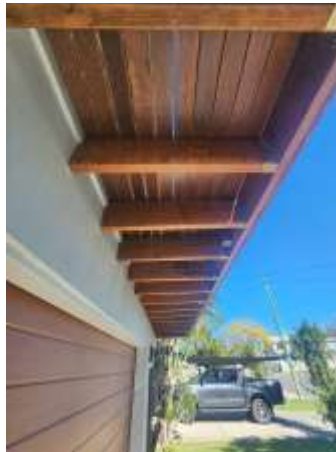
Front Elevation

Some nails to the front deck joist boots require nailing to completion

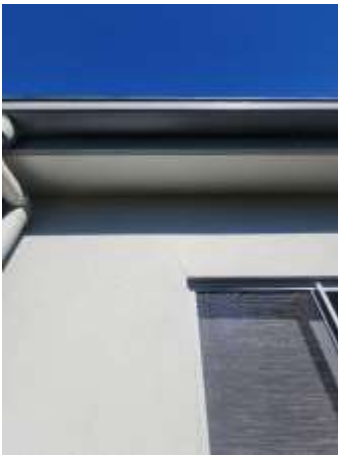
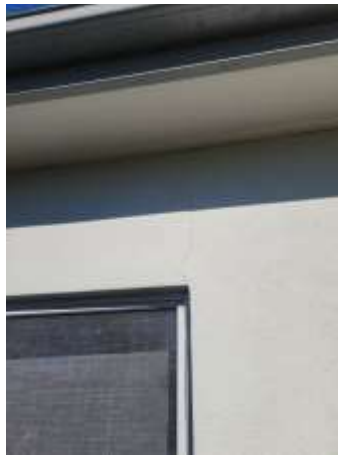
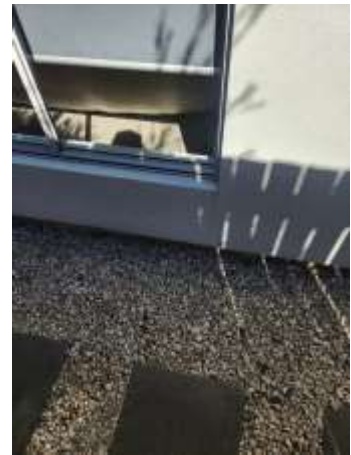
Left Side Elevation

The external render is cracking in places

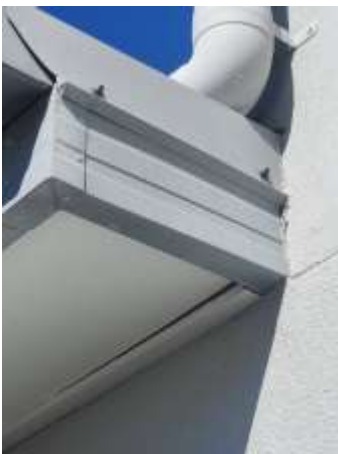
The timber soffit bead has popped; maintenance is recommended.

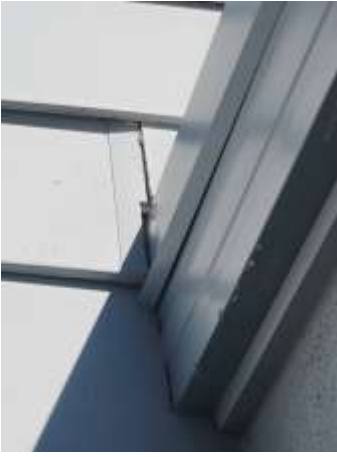
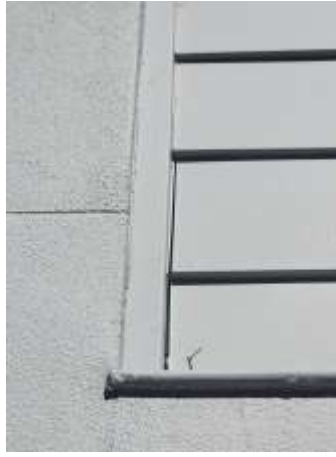
Gaps visible to external cladding

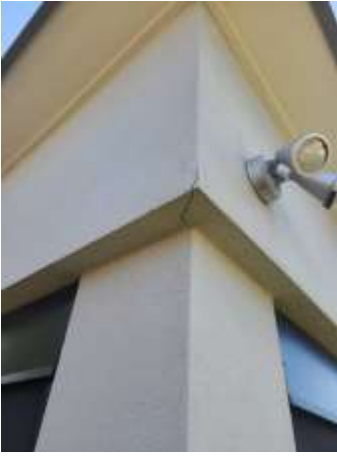
Right Side Elevation

Minor cracking noted to render

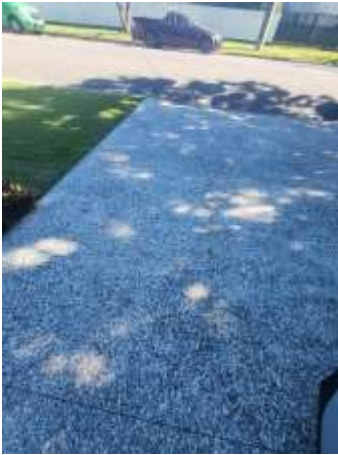
Driveways

Defect Severity	Minor Defect
Comment	The concrete driveway has some visible cracking, this type of cracking is common with concrete driveways,

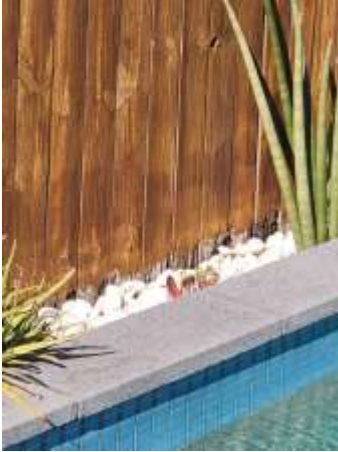
Fencing

Defect Severity	Minor Defect
Comment	Wet rot decay was noted to some fencing timbers;

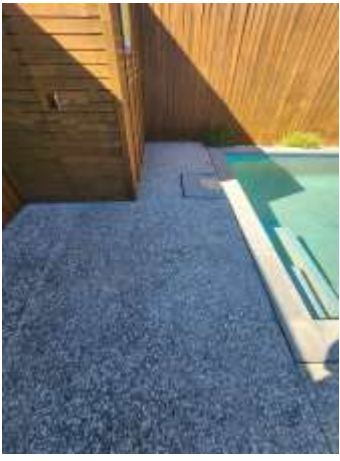
Paths

Defect Severity	Minor Defect
Comment	The concrete pathways have some visible cracking, this type of cracking is common with concrete,
