# Pre-Sale Building & Timber Pest Inspection Report

92 Mein Street Hendra 4011 Queensland Australia

## Pre-Sale Building and Timber Pest Inspection - ASBIR Pre-Sale Building & Timber Pest Inspection Report

21 Nov 2025

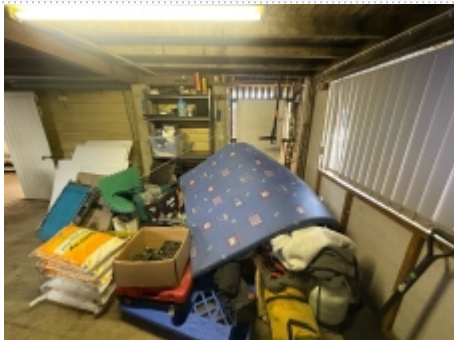
| Photo Comments: | Utility Room - Inspection within some internal areas was significantly restricted by the amount of stored items present |

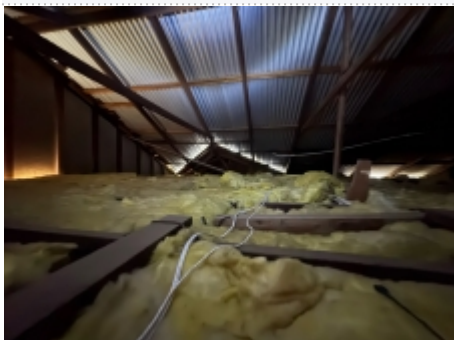
| Photo Comments: | Roof space was inspected from manhole only due to height of ceiling and the presence of asbestos building materials |

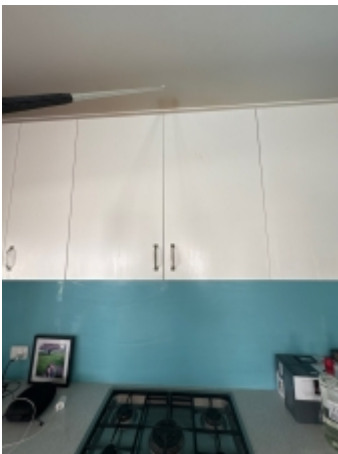
# Kitchen

| Defect Severity | Minor Defect |
| Comment | Extraction fan not vented to exterior |

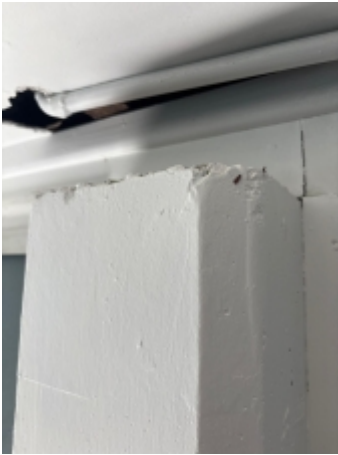
Living Room

| Defect Severity | Minor Defect |

| Comment | No ant caps to concrete stumps. If it is not possible or practicable to fit antcapping, this area should be regularly inspected by a Licensed Pest Inspector. |

Details & Recommendations: Missing ant caps to concrete stumps downstairs

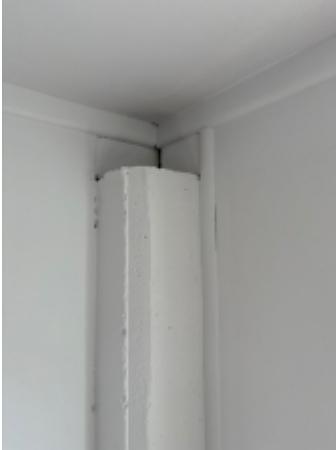
Office

| Defect Severity | Minor Defect |
| Comment | No ant caps to concrete stumps. If it is not possible or practicable to fit antcapping, this area should be regularly inspected by a Licensed Pest Inspector. |

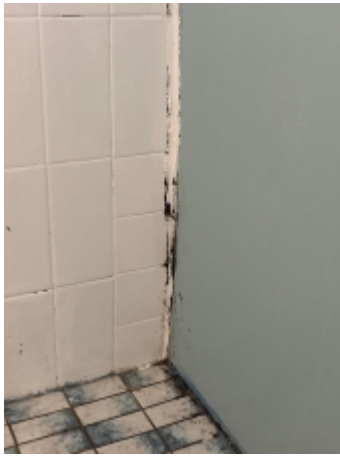
## Bathroom 2

| Defect Severity | Major Defect |
| Comment | Water escaping shower walls. Evidence suggests water is leaking. The cause of this should be further investigated and rectified.<br>Silicone sealant has been applied to the interface of the floor and walls in the shower recess. This method of repair can only be considered to be temporary |

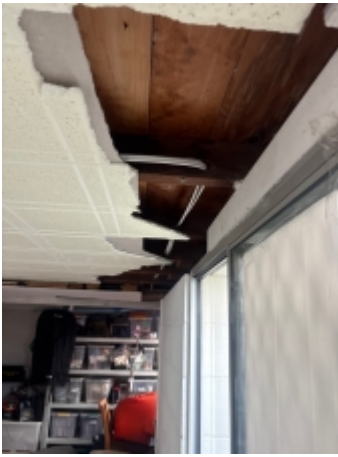
## Utility Room 2 + Laundry

| Defect Severity | Minor Defect |
| Comment | Ceiling lining missing |

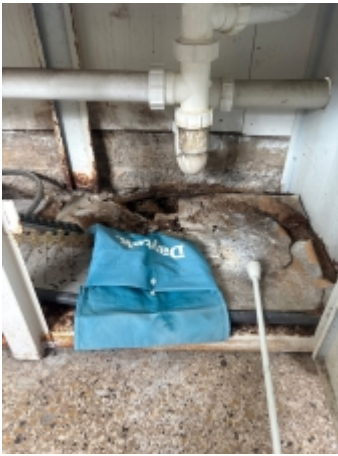
| Defect Severity | Minor Defect |
| Comment | Decayed timber below wash tub |

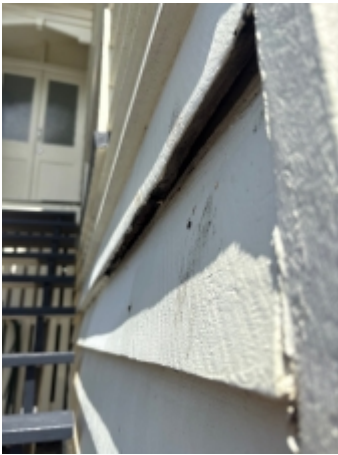
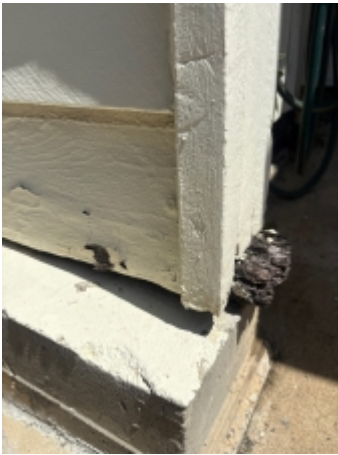
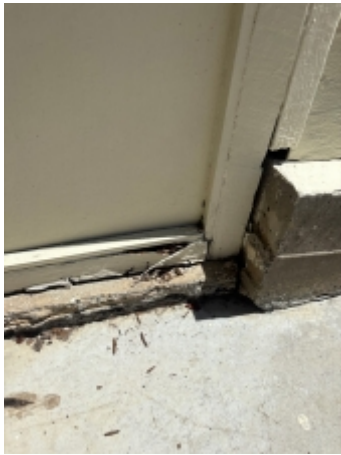
Front Elevation

| Defect Severity | Minor Defect |
| Comment | Timber decay noted weatherboards and mouldings |

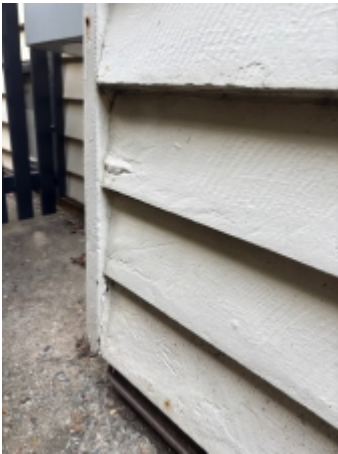
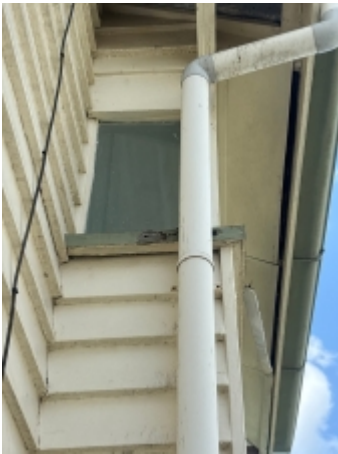
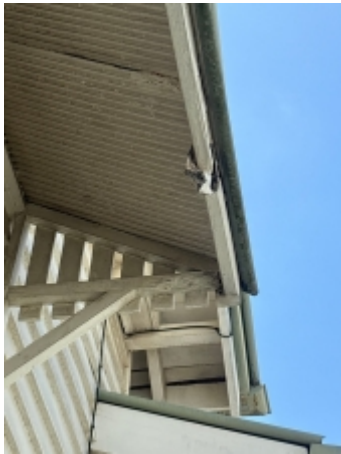
Left Side Elevation

| Defect Severity | Minor Defect |

| Comment | Timber decay noted to weather boards, window sills and window awnings.<br>Gaps noted to walls |

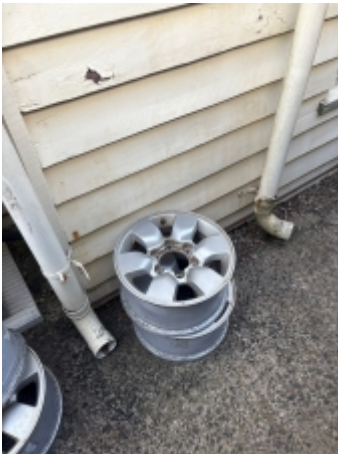
| Defect Severity | Minor Defect |
| Comment | Downpipe is not connected to the stormwater dispersal system; If there is no stormwater system present the downpipes should be diverted away from all foundations. |

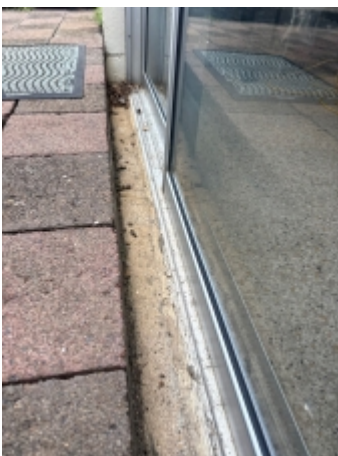
| Comments | External ground level is above internal floor level |

| Defect Severity | Minor Defect |
| Comment | External ground level higher than internal floor. Ideally external ground level should be lower than internal levels and slope away from the house. |

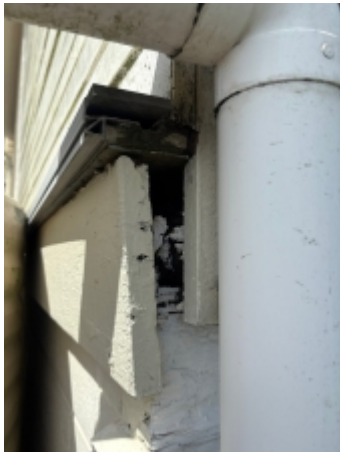
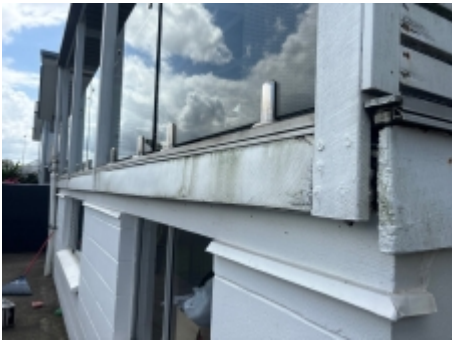
## Rear Elevation

Minor Defect

Timber decay noted to external timbers

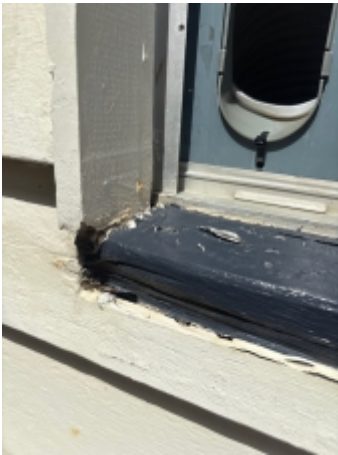
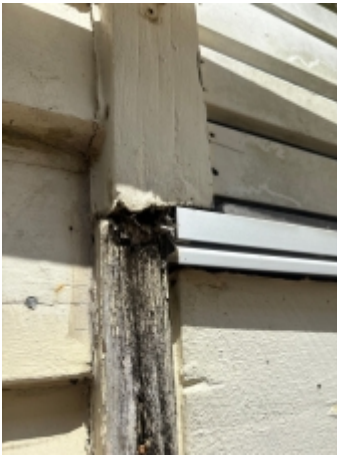
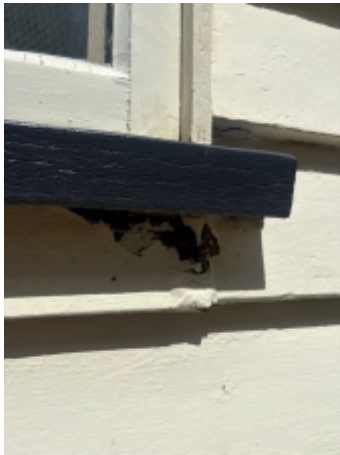
## Right Side Elevation

| Defect Severity | Minor Defect |
| Comment | Timber decay noted to weatherboards, windowsills and mouldings |

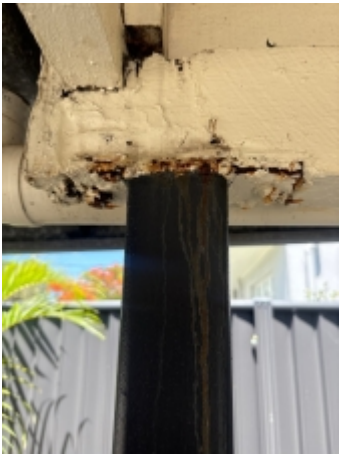
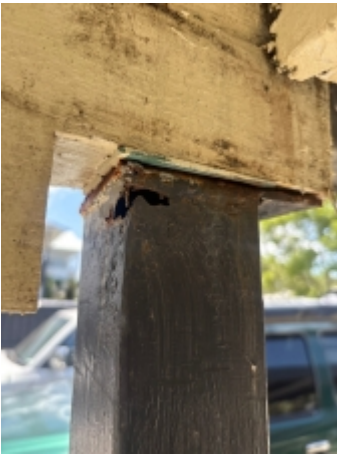
| Defect Severity | Major Defect |
| Comment | Structural steel posts are corroded |

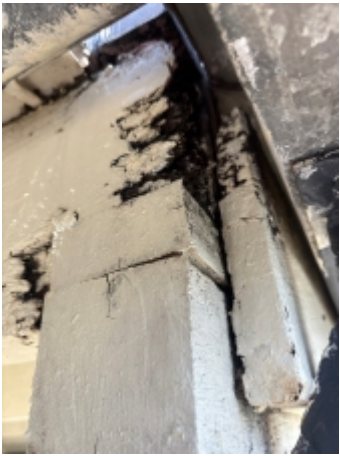
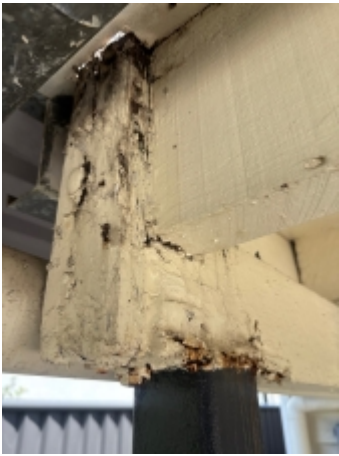
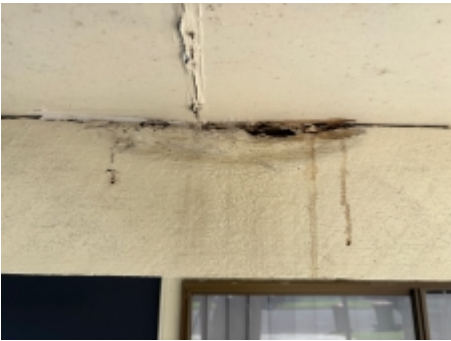
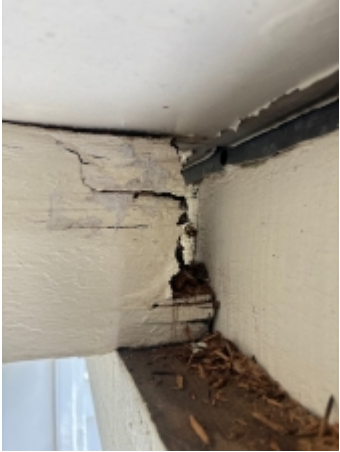
| Defect Severity | Major Defect |
| Comment | Timber decay evident to deck structural timbers (bearers and joists) |

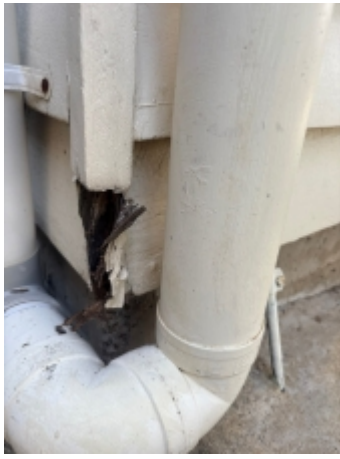
| Defect Severity | Minor Defect |
| Comment | Decay noted to timber weatherboards |

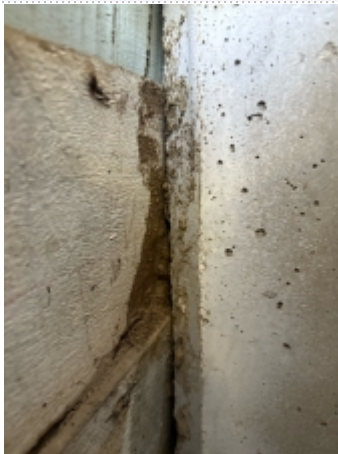
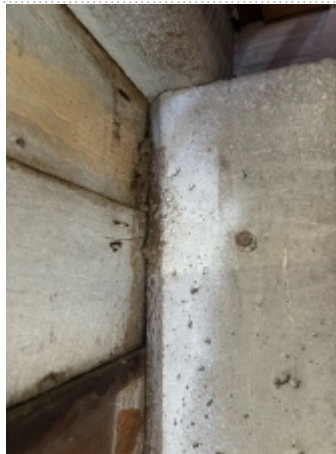
Termite workings found in Utility room. These are old workings. No active termites noted to property.

A more invasive inspection is highly recommended to be carried out. This is outside the Scope of our Agreement for this Inspection.

Is a termite treatment recommended? **Yes**

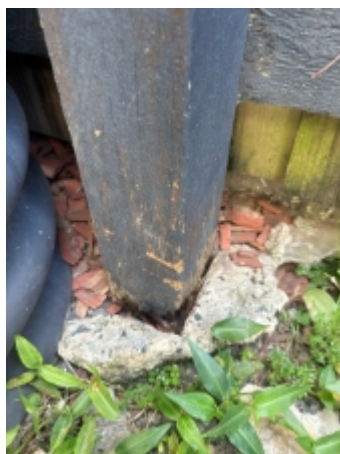
Details of other conducive conditions Fence posts are decayed at ground level due to water ingress

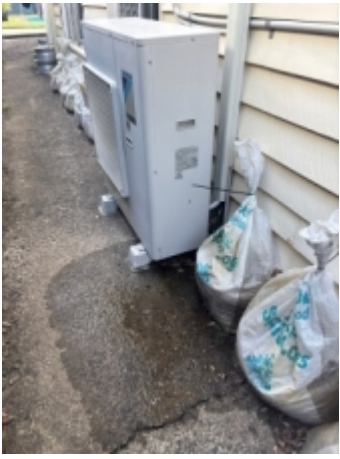
Air conditioning unit releases water alongside the building walls. It is recommended this be piped to a drain if not possible then several meters away from the building.
