# Pre-Sale Building & Timber Pest Inspection Report

289 Nudgee Road Hendra 4011 Queensland Australia

04 Nov 2025

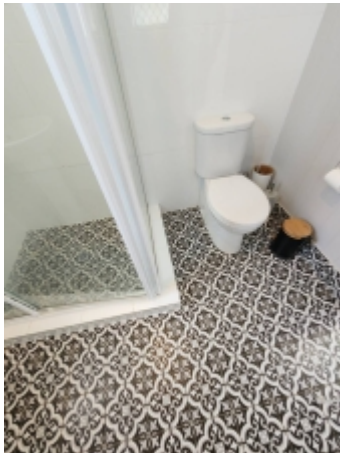
| Defect Severity | Minor Defect |
| Comment | Some drummy tiles were noted to the floor area. |

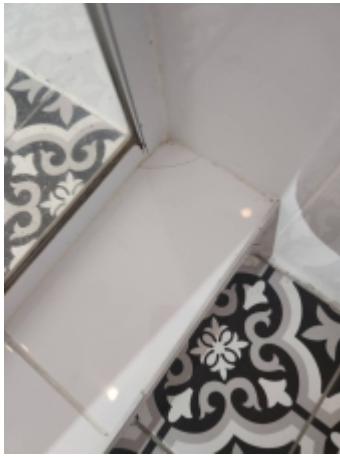
| Defect Severity | Minor Defect |
| Comment | Some cracked tiles were noted to this area; this is considered a cosmetic issue; Rectification may be desired and if so you should contact a licensed tiler |

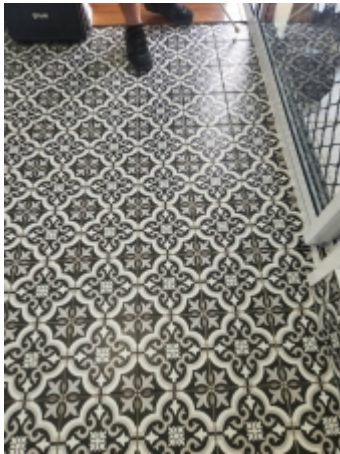
| Defect Severity | Minor Defect |
| Comment | Some drummy tiles were noted to the floor area |

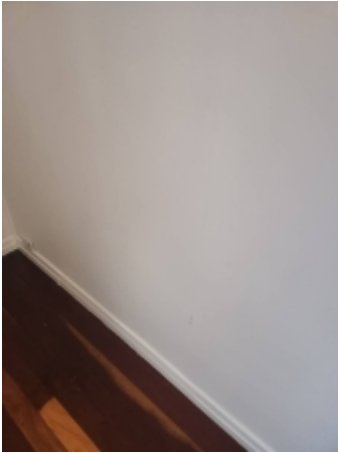
| Defect Severity | Minor Defect |
| Comment | Minor cracking was noted to wall linings. This is considered appearance cracking. |

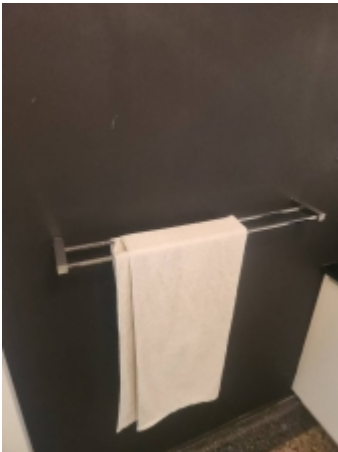
| Defect Severity | Minor Defect |
| Comment | The towel rail is loose |

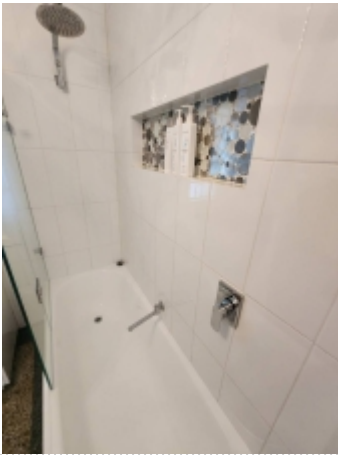
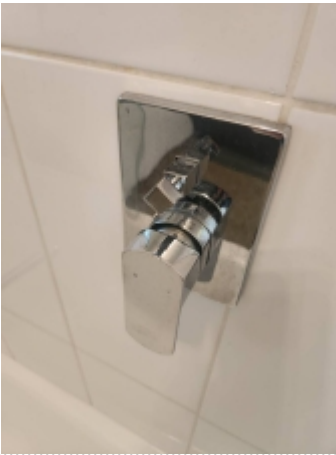
| Defect Severity | Minor Defect |
| Comment | Unable to engage bath switch. |

Recommend Further Inspection By: Licensed Plumber

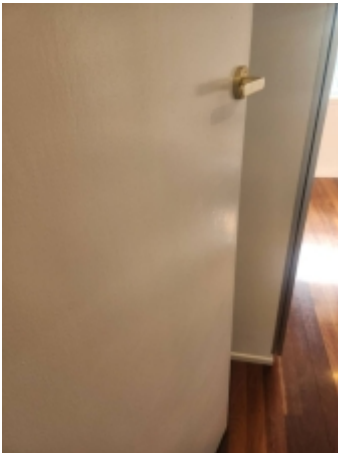
| Defect Severity | Minor Defect |
| Comment | Door not latching to door frame |

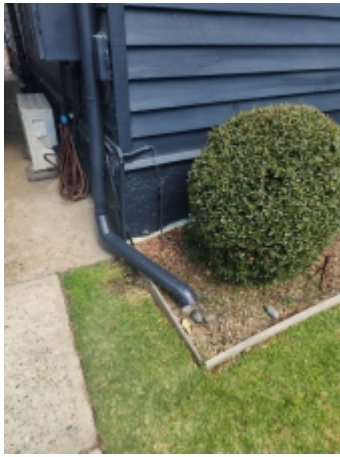
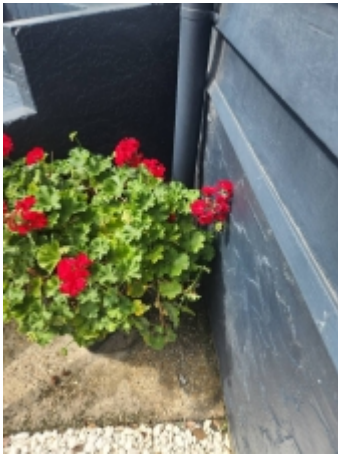
| Defect Severity | Minor Defect |
| Comment | Downpipe is not connected to the stormwater dispersal system; This should be rectified. If there is no stormwater system present the downpipes should be diverted away from all foundations. |

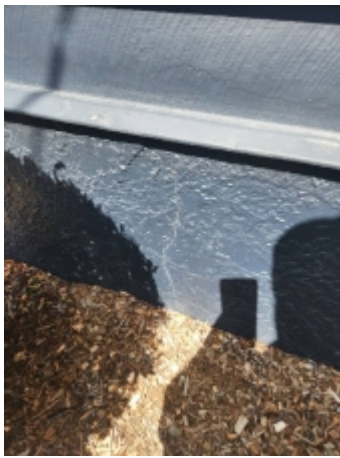
| Defect Severity | Minor Defect |
| Comment | The external render is cracking in places, |

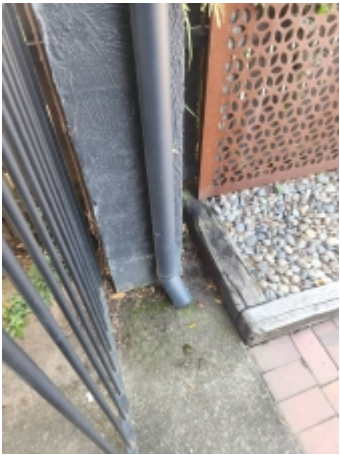
| Defect Severity | Minor Defect |
| Comment | Downpipe is not connected to the stormwater dispersal system; This should be rectified. If there is no stormwater system present the downpipes should be diverted away from all foundations. |

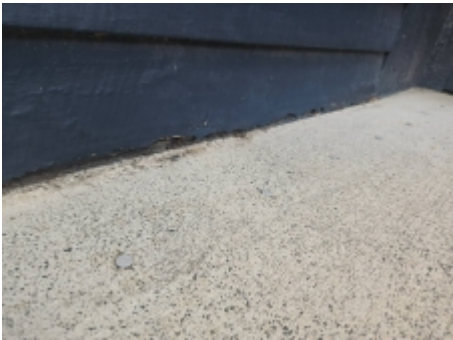
| Defect Severity | Minor Defect |
| Comment | Wet rot decay was noted to some external weatherboards |

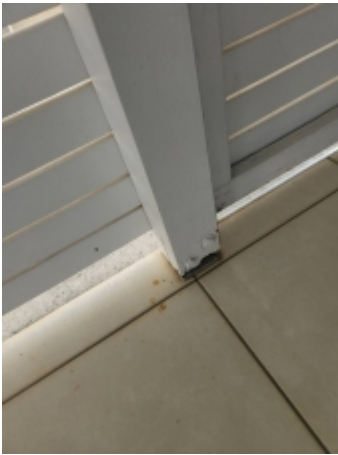
| Defect Severity | Minor Defect |
| Comment | Wet rot decay noted to some external pergola posts |

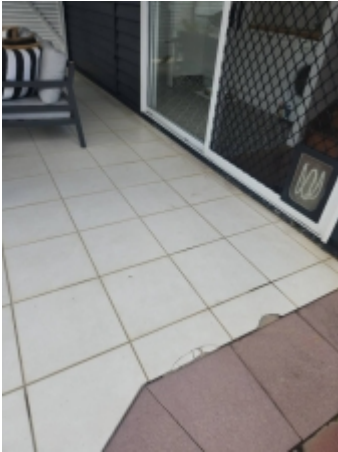
Minor Defect

Cracked and drummy tiles were noted to the floor

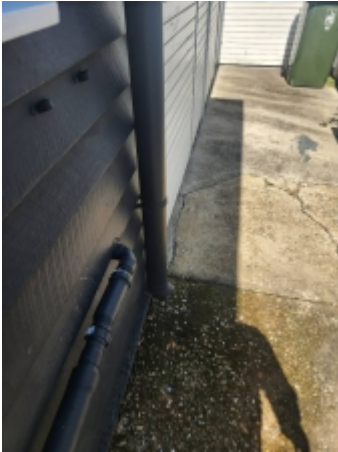
Minor Defect

Downpipe is not connected to the stormwater dispersal system; This should be rectified. If there is no stormwater system present the downpipes should be diverted away from all foundations.

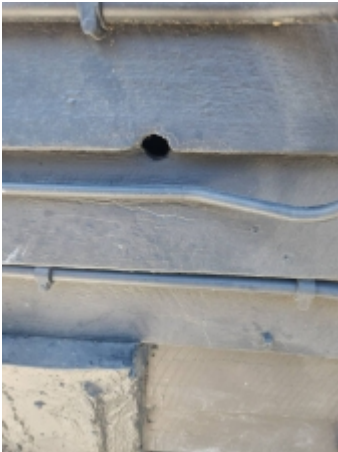
Minor Defect

Holes noted to the external cladding; repairs are recommended.

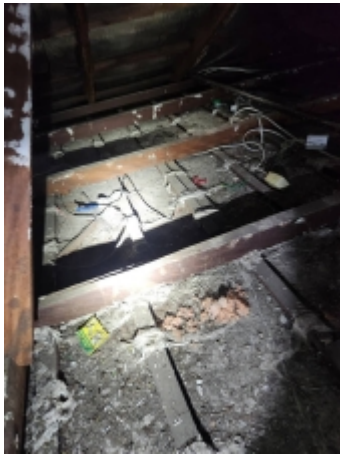
**Safety Hazard**

Exposed wires are present. noted, a licenced electrician should be called to deem safe. A Licensed electrician should be called to make a further evaluation and repairs or rectification as needed and to certify safe

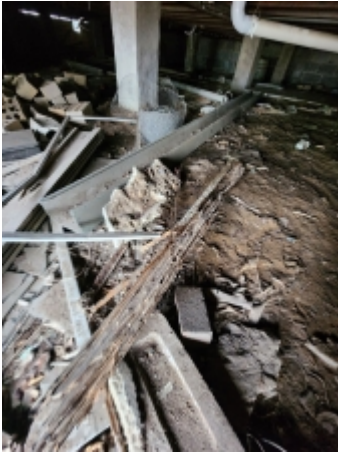
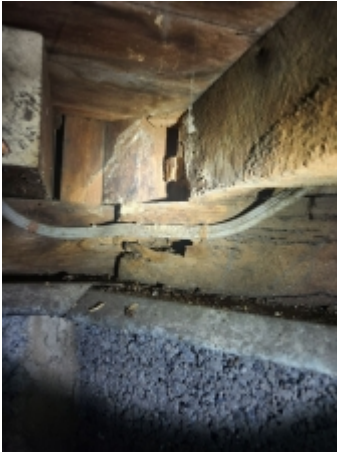
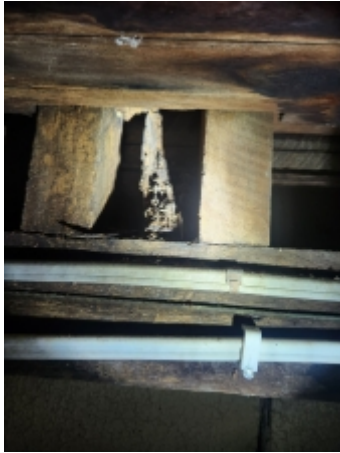
| Defect Severity | Minor Defect |
| Comment | Evidence of what appears to be a termite attack was noted to the some subfloor timbers, repairs are recommended. We strongly recommend the immediate removal of stored and/or loose timbers as these are highly attractive to termite attack and can allow currently concealed termite entry to the building. NO evidence of live termites were noted at time of inspection. |

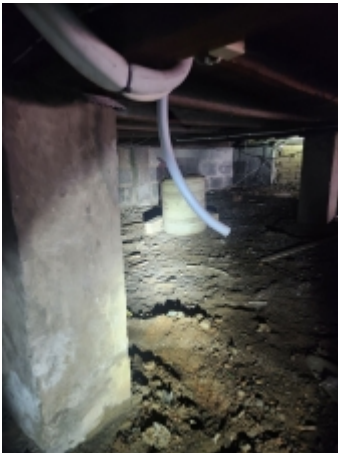
| Defect Severity | Minor Defect |
| Comment | The air-conditioner overflow is directed around the foundations of the house, we recommend this is directed to a drain. |

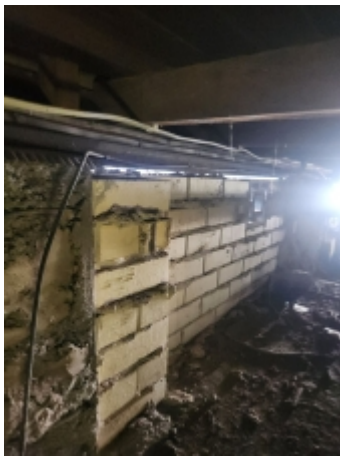
| Defect Severity | Minor Defect |
| Comment | Not all areas have ant caps fitted. If it is not possible or practicable to fit antcapping, this area should be regularly inspected by a Licensed Pest Inspector. |

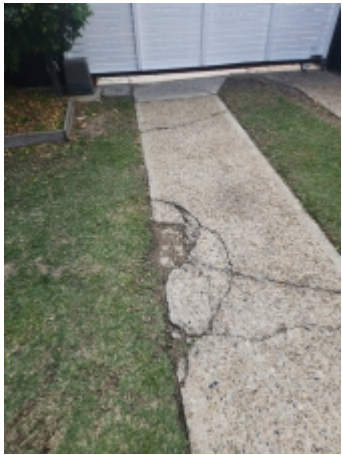
| Defect Severity | Minor Defect |
| Comment | Cracking was noted to sections of the driveway |

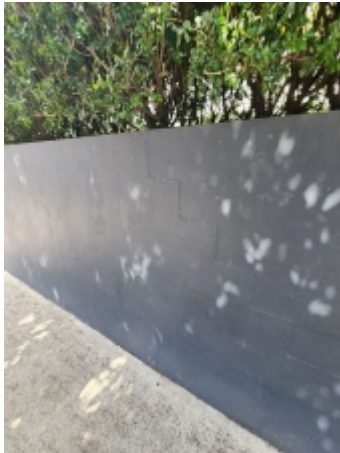
| Defect Severity | Minor Defect |
| Comment | The external render is cracking in places, |

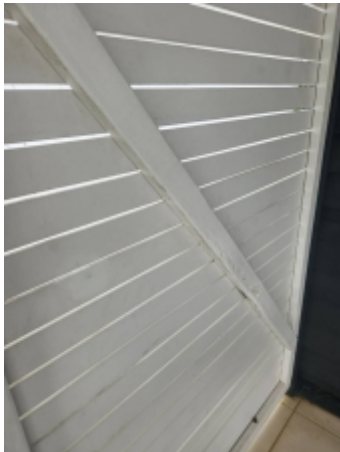
| Defect Severity | Minor Defect |
| Comment | Wet rot decay noted to some fencing timbers, |

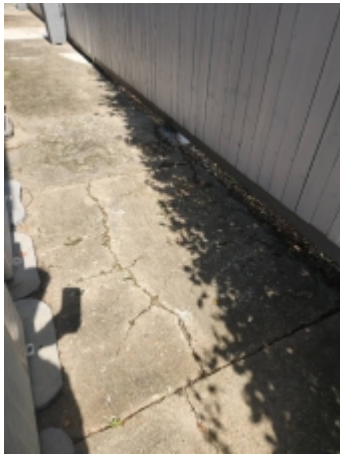
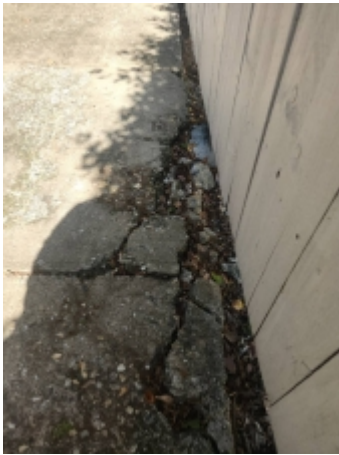
| Defect Severity | Minor Defect |
| Comment | Cracking and deterioration was noted to some external concrete paths, |

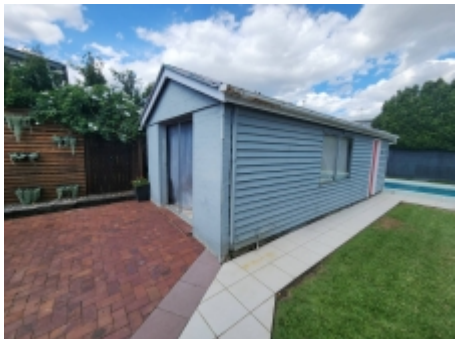
The structure is generally in poor condition, and consideration should be given to its removal. Issues noted include rust on the roof and gutters, as well as damage and decay to internal timbers

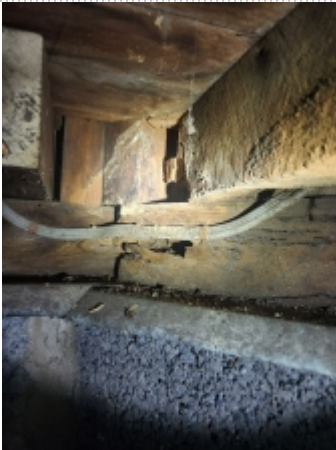
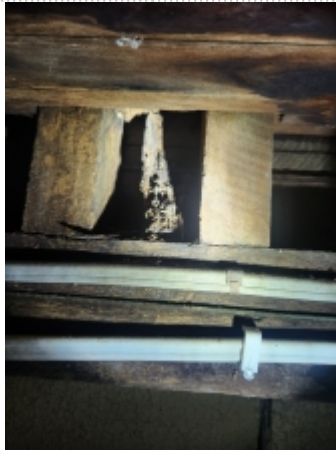
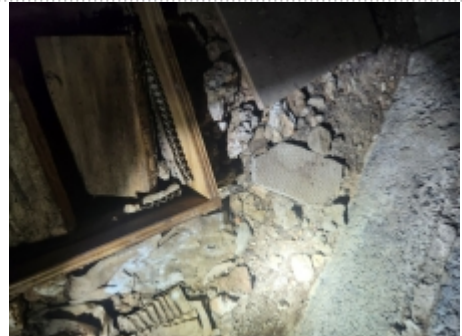
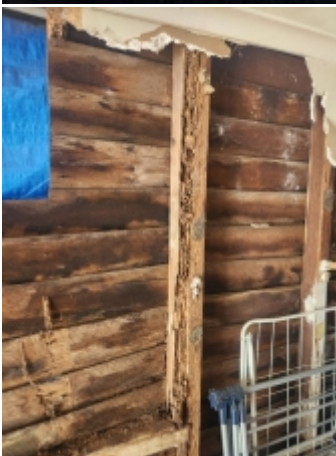
Termite damage noted to the subfloor timbers and to shed internal timbers

A more invasive inspection is highly recommended to be carried out. This is outside the Scope of our Agreement for this Inspection.

It is strongly recommended that the full extent of any such activity and damage be fully understood through the engagement of a Licenced Builder, Structural Engineer or appropriately qualified expert.

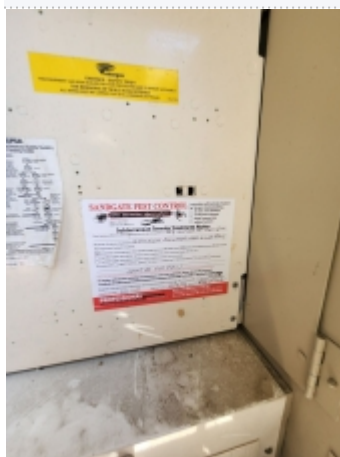
| Description of the evidence found: | Treatment sticker in meter box |

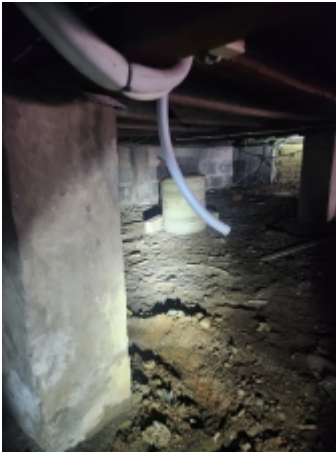
Air conditioning overflow

If leaks are detected, it is recommended that a suitably qualified plumber or builder is engaged to rectify as soon as possible.

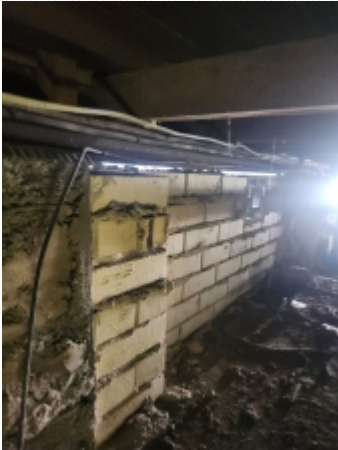
| We claim no expertise in building. However, in our opinion the termite shields appear to be: | Inadequate |
| Details & Recommendations: | Not all areas have ant caps fitted. |

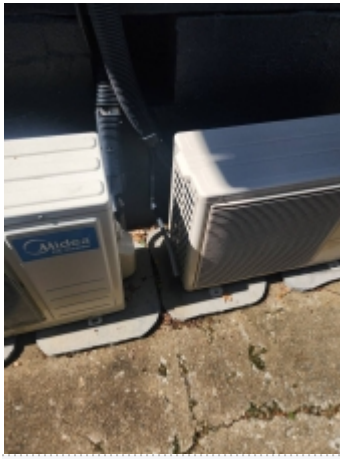
| Photo Comments | The air-conditioner overflow is directed around the foundations of the house, we recommend this is directed to a drain. |

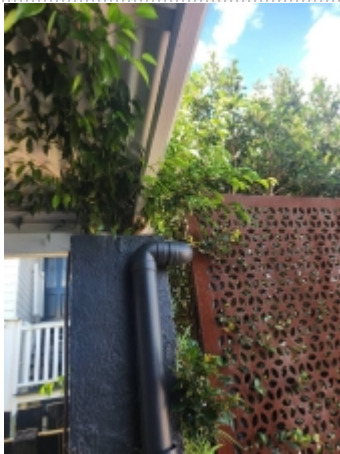
Trees and shrubs are close to the external walls, this can allow concealed termite entry and should be removed.

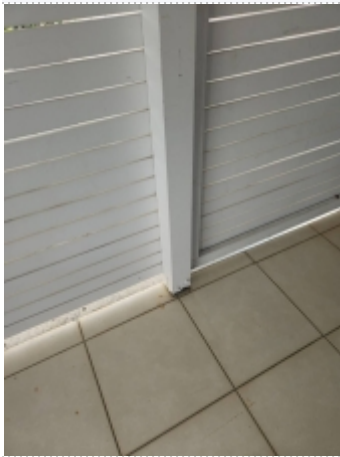
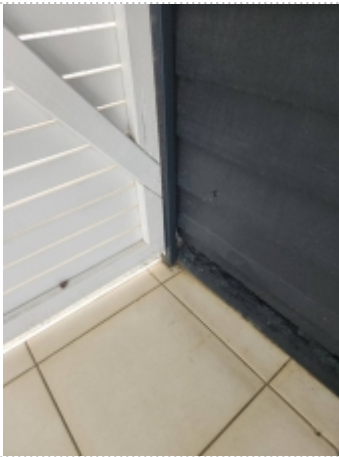
Some external posts are in contact with the ground, this can attract and conceal termite entry, a minimum of 75 mm clearance is recommended.
