# Pre-Sale Building & Timber Pest Inspection Report

7 Long Street Hendra 4011 Queensland Australia

## Pre-Sale Building and Timber Pest Inspection - ASBIR Pre-Sale Building & Timber Pest Inspection Report

08 Jul 2026

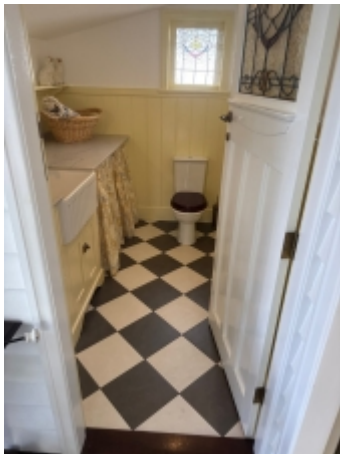
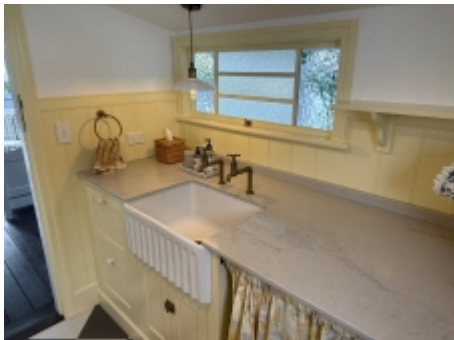
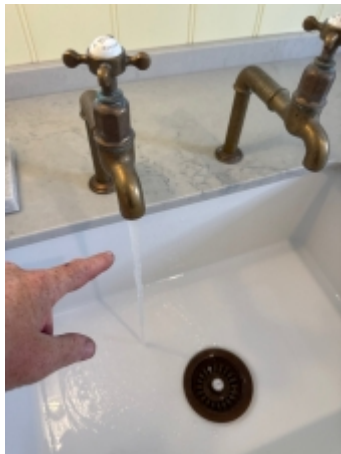
Laundry

No defects found in this room at the time of the inspection

| Comments | Hot water is operational |

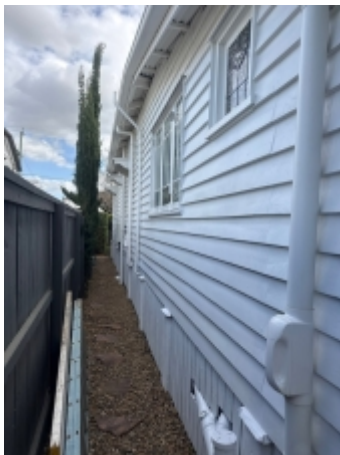
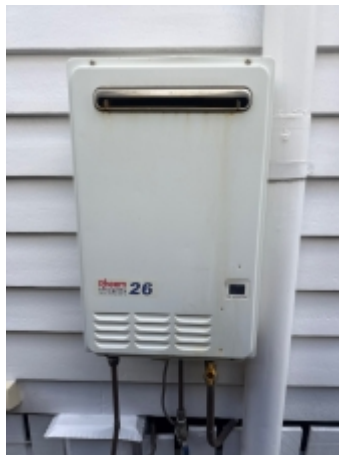
## Left Side Elevation

No defects found in this area at the time of the inspection

| Comments | Gas hot water heater present |

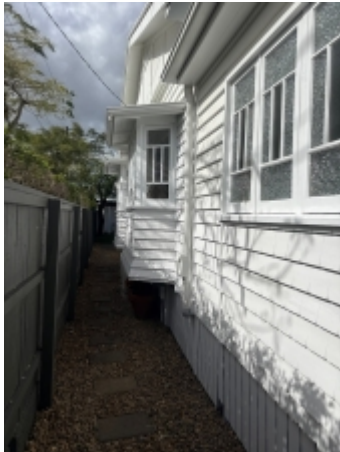
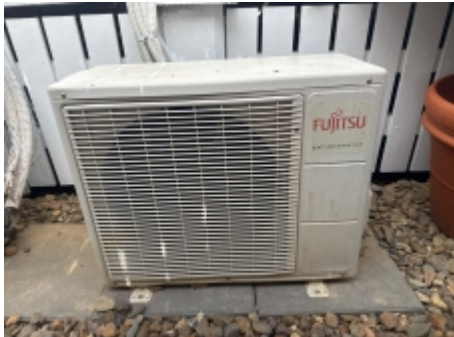
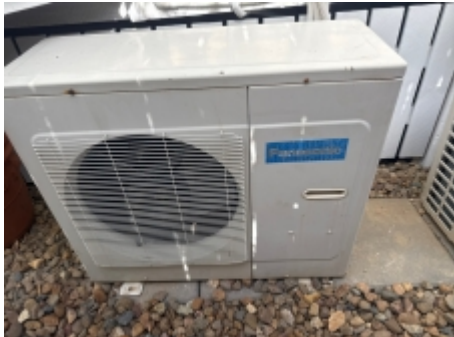
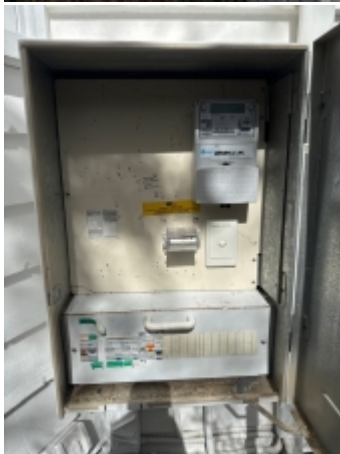
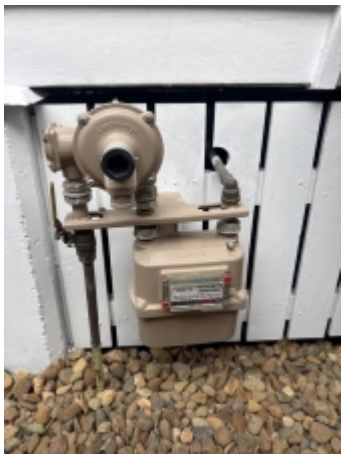
Right Side Elevation

No defects found in this area at the time of the inspection

2 AC units present  
Safety switch is installed

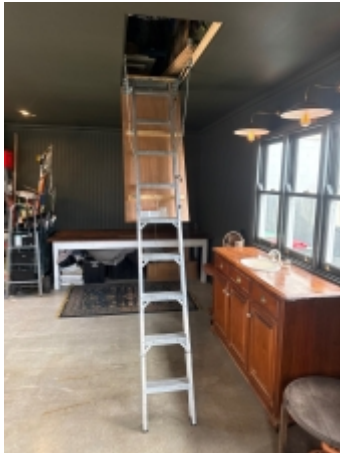
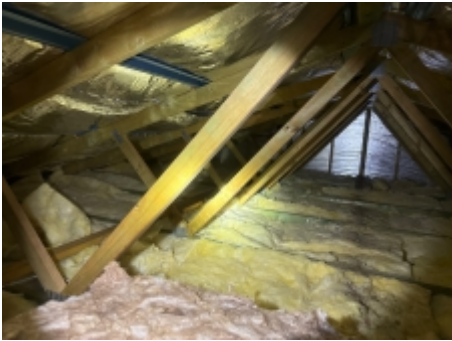
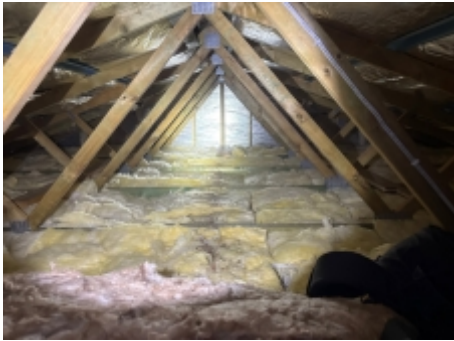
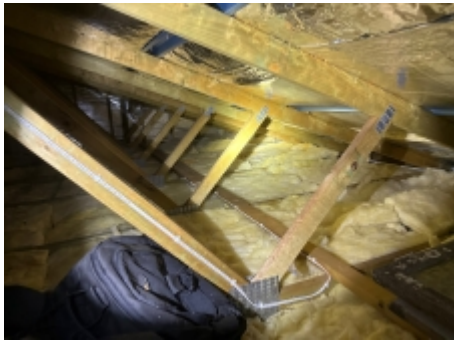
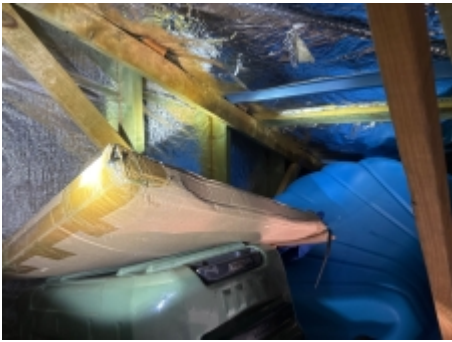
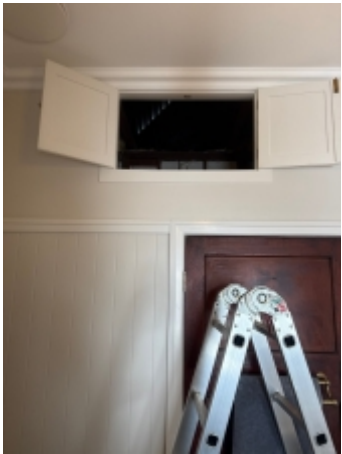
## Roof Space

No defects found in the roof space at the time of the inspection

| Comments for Roof Space | Garage roof space pictures first<br>House roof space access via main bath |
| The Following Observations Are Noted With The Roof Space | Insulation is present |

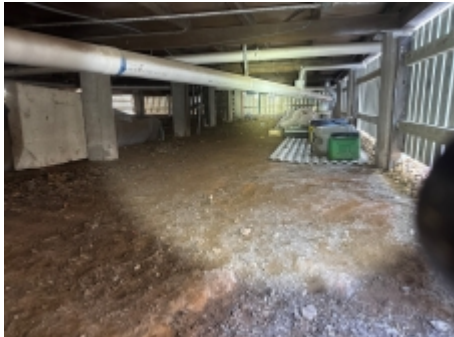
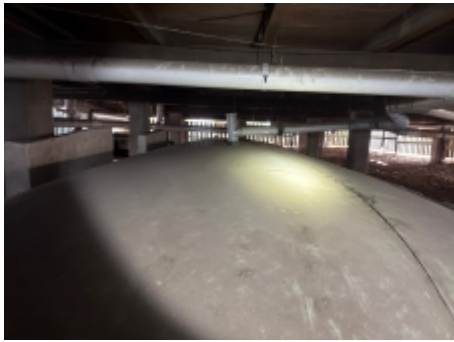
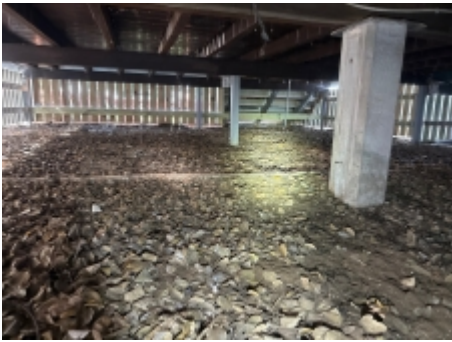
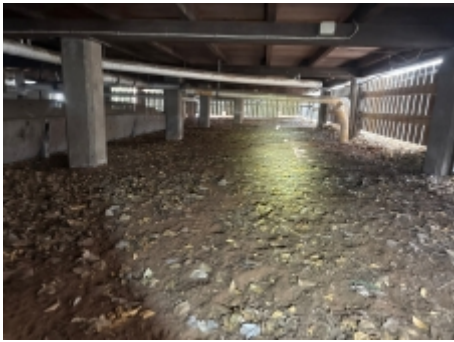
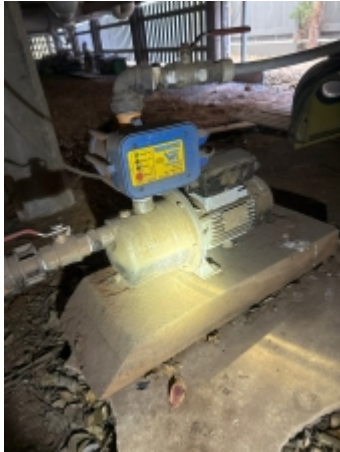
Subfloor Space

No defects found in the subfloor at the time of the inspection

| Subfloor Ventilation Appears To Be: | Adequate |
| Subfloor Drainage Appears To Be: | Adequate |

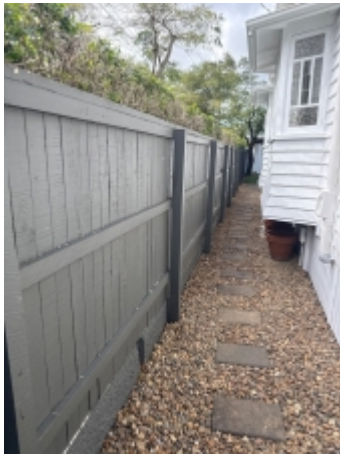
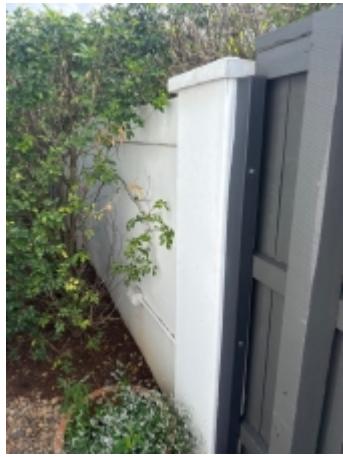
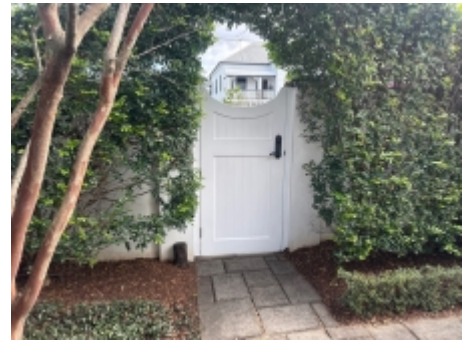
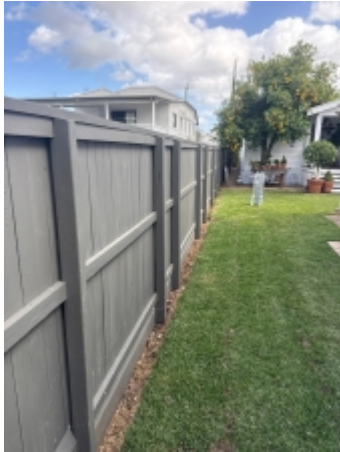
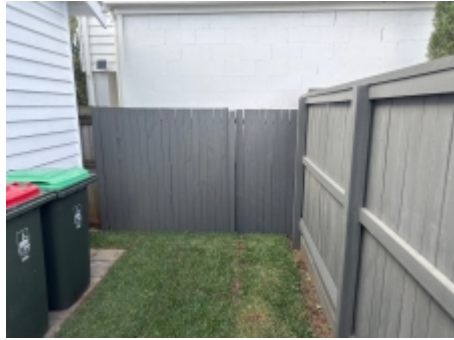
Site Area Photo

**No defects found at the time of the inspection**

This site should be monitored during heavy rainfall to confirm whether there are drainage issues that are not apparent at the time of inspection.

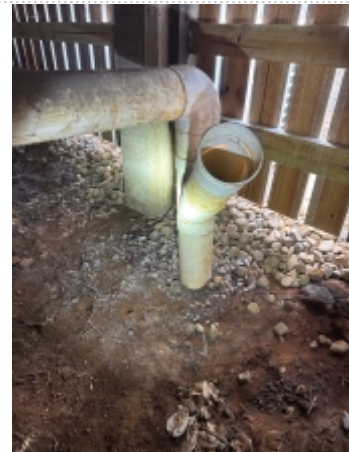
Was a water tank(s) located at the time of inspection? **Yes**

Is there a need for work to be carried out to rectify overflow drainage: **No**

It is recommended that suitable drainage is in place to prevent any retained water or buildup of moisture.
