# Pre-Sale Building & Timber Pest Inspection Report

7 Long Street Hendra 4011 Queensland Australia

08 Jul 2026

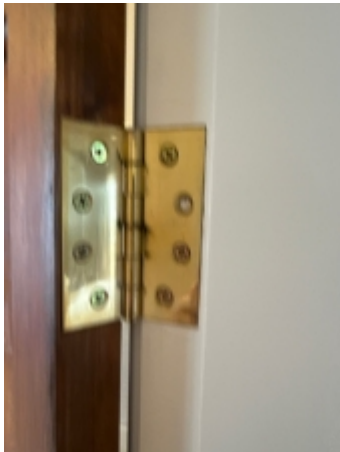
Bathroom 1

| Defect Severity | Minor Defect |
| Comment | 3 screws missing from door hinge |

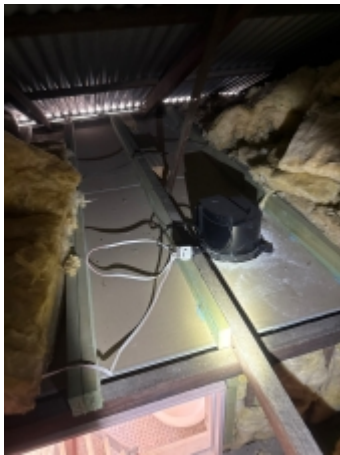
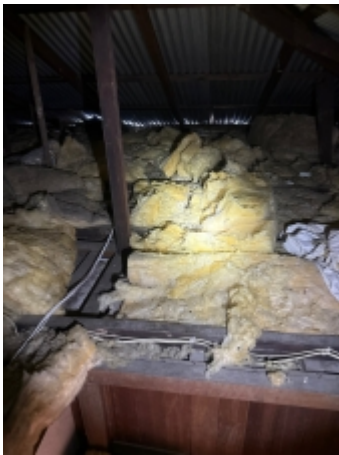
Roof Space

| Defect Severity | Minor Defect |
| Comment | Insulation has been moved out of place in some areas. |

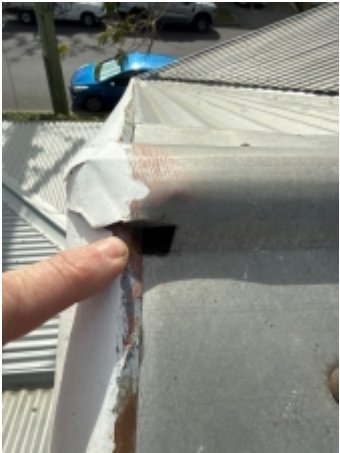
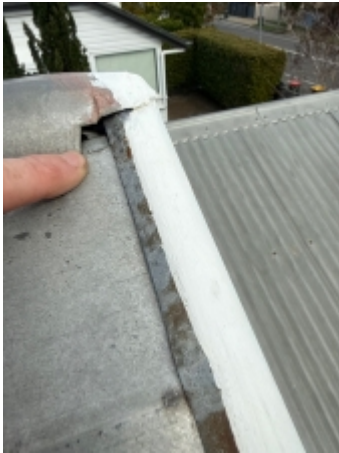
| Defect Severity | Minor Defect |
| Comment | Some gaps visible at tip of ridge cap towards rear of home |

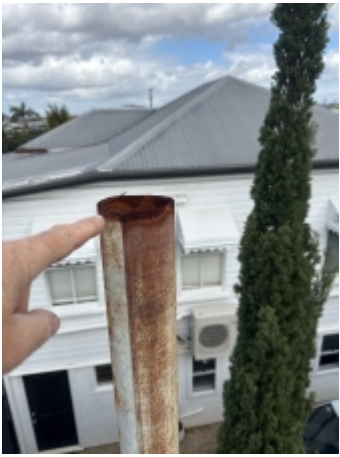
| Defect Severity | Minor Defect |
| Comment | Vent cap not installed |

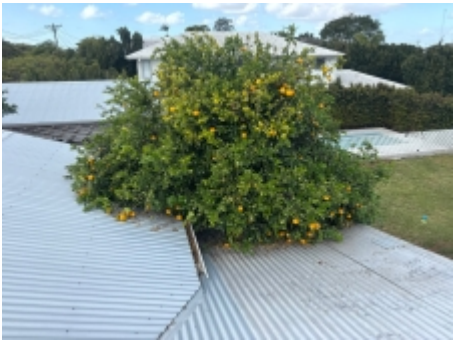
| Defect Severity | Minor Defect |
| Comment | Best practice is to cut back tree so not in contact with the roof |

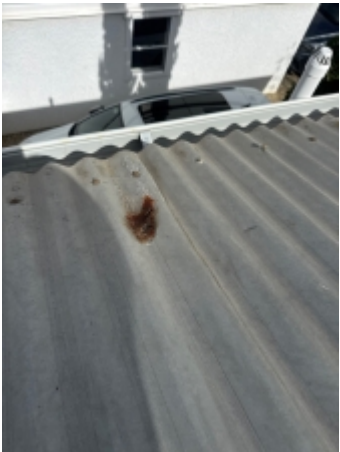
| Defect Severity | Minor Defect |
| Comment | Small corrosion patch needs repair |

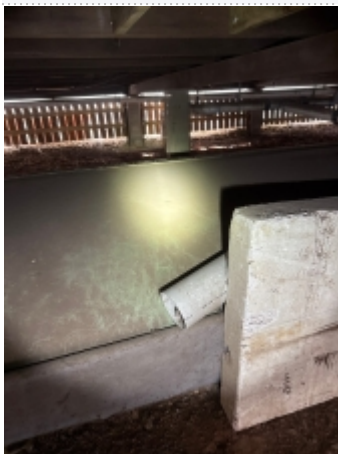
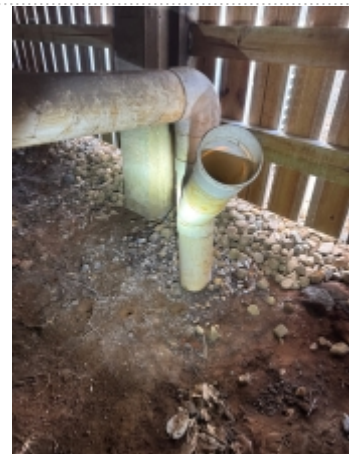
Was a water tank(s) located at the time of inspection? **Yes**

Is there a need for work to be carried out to rectify overflow drainage? **Yes**

It is recommended that suitable drainage is in place to prevent any retained water or buildup of moisture.
