TIMBER PEST INSPECTION REPORT

Complies with Australian Standard AS 4349.3-2010

Inspection Date: 01/08/2025.

25 London St, Nundah QLD 4012.

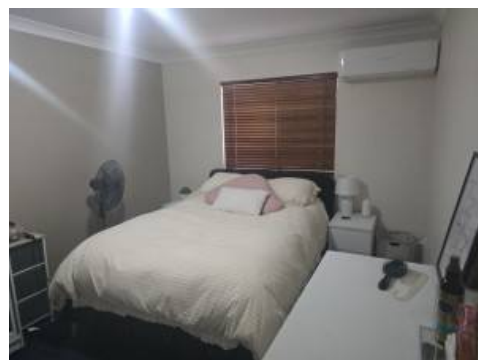
Part floor coverings were present and restricted inspection to the upperside of floor structure. Furniture and window furnishings was present and restricted inspection within this area.

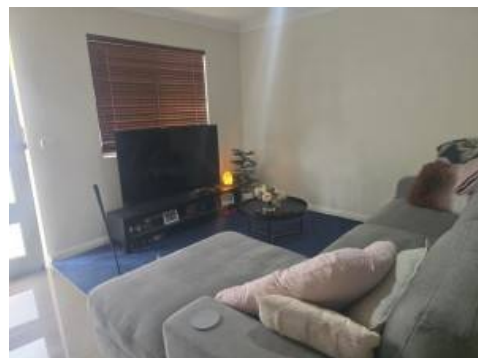
Some stored goods were present to the area(s) listed below which restricted the inspection. Stored items should be removed to allow a more complete inspection to be carried out. Inspection within various cupboards was restricted by stored items.

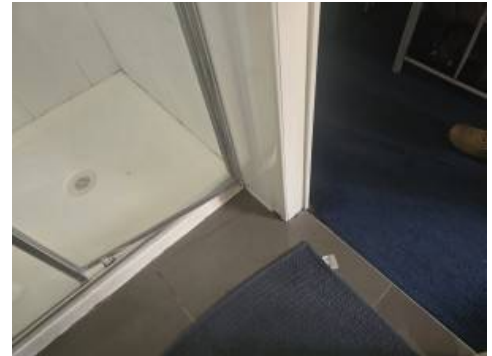
Door frame/jamb timbers.
Bathroom in unit 1.

Visible timber damage appears minor to moderate however, this opinion is based on a visual inspection. A special purpose report can offer a more detailed description. Refer to the definitions section of this report.

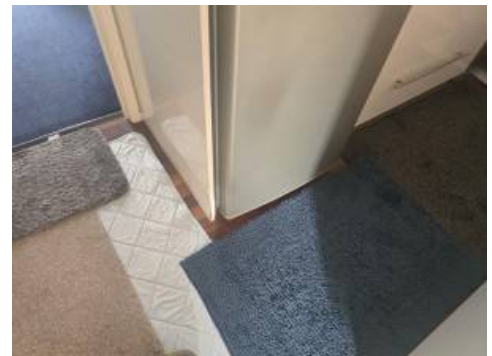
Water damage is present, this is conducive to excessive moisture. In all cases where the presence of moisture is encountered, we strongly recommend further investigations be carried out to determine the cause of this situation. Refer 9.0 The Presence of Excessive Moisture.

Kitchen cupboard timbers in unit 1A.

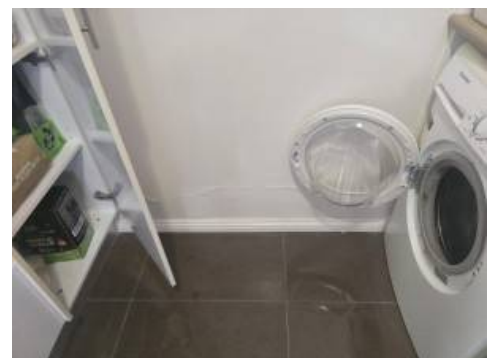
Wall in kitchen of unit 4.

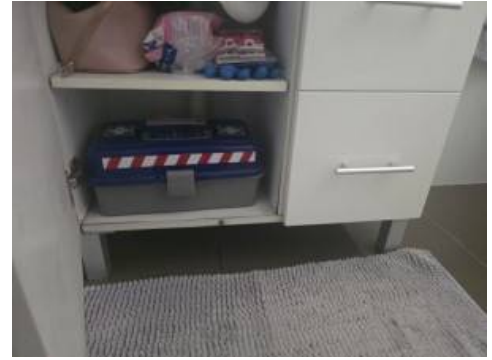
Vanity cupboard timbers in unit 2A.

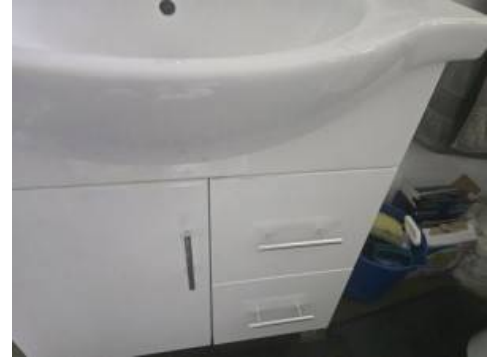
Vanity cupboard timbers in unit 1A.

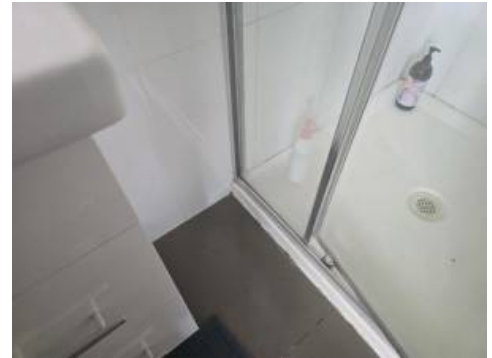
A leak to some shower screens was detected. A qualified plumbing contractor should be engaged to make further evaluation and carry out repairs as needed. Damp conditions are conducive to timber pest attack. Refer 9.0 The Presence of Excessive Moisture. In unit 1, 1A, 2, 2A, 3, 5, 6

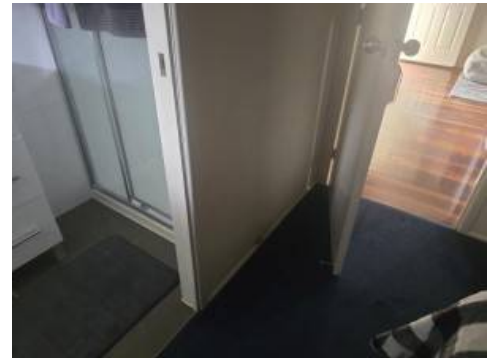
Higher than normal moisture levels was detected. This can be an indicator of a free moisture source. In all cases where a high moisture level is encountered, we strongly recommend further investigations be carried out to determine the cause of this situation. Refer 9.0 The Presence of Excessive Moisture. To wall sheeting in bedroom backing onto shower of unit 2, and wall in kitchen of unit 4 as shown above.

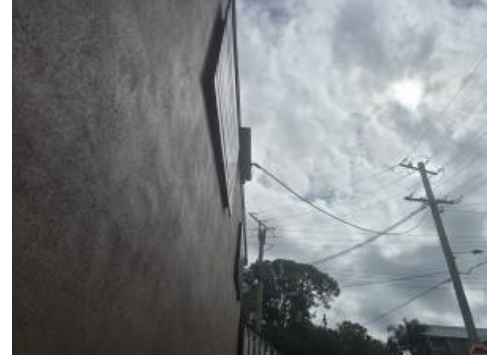
Building elements above 3.6 meters were restricted due height, this limited the visual inspection.

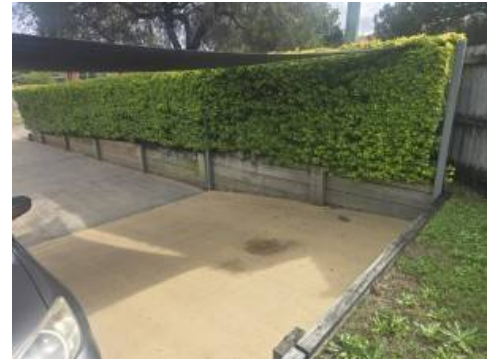
Only one side of retaining walls was accessible at time of inspection.

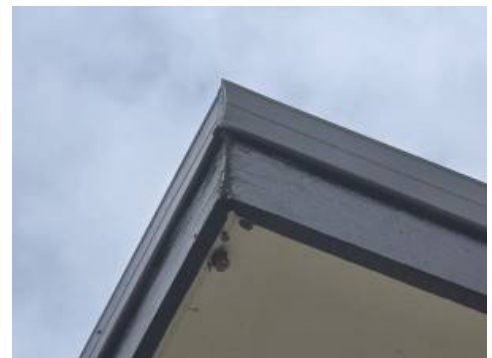
Fascia timbers.

Visible timber damage appears minor to moderate however, this opinion is based on a visual inspection. A special purpose report can offer a more detailed description. Refer to the definitions section of this report.

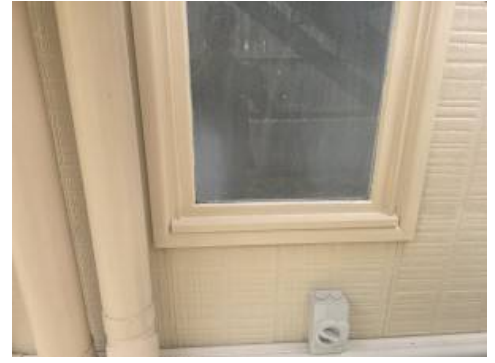
Window frames.

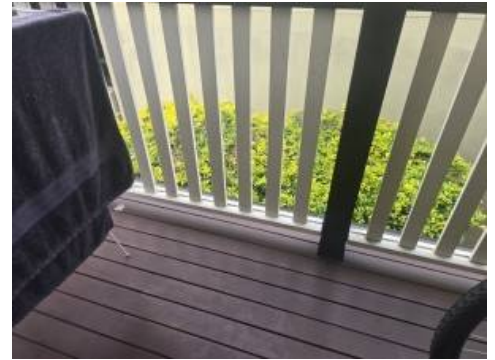
Handrail timbers.

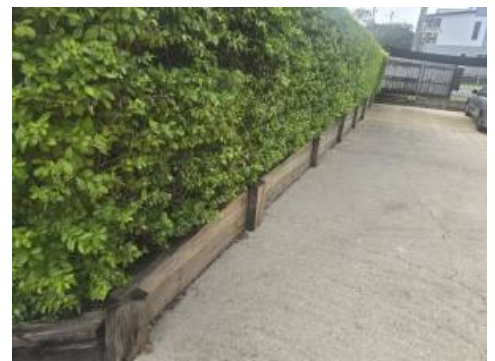
Timber retaining walls.

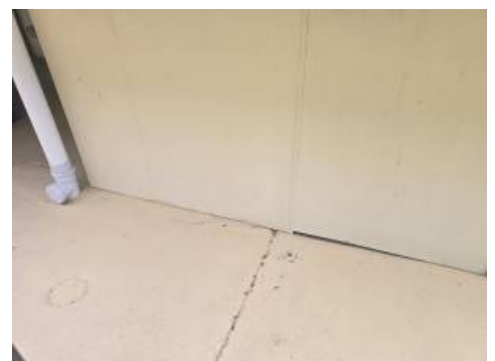
External cladding is in contact with the ground. This can allow concealed termite entry and we recommend modifications be made so that ground is not in contact with cladding.

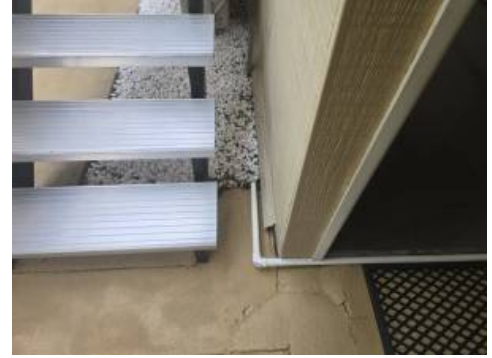
The potential presence of moisture in the form of, Hot water system overflow is discharging moisture adjacent to the structure. We recommend repair, or modification so that water is discharged over or into a drain, not causing damp conditions adjacent to building. These item(s) should be rectified as moist soil conditions are conducive to timber pest attack. Refer 9.0 The Presence of Excessive Moisture.

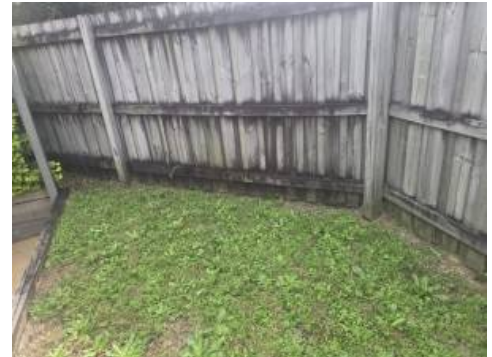
Ground levels have built up against the base of fences in some areas. This build up can cause wood decay and/or conceal current timber pest attack and significantly increases the risk of future attack. Soil etc, should not be built up against fencing timbers and we recommend modifications be made.

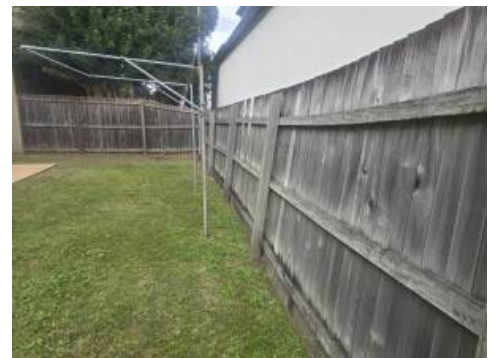
Various fencing timbers:

Visible timber damage appears moderate however, this opinion is based on a visual inspection. A special purpose report can offer a more detailed description. Refer to the definitions section of this report.

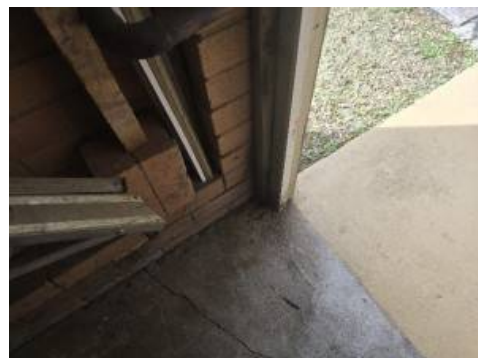
Inspection of the concrete Joins/cold joints appears to have no termite protection. In our experience, termites may enter through these areas and therefore, we recommend that the joins be treated with an approved product to protect from termites gaining entry.

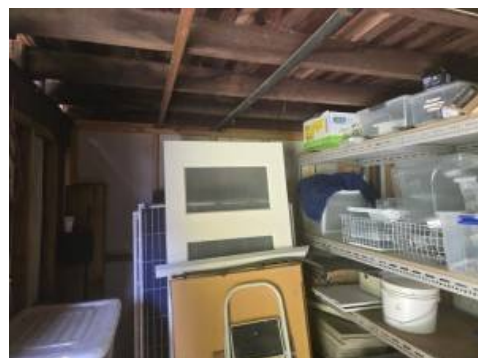
We note the general lack of ant capping or deficiencies. The purpose of ant capping is to reduce the risk of concealed termite attack. As the Ant capping is not continuous or adequate, the option to replace ant capping is not normally economical. Ant capping is installed at the time of construction, and therefore is embedded in the buildings structure. So in this case the most economical procedure is to install a termite management system in accordance with the current building codes and best practices the termite management. Timber partitions walls/ lined sections in subfloor do not have adequate ant capping and therefore are at risk of undetected termite entry. These walls should be modified to allow a visual inspection of presently concealed timbers. A chemical treatment or physical termite barrier may be installed to minimize the risk of undetected termite entry.

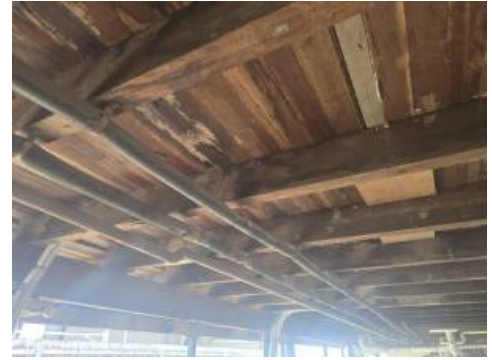
Water staining is present to the flooring in various areas, suggests previous leak, and monitor for any change as moist conditions are conducive to timber pest attack. Refer 9.0 The Presence of Excessive Moisture.
