Pre-Sale Building & Timber Pest Inspection Report

2 Mikado Street Hamilton 4007 Queensland Australia

19 Dec 2025

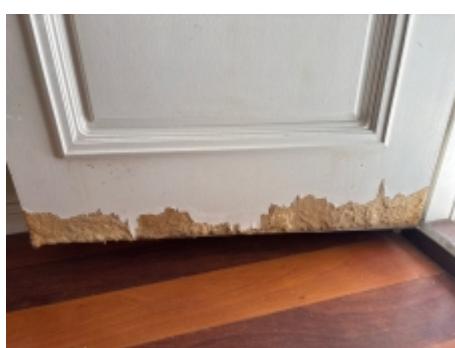
Defect Severity	 Minor Defect
Comment	Damage noted to front entry door

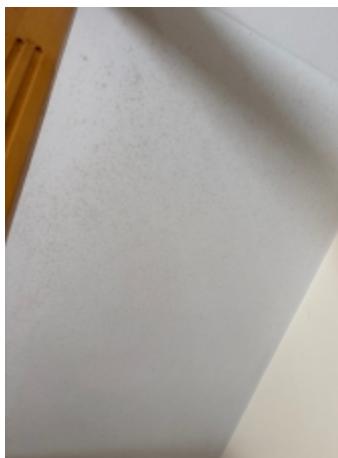
Mould present on ceilings

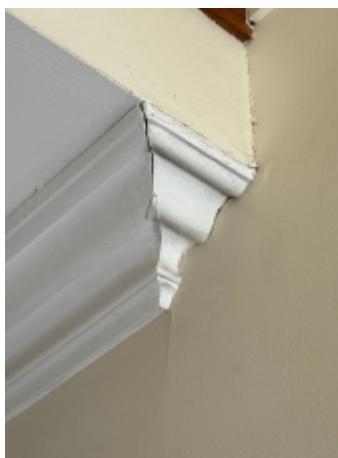
Minor damage noted to cornice

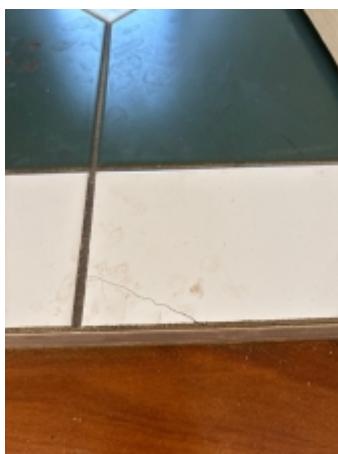
Some cracked tiles were noted to the floor area; this is considered a cosmetic issue;

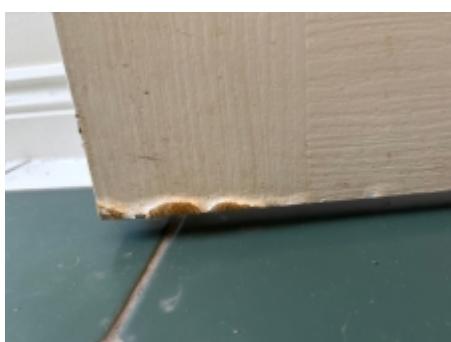
Damage noted to door

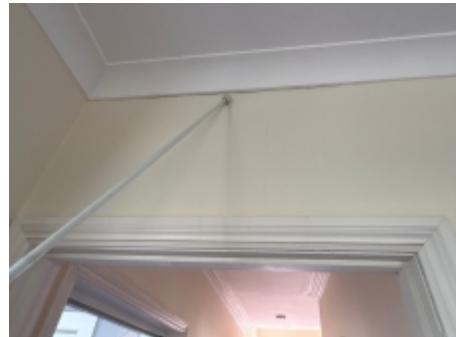
Defect Severity	 Minor Defect
Comment	Water stain on ceiling. The cause of this should be further investigated and rectified if necessary.
Defect Images

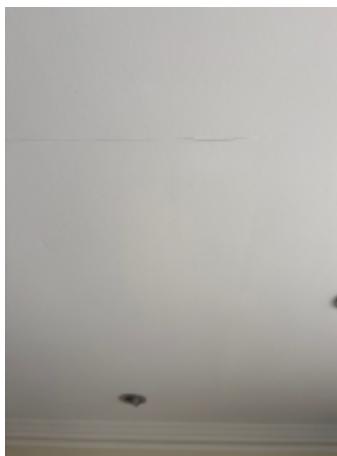
Defect Severity	 Minor Defect
Comment	Minor cracking noted to ceiling

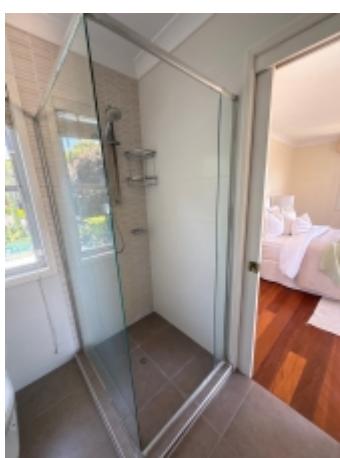
Shower screen door not installed

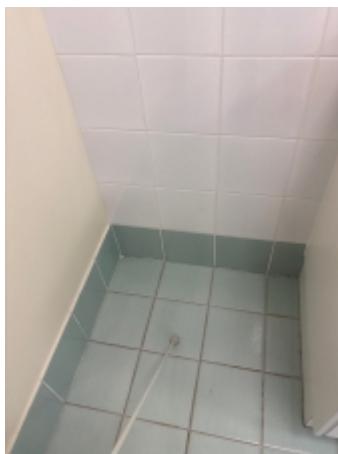
Some drummy tiles were noted to the floor area

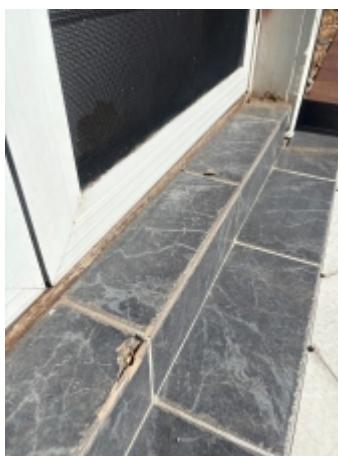
Cracked and drummy tiles noted to the floor

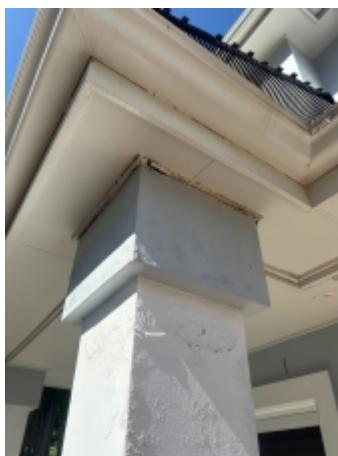
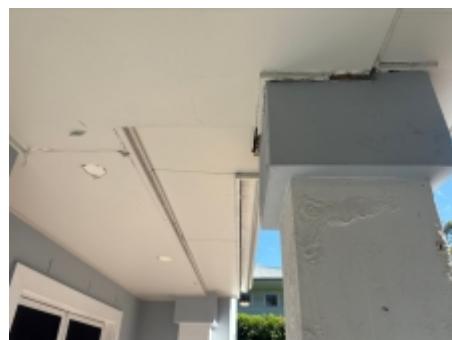
Water damage noted to pier and around soffit.

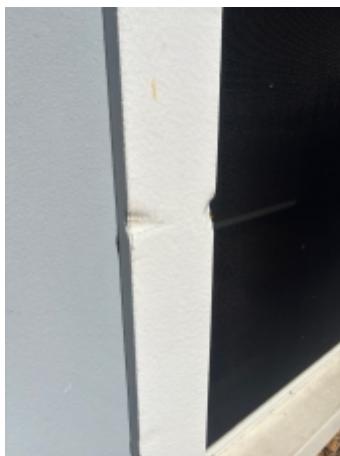
Damage noted to door and window trims

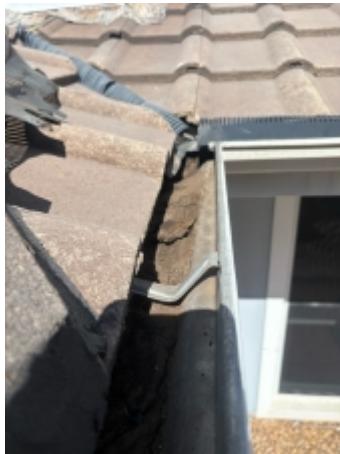
Gutters contain leaves and debris; it is recommended that the gutters be cleaned out.

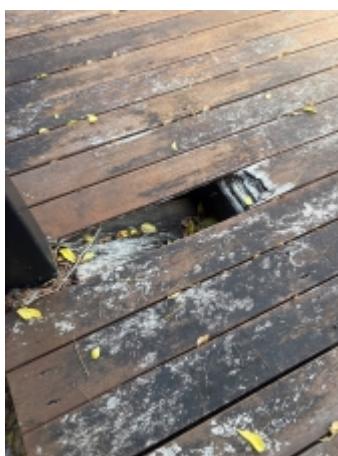
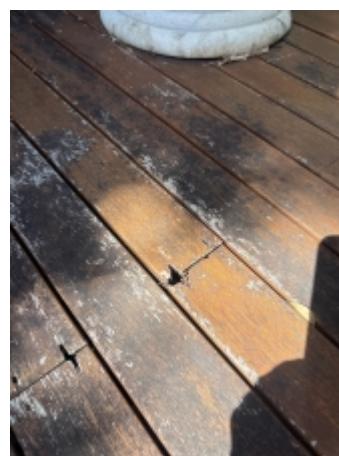
Decay to timber deck requires repairs

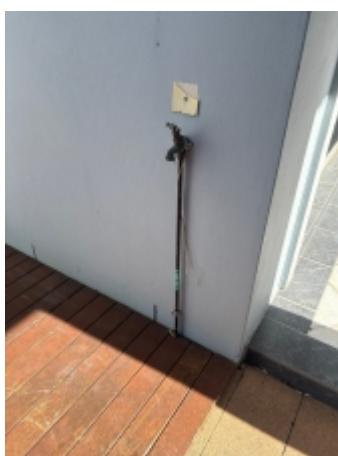
Recommend tap overflow be directed to a drain

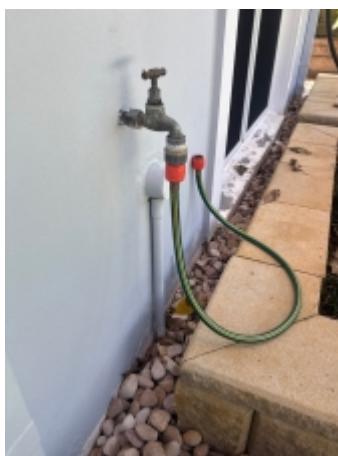
Recommend tap overflow be directed to a drain

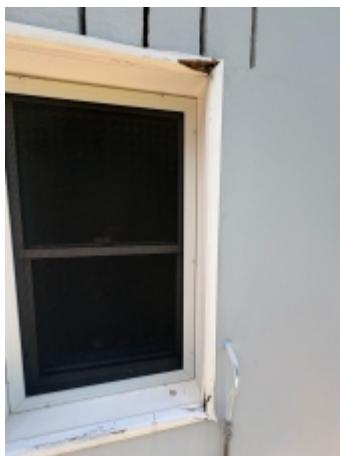
Timber decay noted to trims

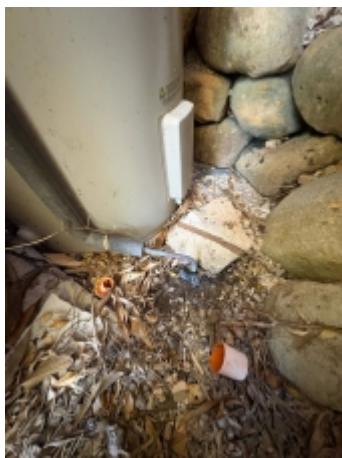
Recommend hot water cylinder overflow be directed to a drain

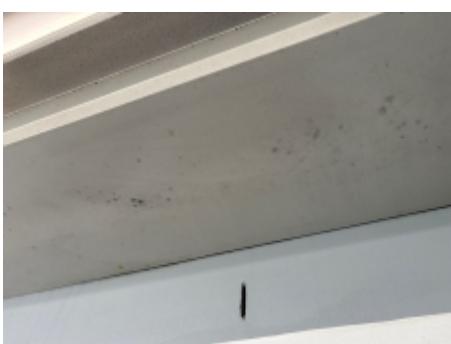
Mould evident to area

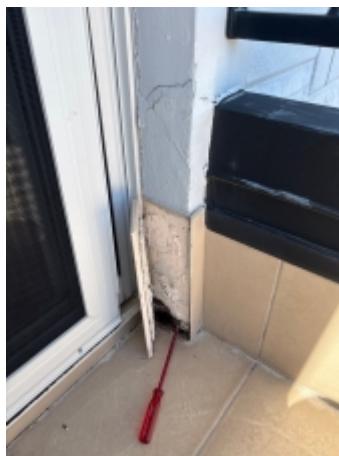
Defect Severity	 Major Defect
Comment	Cracks noted in the cladding and plant root is growing under the tiles

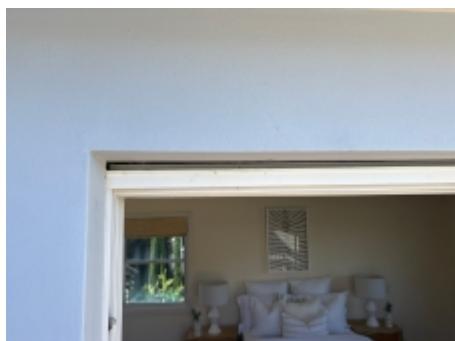
Defect Severity	 Minor Defect
Comment	Recommend sealing gap above sliding door

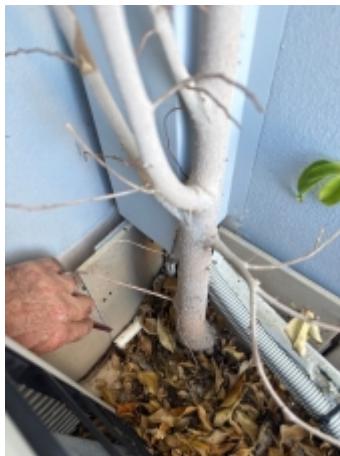
Plant is growing up through the tiled floor. Plant roots have got in behind tiles.

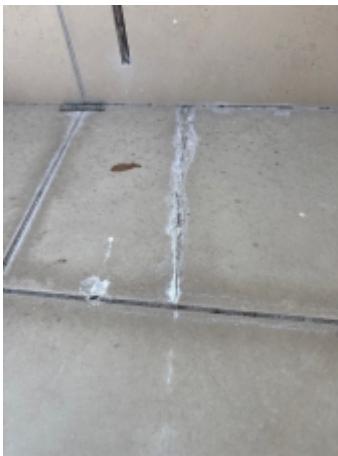
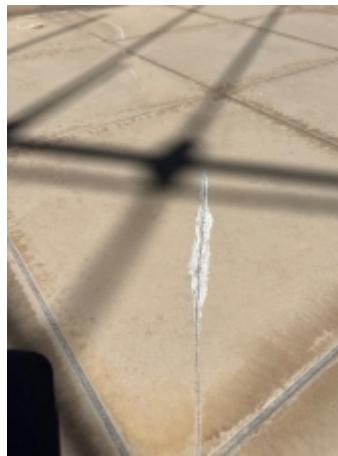
Cracked tiles noted

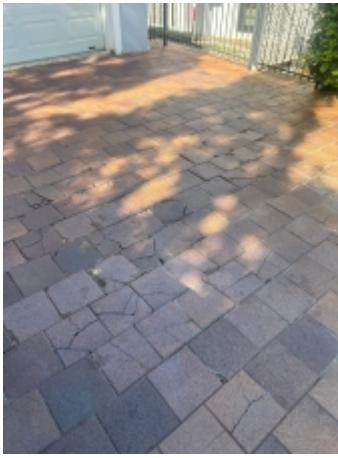
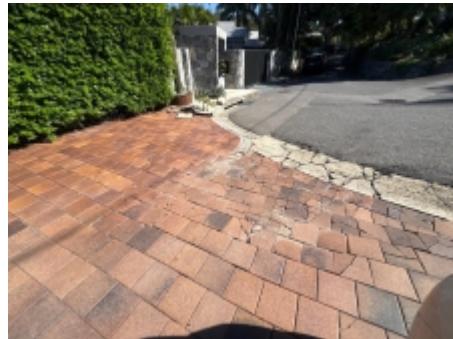
Many cracked pavers noted due to ground subsidence. This may present a tripping hazard. Rectification should be considered.

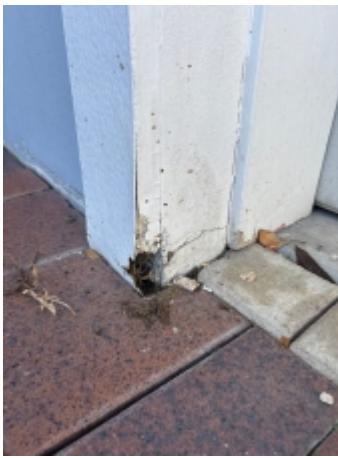
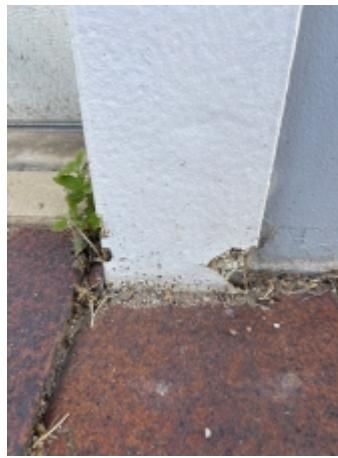
Damaged trims both sides of garage door

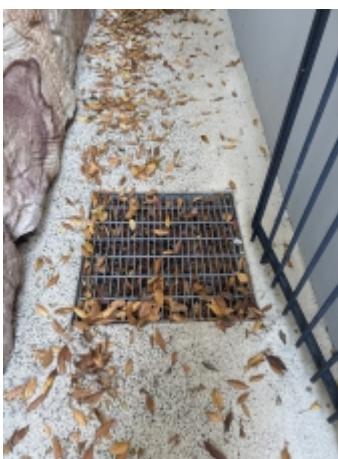
Recommend cleaning out stormwater drain

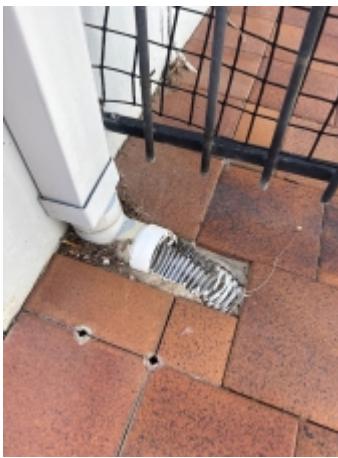
Broken stormwater pipe. Recommend rectification to prevent overflow directing towards dwelling.

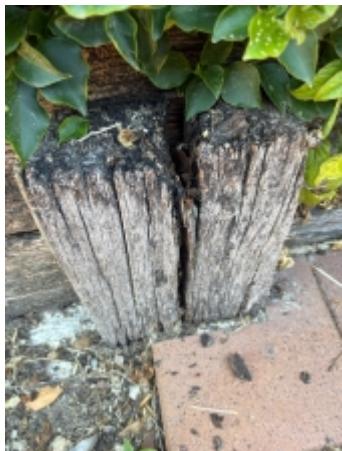
Defect Severity	 Minor Defect
Comment	Decay to timber retaining wall

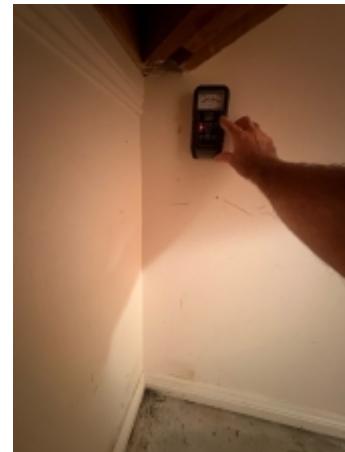
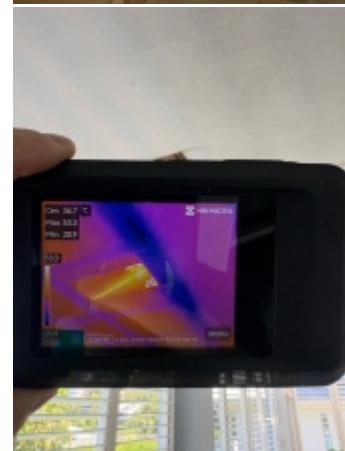
Outdoor area ceiling has had a leak and repairs are on going. Timber moisture levels are high
