Building and Pest Report

Property Address:
75 North St, Kedron

BUILDING & TIMBER PEST INSPECTION REPORT TO AS4349.1 2007 & AS4349.3 2010

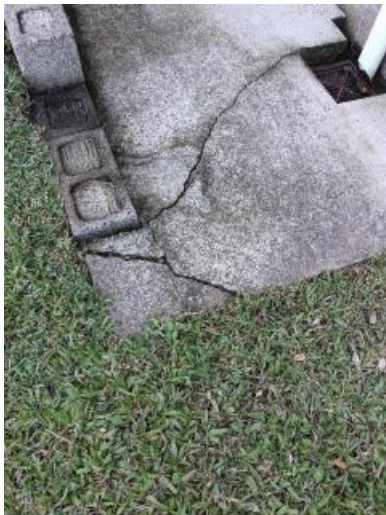
PATHS

Some cracks

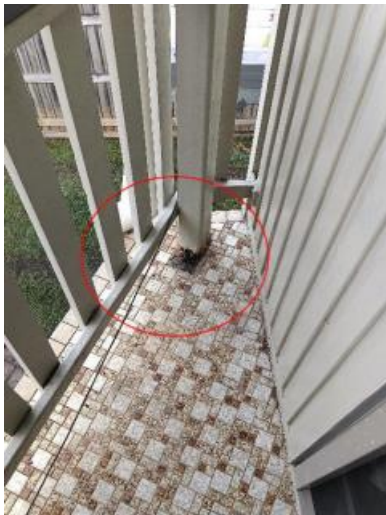
Sever rust noted to steel post on the right corner of the house. Treatment or replacement recommended.

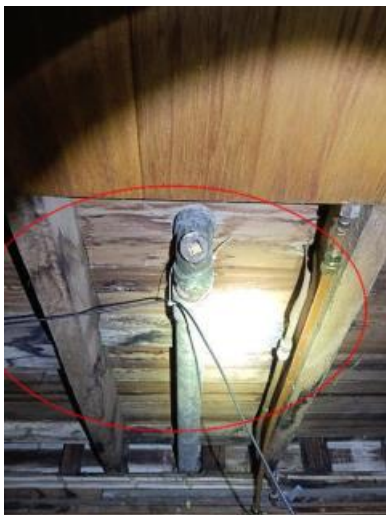
Dampness and Drainage

Past water damage noted below wet areas. No current leak detected.

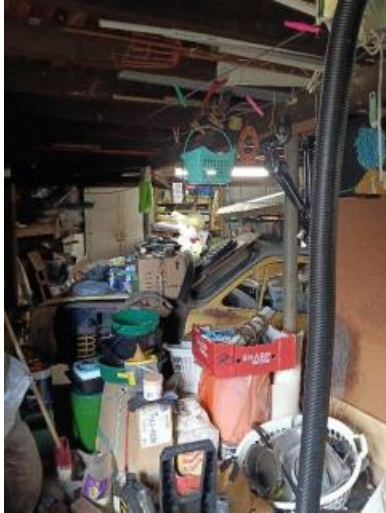
Other (specify)

Stored goods are present in this area and restricted inspection. **Further inspection of these areas is strongly recommended once access has been obtained.**

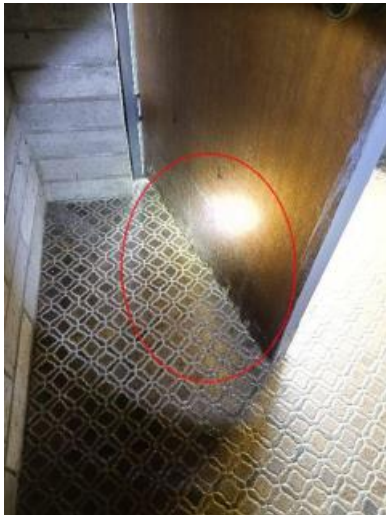
Doors Condition:

Water damage was noted to some doors and will require repair or replacement.

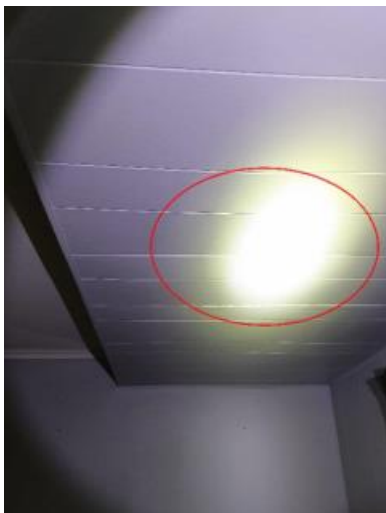
Ceiling Condition:

Moderate undulations were noted to the ceiling lining. This is to be expected in a house of this age. Periodic maintenance will be required.

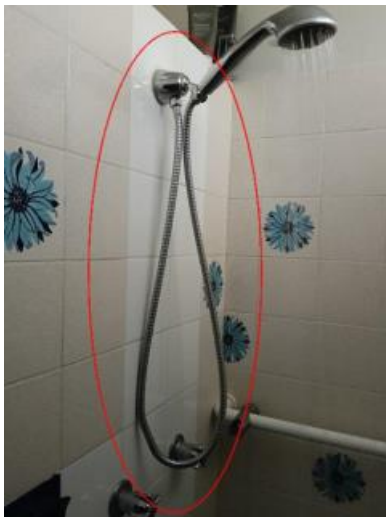
Shower/Bath Condition:

Bathroom tiles have been replaced over the shower combination. The current owner should be asked for more information regarding this.

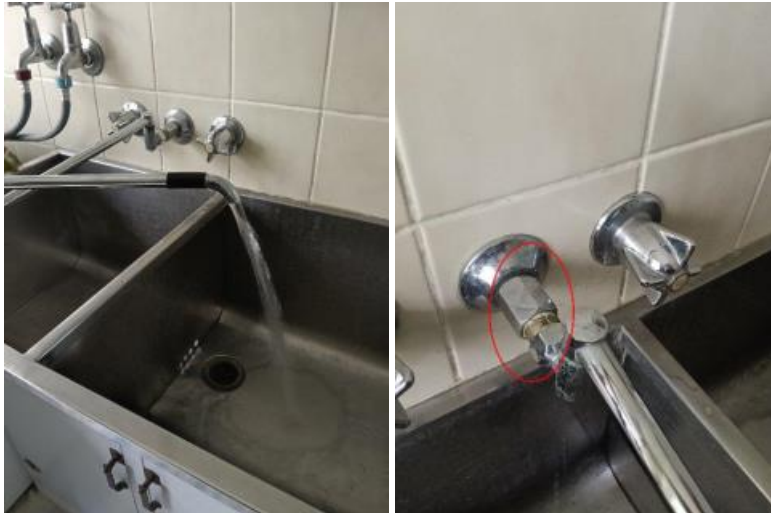
Basin & Taps:

Tap leaks at o-ring/seals. Repairs are required.

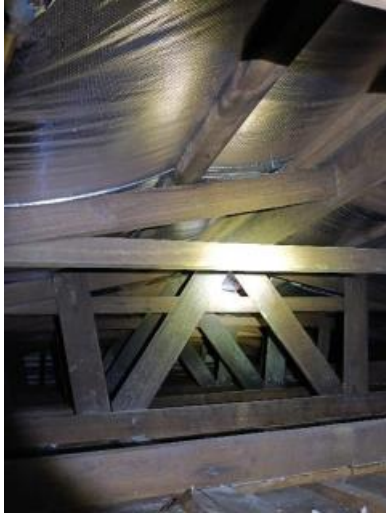
Restrictions to Inspection

Sarking paper covered roofing battens restricting inspection. Removal of sarking paper is not within the scope of a standard building inspection report.

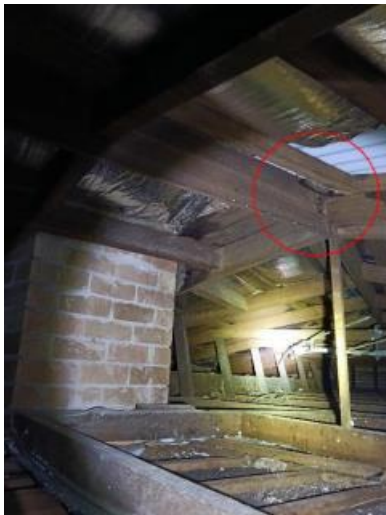
Roofing Frame - Type and Material

May have been a previous leak. No current leak detected.

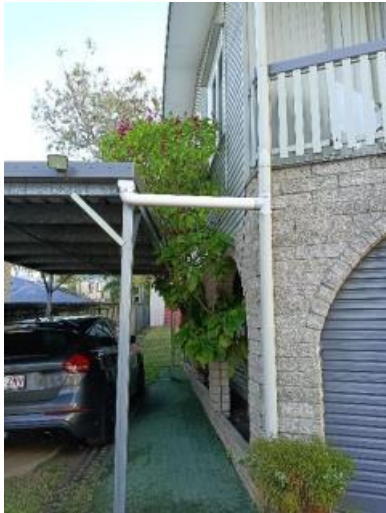
- Remove garden beds and vegetation close to or abutting the external walls of the structure. These can attract / allow concealed termite entry and should be removed.
