# Caboolture Building & Pest Inspections

## PRE-SALE STANDARD BUILDING REPORT

Report number: 2026048

Property address: 9 Newman St  
Caboolture

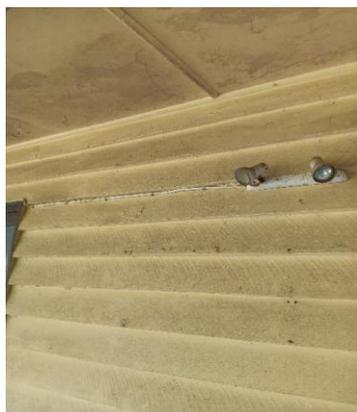
All electrical to be checked by an electrician.

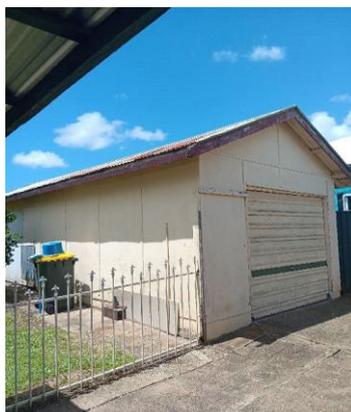
Rear Shed.

Major.

No access into the shed.  
External wood decayed timbers plus guttering and a new roof required. Recommend a builder to replace all as required. High chance of asbestos sheeting.

- Safety Hazards.  
Subject to the age of the property, there is a high possibility of asbestos sheeting. If the buyer is concerned, we would recommend an asbestos inspector to inspect and report on the house.

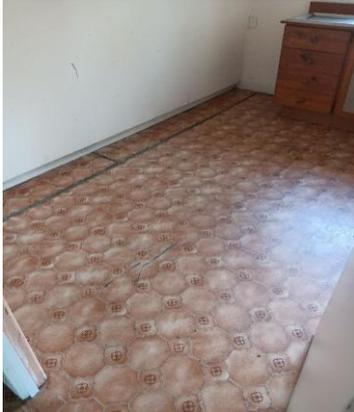
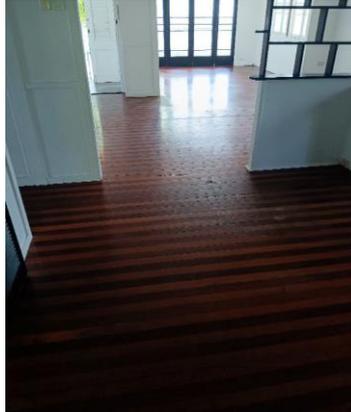
Major.

Please note that the floors are out of level. This is subject to fact that the timber stumps have deteriorated under the house. Recommend a builder to fix this.

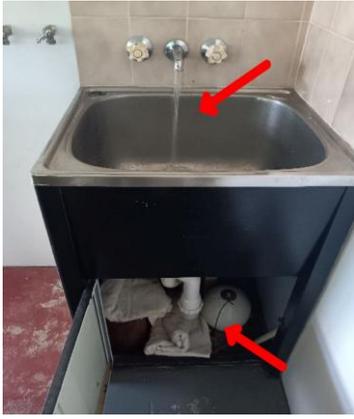
Laundry.

Signs of a past water leak.  
Recommend a plumber to fix  
required.

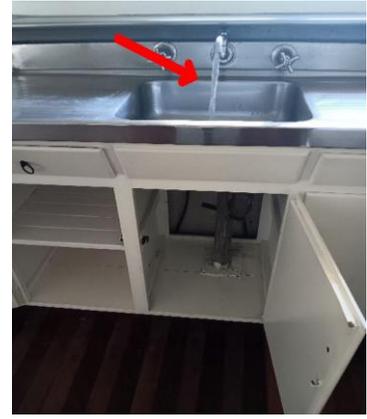
Kitchen.

No water leaks were found  
under the kitchen sink on the  
day of inspection.

Minor water stains and  
moisture damage to the  
cabinets. Please note that this  
was dry on the day of  
inspection.

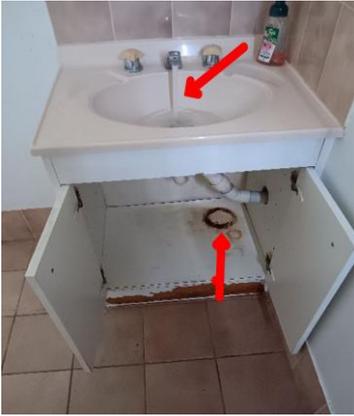
Rear Eastern Bathroom.  
No water leaks were found on the day of inspection. Signs of past water leak to the cabinet.

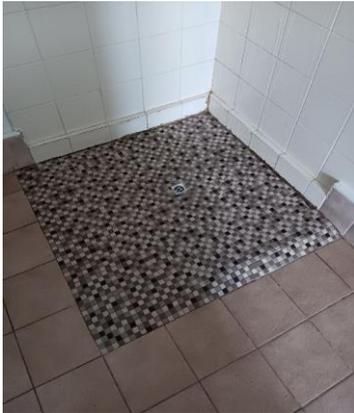
Major.  
Rear eastern shower tray. Handyman shower tray. Please note will leak subject to there being no membrane installed. Recommend a builder to rebuild this

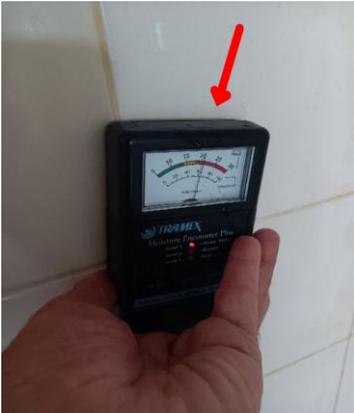
Moisture Readings Found- Major Defect.  
Rear eastern bathroom. Major moisture readings were found as per the photo supplied, after using a Tramex Plus moisture unit.

Major moisture readings were found to the rear eastern bathroom.  
Please note, water leaks can occur at any time. Recommend the owner to visually inspect all wet areas.

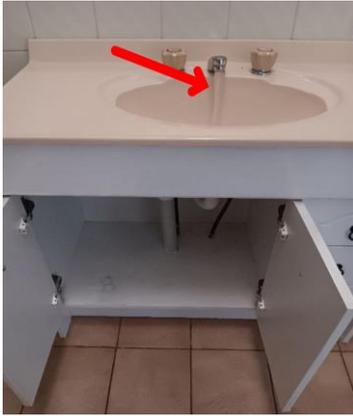
**Main Bathroom Vanity.**  
No water leaks were found inside the cabinet on the day of inspection.  
Please note, the red arrow shows the water running for water leak inspection.  
Minor stains & minimal moisture damage to the cabinet. (This was dry on the day of inspection.)

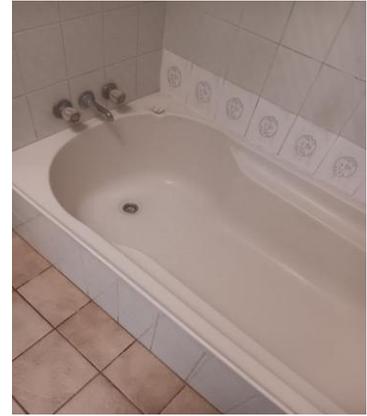
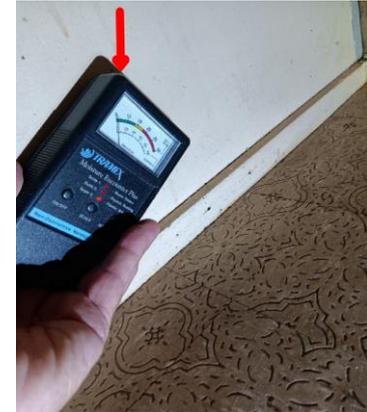
**Main Bathroom.**  
**Moisture Reading Test.**  
( Internal wall reading)  
No major moisture readings or water leaks were found around the wet areas or behind the shower recess on the day of inspection.  
Please note, water leaks can occur at any time. Recommend the owner to visually inspect all wet areas.  
Water leaks were found in the subfloor section.

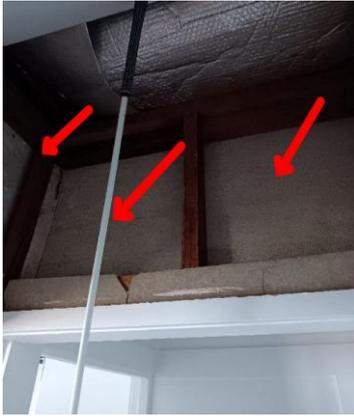
Roof cavity.  
Signs of possible asbestos sheeting. Recommend an asbestos inspector to check this however, we cannot access a roof cavity that has asbestos dust. Sorry.

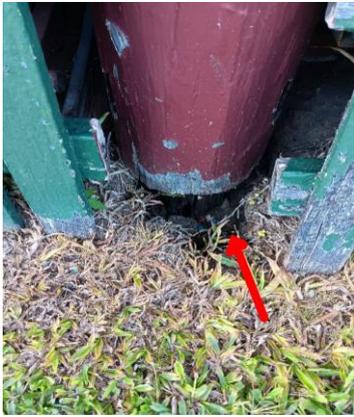
Major Structural.  
Deterioration to the timber stumps under the house.  
Recommend that all the timber posts be replaced by a builder.

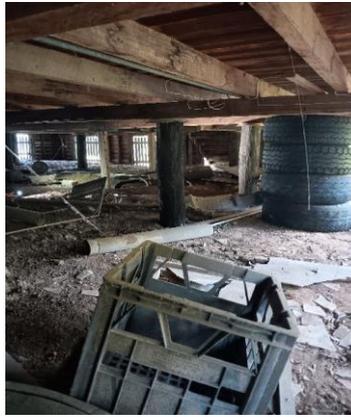
Obstructions to the subfloor area.

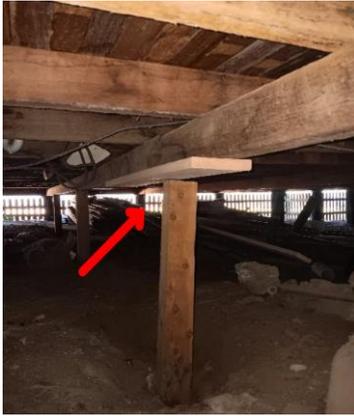
Major Structural.

Please note that a handyman has tried to replace the timber stumps under the house. Recommend a builder to do this.

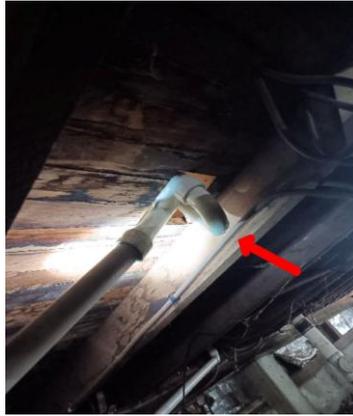
Minor.

Water leaking from the bath area. Recommend a plumber to fix this.

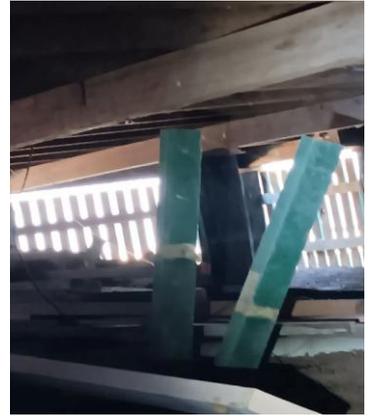
Major Structural.

Handyman installation of structural posts. Recommend a builder to replace all the timber posts under the house.

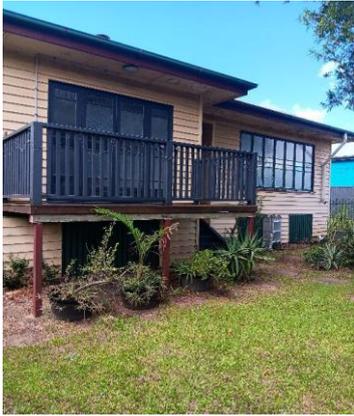
External cladding has deterioration. Recommend a builder to replace any wood decayed timbers.

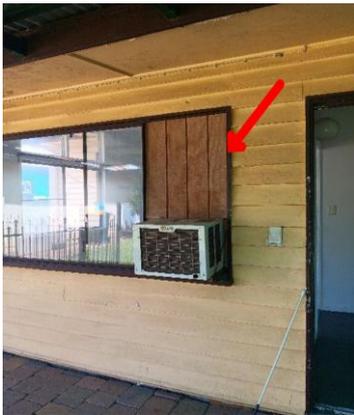
Minor.  
The rear eastern window requires replacing.

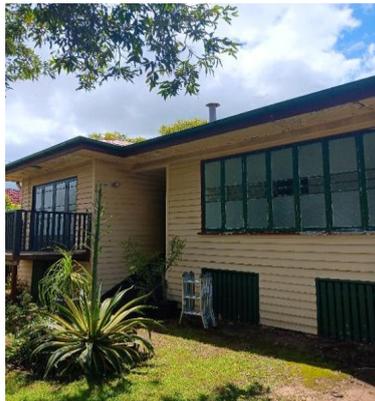
Major.  
Recommend a carpenter to fix all the windows, window frames & sills as required around the house.

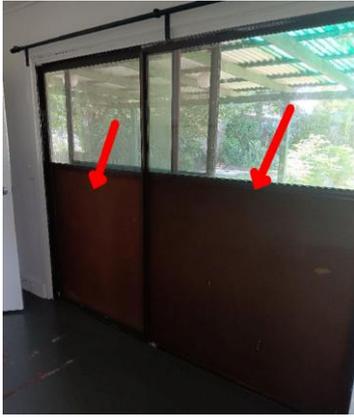
Major.

The rear eastern glass door panels require replacing by a glass door specialist.

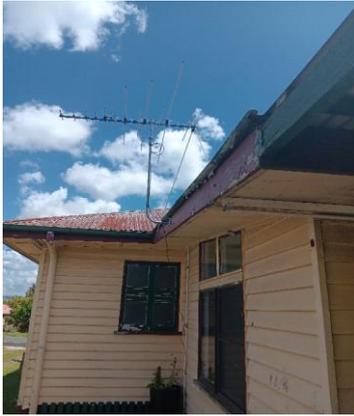
Wood decay to the fascias.  
Recommend a builder to  
replace or repair as required.

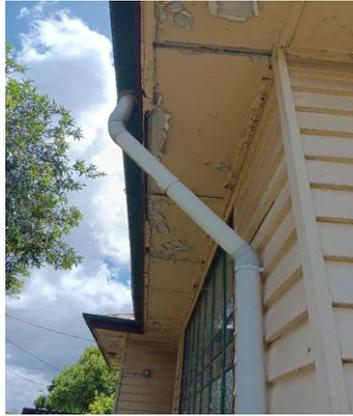
Major.  
Eave sheets require repairing  
and repainting by a builder &  
painter.

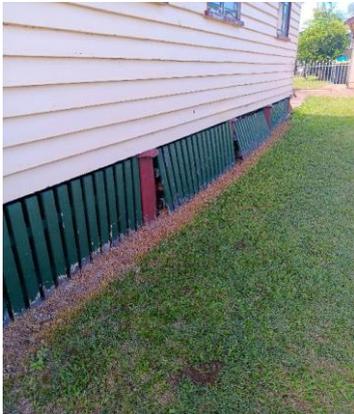
All external balustrade timbers  
will require replacing or  
reinstalling by a builder.

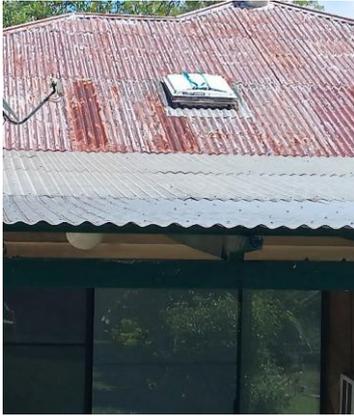
Major.  
The total roof requires replacing by a builder.

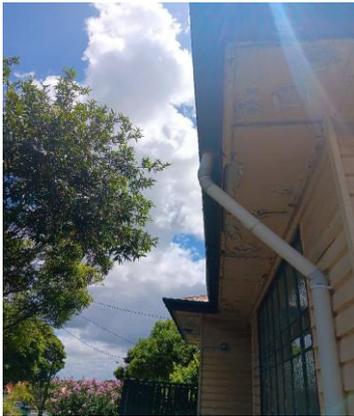
Sections of rust to the guttering. Recommend a plumber to replace as required.

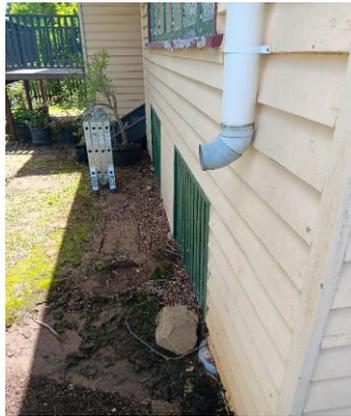
Major.  
Recommend that all the downpipes be directed to the storm water service by a plumber.

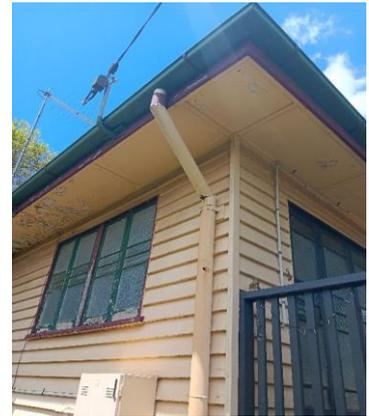
Recommend that any rusty downpipes be replaced by a plumber.

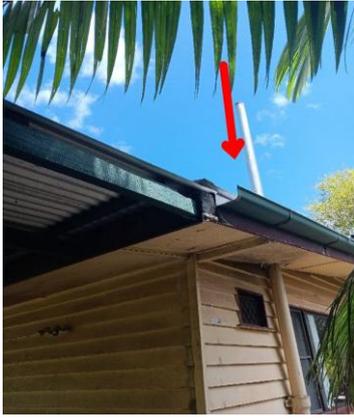
Minor.

The guttering on the northern side of the house to be fixed by a plumber.

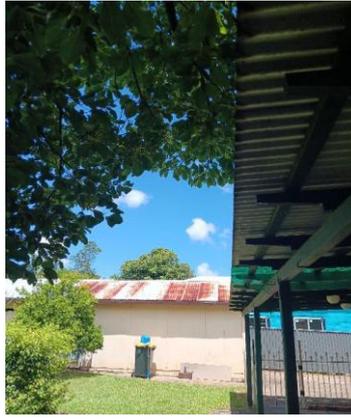
Minor.

Guttering required for the rear eastern pergola. Recommend a plumber to fix this.

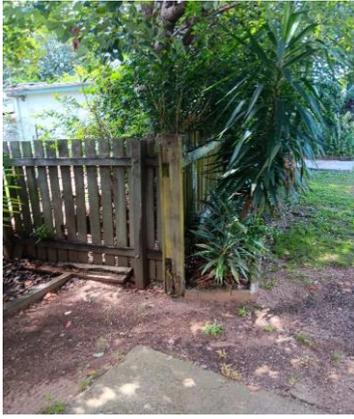
Major.

Northern fence requires replacing by a carpenter.

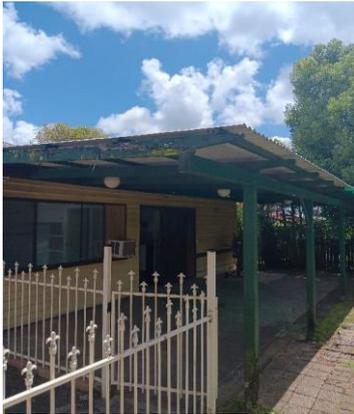
Major wood decay to the rear eastern pergola timber frame.

Recommend a builder to replace all damaged timbers.

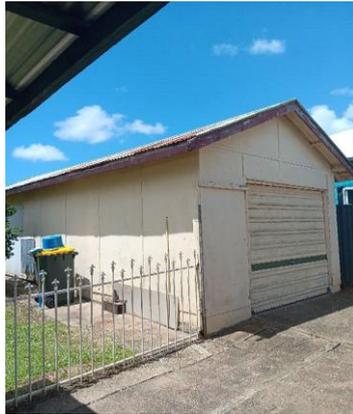
Rear shed.

Major.

No access into the shed. External wood decayed timbers plus guttering and a new roof required. Recommend a builder to replace all as required. High chance of asbestos sheeting.

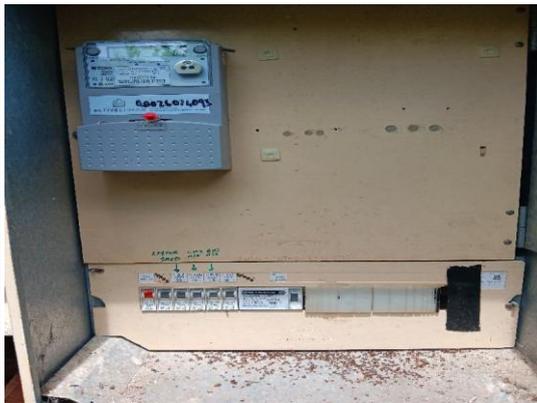
Switch Board.  
Observation Only. (Not listed as a Defect.)  
Attached is a photo of the switch board.  
If the buyer is concerned, we recommend an electrician to check that all required safety switches have been installed.
